Wells Cathedral West Front pilot study: Setting the tone for appraisal and repair strategies

Received (in revised form): 16th May, 2022

Berenice Humphreys

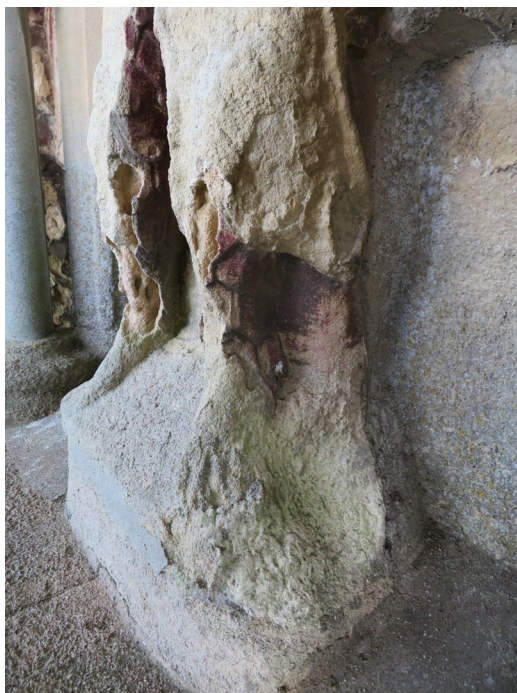
Figure 3: Typical blistering patterns and loss of structure to form

In addition to designing mortars that were a suitable match for the stone itself, the method of application and also extent of repairs needed careful agreement with the cathedral team. Some of the figures (particularly the angels) are unidentifiable 'blobs' of stone, with blistering to their legs (see Figure 3) and lack of features to their bodies and faces. There are few photographs of the sculptures to aid in building up the shape of the figures, and care needed to be exercised not to be conjectural in the application or styling of repairs. Having said that, it was also important to ensure the figures could be 'read' in their sculptural form.

- Mortars should not have feathering edges which would dry out and fail;
- Where blistering edges of the stone (generally on the front side of the angels) were noted, the mortars would carry *over* the blister, to act as a protective skin to prevent further blistering;
- Where historic mortars were sound to the touch but had lost their edges, they would be cut back to sound material and filleted;
- Where mortars sounded hollow to the tap, they would be gently removed and replaced;
- Sculptural form would only be attempted where there was a clear line to follow — legs, arms and in some cases wing tips. The front of the torso was increased on some of the more decayed figures of angels and resurrection tiers to give shape,

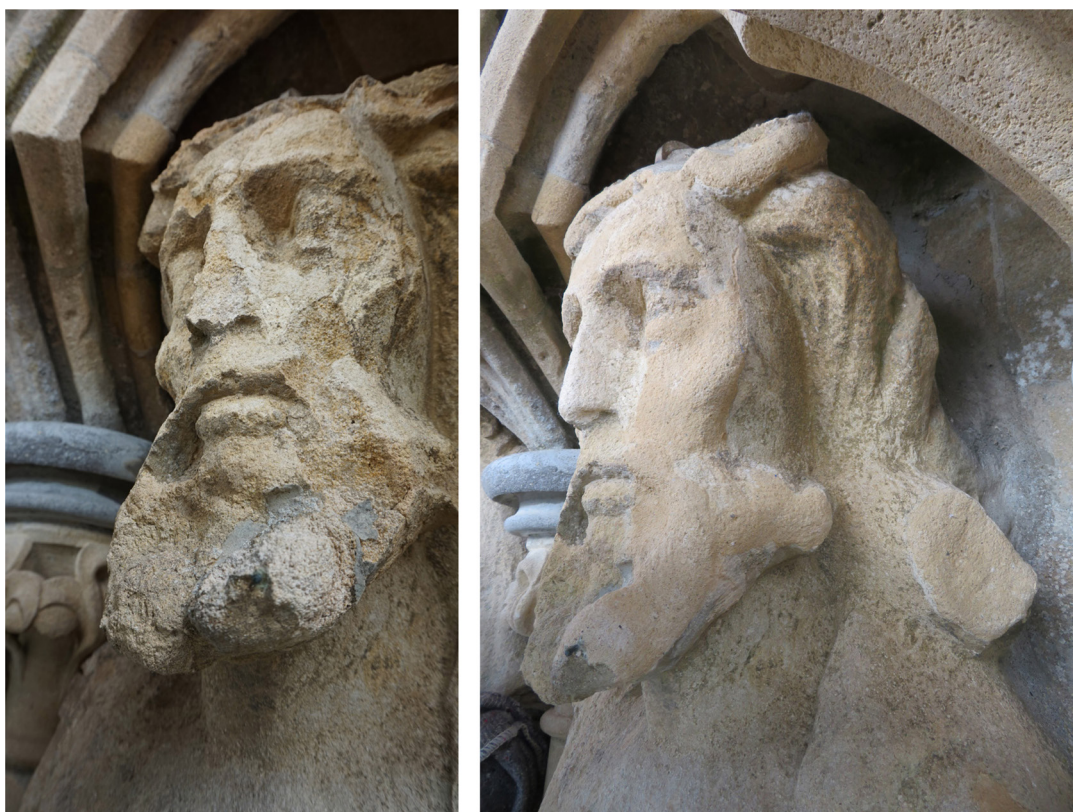
Figure 4: The head of St Peter before and after

- Where the repair was intended to provide sculptural form, the aim was for a closed texture which would mimic the finish of newly carved stone (see Figure 4). Where the mortar was a cap to prevent water ingress, this would be left open to aid evaporation.

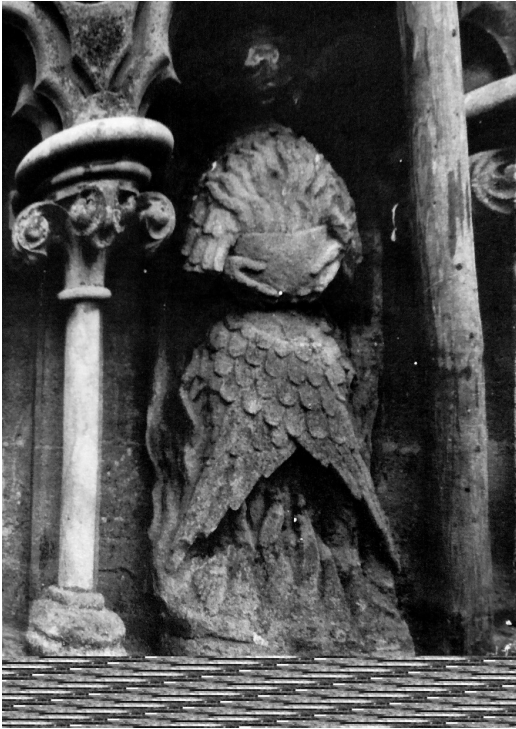
Figure 5: Angel 021 historical image (date unknown, pre-1930s)

using sheltercoats, the tradition would continue, and there was good evidence to show they would help to protect the new mortars and any cleaned stone surfaces (see Figures 5 and 6).

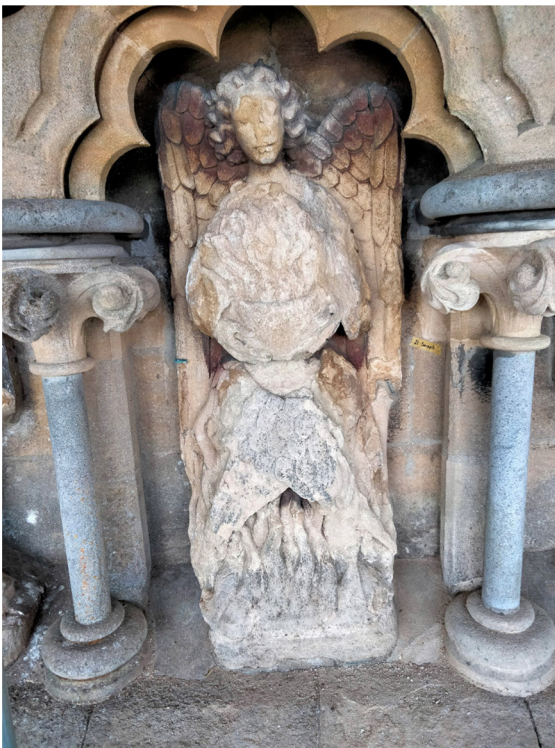
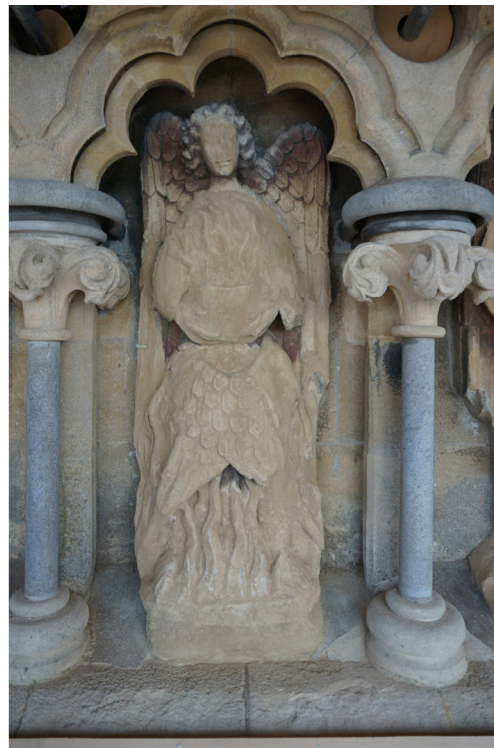
Figure 6: Angel 021 before and after works

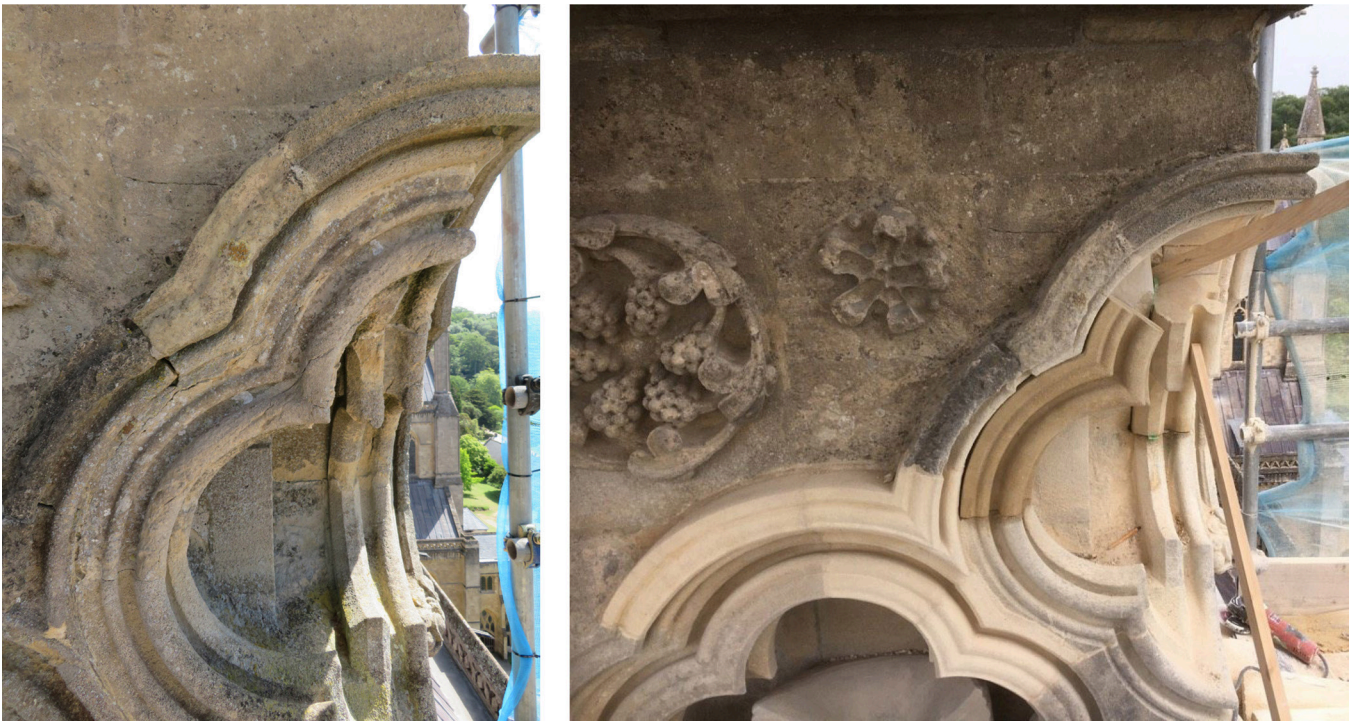
Figure 7: Quatrefoil section before and during works

The following areas were replaced, cutting out the existing to as small an area as possible to provide adequate fixing, and new carved stone dowelled into position using a stainless steel dowel and epoxy acrylic resin. All joint beds had a lime mortar slurry.

- The right-hand quatrefoil to the upper gable (see Figures 7 and 8);

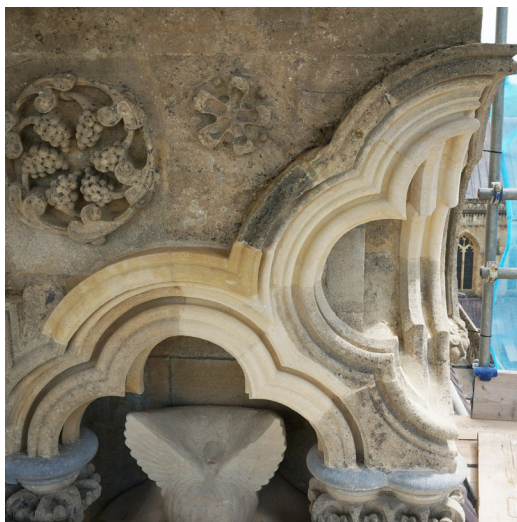
Figure 8: Completed stone repairs to quatrefoil

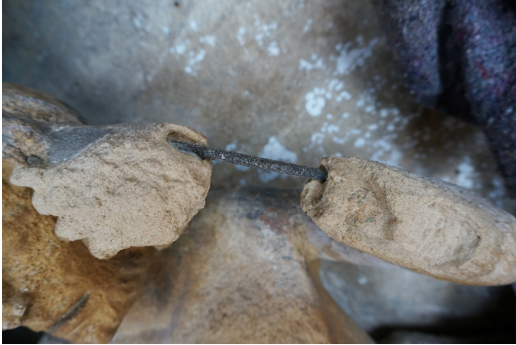
Figure 9: 'Rockbar' dowel used as armature for figure

Hand-made ceramic dowels were incorporated into the mortar repairs to act as armatures, and a small dowel of 'Rockbar' was used to bridge a gap when recreating a missing arm (see Figure 9).

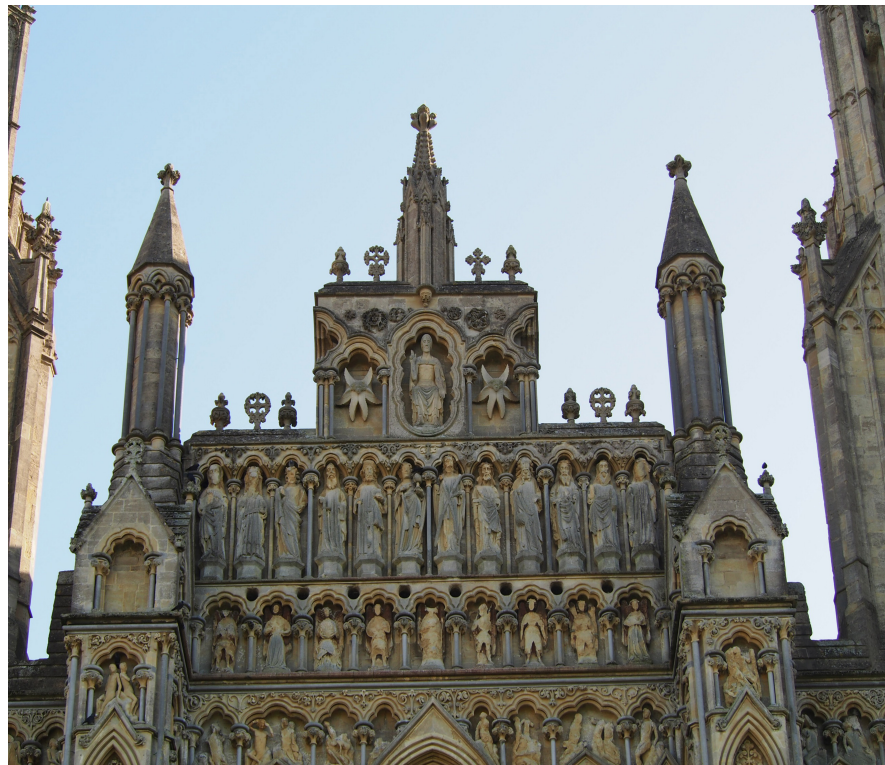
Figure 11: Before works

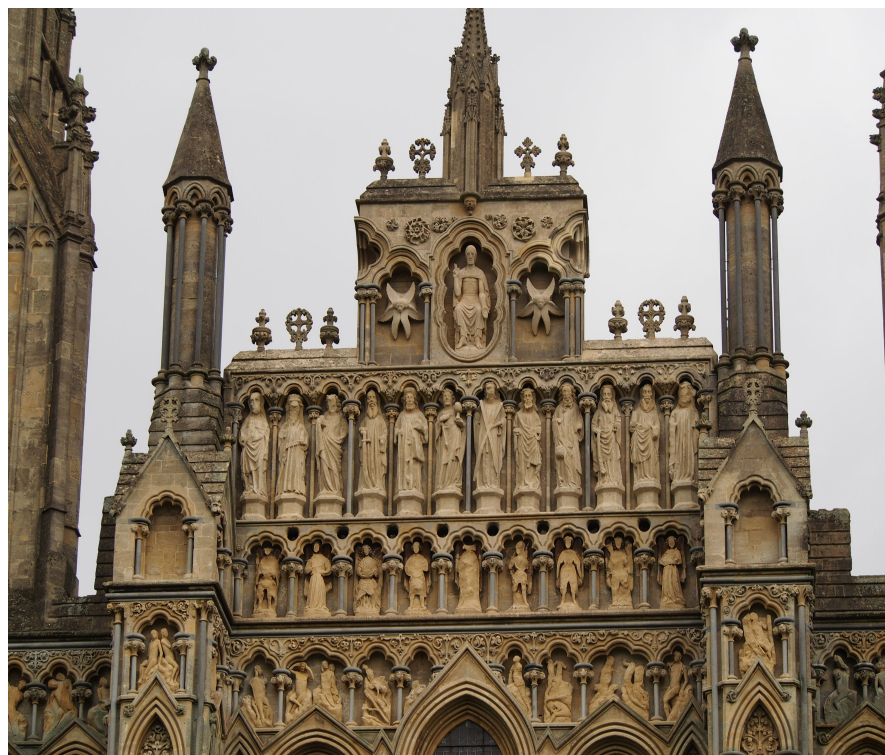
Figure 12: The completed works
