## **Tree Inspection Report**

**Lancing College Preparatory School  
Hove**

**April 2019**

**Our reference:** TIR/0419/1

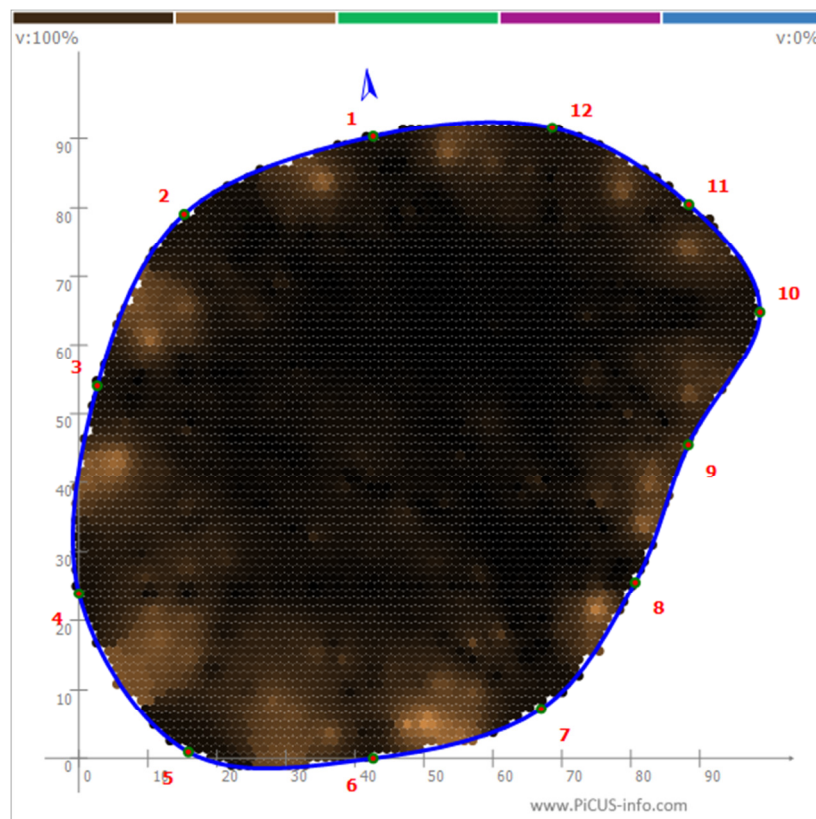
No decay is indicated on the tomogram.

In view of the result no further investigation was undertaken and no other action appears necessary in relation to the lower stem at present.

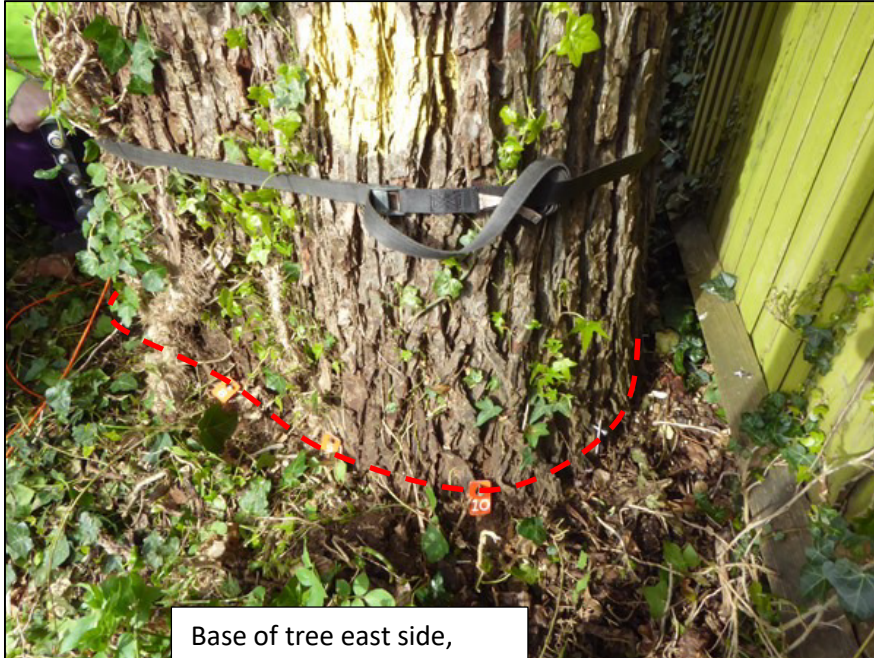
Base of tree east side,  
showing the level of  
assessment (red dotted  
line)

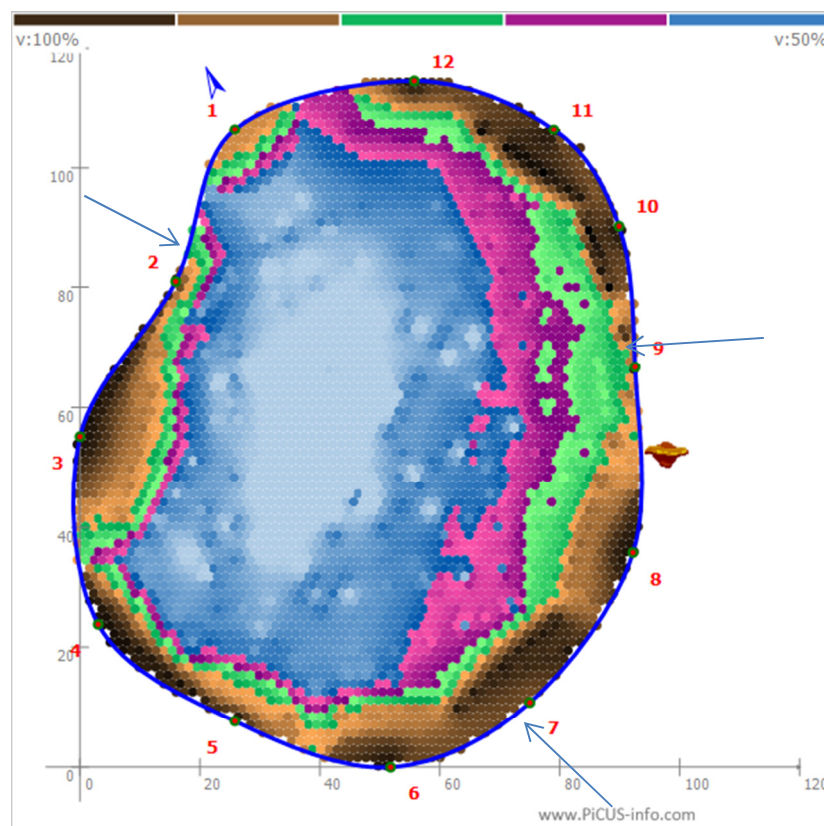
The tomogram appears to indicate extensive decay/hollowing within the stem (area coloured maroon/blue).

The combined results confirm the presence of extensive internal decay and hollowing in the lower stem of this tree; significant crown reduction has already been recommended in the recent report by DAA but in view of the results of this investigation and the tree's proximity to a neighbouring residence, removal may be appropriate.

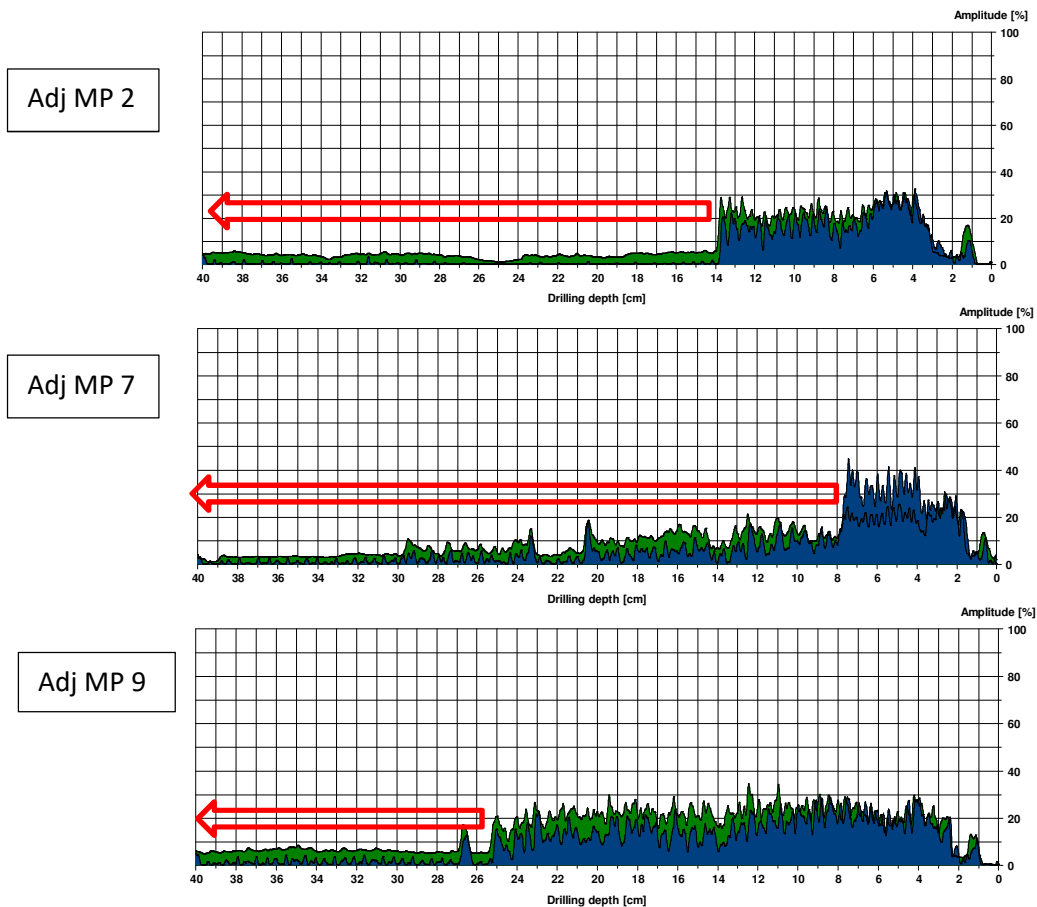
Advanced decay and hollowing is indicated on each measurement with the Resi (highlighted with a red arrow). Depths of residual wood at each point are 14, 8 and 25cm respectively, including the initial bark layer of approximately 2cm.

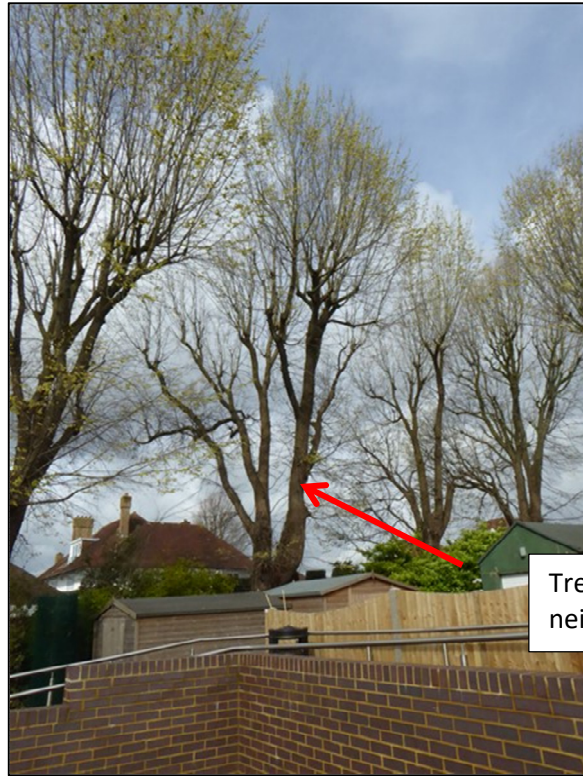
Tree's location adjacent neighbouring residence

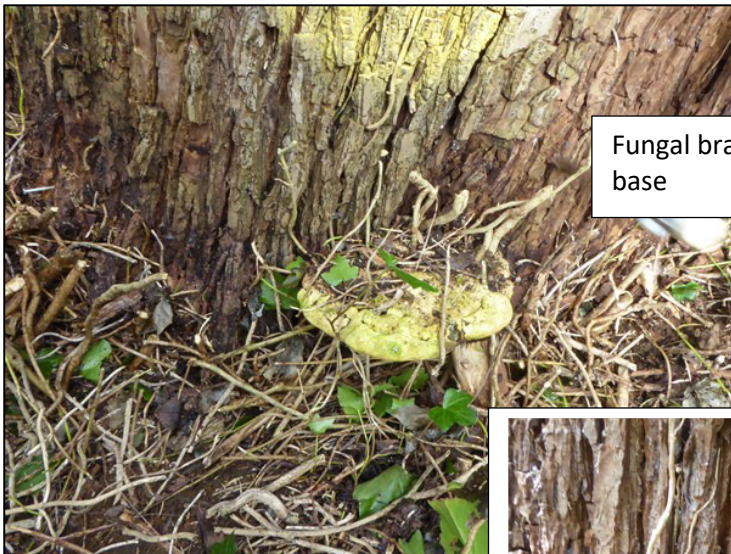
The crown has been heavily reduced previously; visual assessment of the base revealed a fungal bracket on the east side, indicating colonisation with *Rigidoporus ulmarius*, a common cause of extensive 'brown rot' and possible hollowing on older trees of this species. A small basal wound was also noted on the north side, containing fungal mycelium. An occluding pruning wound at 2.5 metres on the south east side also exhibited a fungal fructification, although positive identification was not possible due to its advanced state of deterioration.

Fungal bracket east side of base

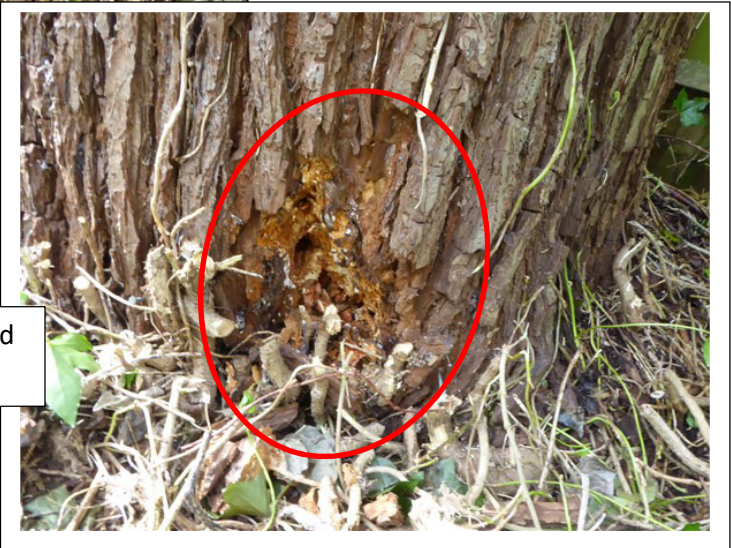
Deteriorating basal wound north side

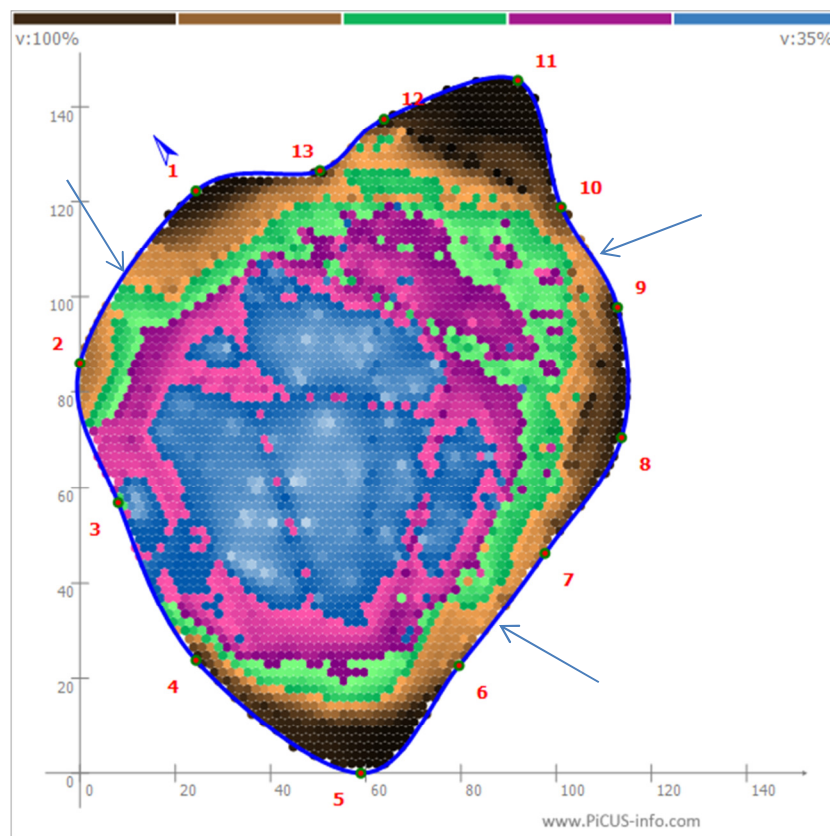
The tomogram again indicates low sonic velocity across much of the stem; the basal wound is located between MP 3-4.

It is apparent from the combined results that extensive internal deterioration is present in the base of this tree, presumably associated with the wound on the west side of the stem. Crown reduction is again recommended in the DAA report but in view of these results it may be prudent to consider complete removal.

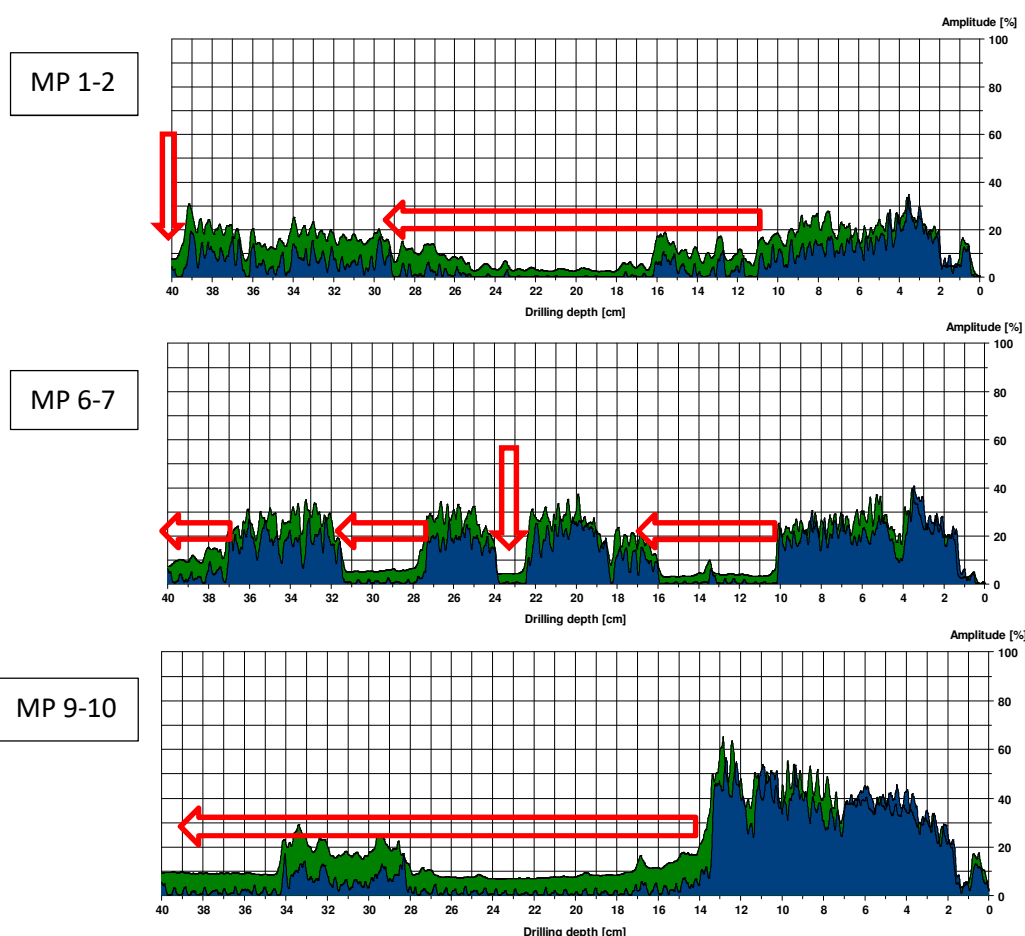
Each of the measurements records the presence of decay, although drilling resistance was erratic on the first two drillings, probably due to the probe passing through small 'islands' of less decayed wood. Drilling resistance drops to the base line on both of these drillings just before the maximum drilling depth of 40cm, and presumably further into the stem. Decay commences at a depth of just 14cm on the final drilling at MP 9-10.

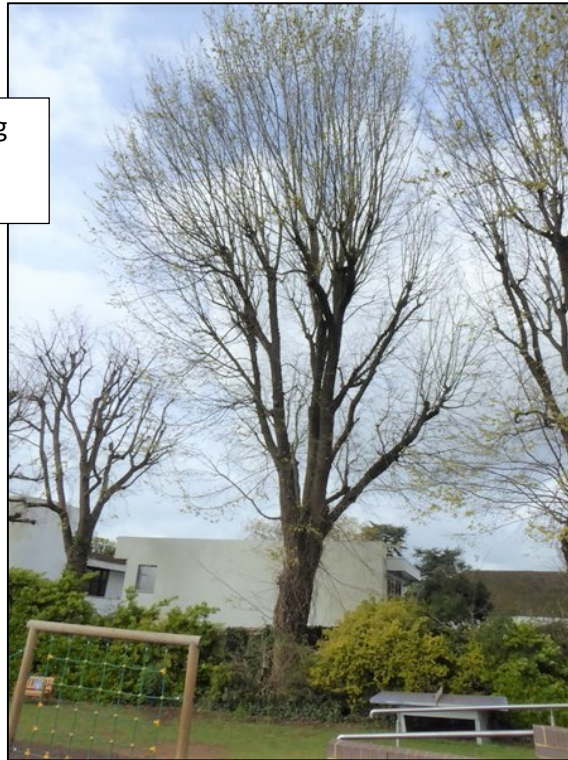
Tree canopy showing vigorous regrowth since last reduction

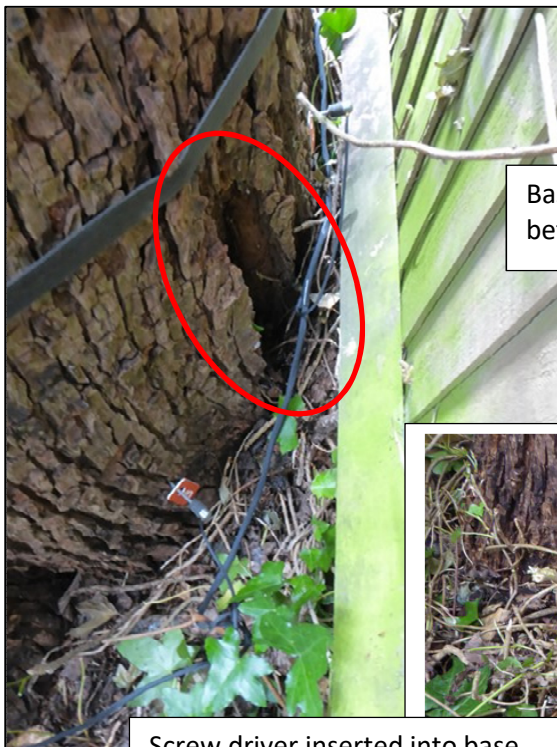
The tree occupies a similar position to T27 immediately adjacent the west boundary of the site; the crown has also been significantly reduced some years ago, although regrowth since that time has been vigorous. Initial inspection revealed the presence of a small basal wound and cavity on the west side; tapping with a nylon hammer also revealed an altered resonance around the base, suggesting internal deterioration.

Basal wound on west side between MP 3-4

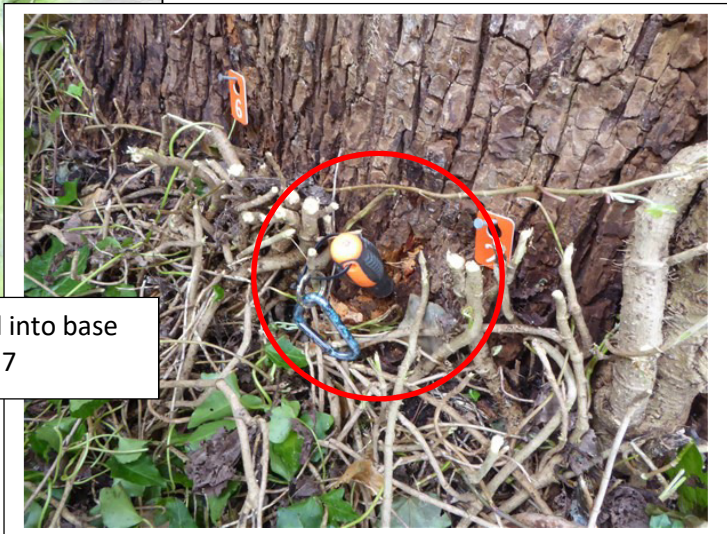
In addition to these indications of decay it was also possible to insert a long screwdriver into the base of the stem just below the level of Picus assessment on the south side, suggesting that deterioration is more extensive below ground level (see photo overleaf).

Screw driver inserted into base of stem adjacent MP 7
