NONCONFORMANCE - REPORT LOG & STATUS BOOK

1. PROJECT NO. 7220

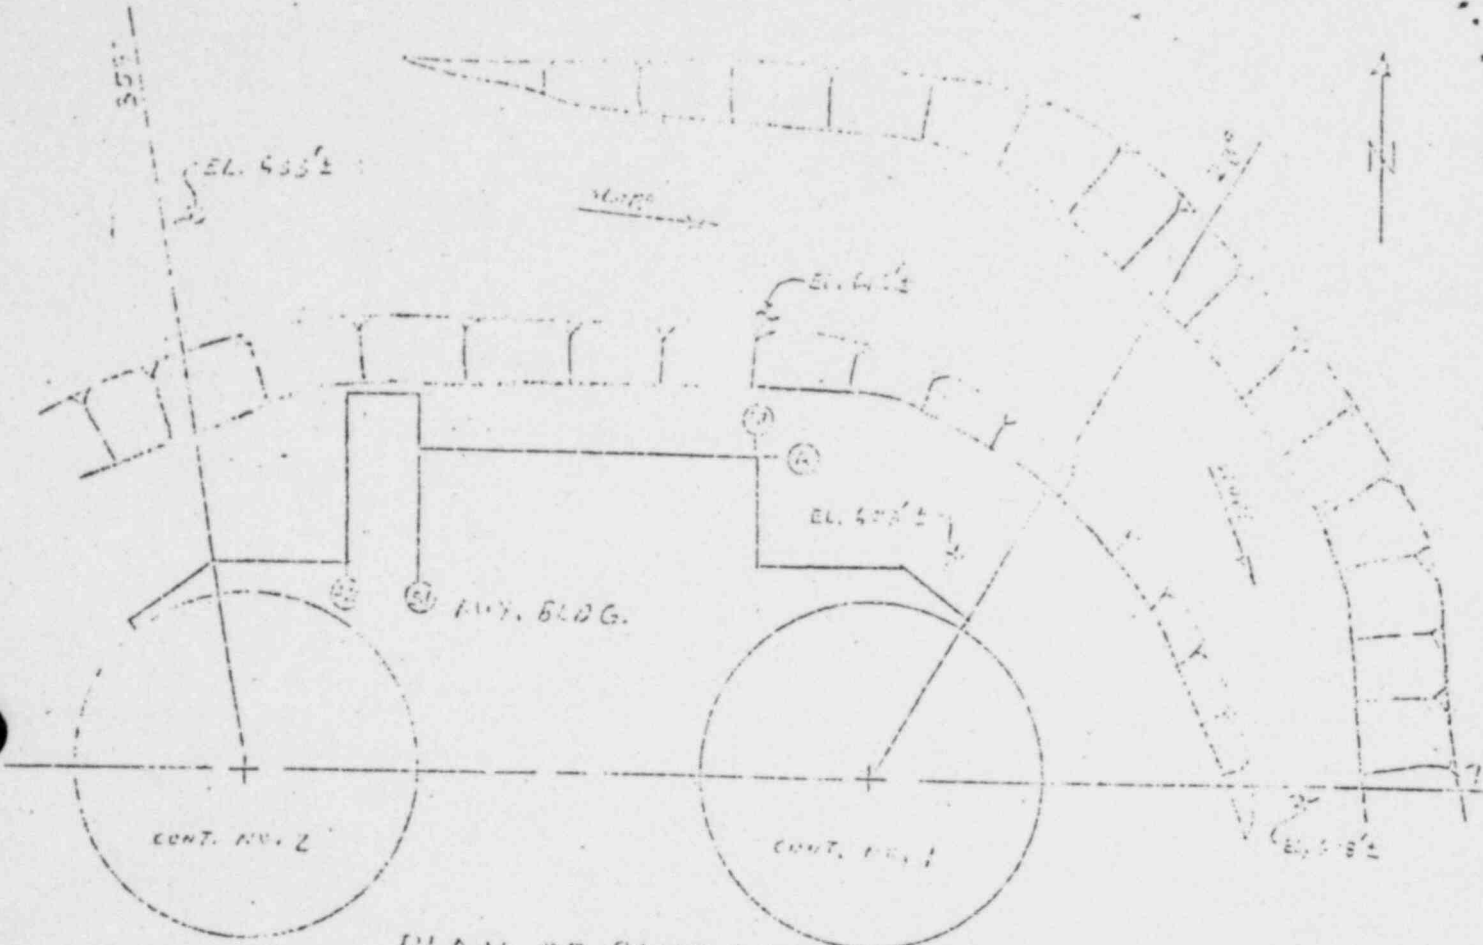
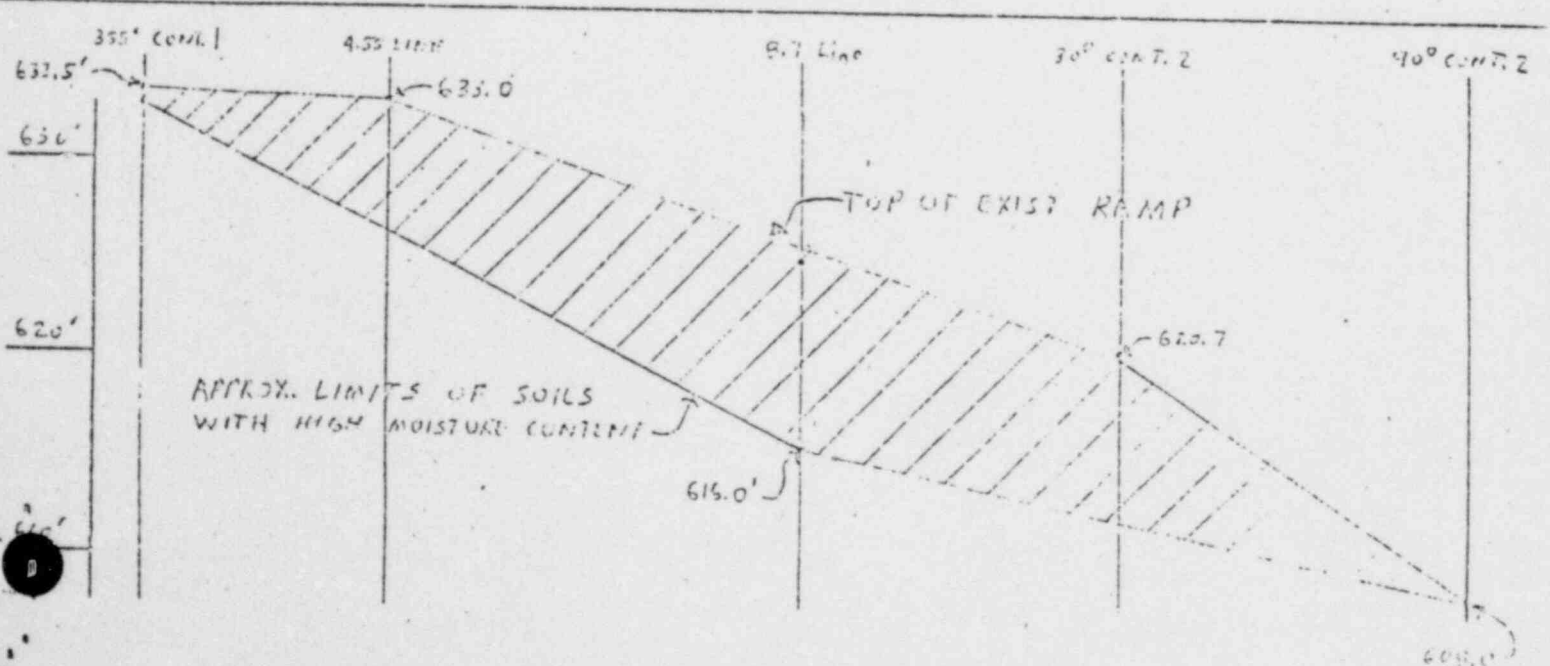
PLAN OF RAMP AREA
N.T.S.

19. NONCONFORMING CONDITION: Specification 7220-C-210, Rev. 4, Para. 12.6.1 states in part, "The water content during compaction . . . shall not be more than 2 percentage points above optimum moisture content . . ." Contrary to the above, during the fall of 1975 a construction access ramp was constructed from material which exceeded the moisture content requirements of Specification C-210. The field forces, including Bechtel Quality Control, were aware that the material exceeded moisture when placed. When the material was placed it was

22. ENGINEERING DISPOSITION Discussion of the background to this condition with Field personnel indicated (1) that the ramp was installed as a temporary means for access into adjacent work areas and not as permanent backfill; and (2) that the Field now wishes to use the ramp as part of the permanent backfill. We understand that should the ramp not be suitable as

permanent backfill it can readily be removed. Hence Engineering submits that a non-conforming condition does not exist since the ramp is still a temporary facility.

Recommend "accept as is," subject to Project Engineering review and evaluation. Backfill material has been compacted to not less than 95% of maximum density in accordance with Specification C-210. C.H. Nelson 5/14/76 J. Hurler

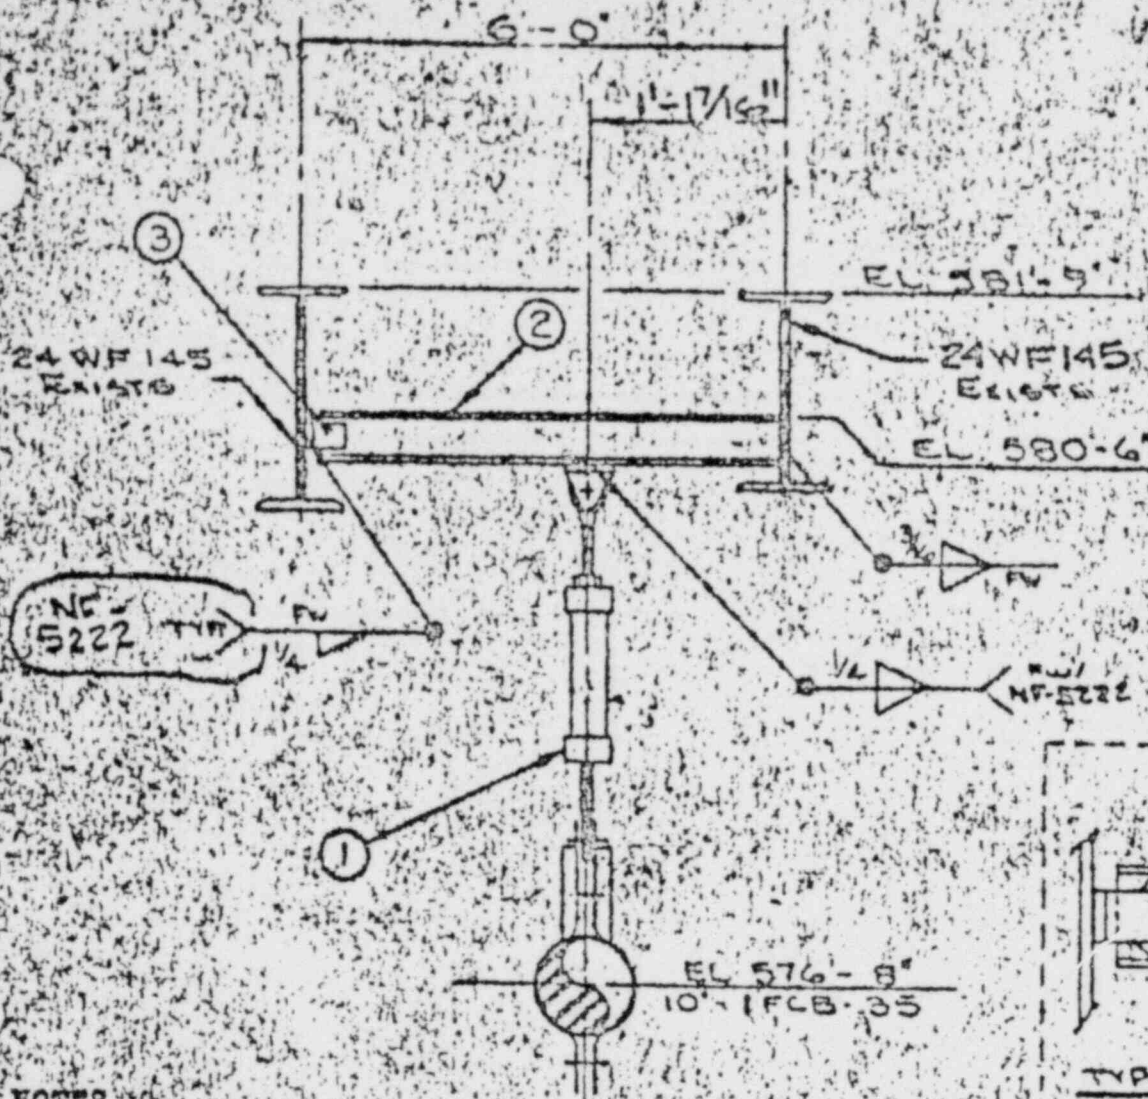
NCR 1-5
PAGE 2 of 2

8. ITEM LOCATION 580' 16" el. Aux.	18. ROUTE TO MATERIAL SUPERVISOR
9. STARTUP SYSTEM NO. N/A	19. NONCONFORMING CONDITION: Visual inspection by QC of the weld which connects item #1 to item #2 (Grinnell drawing 1-610-6-3) revealed a complete fillet weld all around item #1. The Project Engineering approved drawing calls for a fillet weld only on two (2) sides of item #1. Reference attached drawing. Q Number is 4.102

10. QC FIELD INSPECTION PLAN NO. QCIR-M-326-11V	20. FIELD RECOMMENDATION/ROUTE TO PROJECT ENGINEERING
11. ASME CODE ITEM NO. <input type="checkbox"/> YES <input checked="" type="checkbox"/> NO	21. FIELD DISPOSITION RESULTS: Use as is.

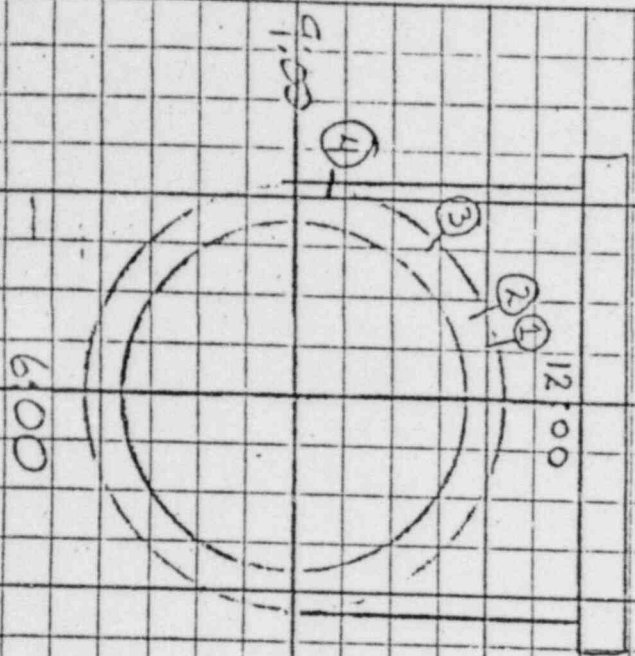
NDE REPORT NO. 1662

- 1) 3/4" From 12:00
- 2) 4 3/4" From 12:00
- 3) 7 1/2" From 12:00
- 4) 11" From 12:00
