**PINE-STRAWBERRY WATER IMPROVEMENT
DISTRICT**

**PRELIMINARY ENGINEERING REPORT
FOR
WATER DISTRIBUTION SYSTEM IMPROVEMENTS**

September 2020

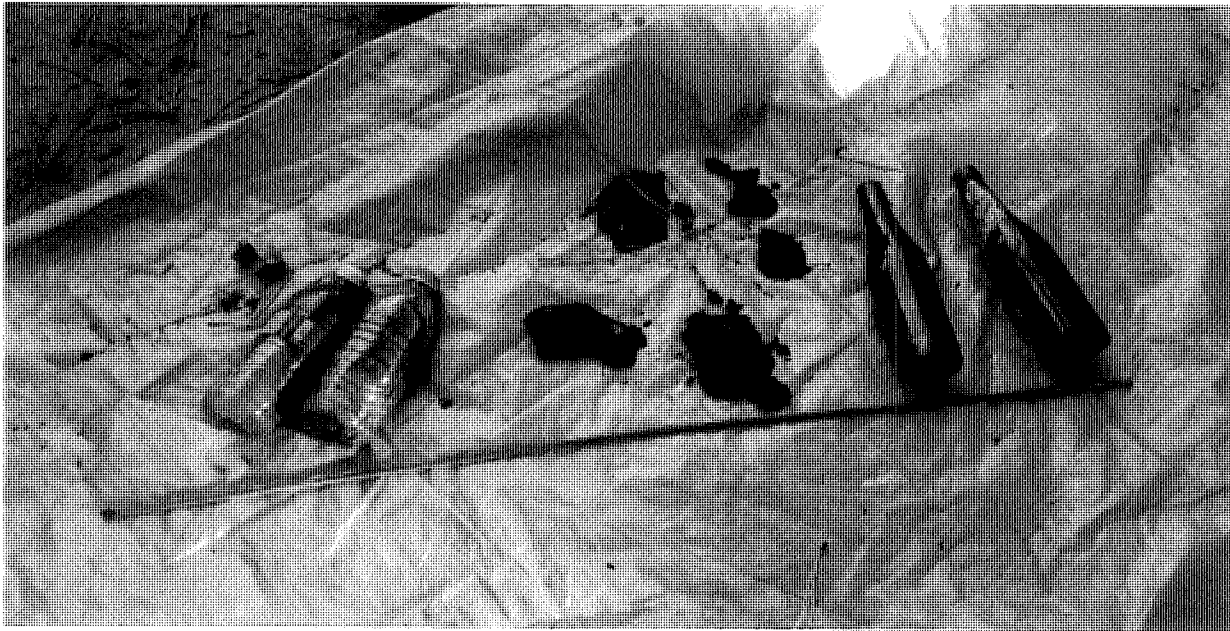
These are some of the item we found in the tank.

1. Lots of small rocks. 1" to 2" in diameter
2. Brass rod approximately 3' long.
3. 2 beer bottles.
4. about a dozen hand sized pieces of rusty steel. Approximately 1" thick.
5. Approximately 40lbs of rust particles 1/4" and larger.
6. Debris on bottom of tank including sand, clay, rust, interior coatings buried from 4" to 8" thick
7. Some white in color biofilm on bottom of tank under 8" sediment.

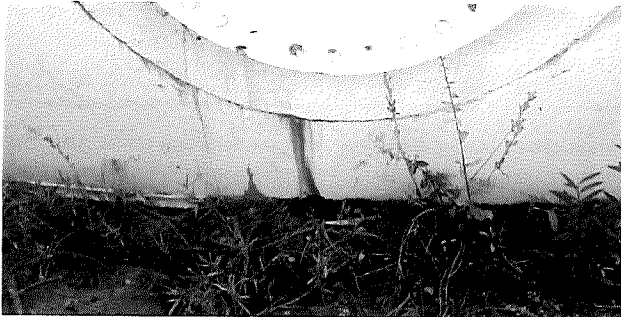
1. Exterior of tank needs recoating. Paint is almost completely gone.
2. Paint thickness was about 1 to 2 mm with lots of rusty spot areas.

1. Exterior coating needs recoating.
2. Interior coating needs recoating.
3. Sunken roof due to collapsing rafters, from failed dollar plate.
4. No OSHA hand rails on top of tank.
5. No seal on hatch.
6. Exterior ladder is not OSHA approved.
7. No security lockout plate on ladder.
8. 2" hole in rodent screen on overflow assembly.
9. Target and float work but no water level indicators.
10. Some fire hazard with grass and brush near exterior electric connections.
11. No fence around entire area.

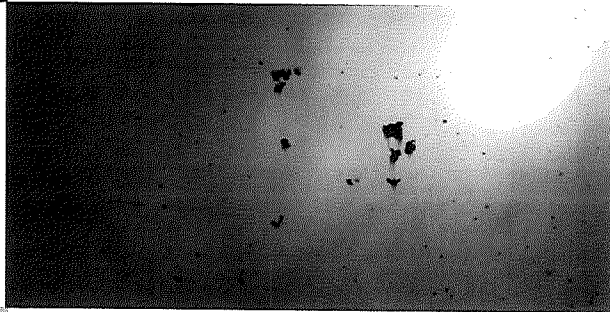
1. rusty areas around entire tank and on roof area.

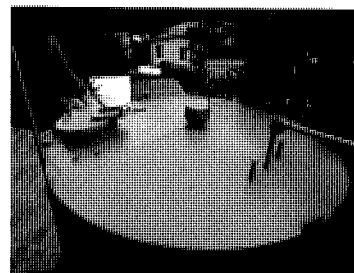
SUMMARY : Oxidation present

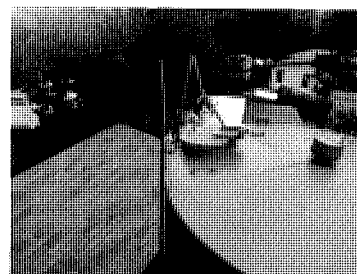
SUMMARY: Access hatch in excellent condition

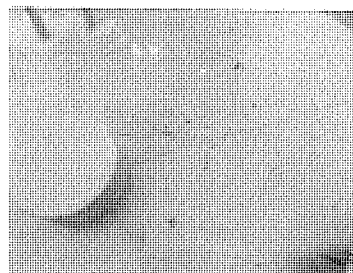
SUMMARY : Oxidation present

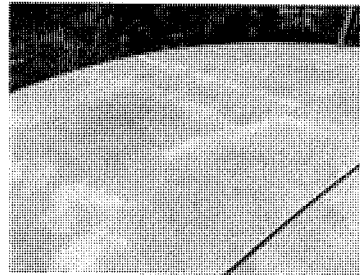
SUMMARY : Needs paint

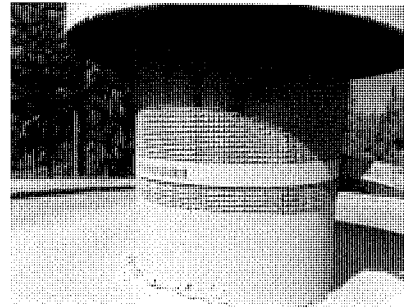
SUMMARY : Beginning to corrode

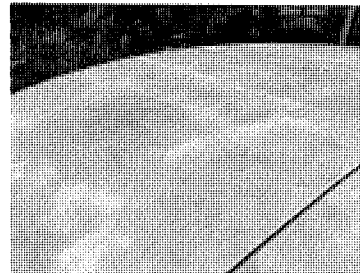
SUMMARY : Total paint failure

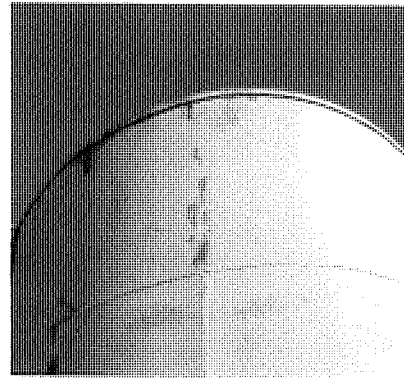
COATING CONDITION: E G F P
 WELDS CONDITION: E G F P
 CORROSION: YES NO
 OXIDATION: YES NO
 DELAMINATION: YES NO
 DENTS: YES NO
 HOLES: YES NO
 SUMMARY: Seeping at foundation in 4 spots

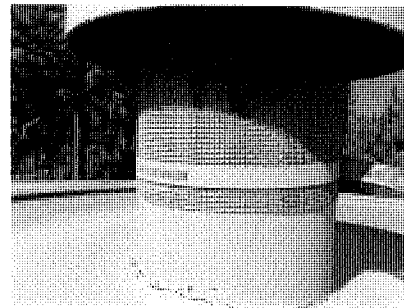
SUMMARY : Needs screen checked

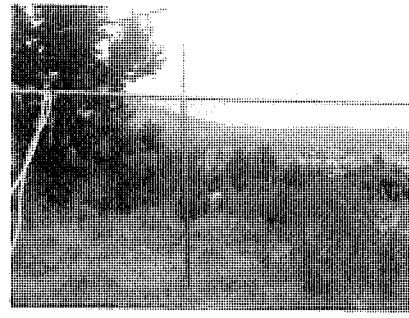
SUMMARY: Vandal could crawl under gate, tank hatch not lockable, vandals have thrown materials into tank

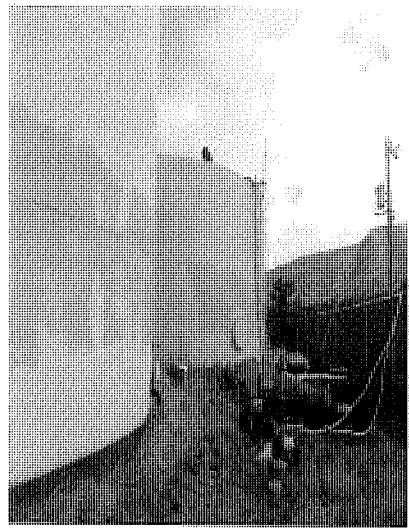
SUMMARY: Misc. items rusted to floor

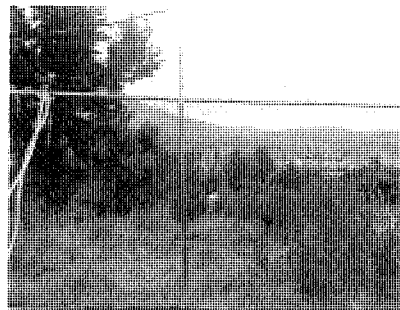
SUMMARY: Vandal could crawl under gate, tank hatch not lockable, vandals have thrown materials into tank

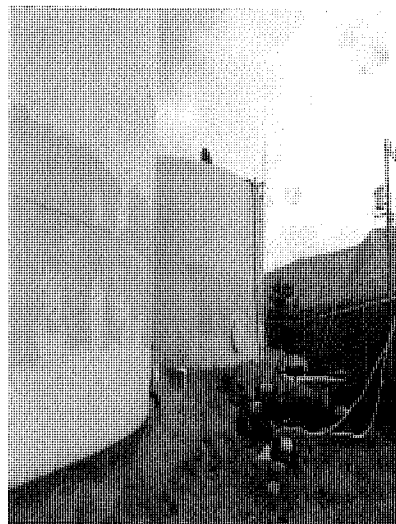
SUMMARY: Misc. items rusted to floor

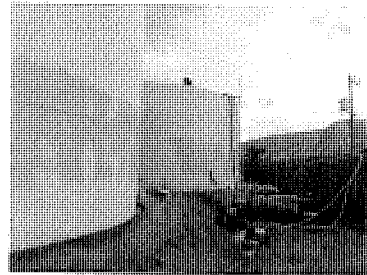
SUMMARY : Needs Paint

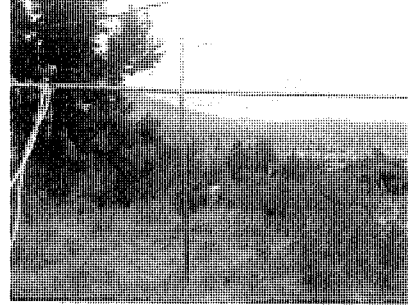
SUMMARY: Large hole under gate

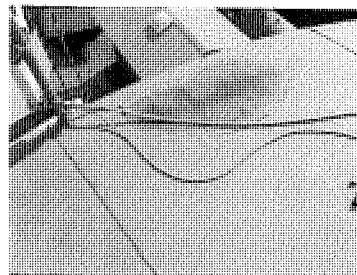
SUMMARY : 7 low spots around perimeter of roof
