Servicing the Ferguson TX100 Chassis

J. LeJeune

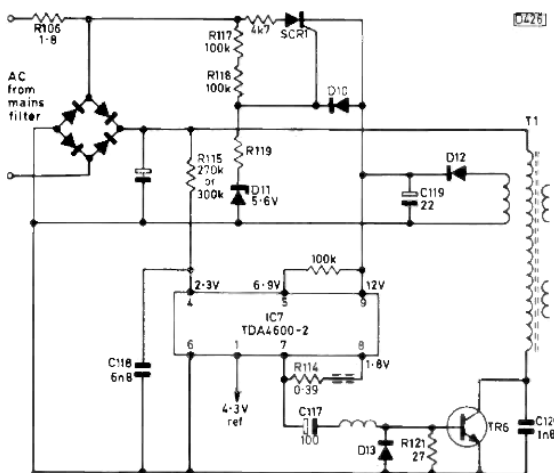
Further problems occur in the chopper control circuit – they are commonly found in other manufacturers' models that use the TDA4600 series chip (a TDA4600-2 here, IC7). Fig. 1 shows the relevant circuitry. The chopper transistor TR6 is current limited by the action of the components connected to pin 4 of IC7. C118 charges

from the rectified mains supply via R115. While TR6 is conducting, pin 4 of IC7 is open-circuit, allowing C118 to charge. When the control circuit switches TR6 off, pin 4 of IC7 goes low and C118 is discharged. Thus a sawtooth waveform is developed at pin 4. The amplitude of this sawtooth waveform depends on the length of time during which TR6 is conductive. To prevent TR6 passing excessive current the control circuit checks on when the amplitude rises to 4V. The time C118 takes to charge depends on the value of R115, and in early TX100 sets this resistor gave trouble – as it did in the TX9 chassis (PC1044 board). R115 has to withstand the 350V or so produced by the mains rectifier, so a standard 250V working type will not do as a replacement. A 500V, metal-glaze type is required and is available from Ferguson.

Another critical resistor is R114, whose value was standardised at 0.39Ω for all models. We've had earlier models in the workshop with this resistor having gone high in value. This reduces TR6's base drive, the result being destruction of TR6. A word should be said on the trail of destruction that accompanies failure of TR6. It usually goes short-circuit collector-to-base. D13 then has 350V at its cathode and disintegrates. R121 burns up, and current flows via C117 into pins 7 and 8 of IC7. C117 frequently survives this treatment, but IC7 rarely does.

Fig. 1: Part of the chopper circuit, showing the items that can give trouble.

The recommended replacement for TR6 is a T9063V, which is a selected BU508A. It's wise to replace the spring retaining clip and the grey thermopad at the same time. A kit for the job is available from Ferguson. These comments apply equally to the line output transistor TR10, which we'll come to in a moment. In 110° sets D28, which is connected in series with the 119V h.t. supply to the line output stage, is a common offender, either going very leaky or short-circuit. In the leaky condition the diode exhibits an excellent leakage resistance/temperature characteristic!

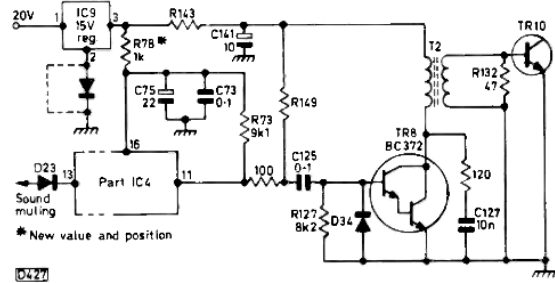
Failure of the line output transistor TR10 was a common occurrence in early TX100 sets. A couple of modifications ensure that it doesn't recur. Fig. 2 shows the relevant circuitry. Note the change in the supply to the timebase generator chip IC4, at pin 16: C75 is changed to 22 μ F while R78 becomes 1k Ω and is connected to pin 3 of the 15V regulator IC9. TR10 should preferably be type T6071V with 90° tubes and type T9063V with 110° tubes. These transistors are both selections from the BU508A family.

The line driver transistor TR8 occasionally fails, though this isn't an everyday happening. In this event it's worth checking C127, C141, D34 and the output from IC9. If a scope is to hand check TR8's base and collector waveforms to see if the transistor is operating with full drive. TR8 should be replaced using another BC372 or a recommended equivalent.

Fig. 2: The line driver circuit, showing modifications to IC4's supply at pin 16. The value of R143 depends on the tube type. R149 is 1k Ω or omitted depending on tube. D34 is omitted when R149 is not present.

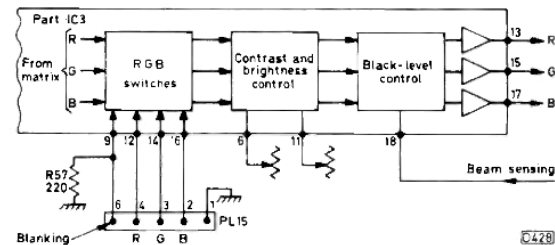
Fig. 3: Inputs to the video switches in IC3. 1.5V at pin 9 of IC3 (pin 6 of PL15) changes the switches over.

from decoded off-air or external (via the scart socket) signals to teletext RGB signals. Switching control is applied to pin 9 of the chip: there is access to this at pin 6 of PL15, see Fig. 3. Application of 1.5V from a torch cell to this point changes the video switches over and could be a useful way of isolating the source of any video disturbance. IC3 is very reliable and provides long service. It can however be destroyed by a c.r.t. flashover.
