# Currawong Farm

## Bushland Vegetation Snapshot Habitat Survey

Eco-restoration planning as part of Gondwana Link

## September 2019- Draft Report

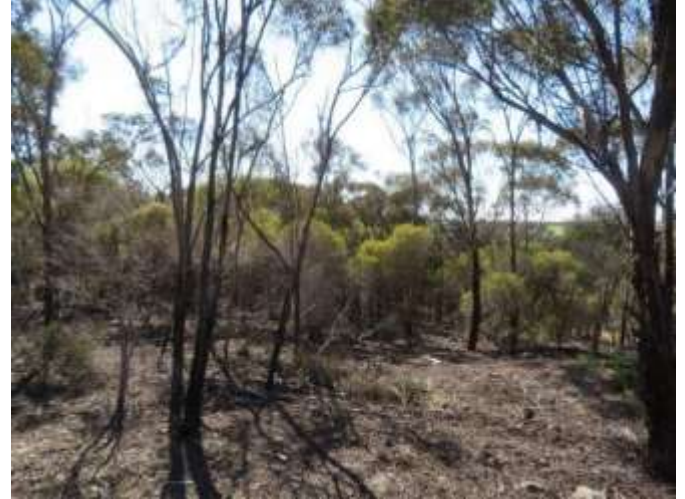
Site 94: Understorey of *Melaleuca acuminata*

- Amalgamate Site 94 & 104 with fencing and revegetation
- Site 94 – Spongelite breakaway
- Recommend retaining remnant vegetation and continue to exclude stock
- Already partially fenced, close to homestead

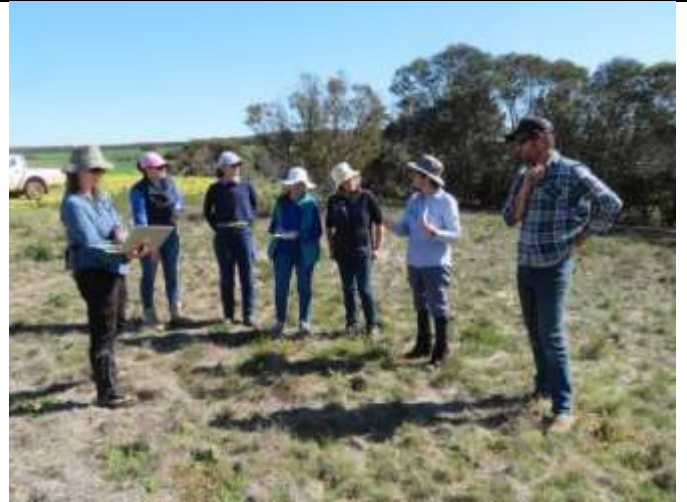
Site 104: Proposed revegetation area to amalgamate Site 103

- Revegetation desired by landholder, recommended
- No scalping or mounding as this may encourage weed establishment
- Some Cape weed present

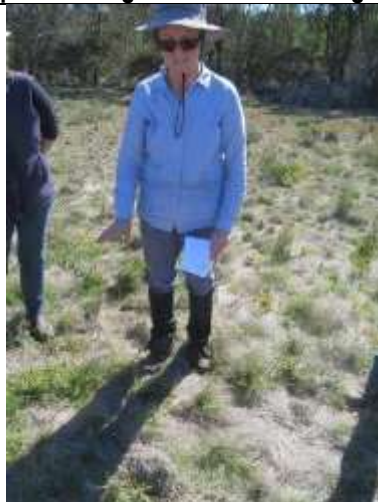
Site 104: Angela Sanders recommends not to dig with machinery during revegetation efforts to avoid weed encroachment. Many native grasses are already established.

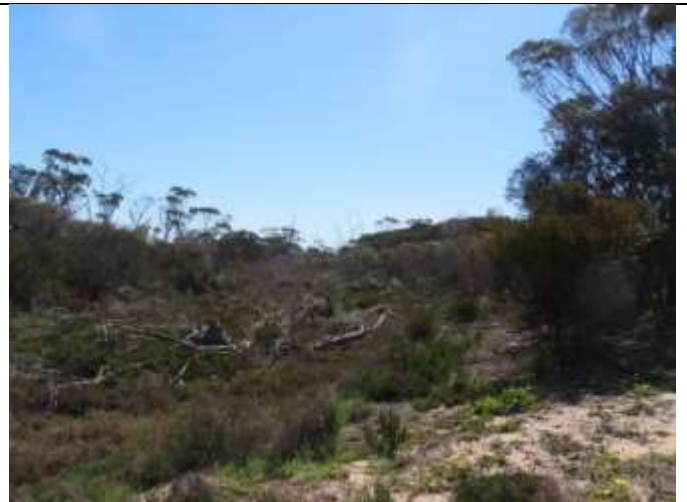
Site 104: Creekline vegetation damaged by flood in 2016.

- Brush matting with seed
- Mallee heath vegetation adequate for revegetation species due to soil type
- Creekline degraded due to damage from flooding, possibly some salinity

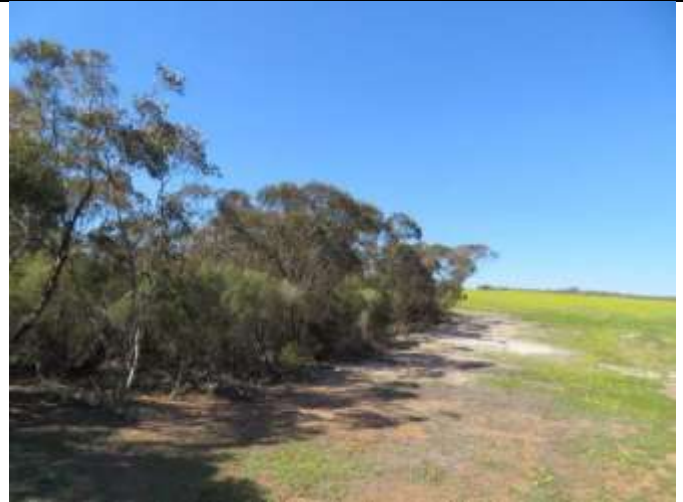
Site 66: Unfenced Mallee heath remnant vegetation in Very good condition

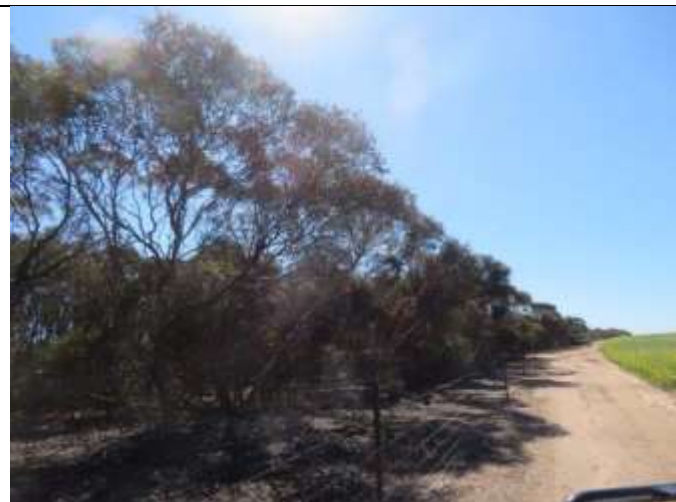
**Site 55: Fenced remnant Mallee heath vegetation in Very good condition**

- High priority to retain remnant vegetation
- Recommend fencing for Site 60
- Site 55 is partially fenced

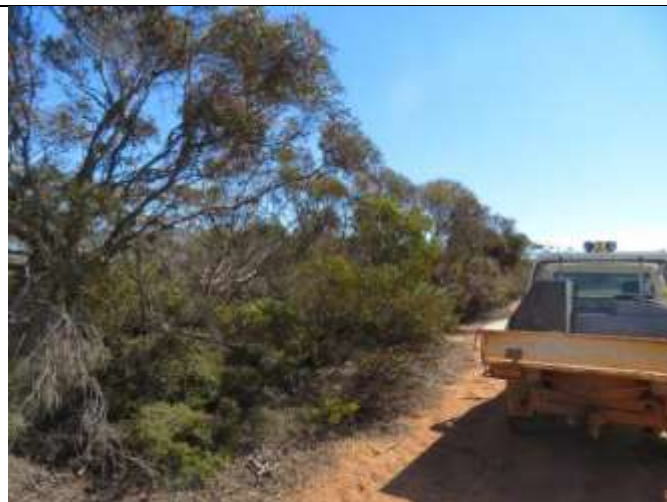
**Site 60: Unfenced remnant Mallee heath with dominant Melaleuca species understorey**

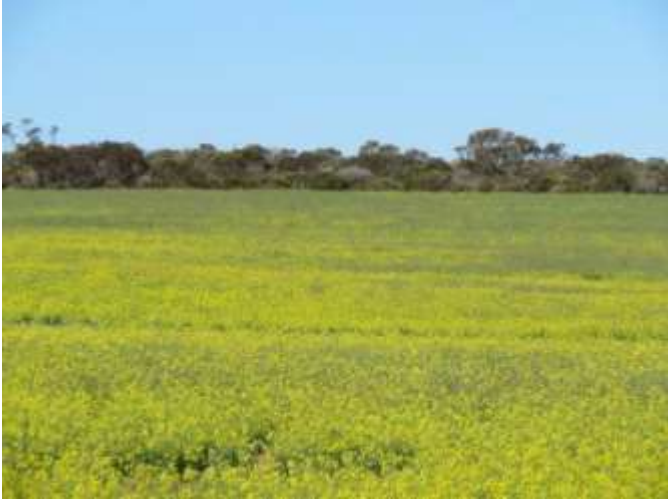
<p><b>Site 59: 8.86 ha Mallee heath remnant, a high priority for fencing</b></p>

MANAGEMENT RECOMMENDATIONS AND/OR REASON FOR PRIORITY
<p><b>Project 10 – Fencing: 1528m (8.9ha)</b></p> <ul style="list-style-type: none"> <li>➤ Currently no fencing, rocky ground</li> <li>➤ Very high priority for fencing</li> </ul>

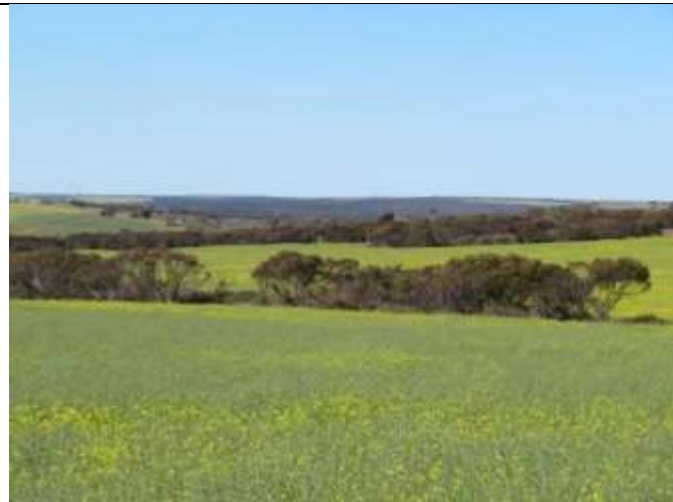
Site 43: Mallee heath

- Low priority for fencing, management
- Landholder wants to clear 40, 41, 42, 43 (particularly 42 & 43)
- All remnants have high edge to area ratio (long thin vegetation corridors) and have been assessed as being in a Degraded condition
- Some of the remnants contain good food plants for Black cockatoos

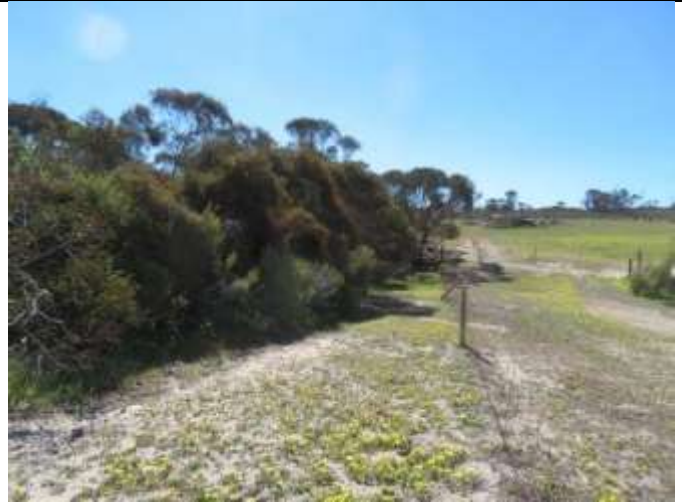
Site 73: Assessed to be in Good to Very Good condition

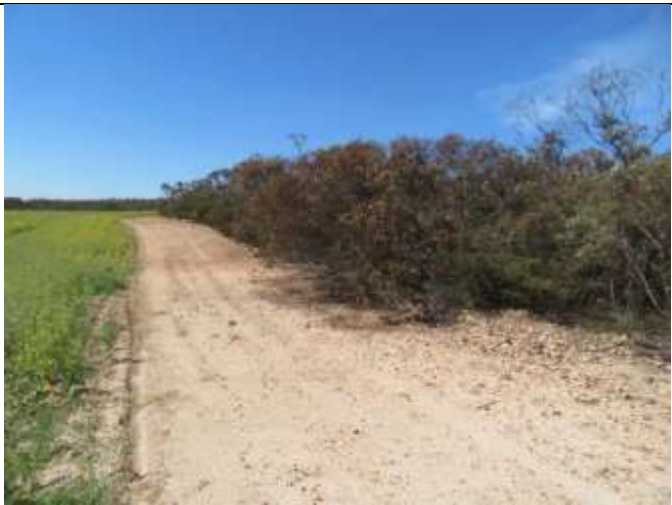
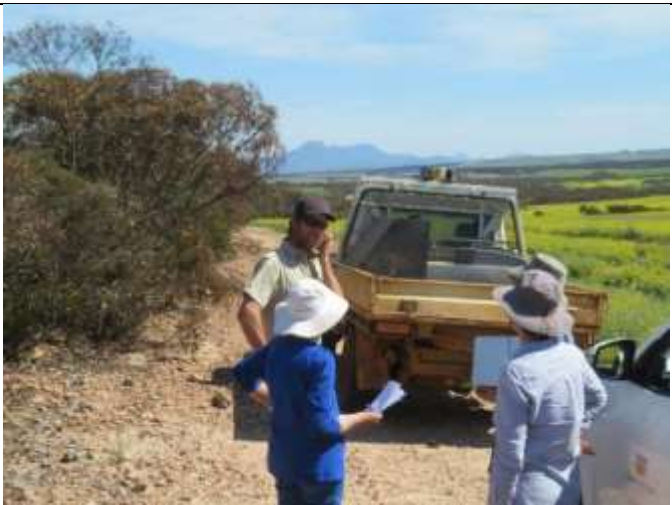
<p><b>Site 71: Unfenced Mallee heath with potential burning from chemical spray drift</b></p>	<p><b>Site 71: 4.53 ha Mallee heath remnant vegetation recommended as a Very high priority to be fenced</b></p>

- Very high priority for fencing due to decent size and Very good condition

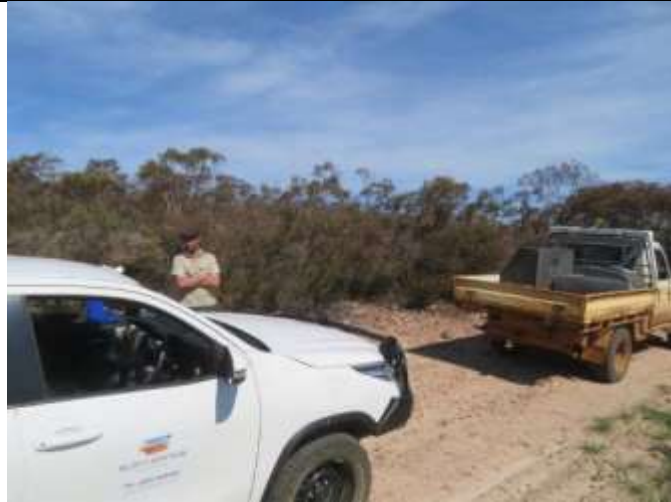
**Site 71: Mallee heath remnant assessed to be in Very good condition**

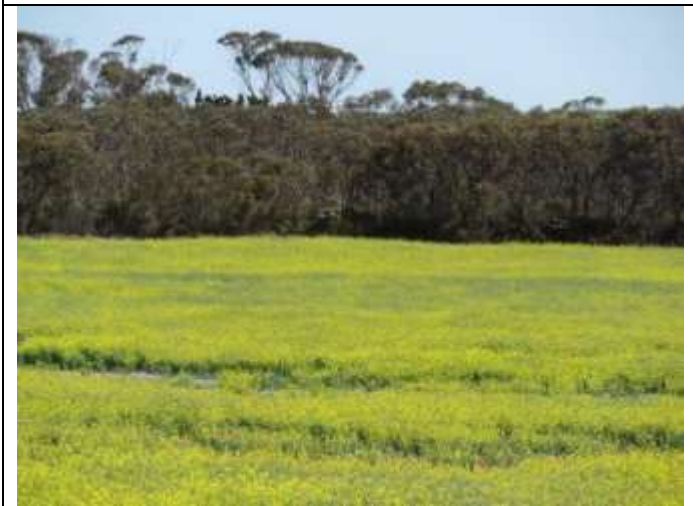
**Site 101: 10.41ha Mallee heath remnant vegetation recommended as a Very high priority for fencing**

- Very high priority for fencing due to large size, Very good condition and presence of Priority 4 conservation species, *Eucalyptus vesiculosa* (Red Moort)

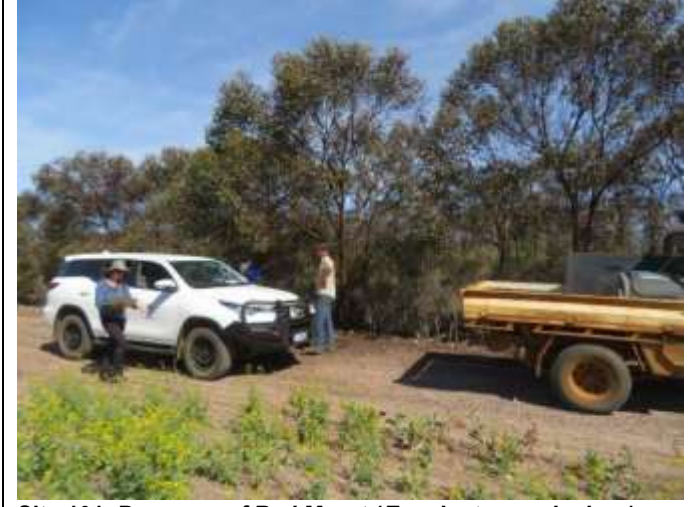
**Site 101: Presence of Red Moort (*Eucalyptus vesiculosa*), a Priority 4 conservation species.**
