# Destruction of Mature Tree Geebungs (*persoonia arborea*) Breach Report

Icy Creek, Tanjil State Forest

461-503-0006 'Glanworth'

Report on the destruction of mature Tree Geebungs (*Persoonia arborea*) within active VicForests coupe 461-503-0006 'Glanworth' in Icy Creek in breach of the 'Management Standards and Procedures for timber harvesting operations in Victoria's State forests' and 'Code of Practice for Timber Production'.

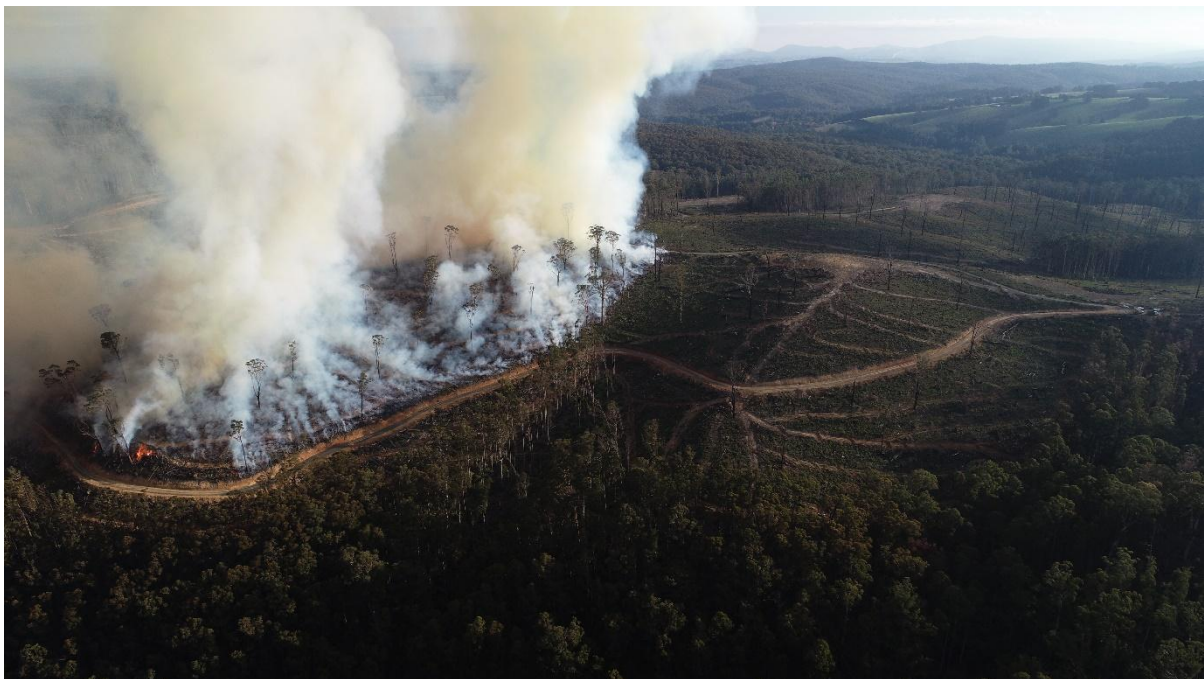
Figure 2. Past Clearfelling and post-harvest burning along the Ballantynes Saddle.

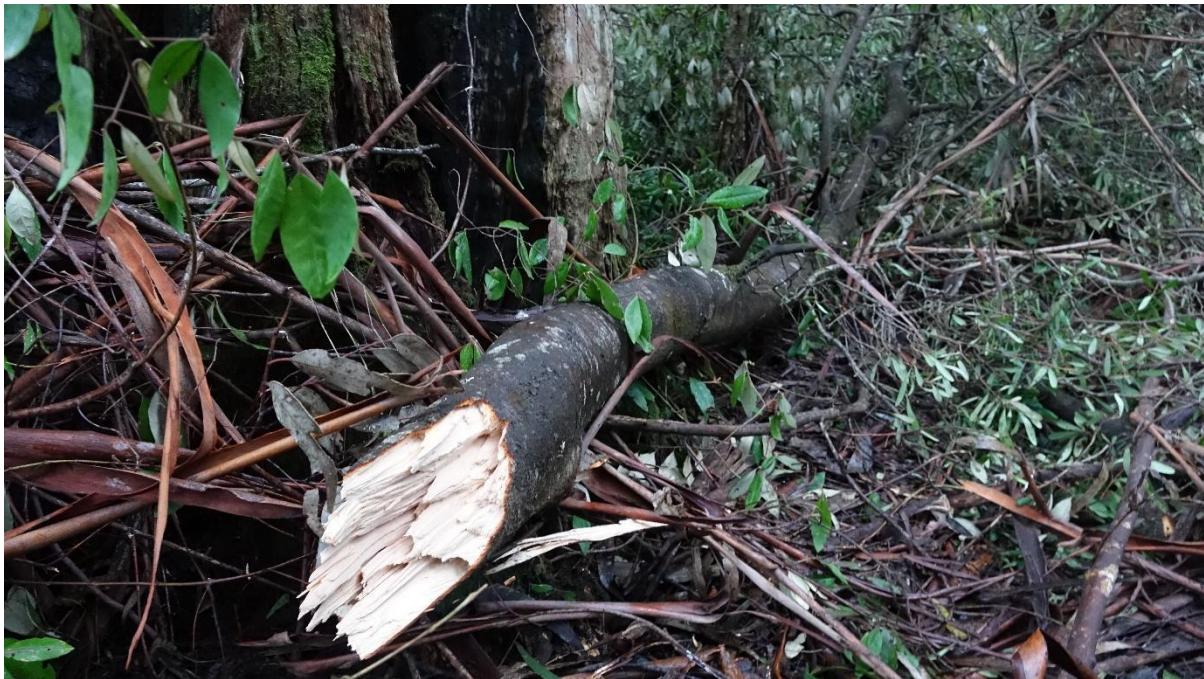
Figure 3a. Destroyed mature Tree Geebung #1, with obvious physical destruction from VicForests current timber harvesting operations within coupe 461-503-0006.

Destroyed Mature Tree Geebung #1 (00239, attached) has been pushed and snapped off from physical force asserted from VicForests machinery

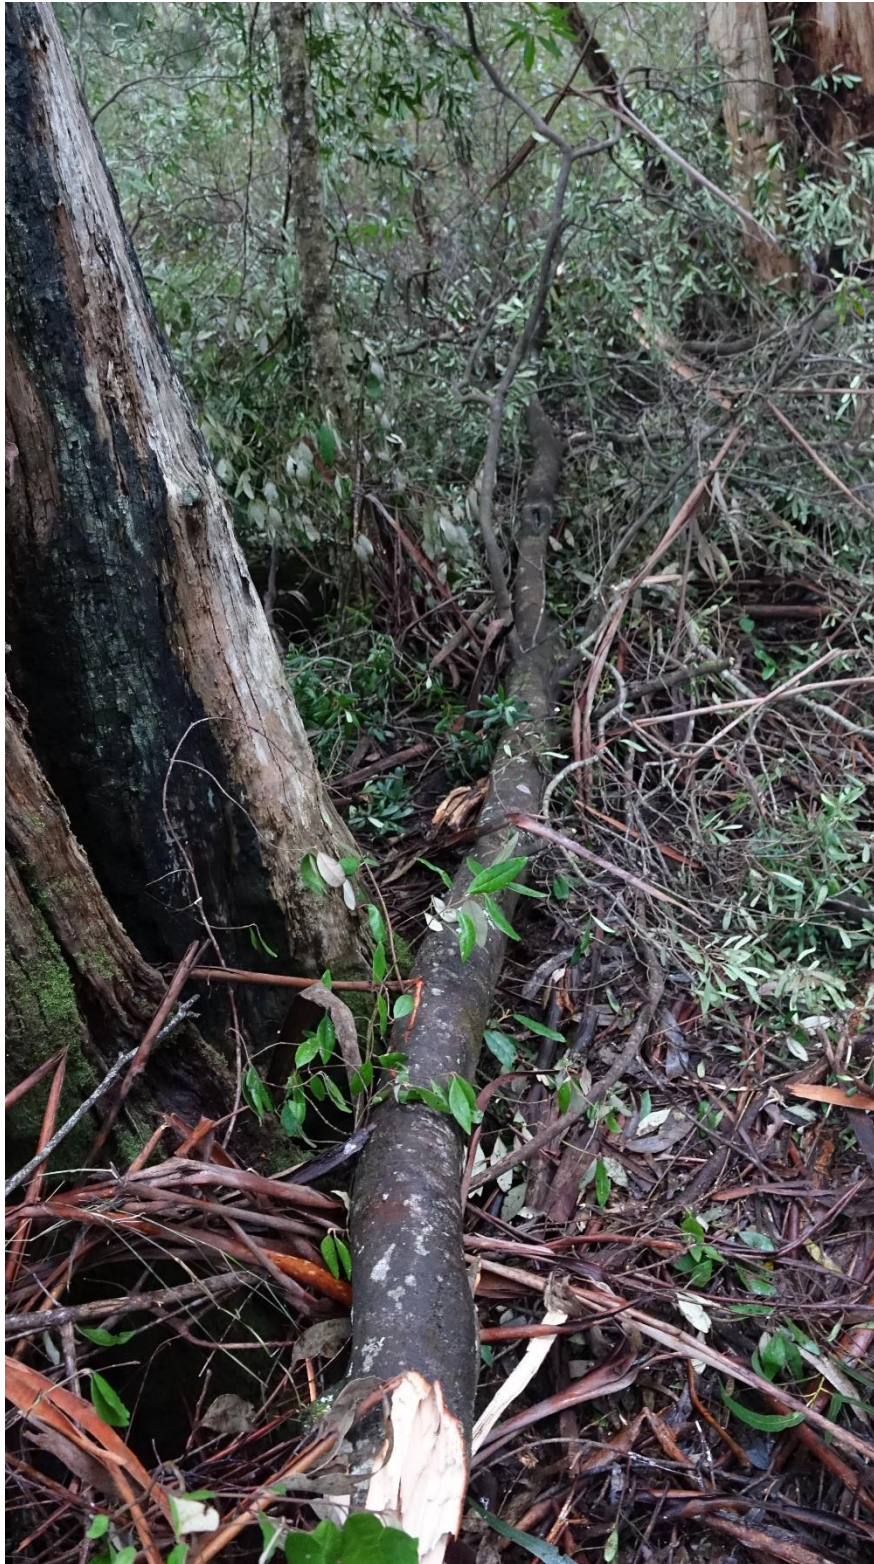
**Figure 3b. Destroyed mature Tree Geebung #1, with obvious physical destruction from VicForests current timber harvesting operations within coupe 461-503-0006 and prolific foliage/girthy trunk indicative of a mature Tree Geebung.**

The Tree Geebungs are clearly mature, with girthy trunks and prolific foliage as seen in Figures 3a-g and video attachments 00238, 00239, 00240, 00242 (attached). The remainder of these Tree Geebungs would be approximately 8-10m in height and would have been taller before destruction.

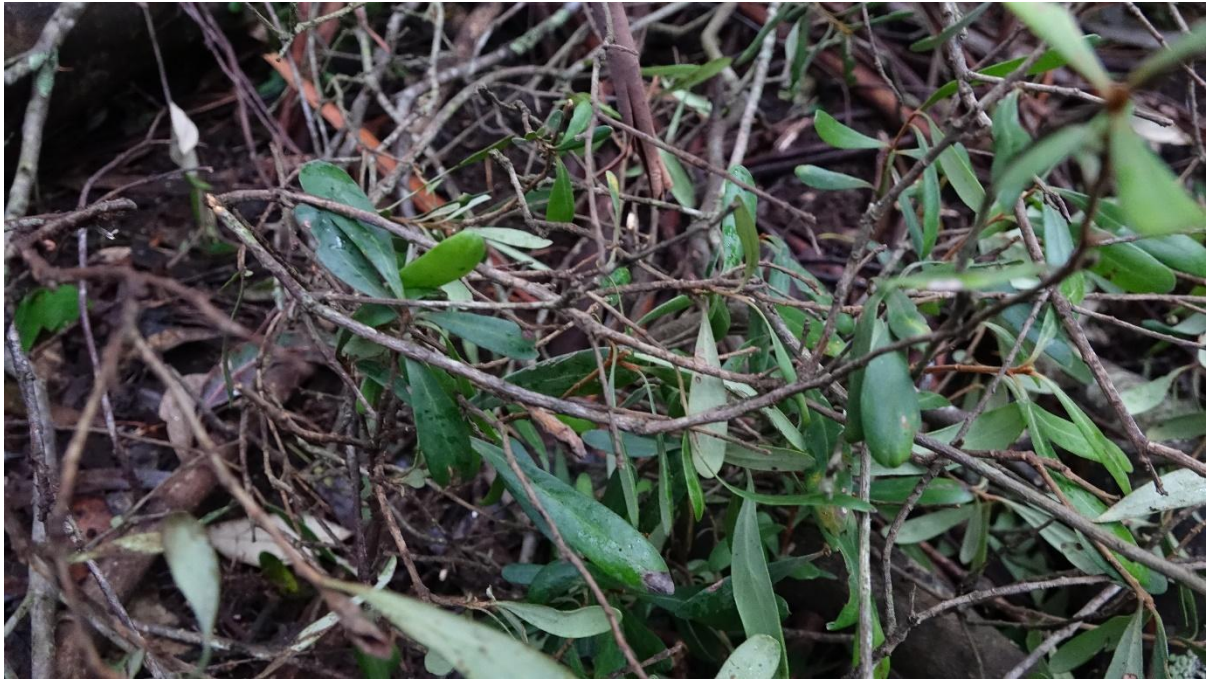
Figure 3c. Destroyed mature Tree Geebung (*Persoonia arborea*) #1 foliage, with a vibrant green colour indicating that the destruction of the individual occurred within a week.

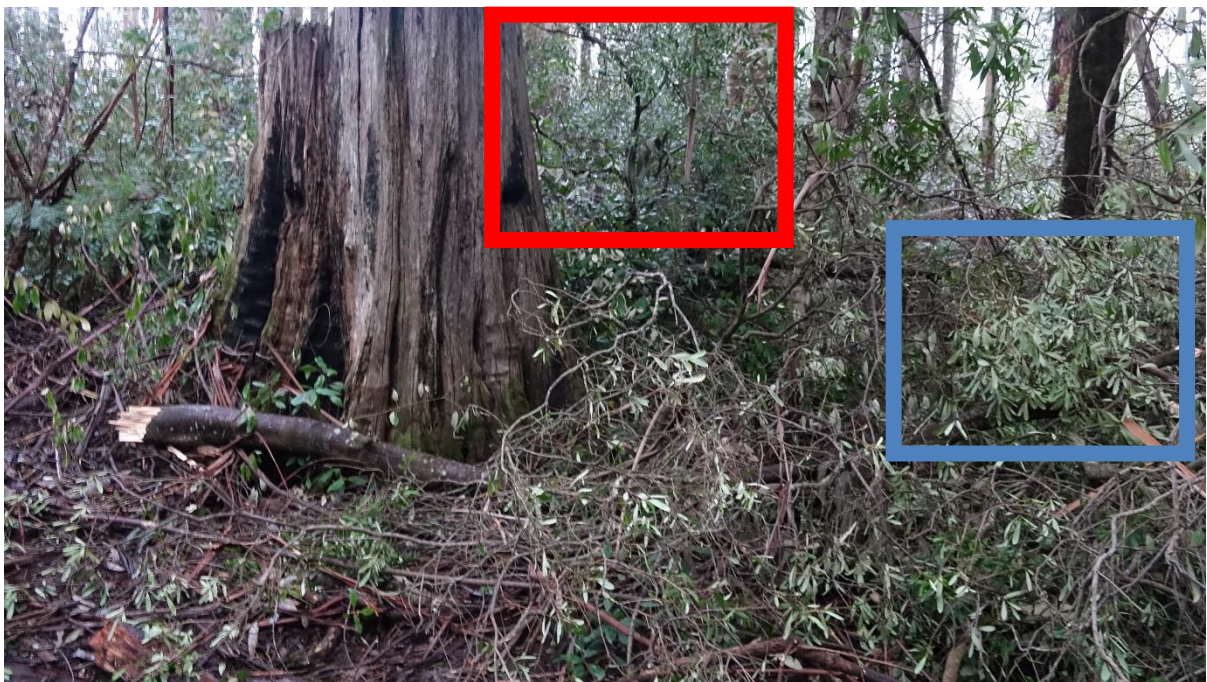
Figure 3d. Destroyed mature Tree Geebung #1 prolific foliage in blue, and #2 in red. Destroyed mature Tree Geebung #2 is located behind this stag and has clearly been destroyed during harvesting operations as it has been squashed by a felled tree. Photo taken from the cleared track.

Destroyed Mature Tree Geebung #2 (00242, attached) has either been uprooted, felled, pushed and snapped or squashed by another felled tree. The tree is lying horizontally on the ground with the base of the trunk squashed by a felled tree.

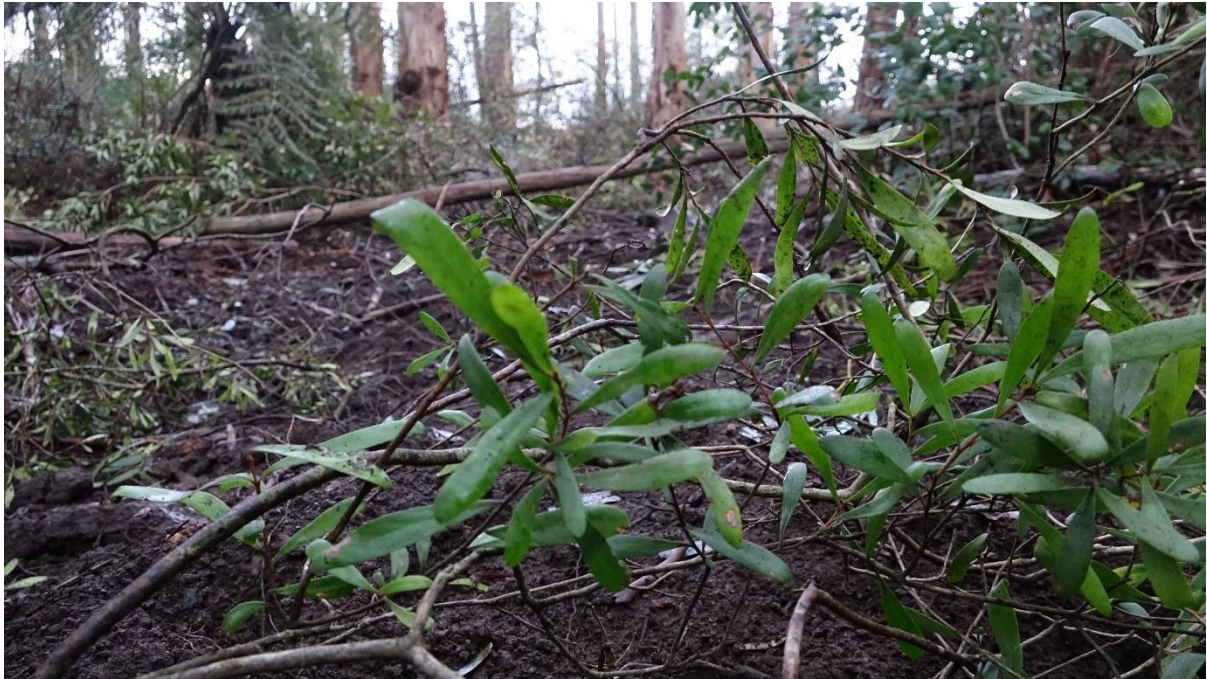
**Figure 3e. Destroyed mature Tree Geebung foliage on the cleared track.**

There is an abundance of Tree Geebung foliage on the cleared track, suggesting that the Tree Geebungs were located on the track before VicForests cleared them and pushed them aside. No VicForests tape was detected on or near the Tree Geebungs to suggest that they were identified before or during timber harvesting operations within coupe 461-503-0006.

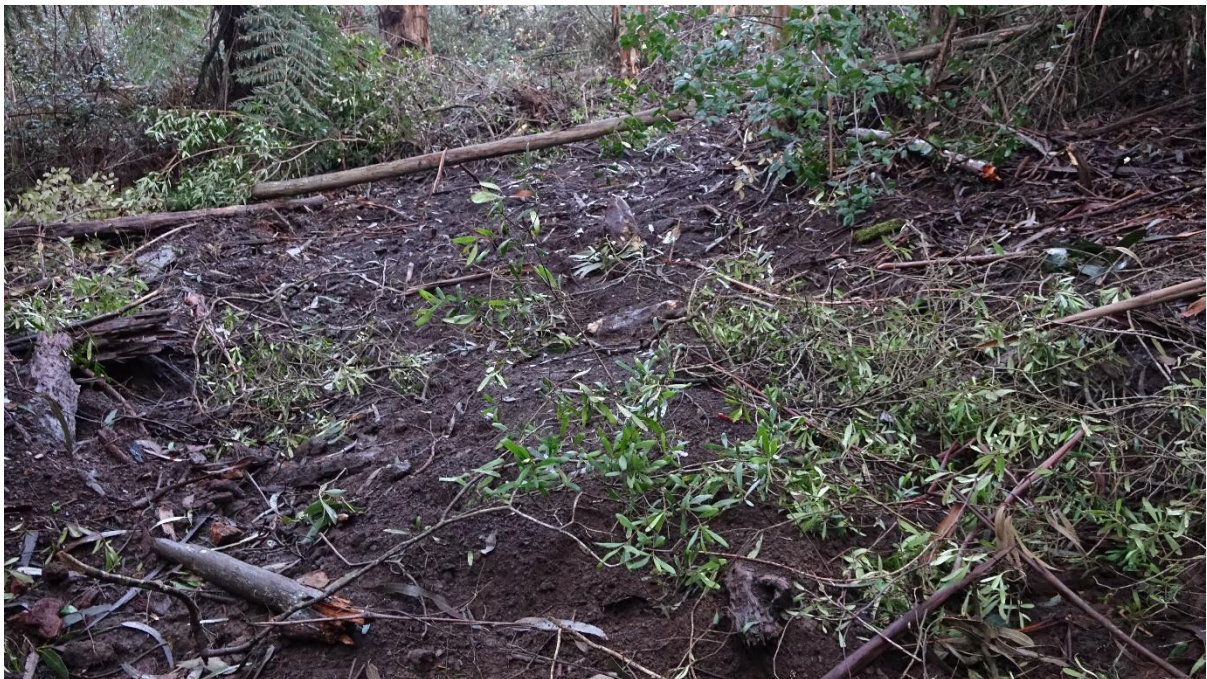
**Figure 3f. Destroyed mature Tree Geebung foliage on the cleared track.**

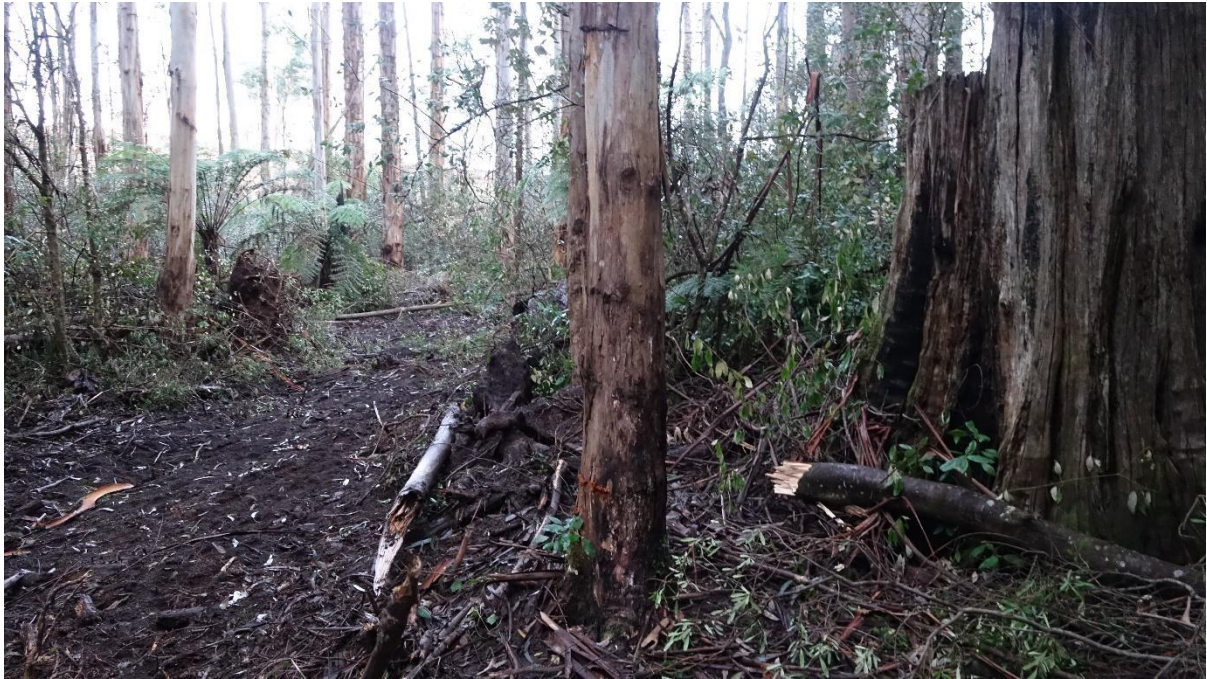
**Figure 3g. Destroyed mature Tree Geebung #1, adjacent to the cleared track with the clearfelled extent in the background. Photo taken facing approximately east.**

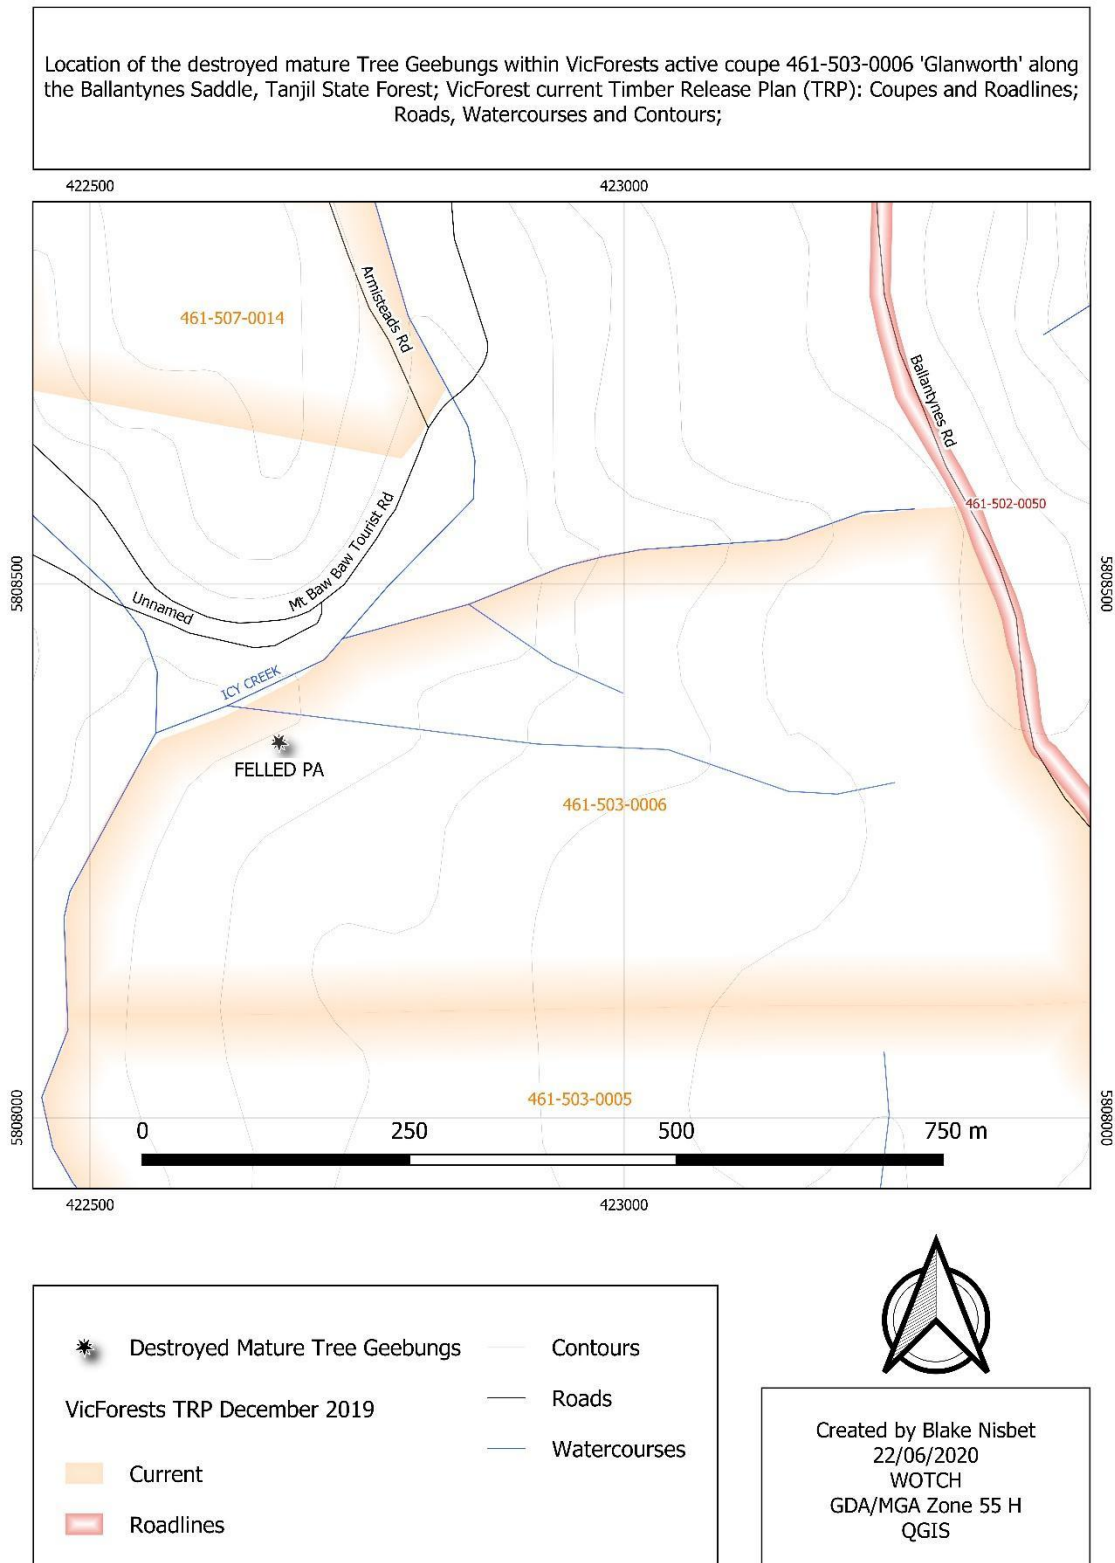
The Destroyed Mature Tree Geebungs are located at approximately 55 H 422677 5808352 (GDA / MGA Zone 55H), adjacent Icy Creek within active VicForests coupe 461-503-0006 as seen below in Figure 4.

Figure 4. Location of the destroyed Mature Tree Geebungs within active VicForest coupe 461-503-0006.

DELWP and the Office of the Conservation Regulator (OCR) must investigate this breach of the law which has occurred within VicForests active coupe 461-503-0006. The location coordinates for the destroyed Mature Tree Geebungs at 'FELLED PA' (Figure 4) are: 55 H 422677 5808352 (GDA / MGA Zone 55 H).

503-0006. We request DELWP and OCR to thoroughly investigate the destroyed mature Tree Geebungs at 'FELLED PA' (Figure 4) and visit each of the Tree Geebung sites in Table 1 and Figure 5 above to assess if any additional Tree Geebungs have been destroyed. We expect that justice will be delivered for the Tree Geebungs that were destroyed within the coupe and that VicForests will be prosecuted for this breach of the law.
