# North West Coastal Highway

Shire of Northampton  
SLK 145.7

## Material Pit Rehabilitation Plan

Revision 0.0  
June 2011

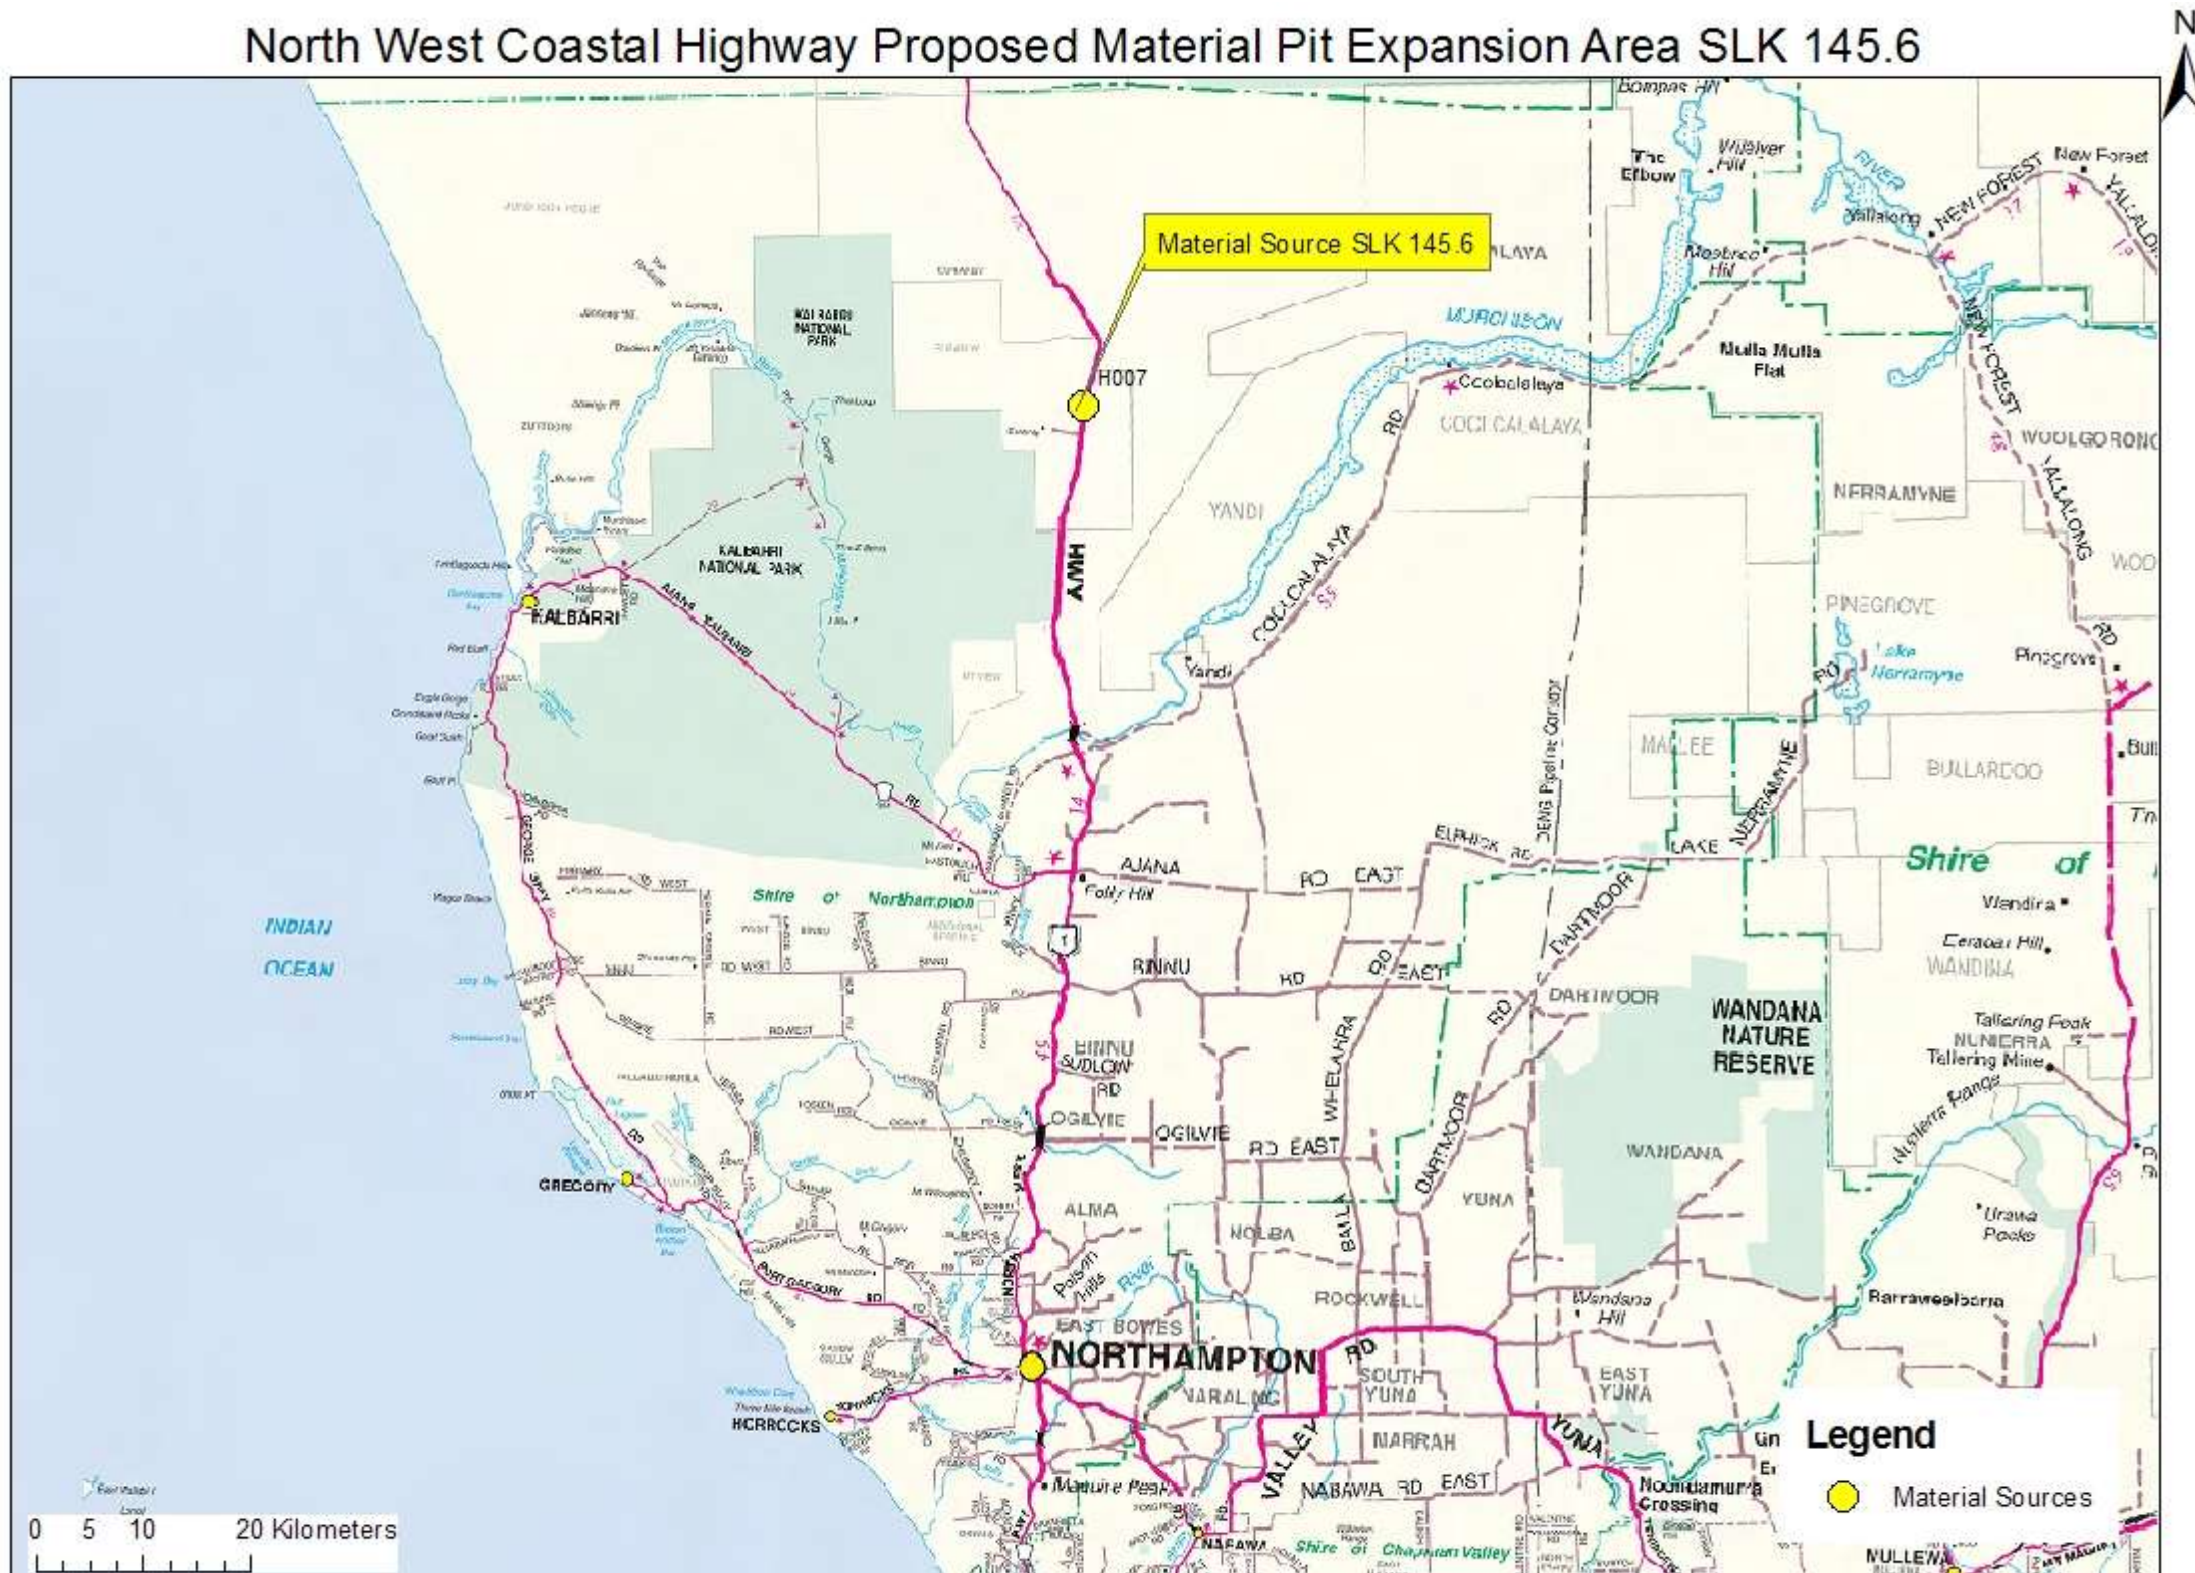
FIGURE 1 MATERIAL SOURCE LOCATION

North West Coastal Highway Proposed Material Pit Expansion Area SLK 145.6

Main Roads has identified a potential material site within Eurardy Station, located along North West Coastal Highway approximately 30 km north of the Murchison River. The proposed material site has been vested to Main Roads through Section 19 approvals for material extraction, in accordance with the *Mining Act 1978*.

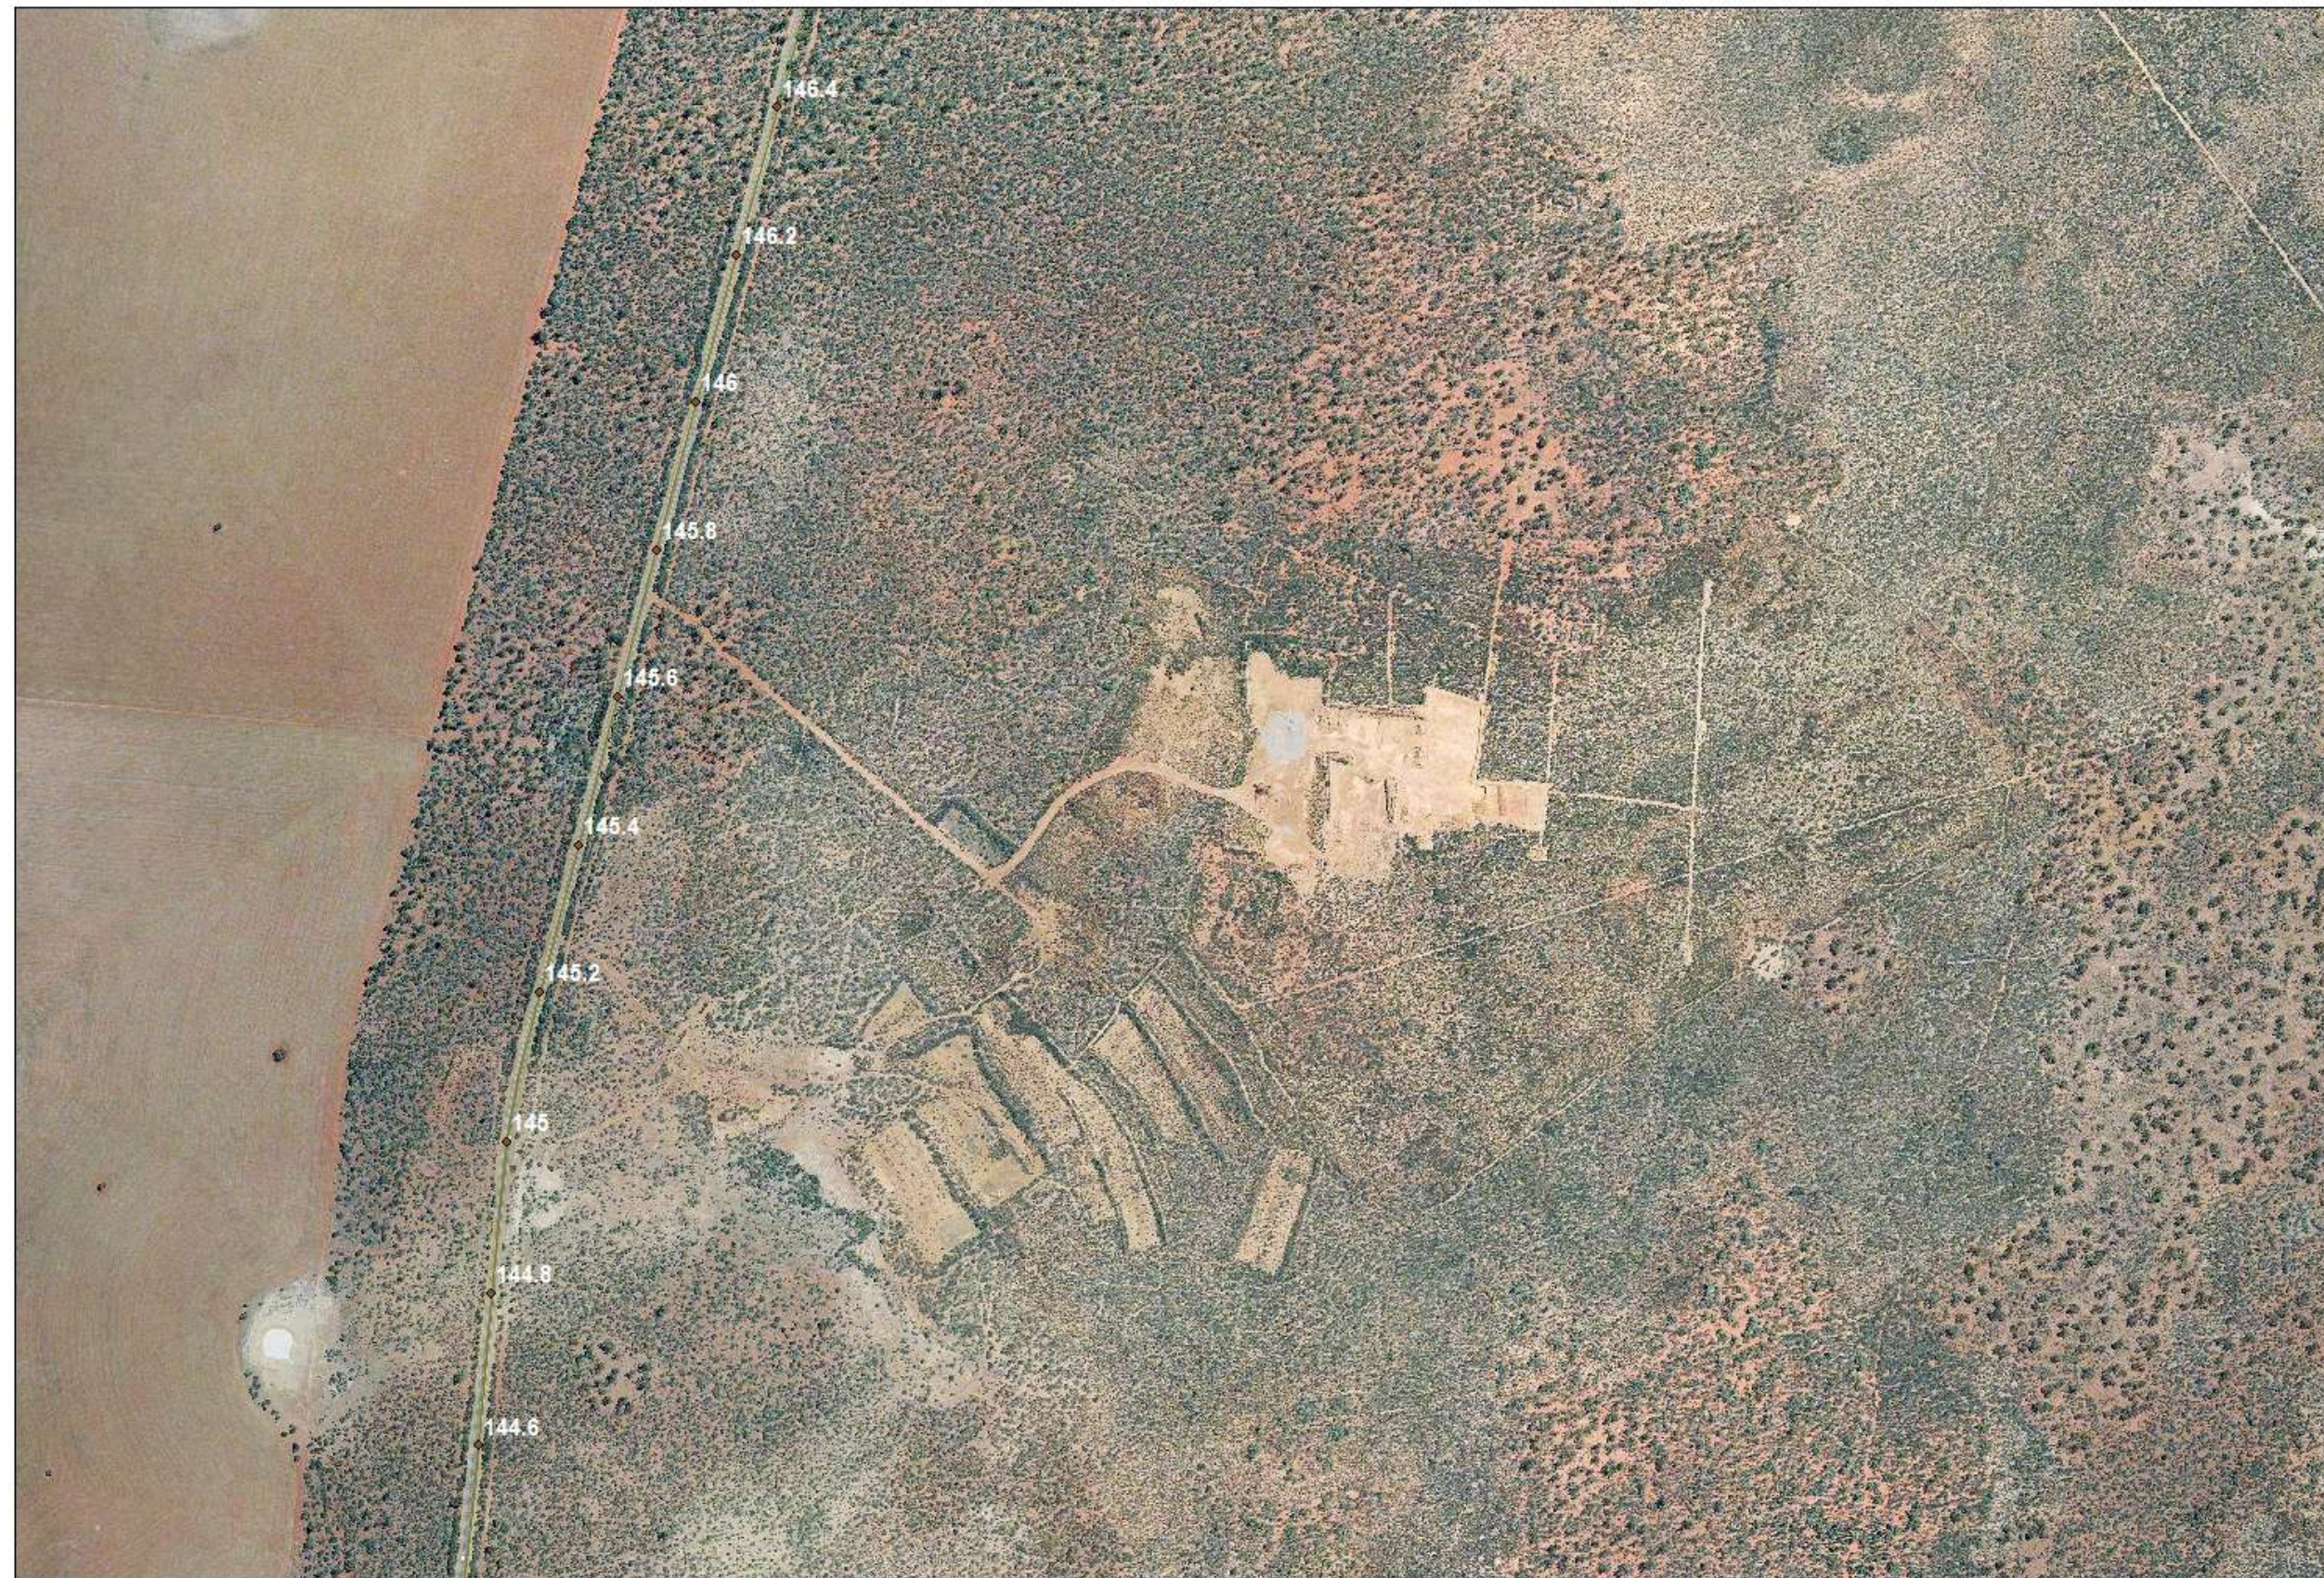
Figure 2 2006 Image of Material Source at SLK 145.7

**North West Coastal Highway Material Source 145.7 - Site Pickup 19/06/11**

Main Roads proposes to extend an initial section of this potential material site for the purpose of grave extraction. The total area of native vegetation proposed to be cleared during this initial stage of grave extraction is 4.5ha. The area identified in blue in figures 2 & 3, will be cleared, with the material to be stockpiled in the green section. This allows the for the blue section to be rehabilitated.

The revegetation of this material pit will be contained within the areas detailed in figures 2 & 3 and comprise of seeding with locally occurring indigenous species. The total area to be revegetated is approximately 9 ha.
