***Updated Biodiversity,  
Habitat Baseline Data,  
and Water Resources  
Assessment

Rapid Cumulative and  
Regional Effect  
Assessment

**Updating Biodiversity, Habitat Baseline data, and Water Resources Assessment for Mieso-Dire Dawa Expressway Project**

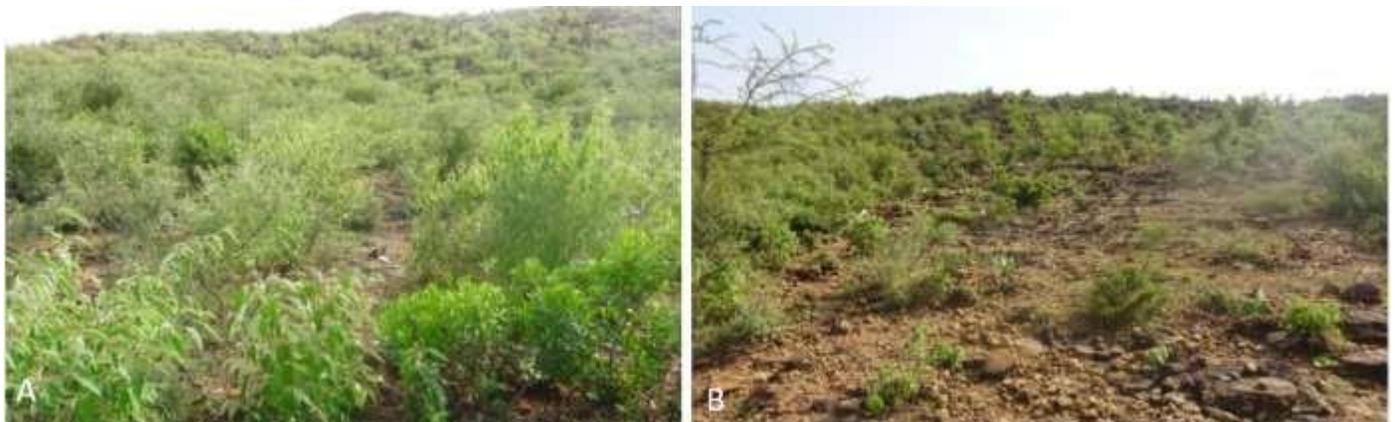
This plant community is located at the beginning of the Expressway in Mieso town (Fig. 6). There are open, rocky places which are not covered by vegetation. This plant community is common along the RoW and access roads to material sources of the project area. The species composition of this plant community is given below.

This community is species poor. *Acacia seyal*, which is a good charcoal tree, is locally rare. There are 3-5 individual young trees in 100 m x 100 m area in this plant community. The height of the individuals of this species ranges from 0.5 m - 1.5 m. Mature trees of *A. seyal* are absent in this community. *Cyphostemma roundifolia* forms very dense stands throughout this plant community. Furthermore, *O. ficus-indica* is invading this plant community and it will homogenize it in the near future. All species of this plant community are of least conservation concern. However, *Caralluma* species are locally rare.

Fig. 6. *Acacia mellifera* - *Croton dichogamous* plant community. A, overview of the community; B, open, non-vegetated rocky places inside this community.

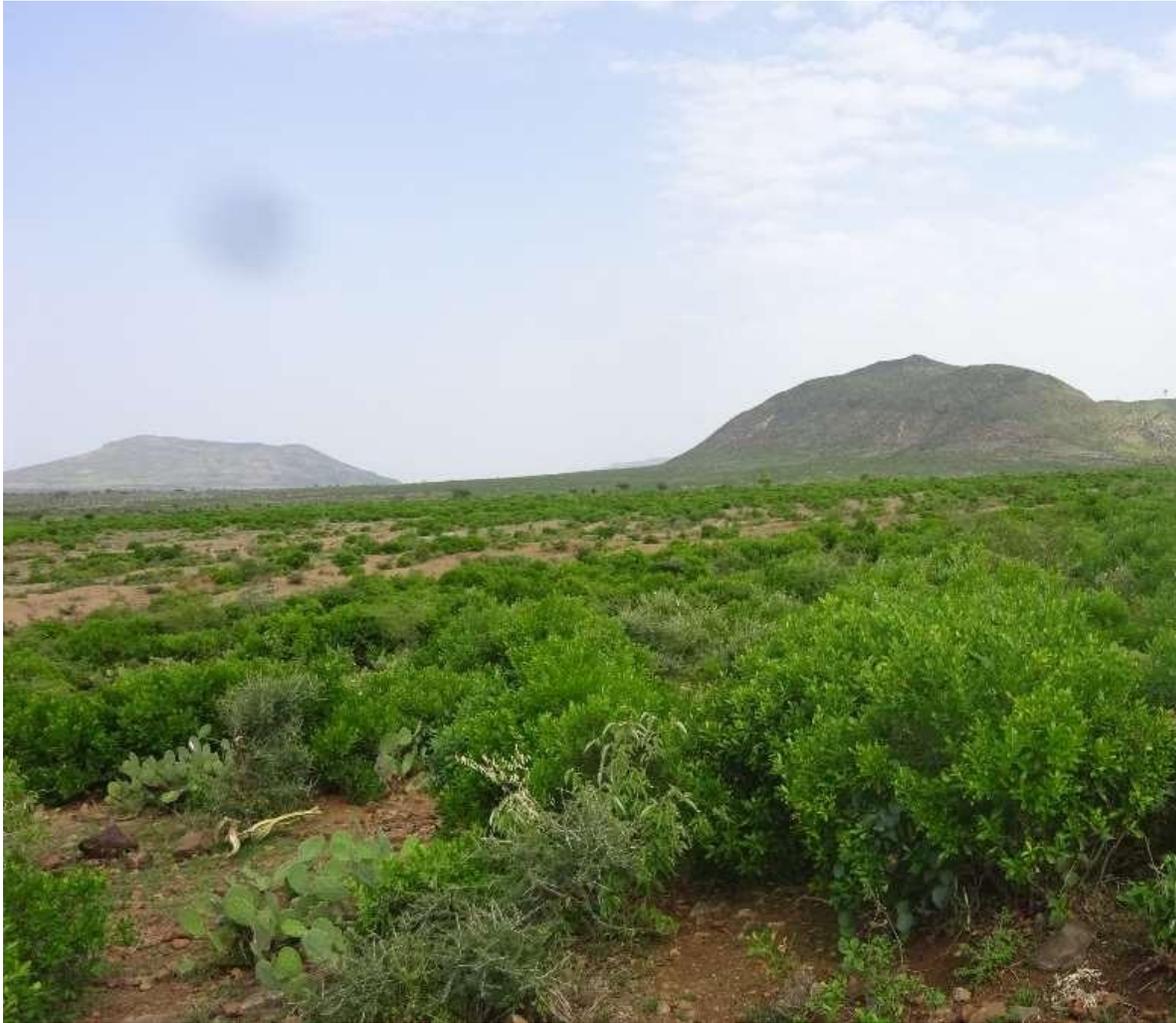
This plant community is entirely dominated by *Euclea divinorum* and occupies the flat plain at the beginning of the Mieso - Dire Dawa Expressway (Fig. 7). It is species poor and the community

grows in a disturbed area. There are, however, scattered individuals of *Acalypha fruiticosa*, *Acacia mellifera*, *Opuntia ficus-indica*, *Croton dichogamous* and *Cyphostemma rotundifolia*. All of these species are of least conservation concern. *Euclea divinorum* usually invade disturbed natural habitats and become dominate vegetation. This plant community is common along the RoW and access roads to material sources of the project area.

Fig. 7. *Euclea divinorum* plant community

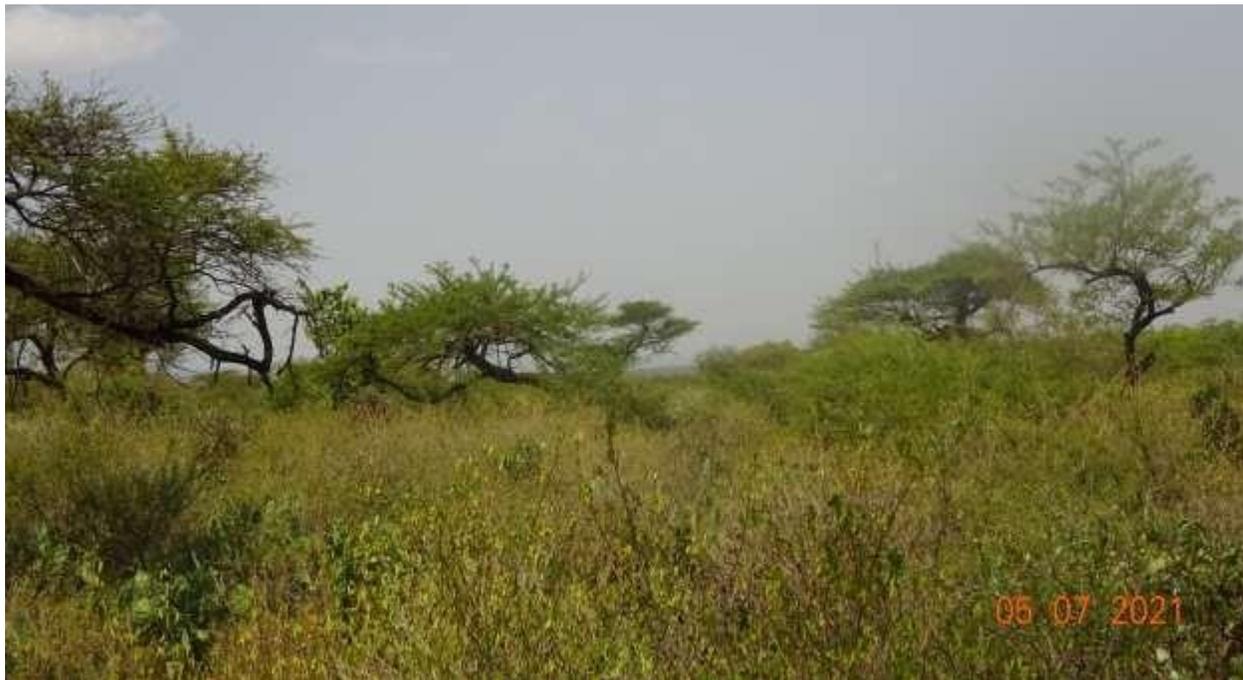
This plant community repeats itself in the project area (Fig. 8). It is species poor and grows in a disturbed area. This plant community is common along the RoW and access roads to material sources of the project area. The following species were recorded from this plant community.

The species of this plant community are of least conservation concern. It is species poor and grows on disturbed area. Although not recorded inside this community, *Prosopis juliflora* was recorded at its margin. There is a potential invasion of this plant community by *Opuntia ficus-indica* and *Prosopis juliflora* in the near future.

Fig. 8. *Acacia nilotica* - *Opuntia ficus-indica* - *Acalypha fruticosa* plant community

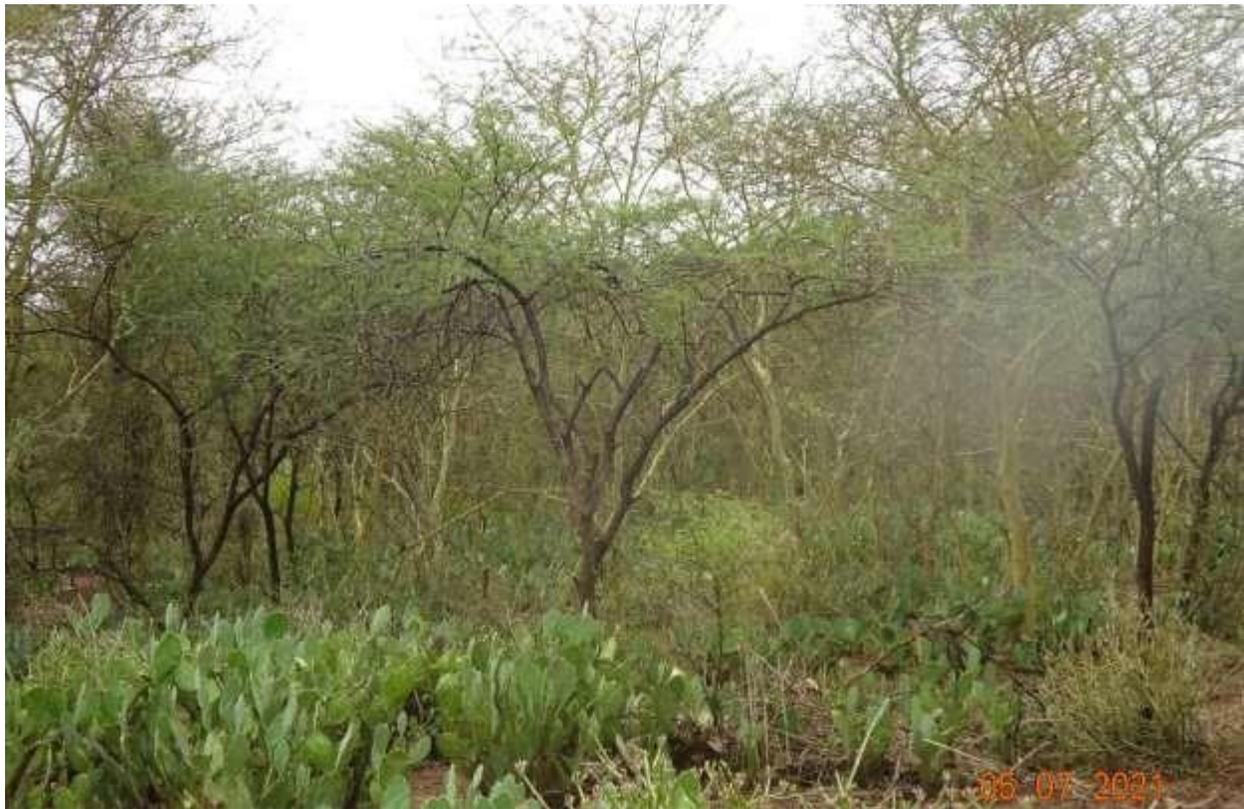
This community grows on a flood plain (Fig. 9). This is species poor and none of the species of this community are of least conservation concern. This plant community is common along the RoW and access roads to material sources of the project area. The species of this community are:

Fig. 9. *Acacia seyal* - *Acacia nilotica* plant community on a flood plain

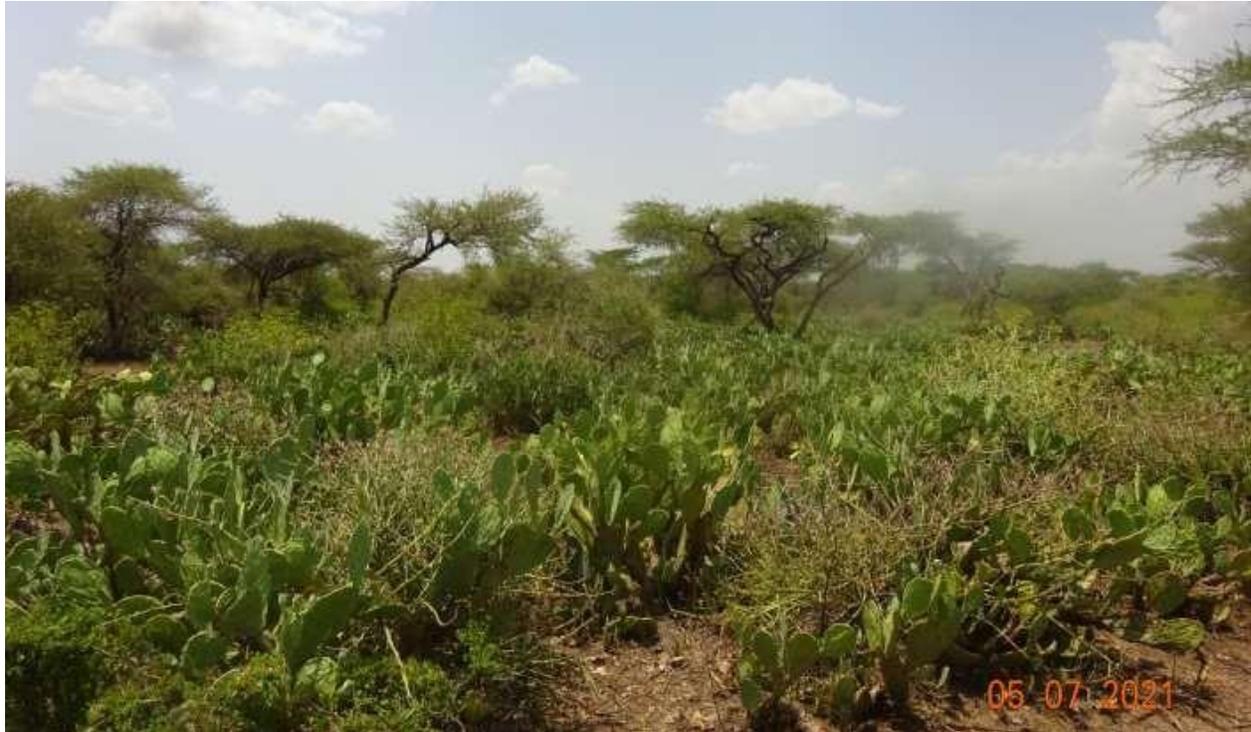
This plant community repeats itself throughout the stretch of the Mieso - Dire Dawa Expressway (Fig. 10). It is species poor and *Opuntia ficus-indica* is invading open sites within the community following anthropogenic disturbances, e.g., cutting mature trees of *A. nilotica*. If the current trend (cutting mature trees of *A. nilotica*) continues, this plant community will be homogenized and can be entirely replaced by a pure stand of *O. ficus-indica*. This plant community is common along the RoW and access roads to material sources of the project area. The species of this community includes, *Acalypha fruticosa*, *Balanites aegyptiaca*, *Kleinia squarrosa*, *Sansevieria ehrenbergii* and *Physalis ixocarpa*.

Fig. 10. *Opuntia ficus-indica* - *Acacia nilotica* plant community

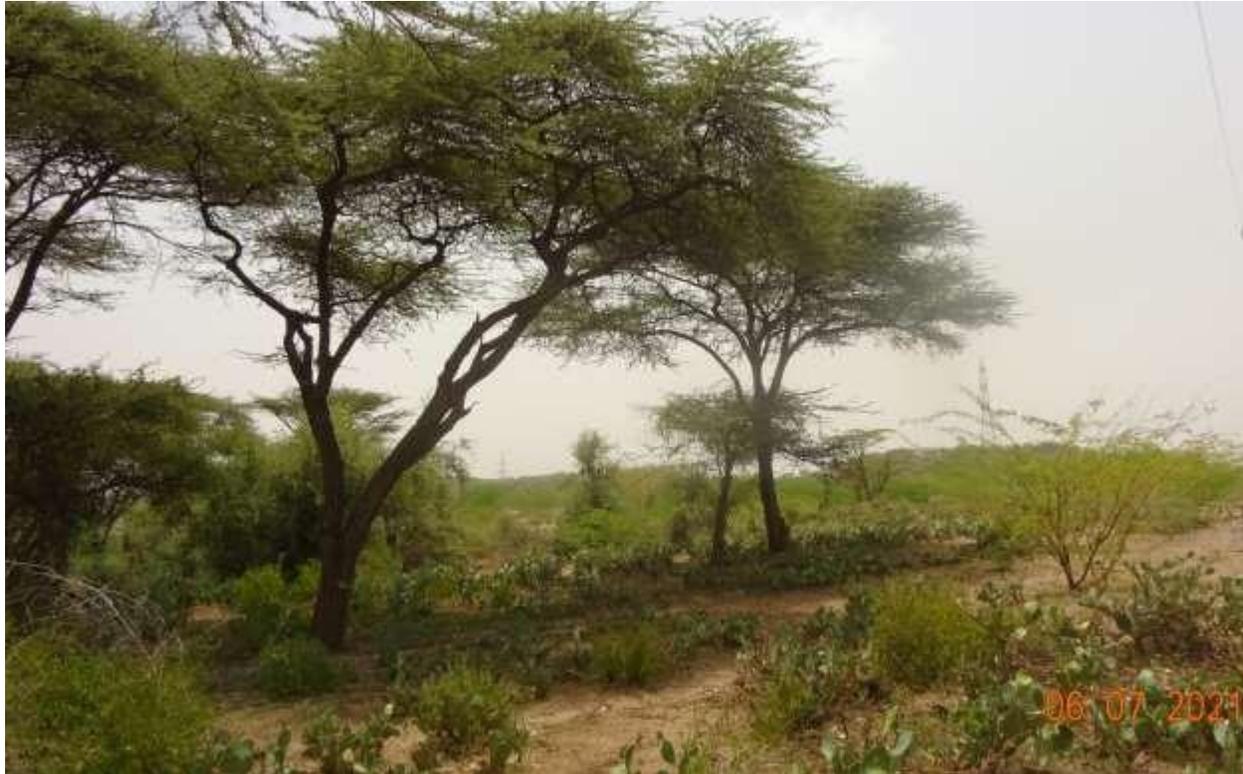
This plant community grows on a degraded area and dominated by scattered trees of *Acacia tortilis* and relatively dense stand of alien invasive *prosopis juliflora* (Fig. 11). This plant community is common along the RoW and access roads to material sources of the project area. The following species were recorded in this community.

This community has three potentially invasive species, i.e., *Prosopis juliflora*, *Parthenium hysterophorus* and *Opuntia ficus-indica*. This community may be replaced by *Prosopis juliflora* since this species form dense stands and due to its high competitiveness through its allelopathic effects (suppressing the growth of other species close to it).

Fig. 11. *Acacia tortilis* - *Prosopis juliflora* plant community

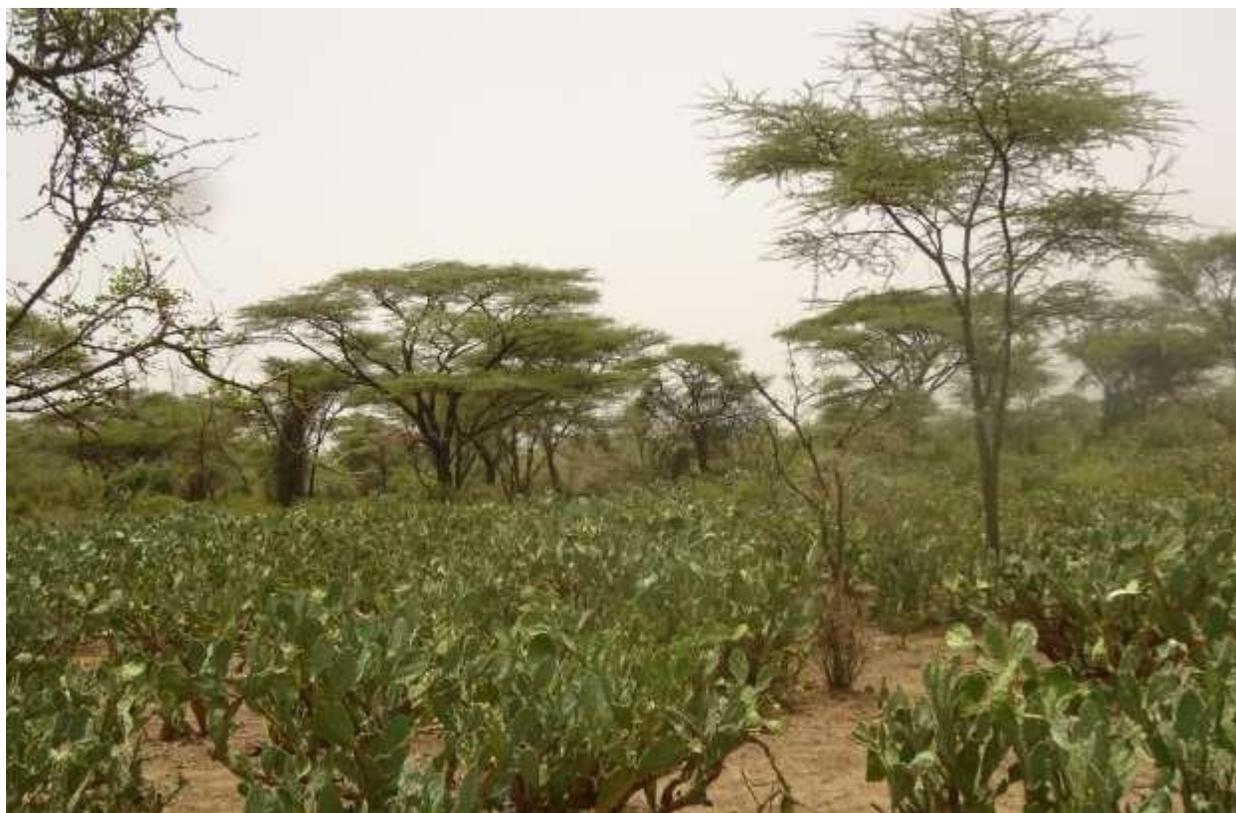
This plant community is dominated by *Acacia tortilis* and *Opuntia ficus-indica* (Fig. 12). There is open, non-vegetated places. This plant community is common along the RoW and access roads to material sources of the project area. The following species were recorded in this community.

Fig. 12. *Acacia tortilis* - *Opuntia ficus-indica* plant community

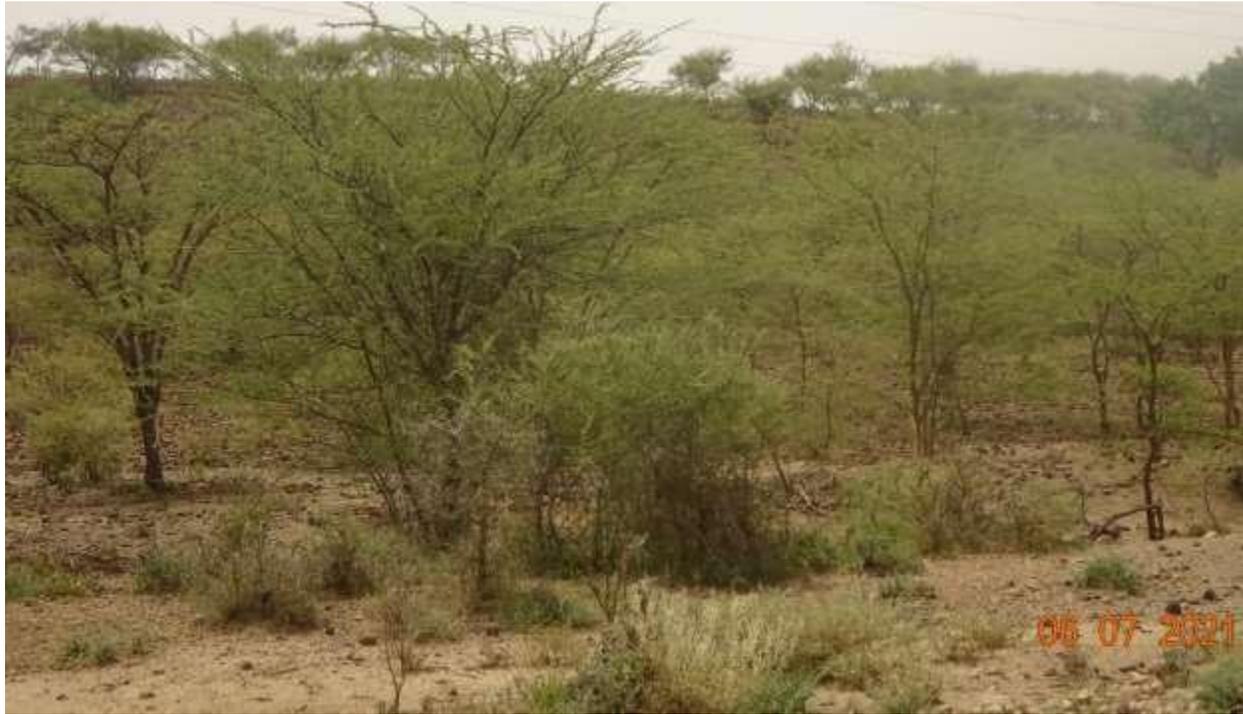
This plant community grows on rocky places on a hill (Fig. 13) and repeats itself along the entire stretch of the Mieso - Dire Dawa Expressway on hilly slopes. This plant community is common along the RoW and access roads to material sources of the project area. The following species were recorded in this community.

Fig. 13. *Acacia senegal* - *Acacia tortilis* plant community

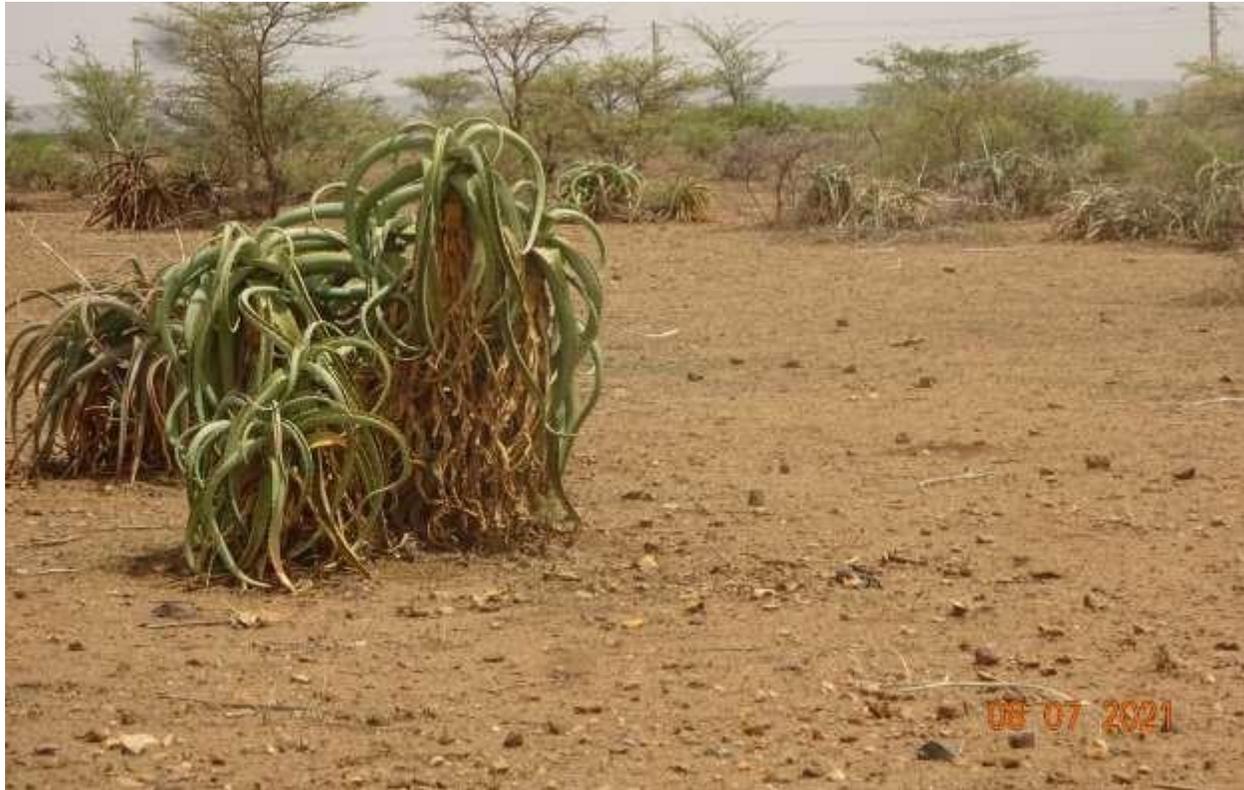
This plant community is dominated by *Aloe megalacantha* and *Acacia mellifera* (Fig. 14). There is a highly level of browsing of *Acacia mellifera* and a footprint of high anthropogenic disturbances such as cutting *Acacia* trees for household uses. This community has two endemic *Aloe* species, i.e., *Aloe harlana* and *Aloe pubescens*. Furthermore, *Caralluma spiciosa* is also locally rare in the project area and is part of this community. This plant community is common along the RoW and access roads to material sources of the project area. The following species were also recorded in this plant community.

The two endemic Aloe species, *A. harlana* and *A. pubescens* are of a great conservation concern. The occurrence of *Prosopis juliflora* in this plant community is a threat since it could gradually invade this community and replace it with its dense stands.

Fig. 14. *Aloe megalacantha* - *Acacia mellifera* plant community

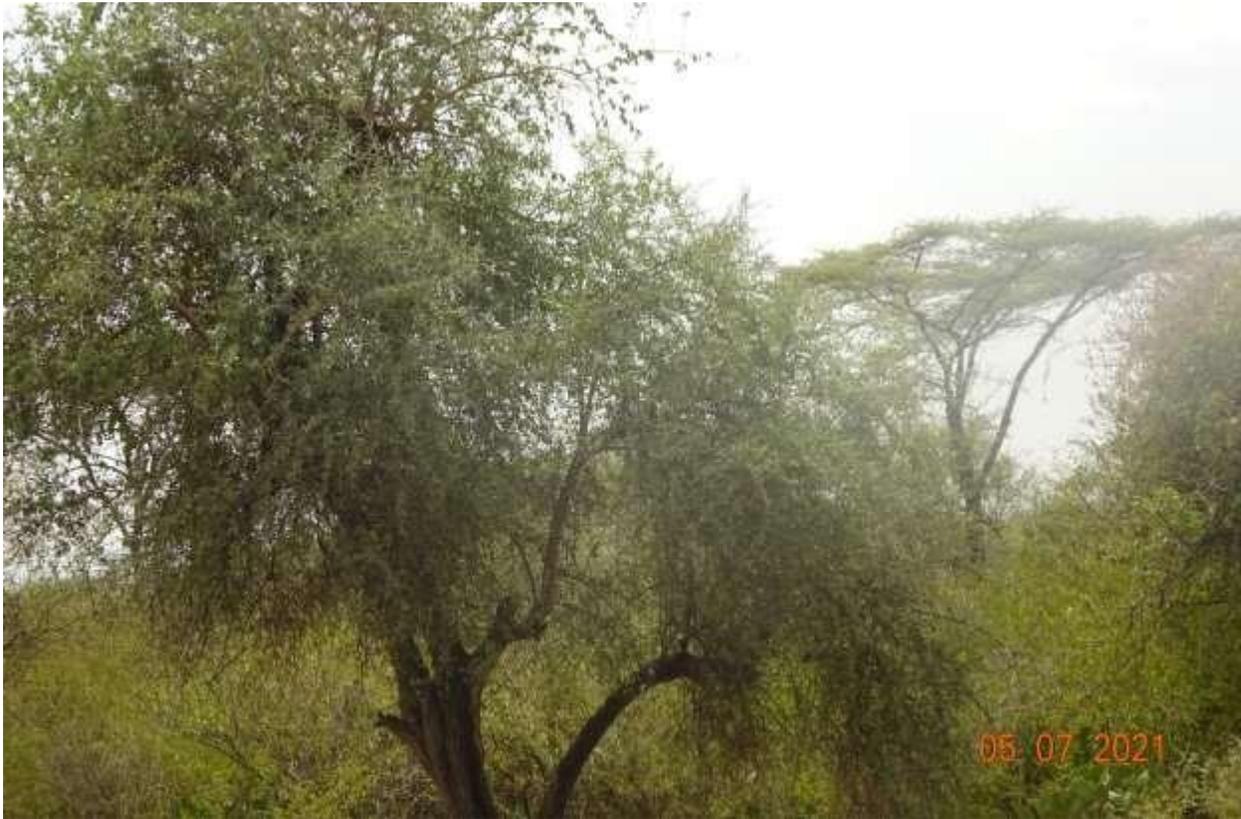
1) *Balanites aegyptica* - *Acalypha fruticosa* plant community (at Wangayo River) - Fig. 15. GPS: 0709538, 1036400

All species of this riverine plant community are of least conservation concern.

Fig. 15. *Balanites aegyptica* - *Acalypha fruticosa* plant community at the banks of Wangayo River

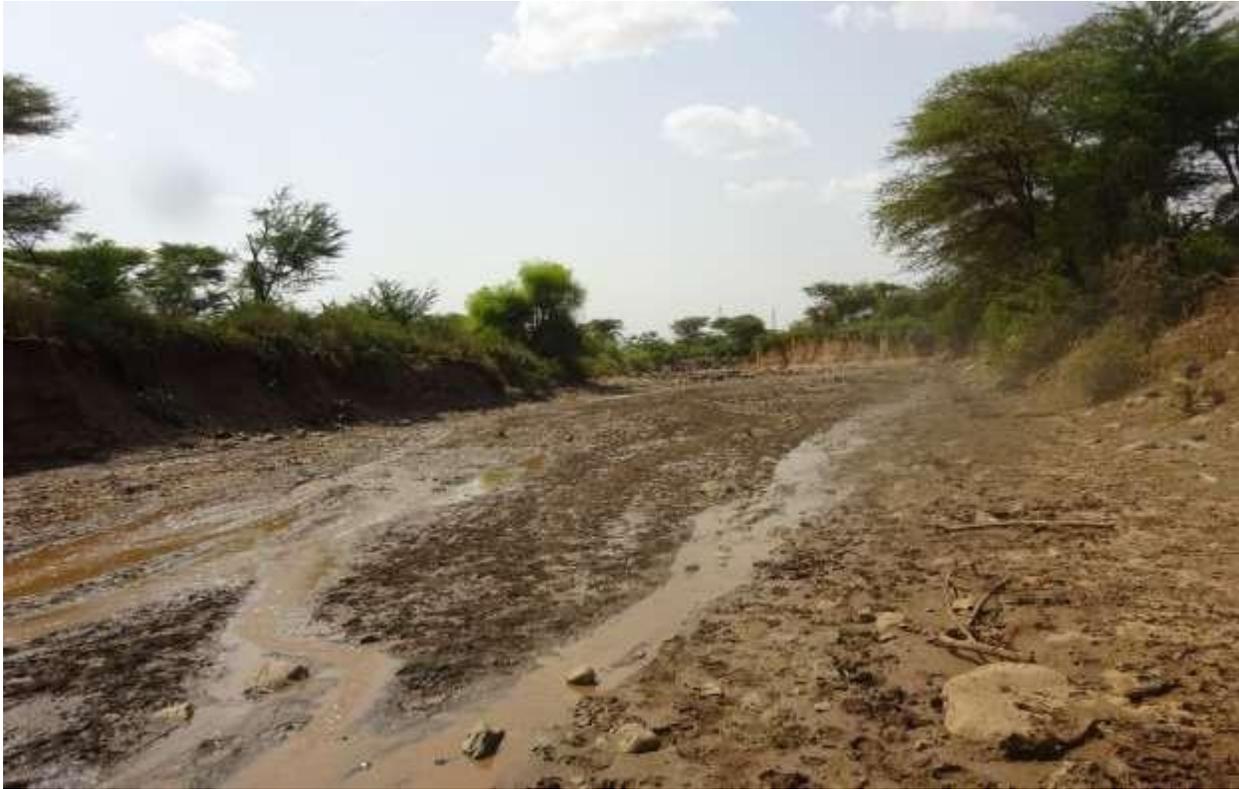
This plant community grows on degraded banks of Doba river (Fig. 16). This plant community is common along the RoW and access roads to material sources of the project area. It is species poor and the following species were recorded in this community.

Fig. 16. *Acacia nilotica* - *Balanites aegyptical* plant community at Doba river

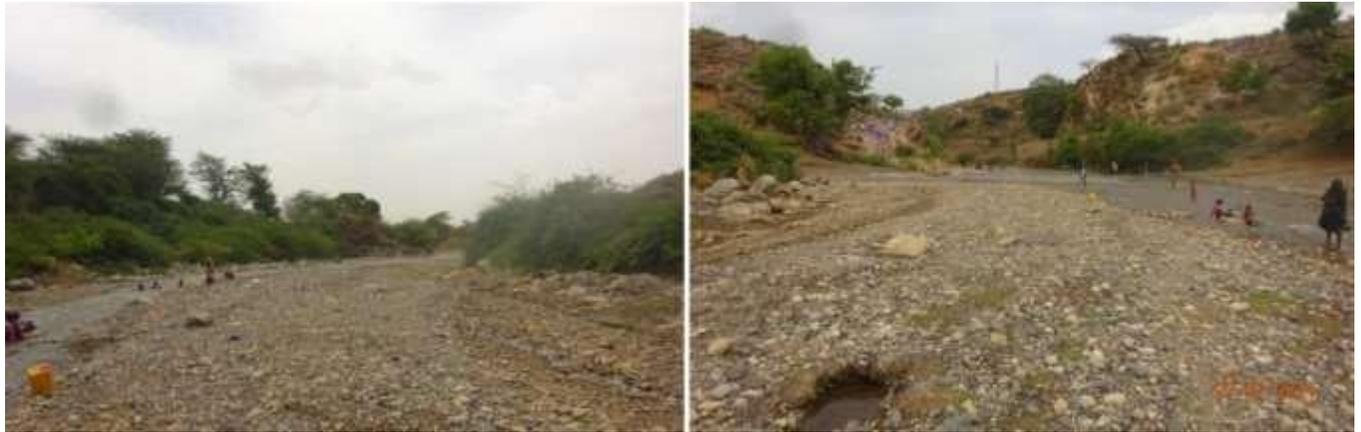
This riverine plant community is highly dominated by dense stands of *Prosopis juliflora* (Fig. 17). It has been noted that there is an expansion of this invasive species along both seasonal river banks. The local people, birds and vervet monkey are using this seasonal river for washing and drinking. The native species, e.g., *Mimusops kummel*, *Dobera glabra* and *Cordia monoica* are heavily pruned for firewood and other household uses. Part of the riverine vegetation is rocky and highly degraded. This plant community is common along the RoW and access roads to material sources of the project area. The following species were recorded in this riverine plantcommunity.

All these species of this riverine plant community are of least conservation concern. This plant community could be overtaken by invasive species, namely, *Prosopis juliflora* and *Lantana camara* in the future.

Fig. 17. *Prosopis juliflora* dominated riverine vegetation of Erer River

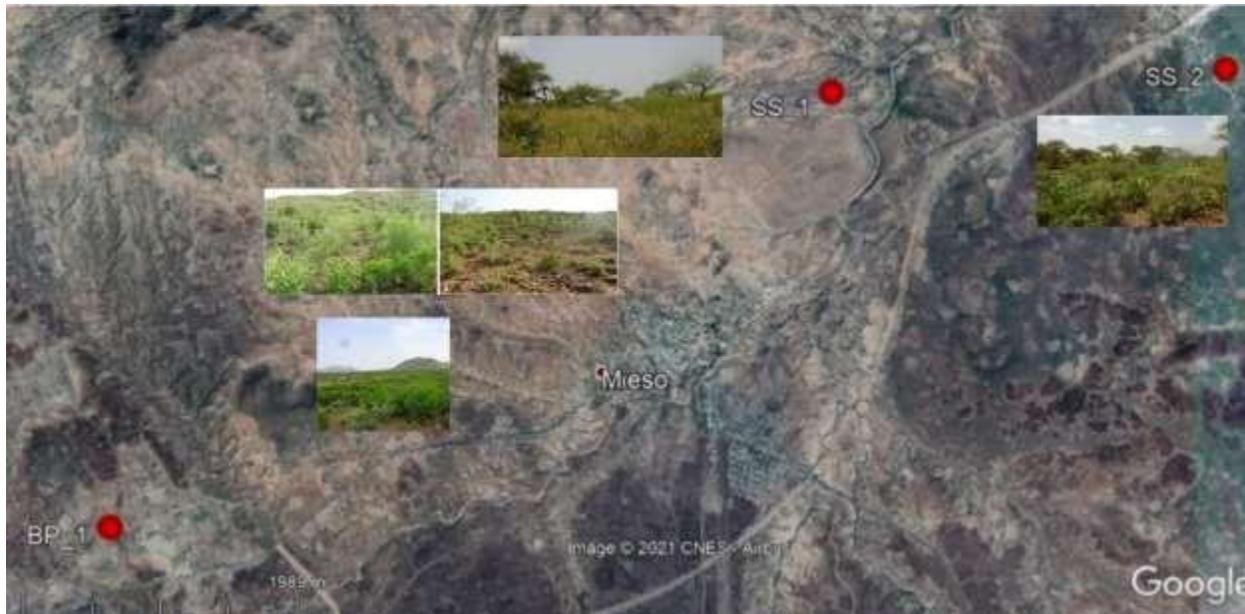
The nine terrestrial plant community types described above [(section 4.2.1 (1)] characterize all the ancillary sites (quarry sites, borrow pits and gravel sources). Sand sources for the construction of the Expressway are located in the riverine plant communities. All these plant communities repeat themselves all along the entire section of the Mieso - Dire Dawa Expressway and all burrow pits and gravel source sites (e.g., Fig. 18). Except for locally rare species such as *Caralluma acutangula*, *Caralluma priogonium*, *Caralluma speciose*, *Kleinia squarrosa*, and the endemic Aloe species (*Aloe harlana* and *Aloe pubescens*), all the remaining recorded plants species of the project area are of least conservation concern.

Fig. 18. The different plant communities of the project area repeat themselves across the entire section of the Mieso - Dire Dawa Expressway in reference to the Right-of-Way and ancillary sites. BP\_1 = borrow pit-1; SS\_1 - sand source-1; SS-2 = sand source-2.

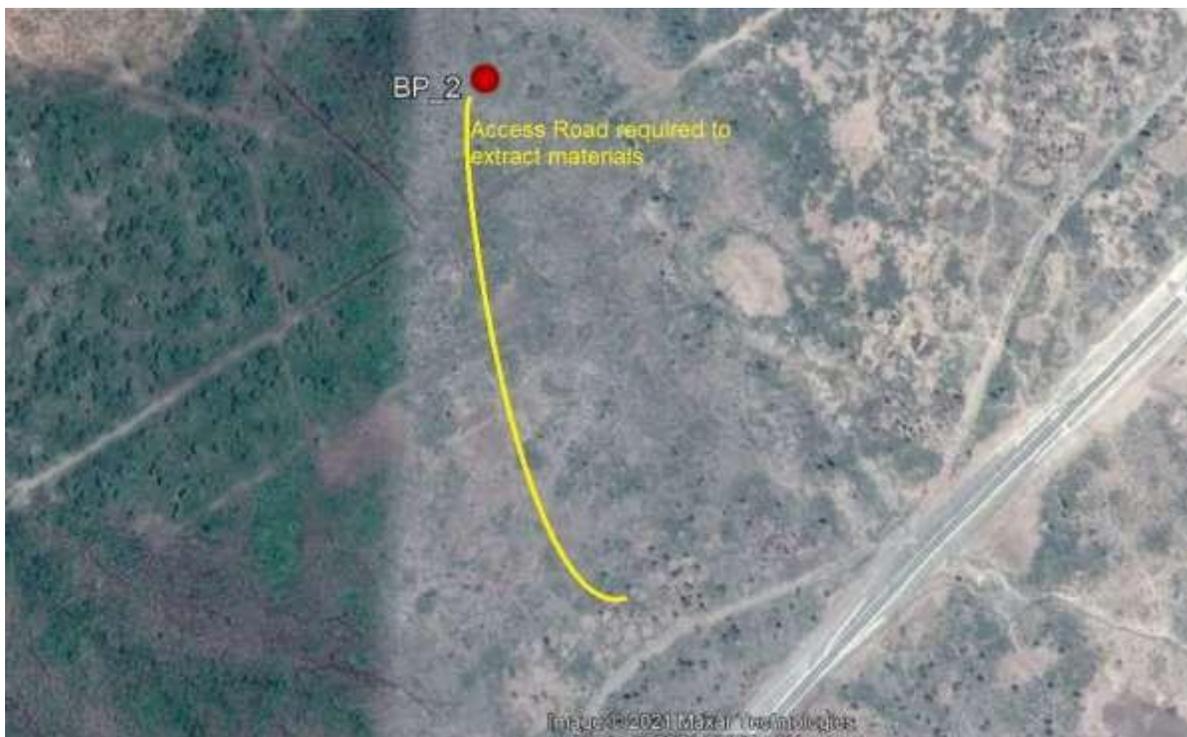
Access roads to the material sites, i.e., quarry sites, borrow pits, gravel source and sand source, cross the same plant communities indicated above. Fig. 19 shows an example of an access road to borrow pit-2 (BP\_2).

Fig. 19. Access roads crossing plant communities of the project area (cf. 4.2.1 and 4.2.2)

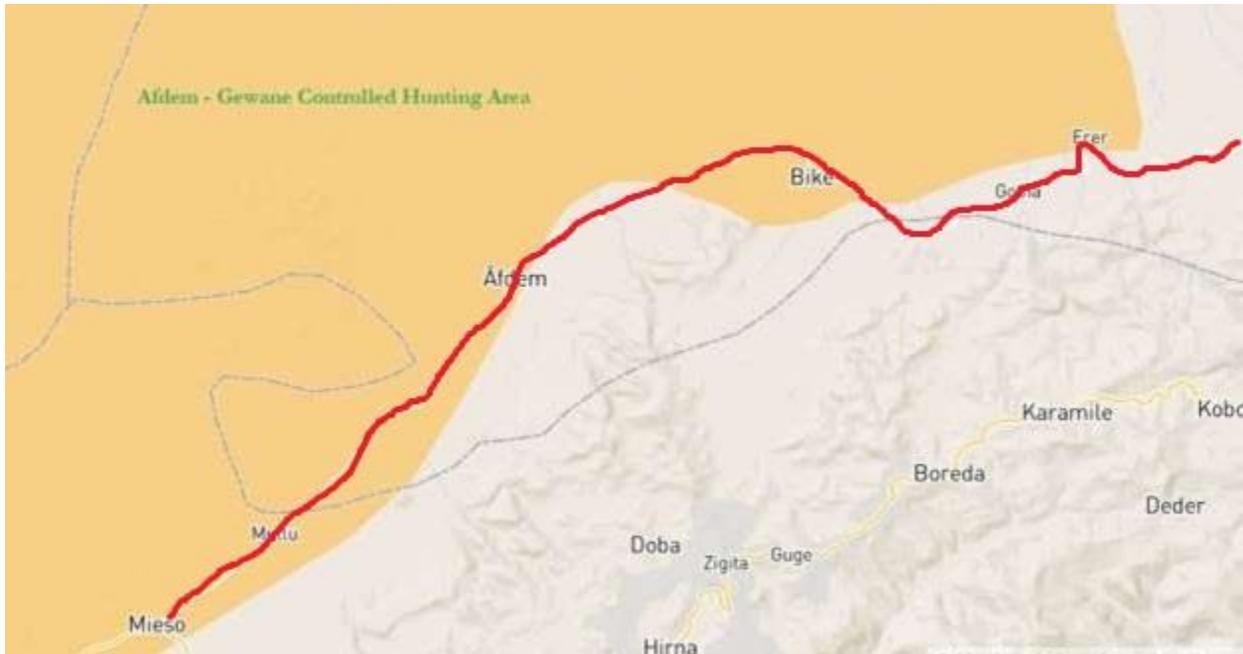
One Key Biodiversity Areas of the Project area is the Afdem - Gewane Controlled Hunting area (Fig. 26). The Mieso - Dire Dawa Expressway crosses this KBAs falling between Mieso and Erer. This KBA was designated as Protected Area and classified as IUCN Management category.

Fig. 26. Afdem - Gewane Controlled Hunting Area

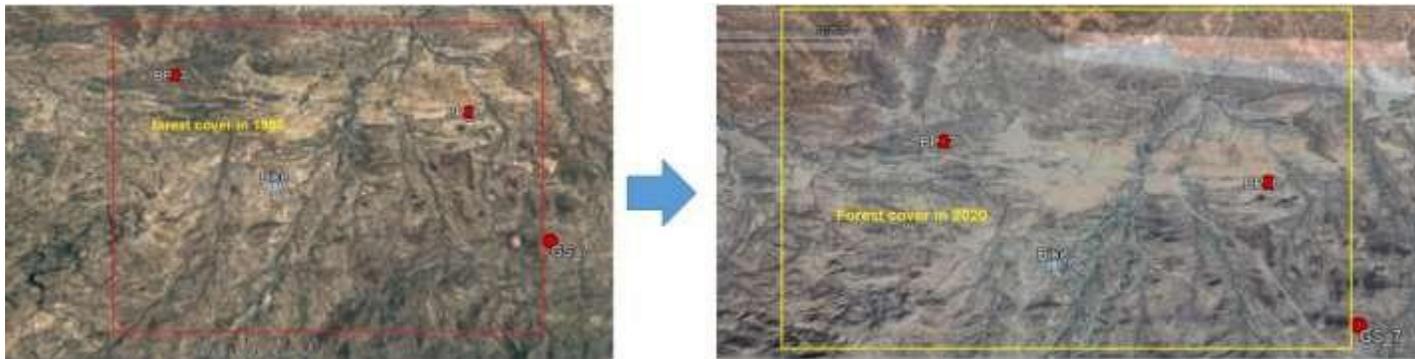
A series of historical Google Earth images of the project area have shown a visible qualitative changes of the vegetation cover of the project area (Fig. 27). The main causes are overgrazing and over browsing, agricultural expansion, expansion of urban settlement and expansion of rural settlement due to increased population.

Fig. 27. An example of qualitative change of the vegetation cover of Afdem - Gewane Controlled Hunting Area around Bike area in 1990 and 2020. Key: BP\_7 = Borrow pit-7; BP\_8 = Borrow pit-8; GS\_7 = Gravel source-7

In 2020, the part of the Afdem - Gewane Key Biodiversity Area has been degraded due to urban expansion

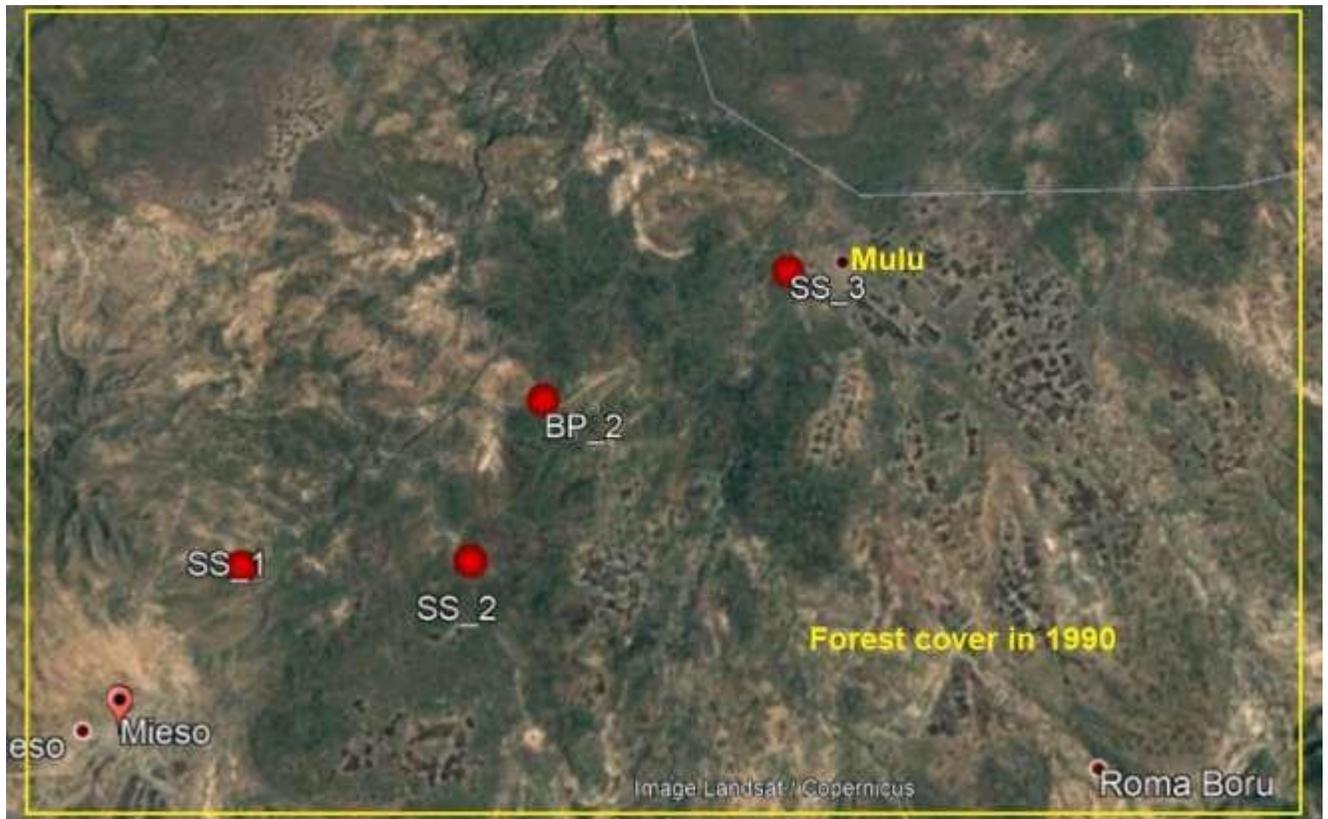
The Afdem - Gewane Controlled Hunting Area from Mieso - Mulu towns was relatively dense and in a natural condition in 1990 (Fig. 28). The expansion of urban settlement and agriculture have played key roles for the degradation of the vegetation cover of this KBA.

Fig. 28. Historical vegetation cover of Afdem - Gewane Controlled Hunting Area and current condition from Mieso - Mulu towns in 1990. Key: SS-1 = sand source-1; SS-2 = sand source-2; SS-3 = sand source-3; BP-2 = Borrow pits-2

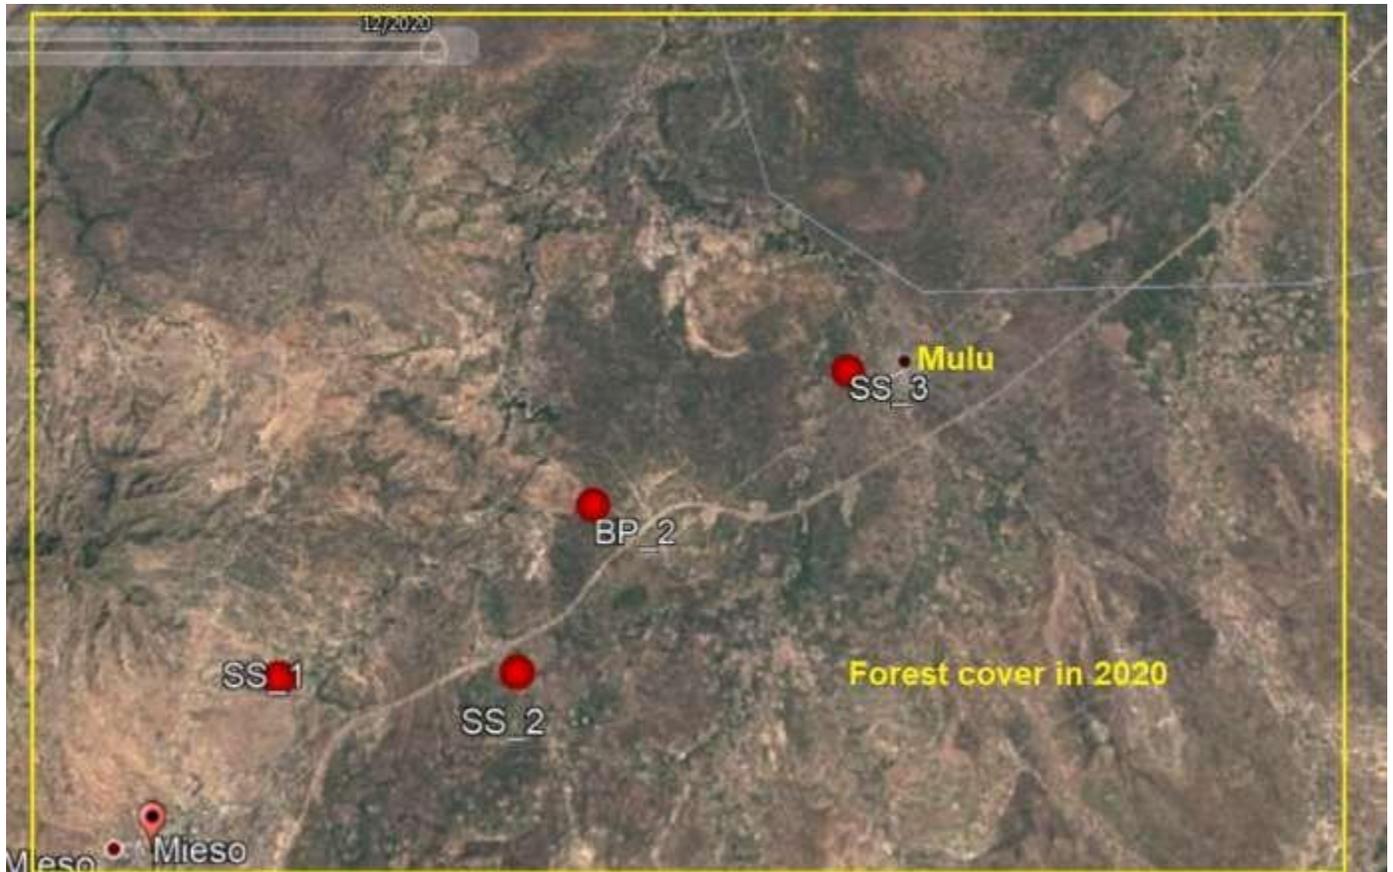
In 2020, the vegetation cover of this section of the Afdem - Gewane Controlled Hunting area has been degraded due to the expansion of urban settlement and agriculture (Fig. 29). There was also a high level of charcoal extraction from the Afdem - Gewane Controlled Hunting Area from Mieso - Mulu towns in the 1990s up until 2015 (interview with Mulu and Mieso Woreda Natural Resources Expert). Charcoal trade has been so extensive that the local communities have used camels to travel to Chiro and other parts to sell their charcoal products. Local vendors have also used Mieso as their center for buying and storing charcoal for national market. In addition to urban and agricultural expansion, unprecedented charcoal production in the Afdem - Gewane Controlled Hunting Area is believed to have contributed significantly to the degradation of the vegetation cover and selective cutting of big *Acacia* trees. The absence of charcoal production in this section of the KBA of the project area is entirely because all mature trees of *Acacia* species are totally cut.

Fig. 29. Historical vegetation cover of Afdem - Gewane Controlled Hunting Area and current condition from Mieso - Mulu towns 2020. Key: SS-1 = sand source-1; SS-2 = sand source-2; SS-3 = sand source-3; BP-2 = Borrow pits-2

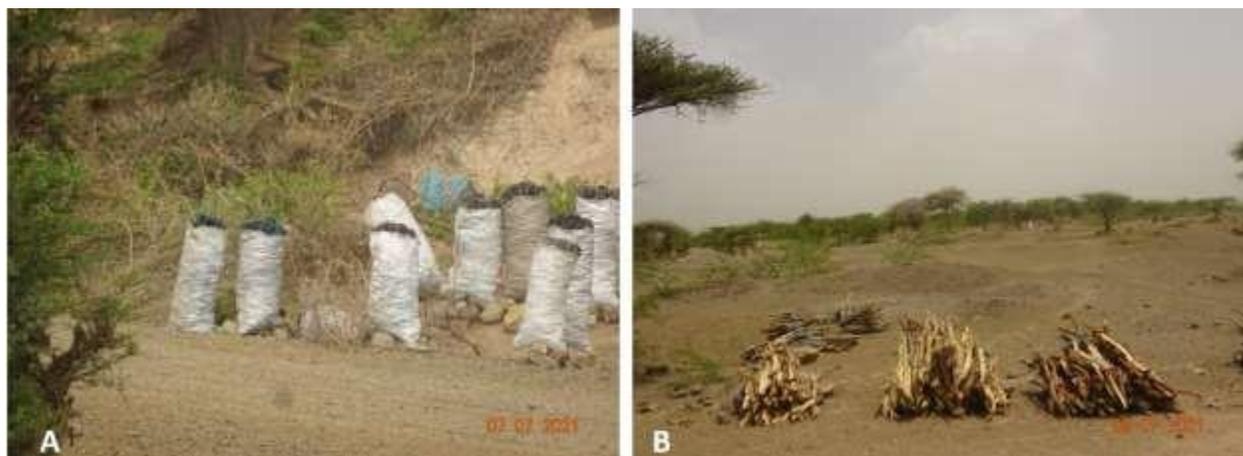
Charcoal production and firewood collection were recorded in the other section of the KBA of the project area (Fig. 30). This activity will result in the cutting of all, highly scattered mature trees of *Acacia* species from the Afdem - Gewane Controlled Hunting Area of the project.

Fig. 30. Charcoal production between Bike and Erer towns; A, Charcoal; B, firewood

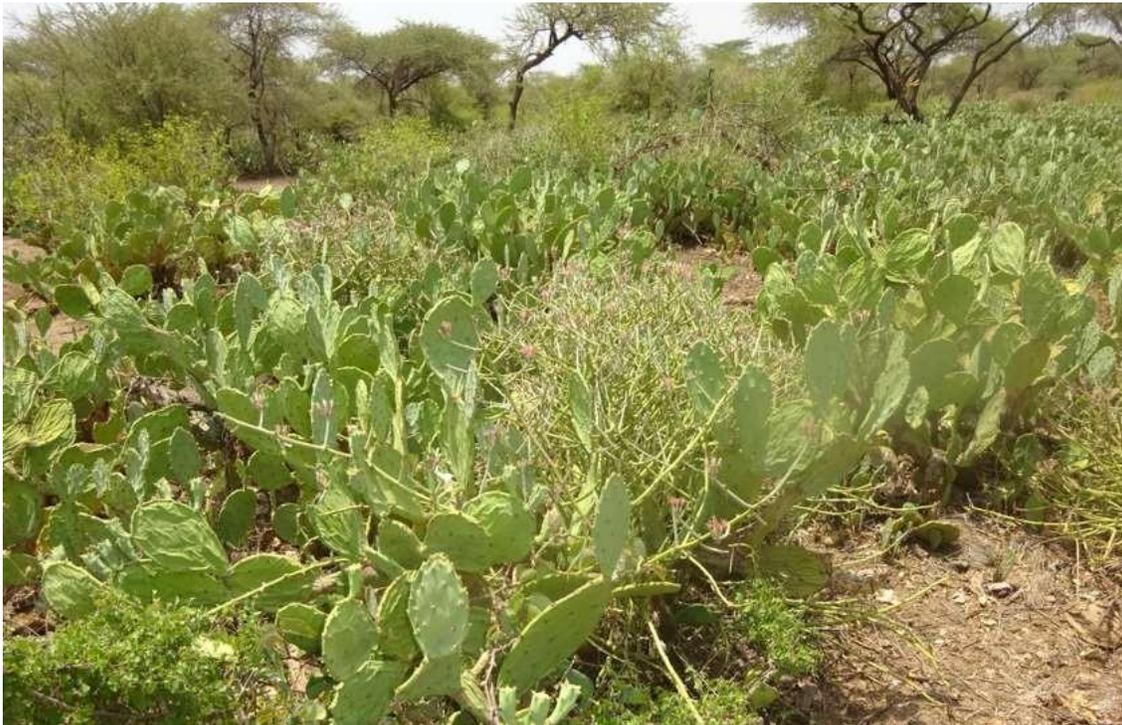
Currently, the vegetation cover of the Afdem - Gewane Controlled Hunting Area from Mieso - Mulu towns has been highly degraded and dominated by a succulent, weedy plant species called *Opuntia ficus-indica* (Fig. 31). This species is economically important fruit and fodder crop. In areas where this species is dominant, there is a homogenization of the composition of the plant communities of the project area, i.e., reduction in species diversity. There is a noticeable invasion of the plant communities of the project area by *Opuntia ficus-indica*. If this trend continues, the species composition of the current plant communities of the project area will be negatively affected. This unabated invasion of this KBA by *O. ficus-indica* will result in homogenized plant communities in the project area with depauperated native flora and biodiversity.

Fig. 31. Vegetation cover between Mieso - Mulu towns dominated by a weed plant species, *Opuntia ficus-indica*.

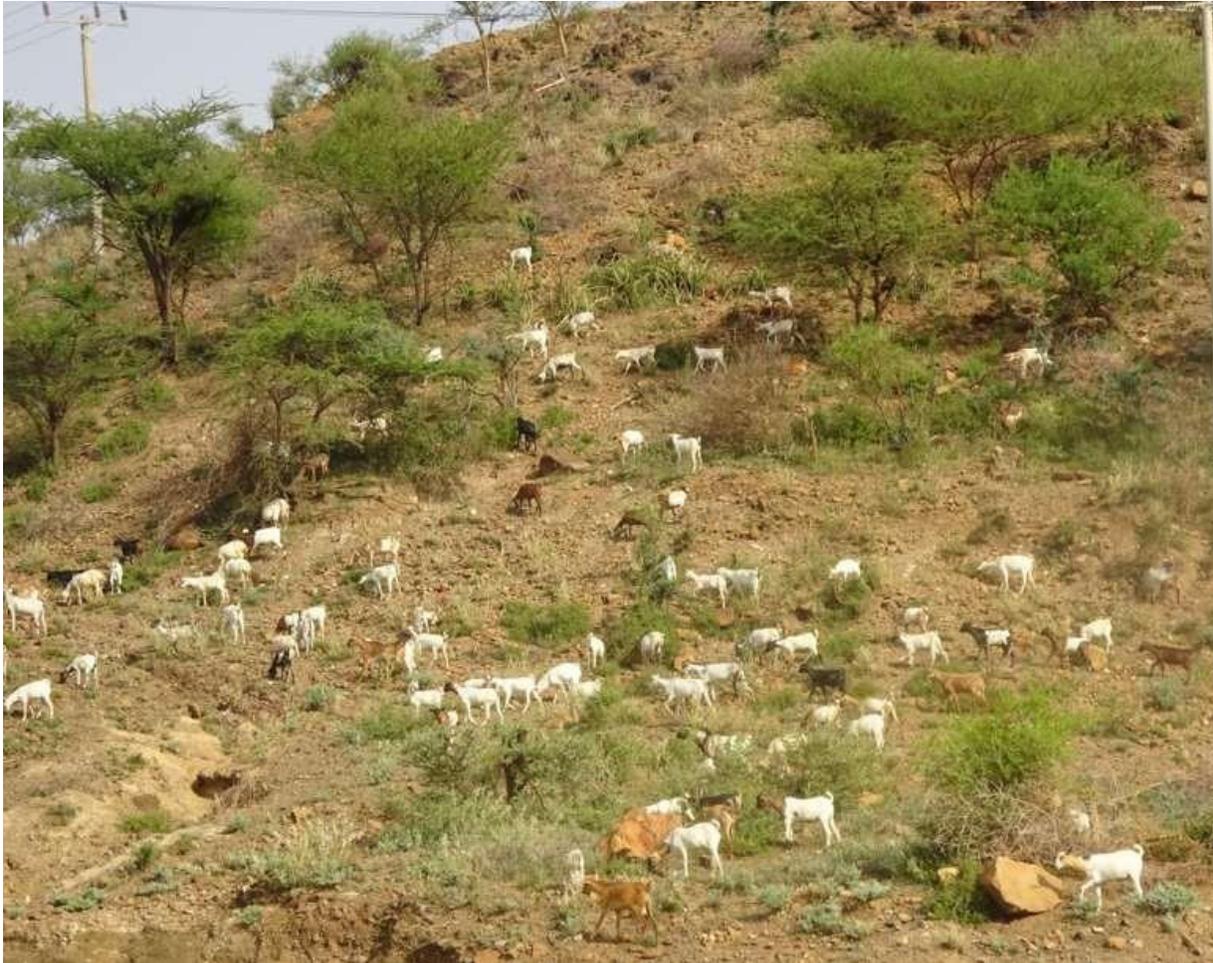
The project area is home to pastoral communities with a large herd of livestock. The local communities keep a large number of goats, sheep and camel. This project area has experienced heavy overgrazing and over browsing over years, which has degraded the vegetation and negatively affected natural regeneration (Fig. 32).

Fig. 32. A large number of goats browsing in the project area

Plant species of the project area were heavily over browsed. Such over browsing has negatively affected coppicing, i.e., repeated over browsing coppiced shrubs and trees has induce stunted growth and degradation of vegetation cover.
