***Updated Biodiversity,  
Habitat Baseline Data,  
and Water Resources  
Assessment

Rapid Cumulative and  
Regional Effect  
Assessment

**Updating Biodiversity, Habitat Baseline data, and Water Resources Assessment for Mieso-Dire Dawa Expressway Project**

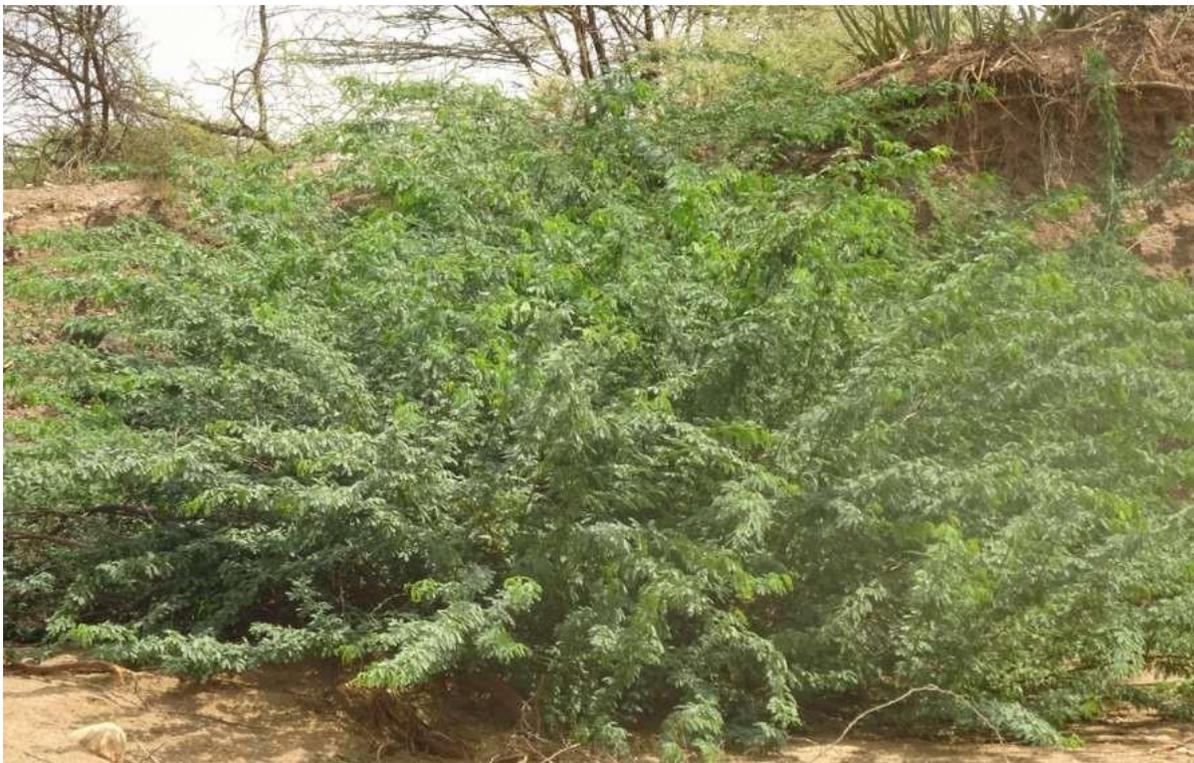
Some areas of the Afdem - Gewane Controlled Hunting Area have been infested with an alien invasive species, *Prosopis juliflora* (Fig. 33). This species is an evergreen shrub which causes degradation of native biodiversity and grazing areas in the arid environment such as the Mieso - Dire Dawa Expressway project area. It is a native plant to Mexico, central and northern South America. It was introduced to Ethiopia to increase wood availability and restoration of degraded areas. A recent study in Afar region has revealed the new dimension of the impacts of this aggressive invasive species on livelihoods, i.e., it diminishes water resources (Shiferaw et al., 2021). This study has reported the following findings.

Fig. 33. Portion of the Afdem - Gewane Controlled Hunting Area infested with alien invasive species, *Prosopis juliflora*

With the current rate of the expansion of *Prosopis juliflora*, most of the areas of the Afdem - Gewane Controlled Hunting Area will be covered by thick, impenetrable thickets of this species. As a result of this, this species will seriously reduce water resources of the project area affecting livelihoods and degraded native biodiversity and rare, endemic plants of the project area. Therefore, the rapid expansion of *Prosopis juliflora* affects ecosystem services such as water availability of the project area, results in ecosystem degradation, changes species composition and alters functioning of the terrestrial ecosystem of the project area.

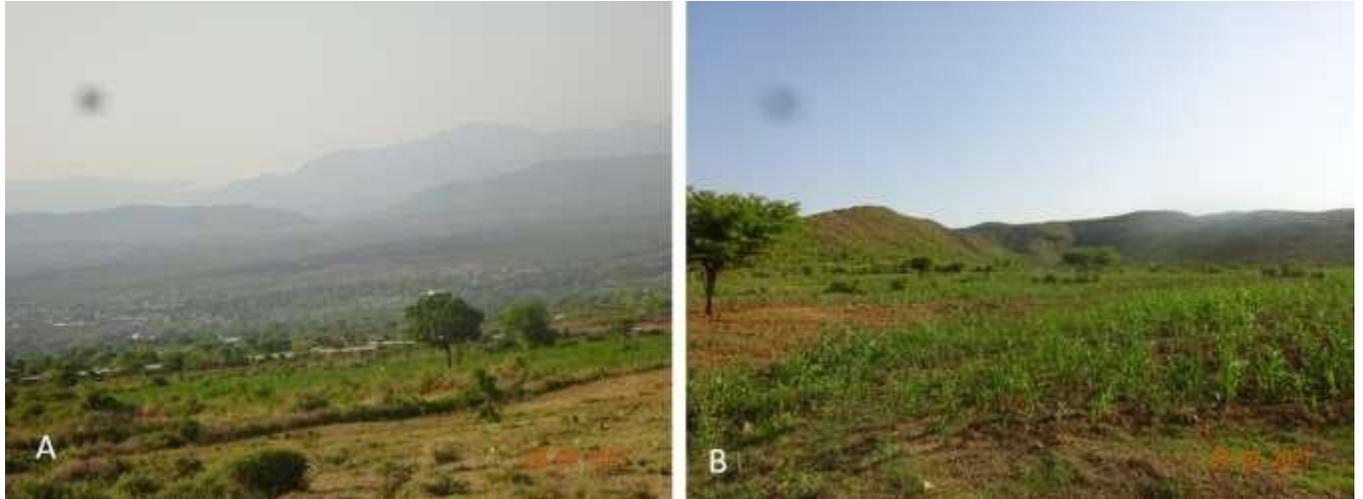
There is a steady increase in the expansion of urban settlement and agriculture in the portion of Afdem - Gewane Controlled Hunting Area falling in the project area (Fig. 34). In 1990, this KBA was in its natural condition with less anthropogenic disturbance as evidenced by sparse settlement both in the urban and rural areas. In 2020, there was an increase in urban settlement and agriculture inside the Afdem - Gewane Controlled Hunting Area in the project area, e.g. Mieso town and its surroundings. This has led to degradation of vegetation cover due to anthropogenic impacts.

Fig. 34. Urban settlement and Agriculture inside Afdem - Gewane Controlled Hunting Area around Mieso. A, overview of Mieso town; B, Sorghum field close to the beginning stretch of the Mieso - Dire Dawa Expressway at Mieso town.

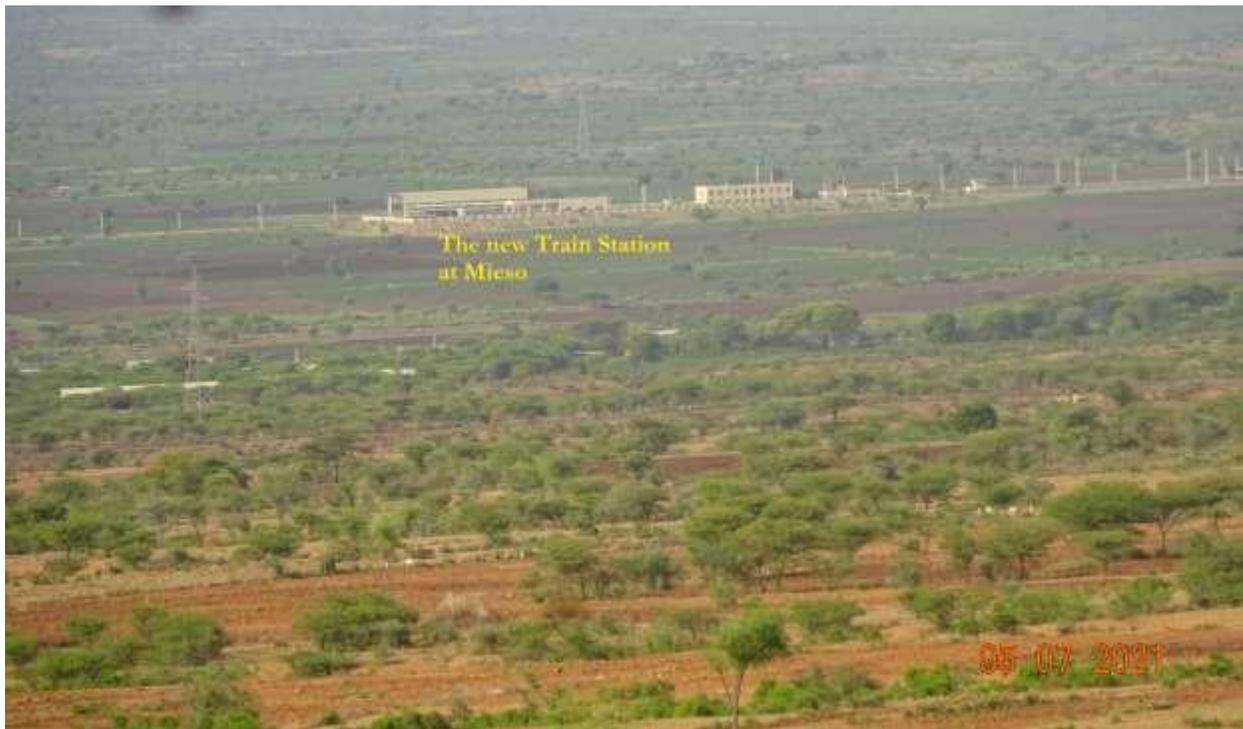
At around the beginning of point of the Mieso - Dire Dawa Expressway, agricultural expansion and settlement has converted the Afdem - Gewane Controlled Hunting Area into a simplified landscape with scattered tree (Fig. 35). These scattered trees of *Grewia mollis* is a source for food for birds. Furthermore, local communities use to store dry hay for their livestock.

Fig. 35. View of the altered vegetation of the Afdem - Gewane Controlled Hunting Area due to anthropogenic impacts at around Mieso town

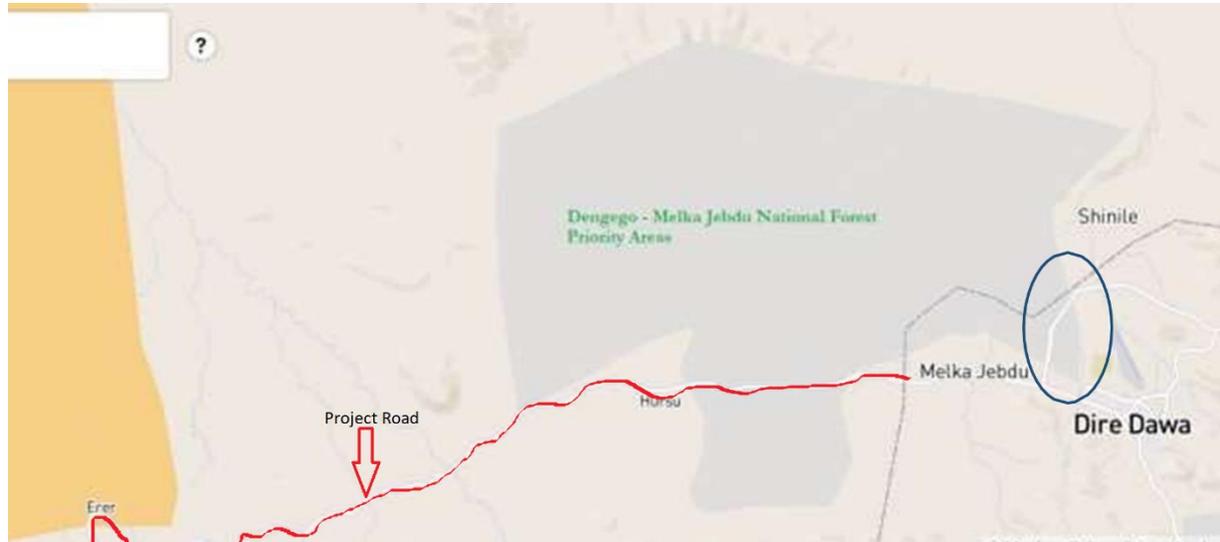
The Dengego - Melka Jebdu National Forest Priority Area (NFPA) is one of the 58 NFPAs of Ethiopia (Fig. 36). Some section of the Mieso - Dire Dawa Expressway crosses part of this NFPA. The historical vegetation cover of this NFPA and its threats are describes below.

Fig. 36. The Dengego - Melka Jebdu National Forest Priority Area in the project areas.

The blue Circle represents (Fig. 36) relative location of the part of the Dengego - Melka Jebdu NFPA in the project area that has been severely affected by expansion of urban settlement and agriculture and invasion by *Prosopis juliflora* between 1985 and 2020. The reported area of this NFPA is 536.19 km<sup>2</sup> (UNEP-WCMC and IUCN, 2021).
