**TERRESTRIAL, AQUATIC AND WETLAND ECOLOGICAL
STUDIES TO INFORM THE ENVIRONMENTAL AND SOCIAL
IMPACT ASSESSMENT FOR THE PROPOSED UNIKA WIND
FARM DEVELOPMENT IN THE EASTERN PROVINCE OF
ZAMBIA**

June 2019

Section B: Floral Assessment

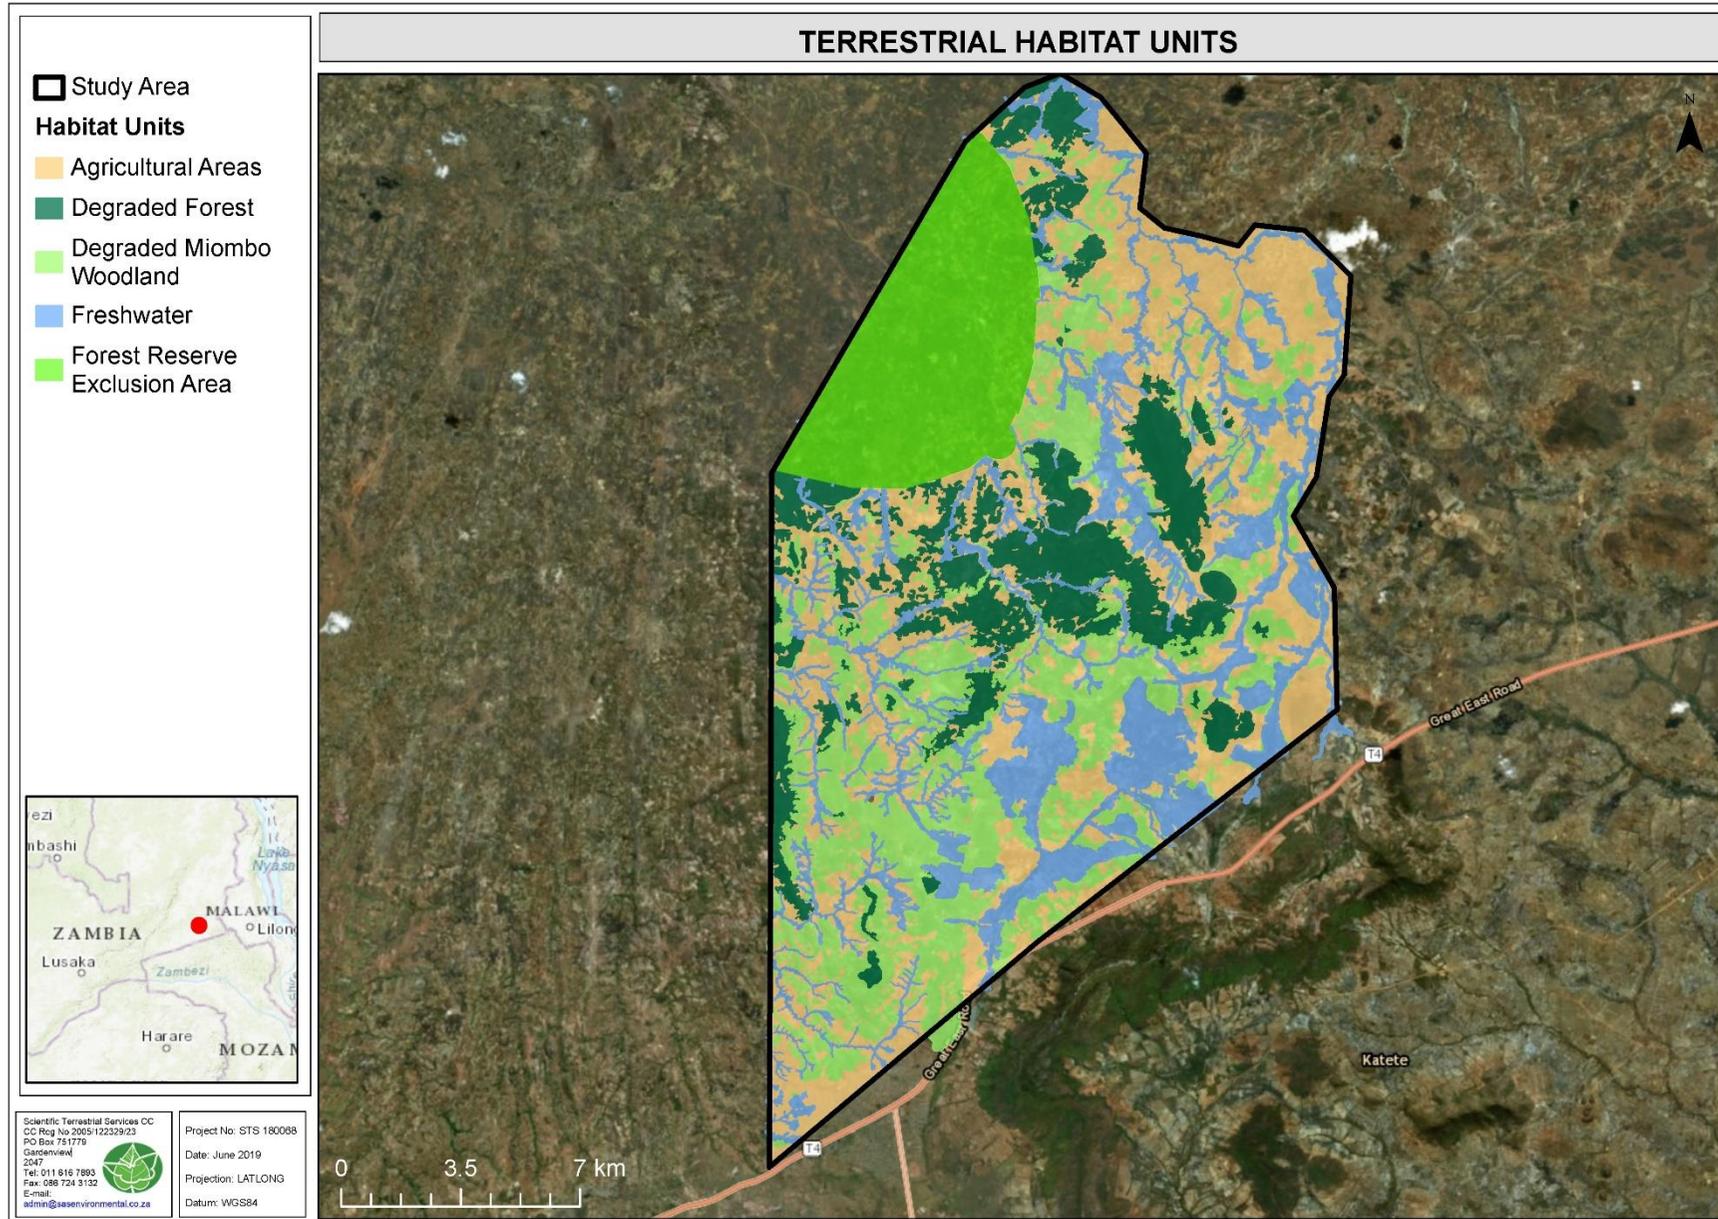
Figure 1: Conceptual illustration of the habitat units within the study area.

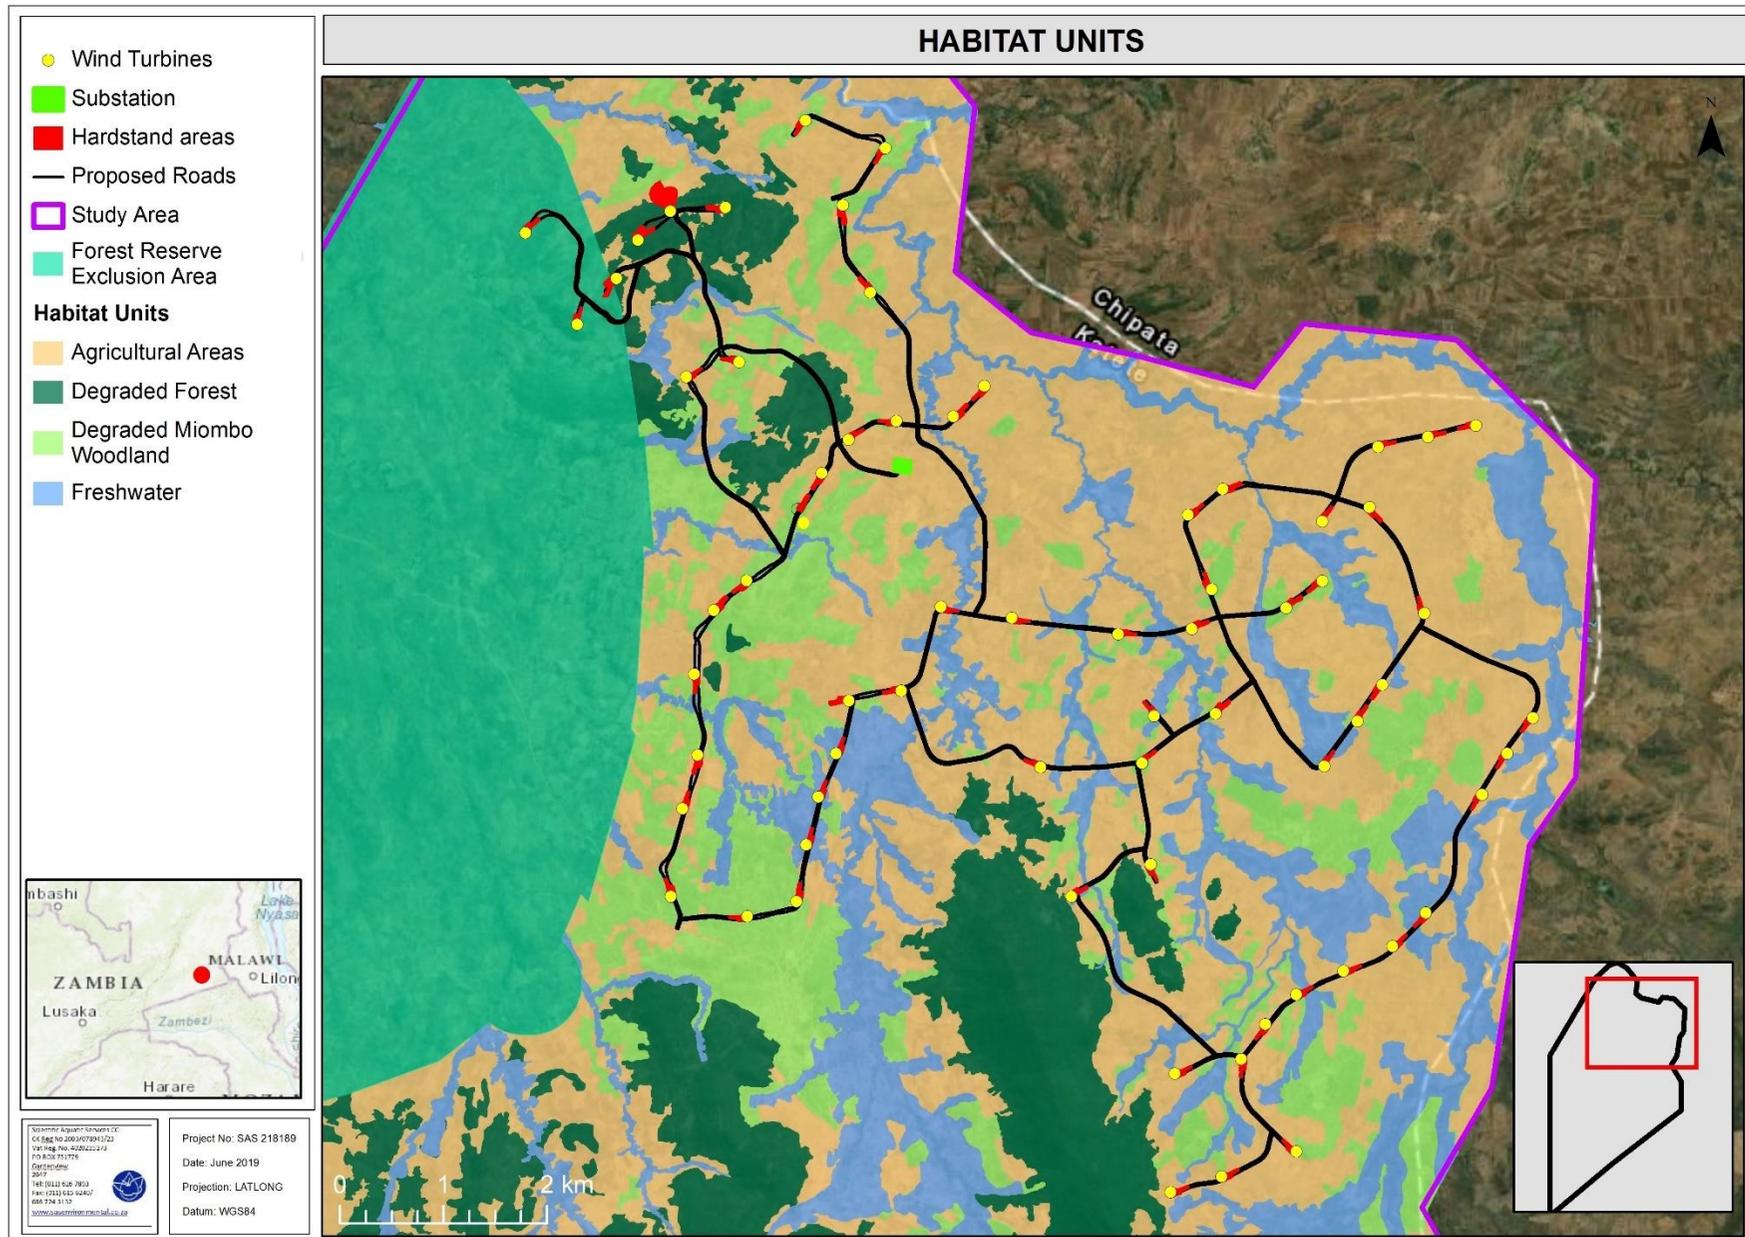
Figure 4: Conceptual illustration of the habitat units associated with the current proposed layout.

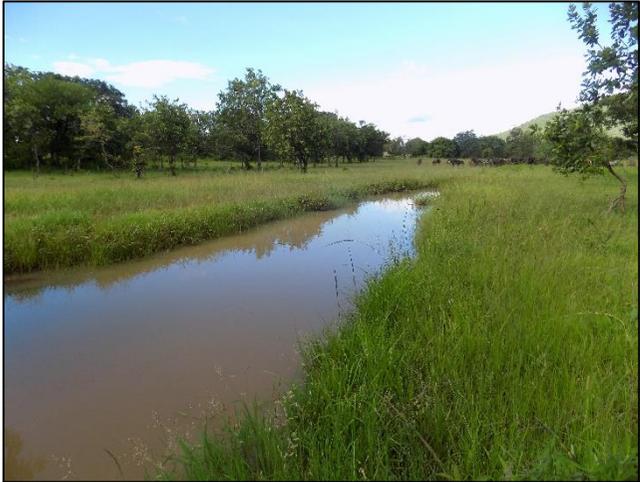
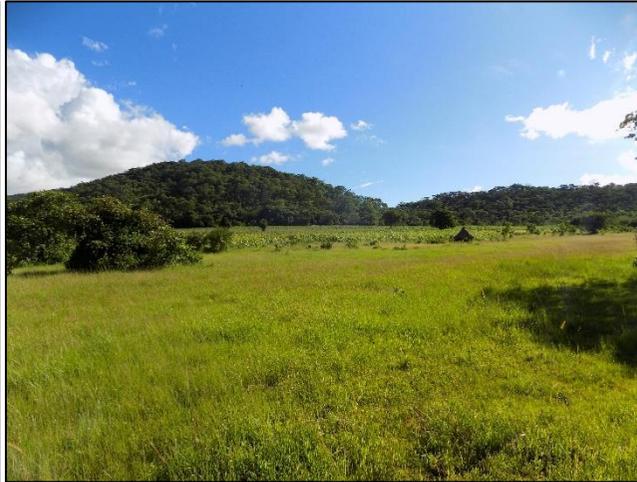
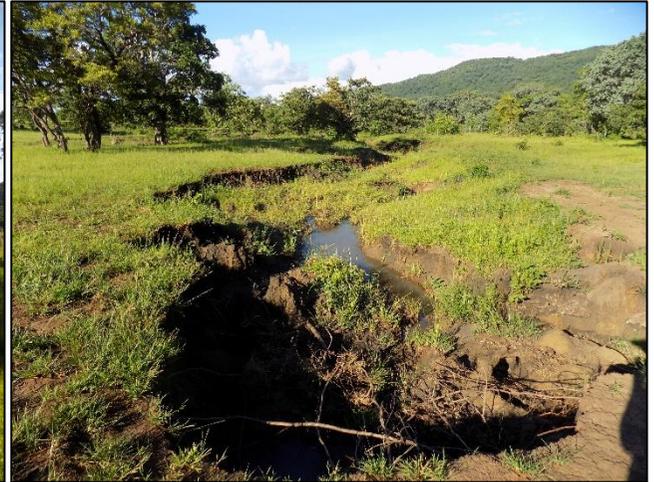
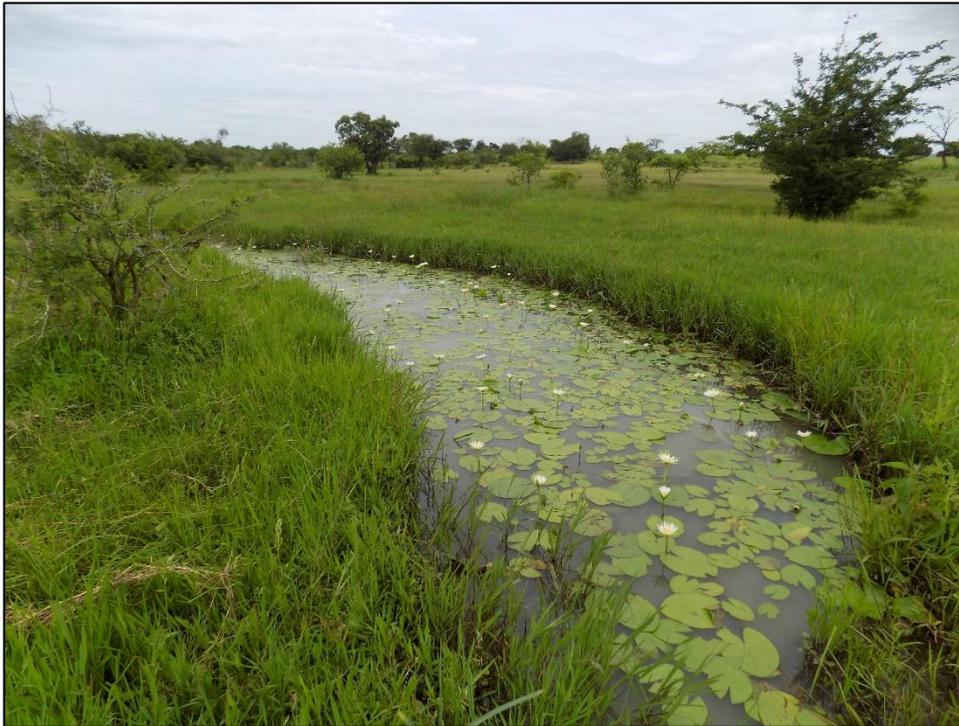
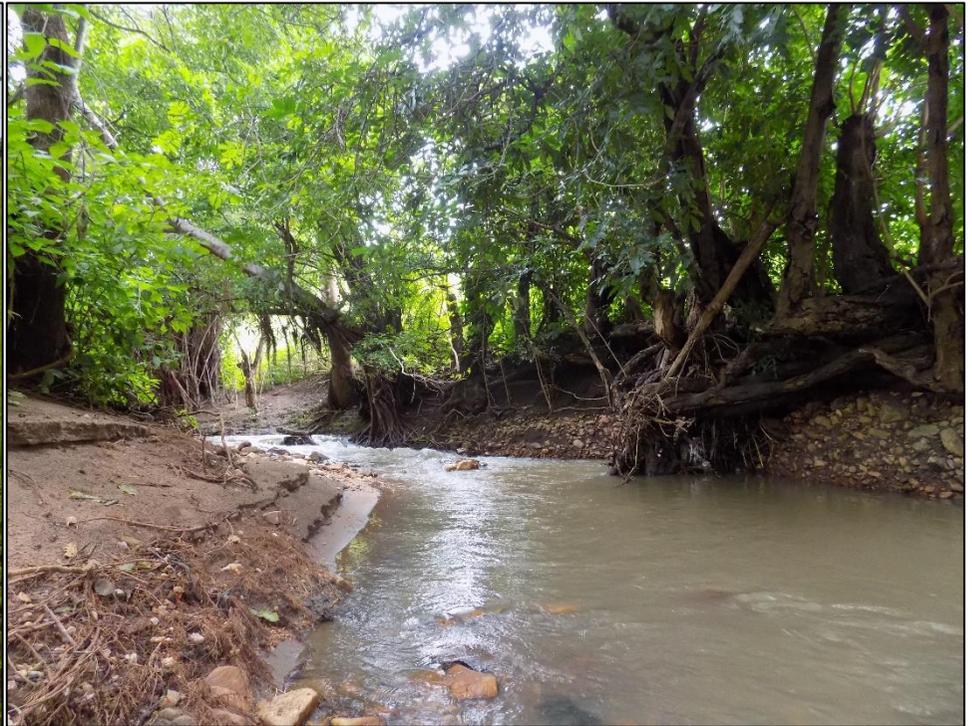
Habitat Unit: Freshwater Habitat Photographs: Dambos and Streams observed in the study area. Increased vegetation clearance has led to erosion and stream incision.

Where the wind turbines are located within the freshwater habitat, be it dambos or riparian areas, it is recommended that these structures be relocated outside of the freshwater habitat so as to ensure that further habitat degradation and species loss does not occur.

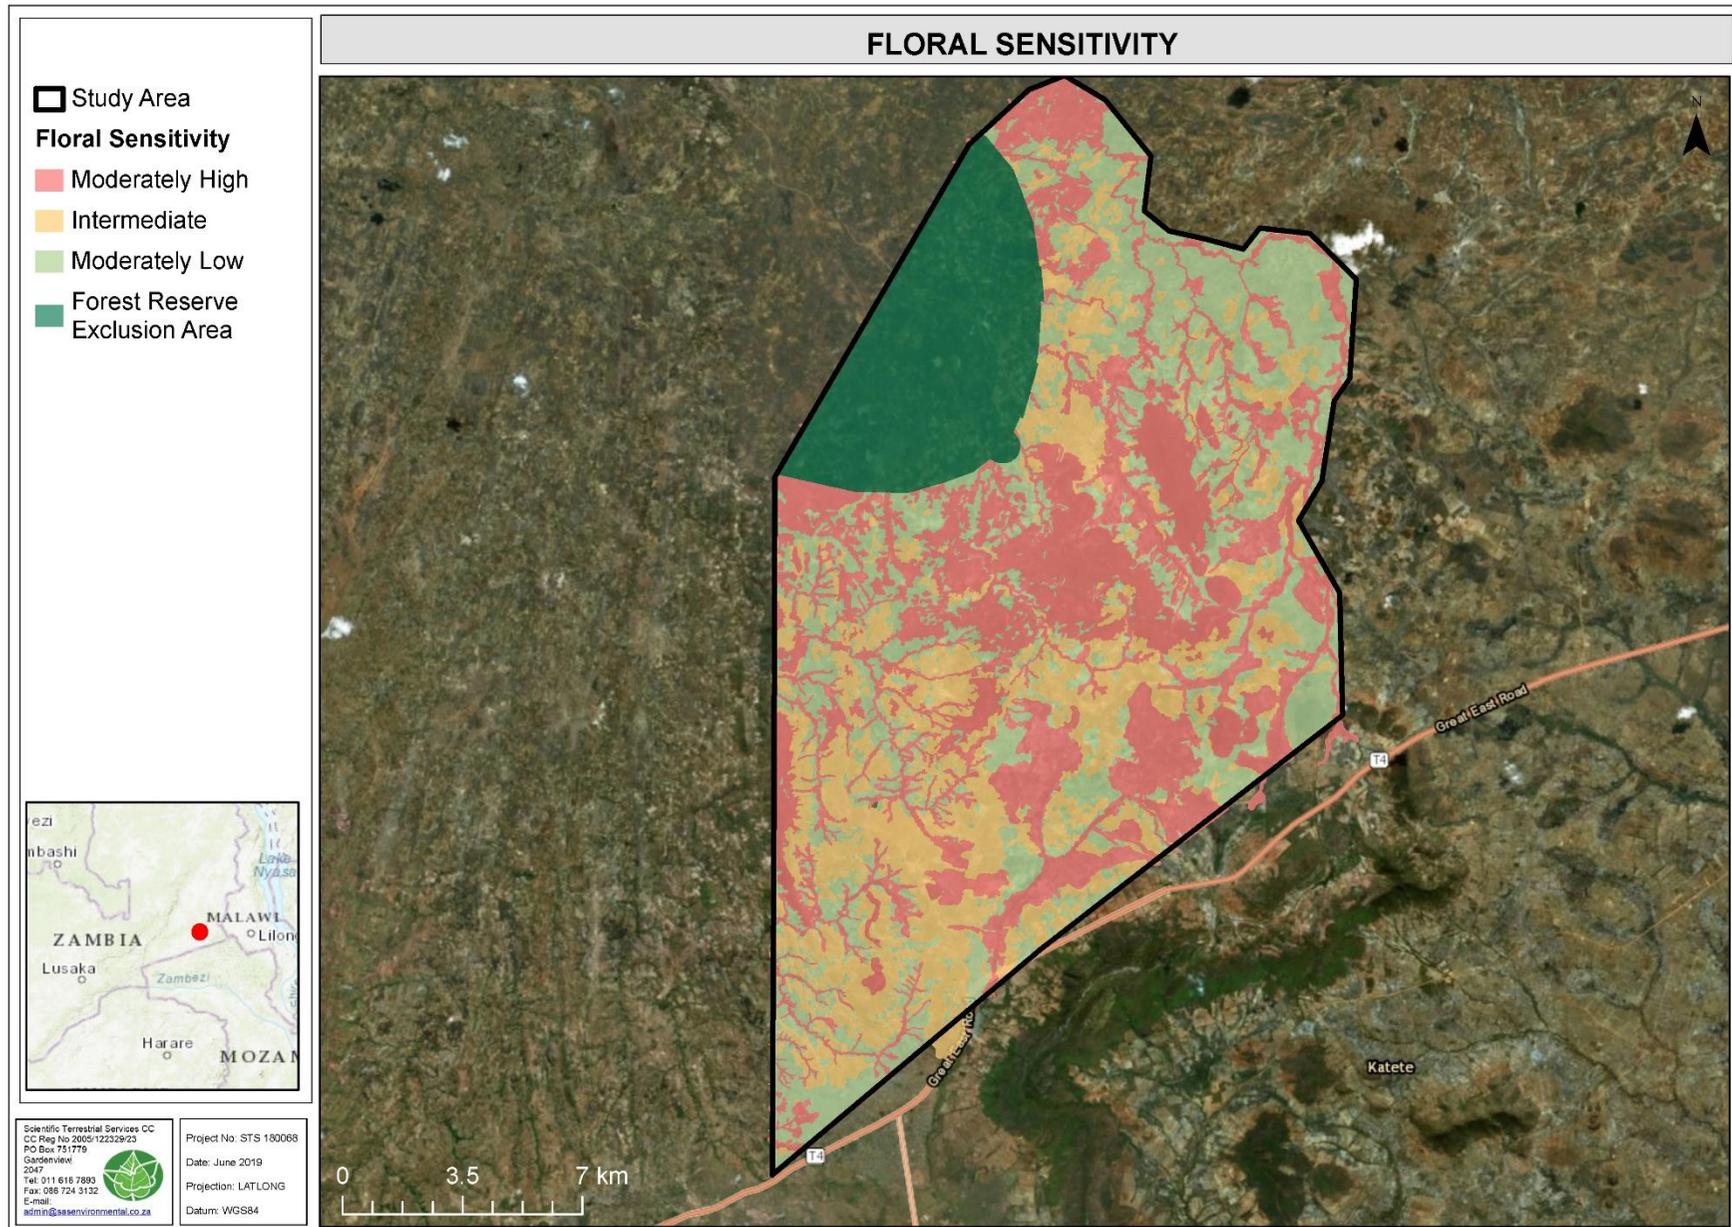
Figure 5: Sensitivity map pertaining to the floral assessment of the study area.

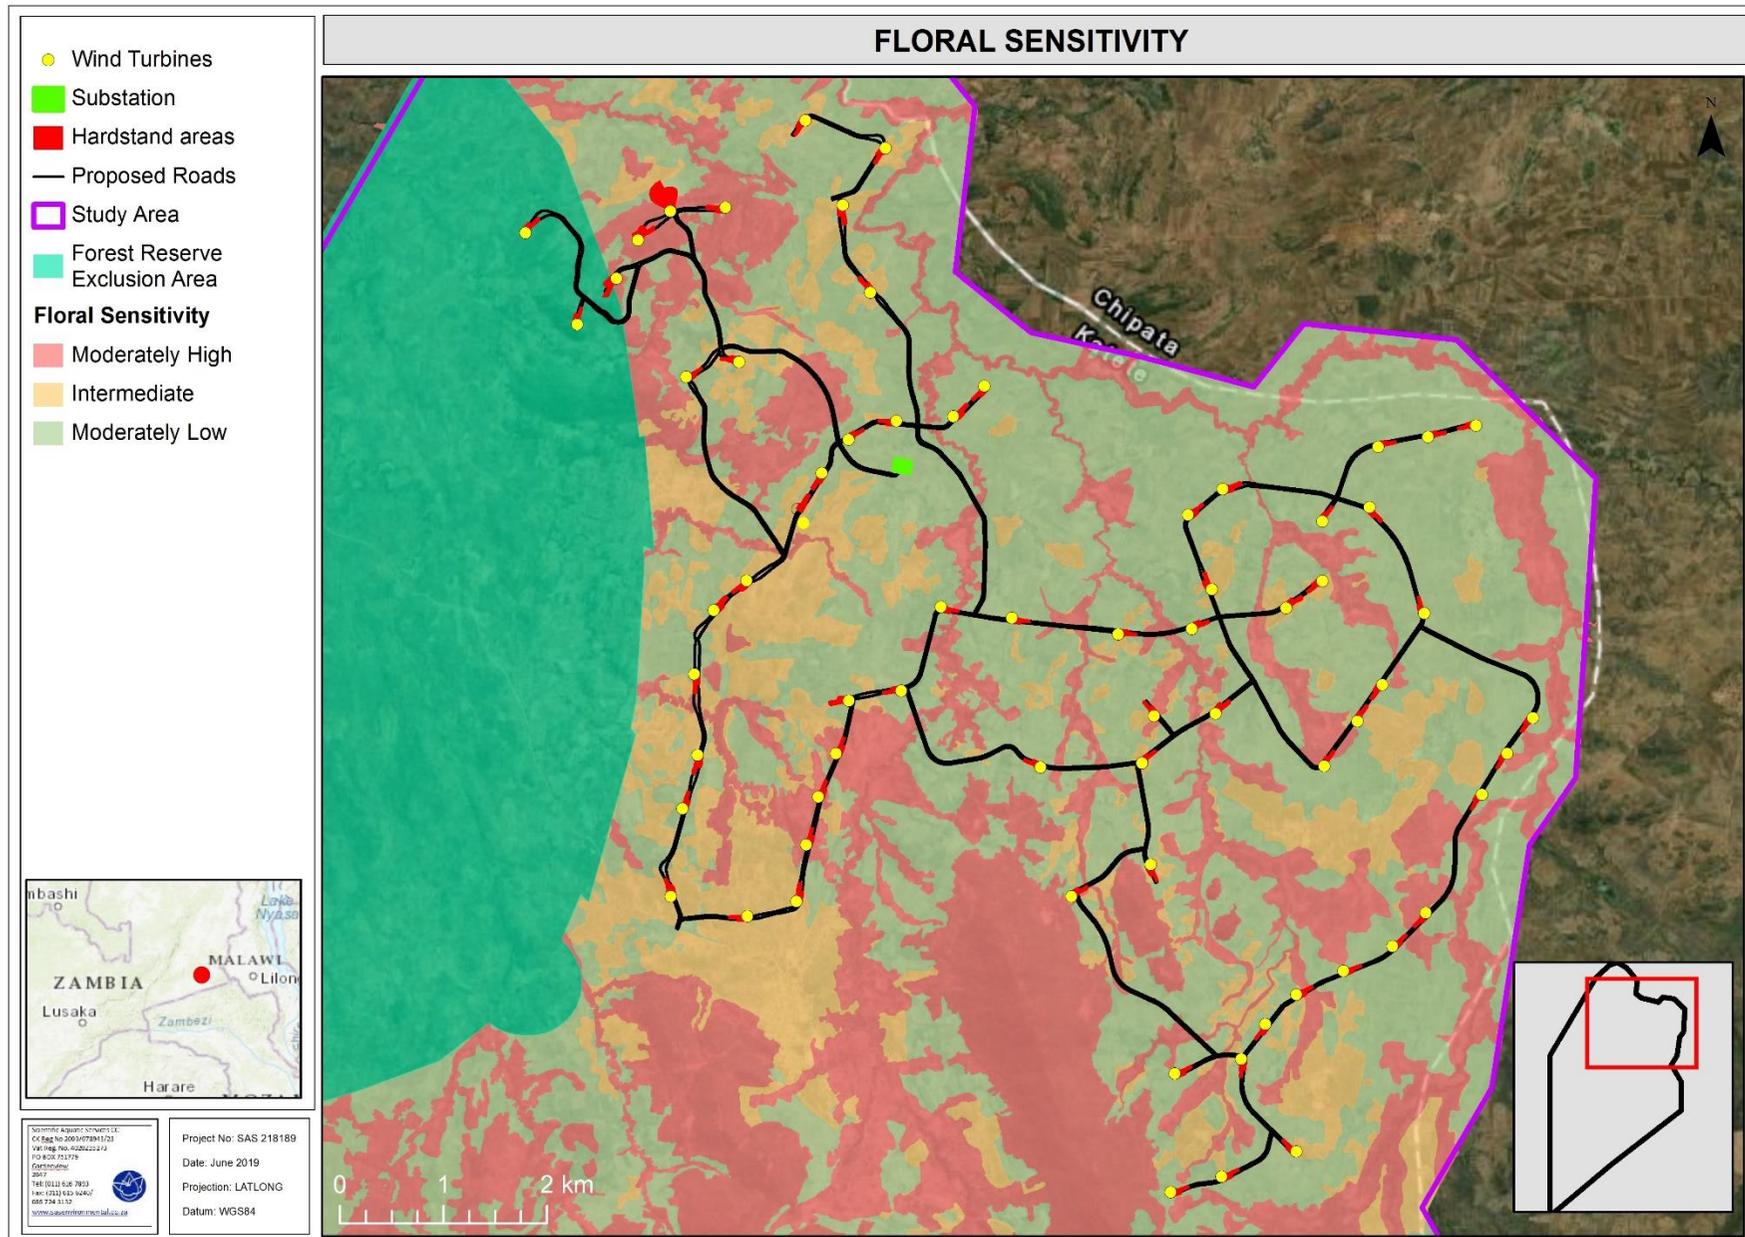
Figure 8: Sensitivity map pertaining to the floral assessment for the proposed layout.

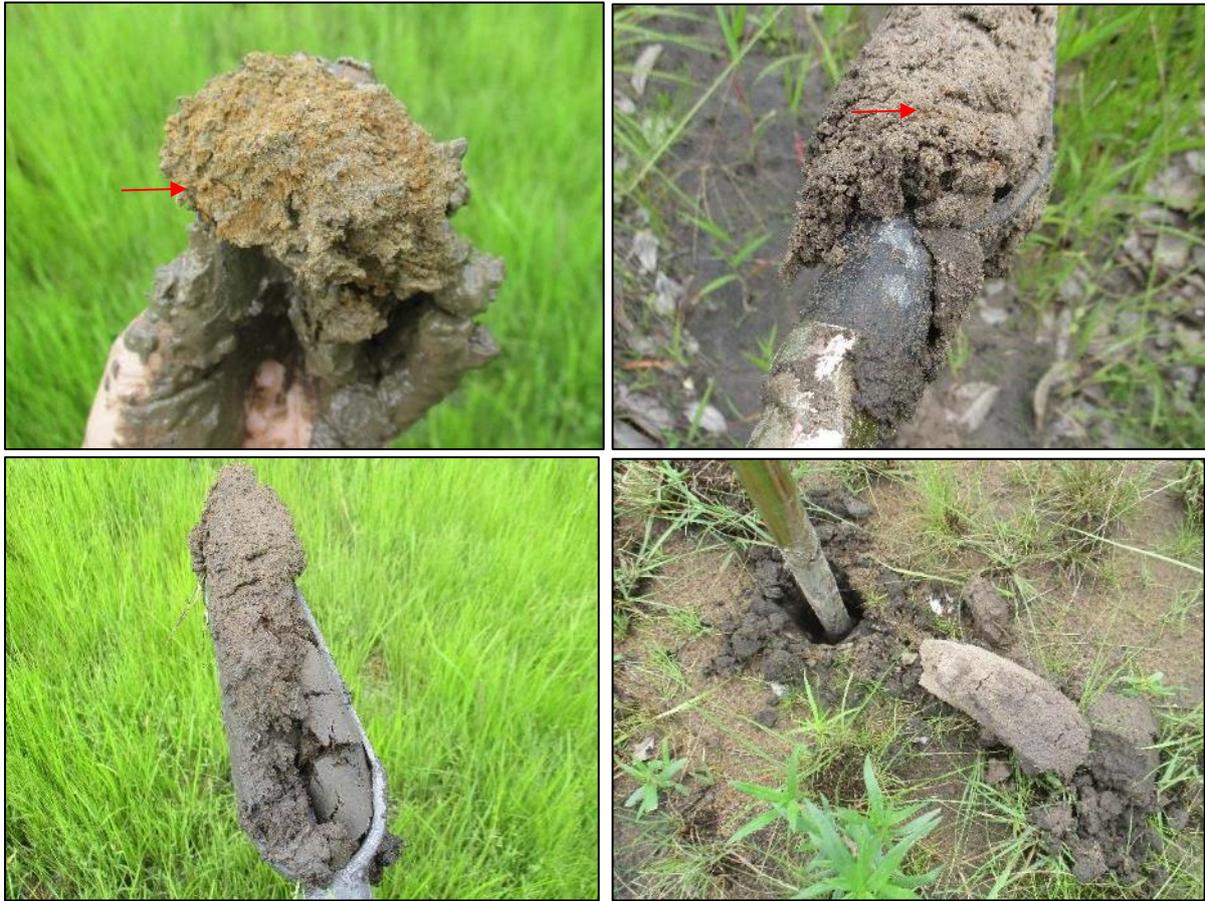
Figure 2: Representative photographs of soil samples within dambo wetland systems, illustrating typical soil morphological characteristics including mottling (top) and gleying (bottom) associated with a fluctuating water table.

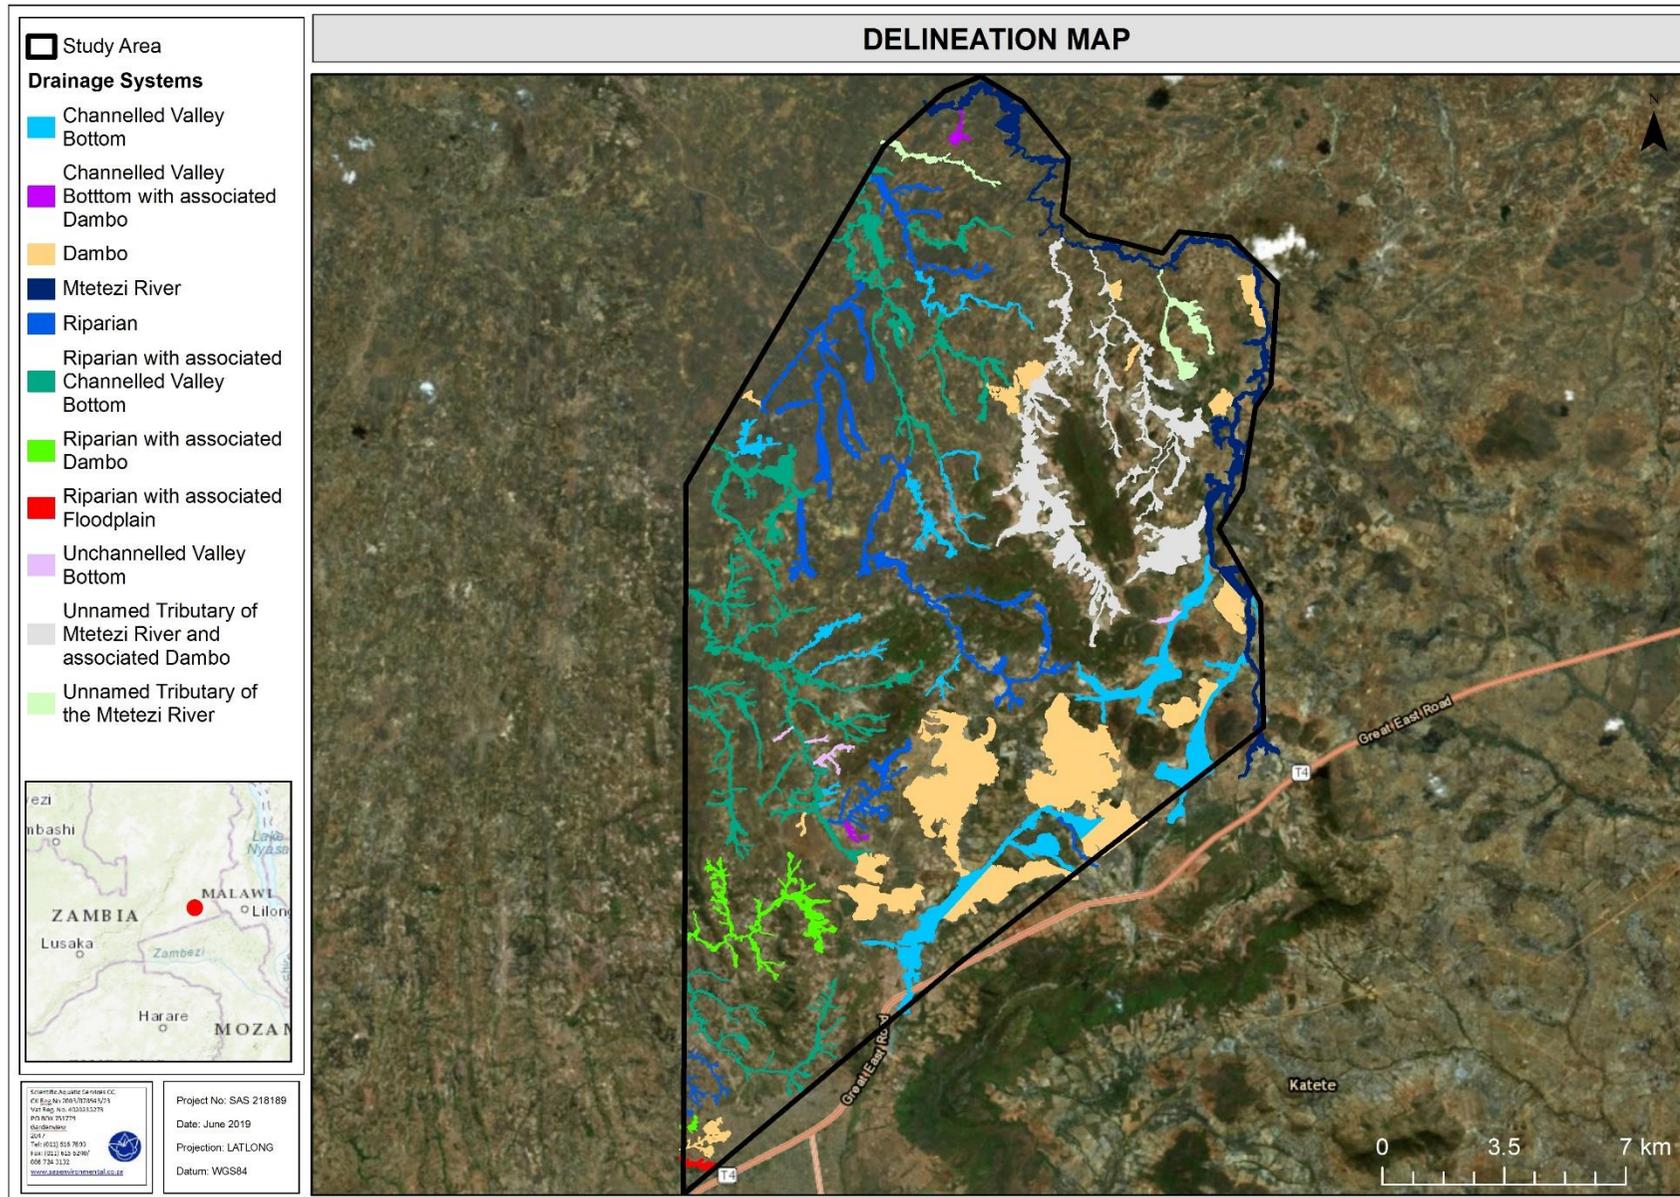
Figure 4: Conceptual depiction of the freshwater resource delineation in relation to the study area.

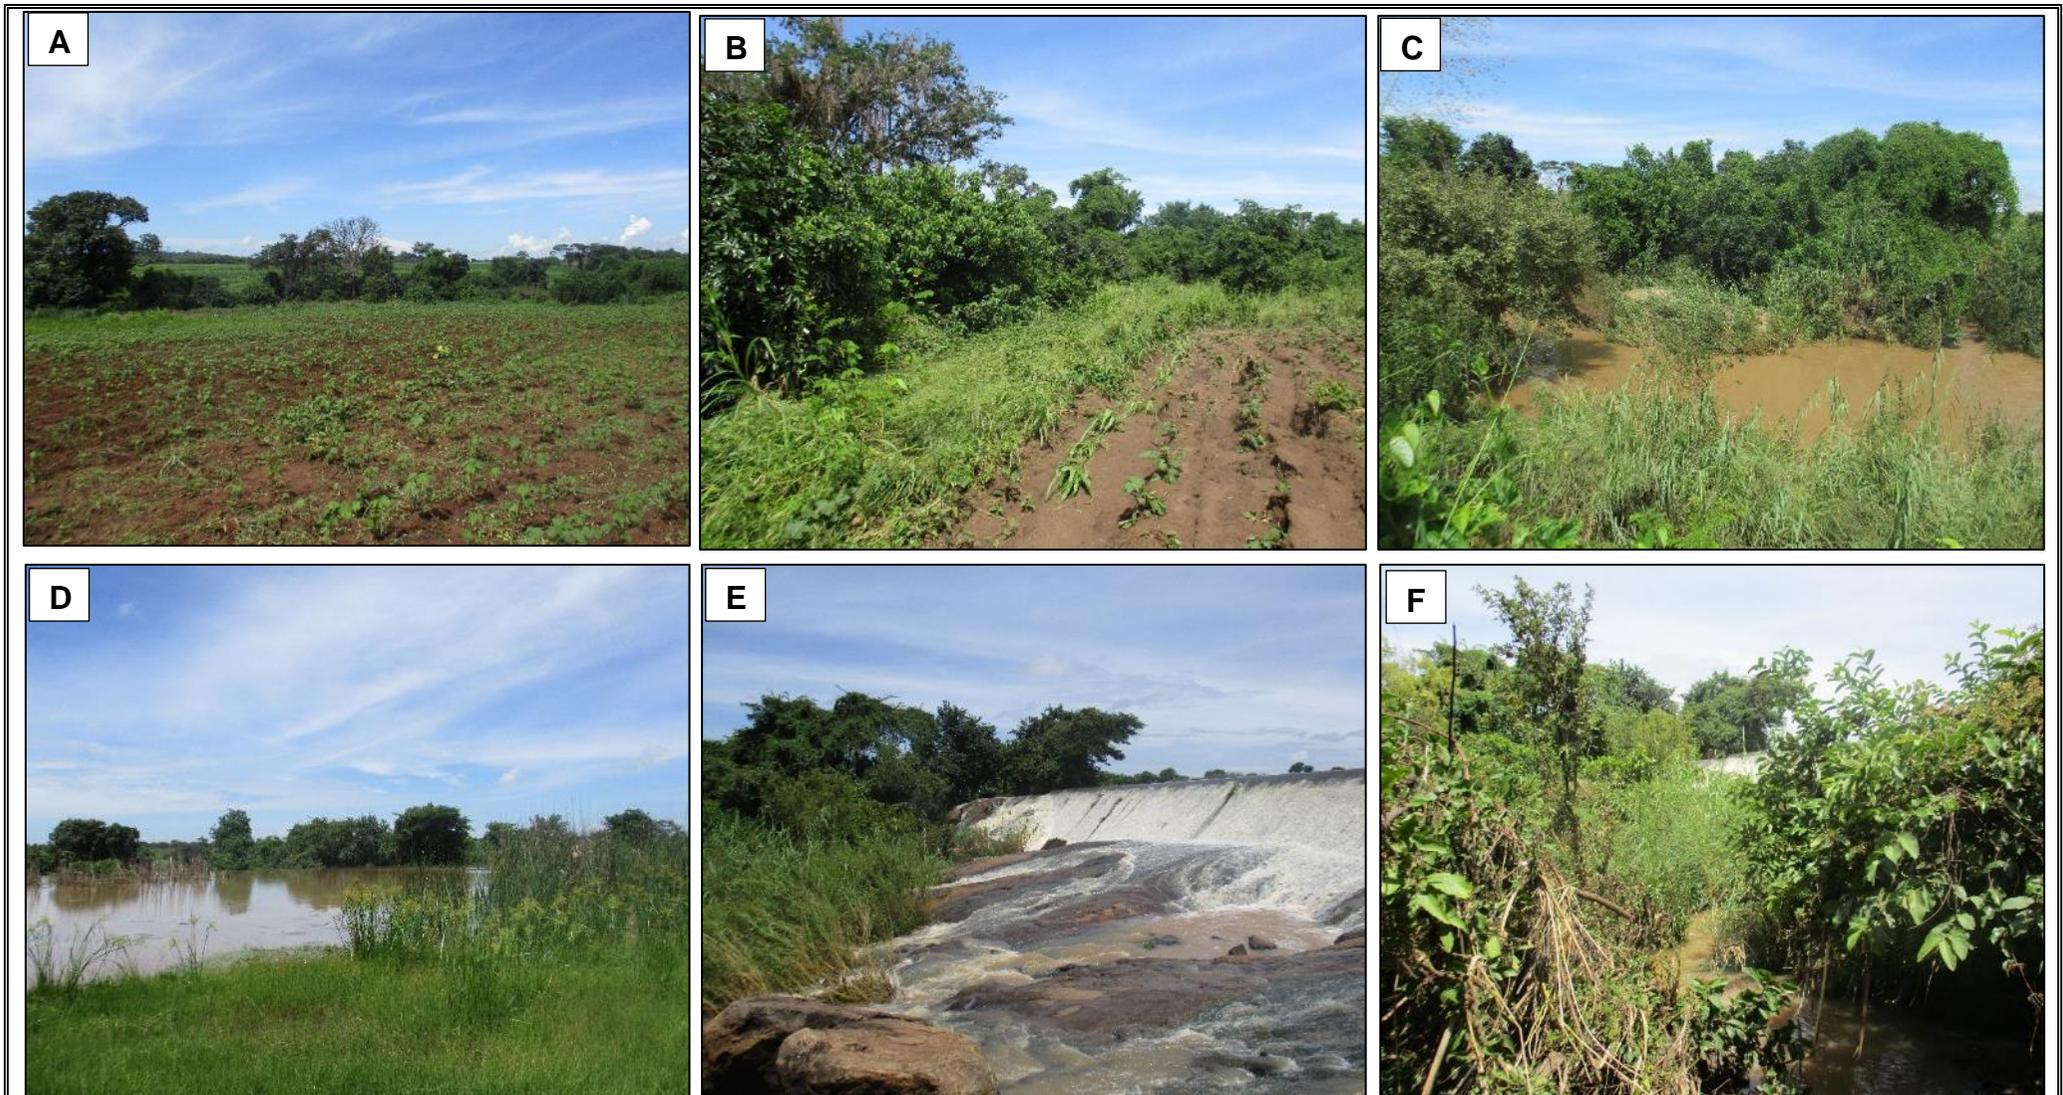
Table 2: Discussion: Mtetezi River

Photograph notes: Representative photographs of the Mtetezi River, taken at two assessment points. Photographs A and B depict clearing of vegetation for crop cultivation. The turbidity of the river at the time of the assessment is clearly visible in photograph C. Photograph D depicts one of the smaller impoundments identified along the reach of the river within the study area, whilst photographs E and F are of the area immediately downstream of the same impoundment depicted in photograph D.

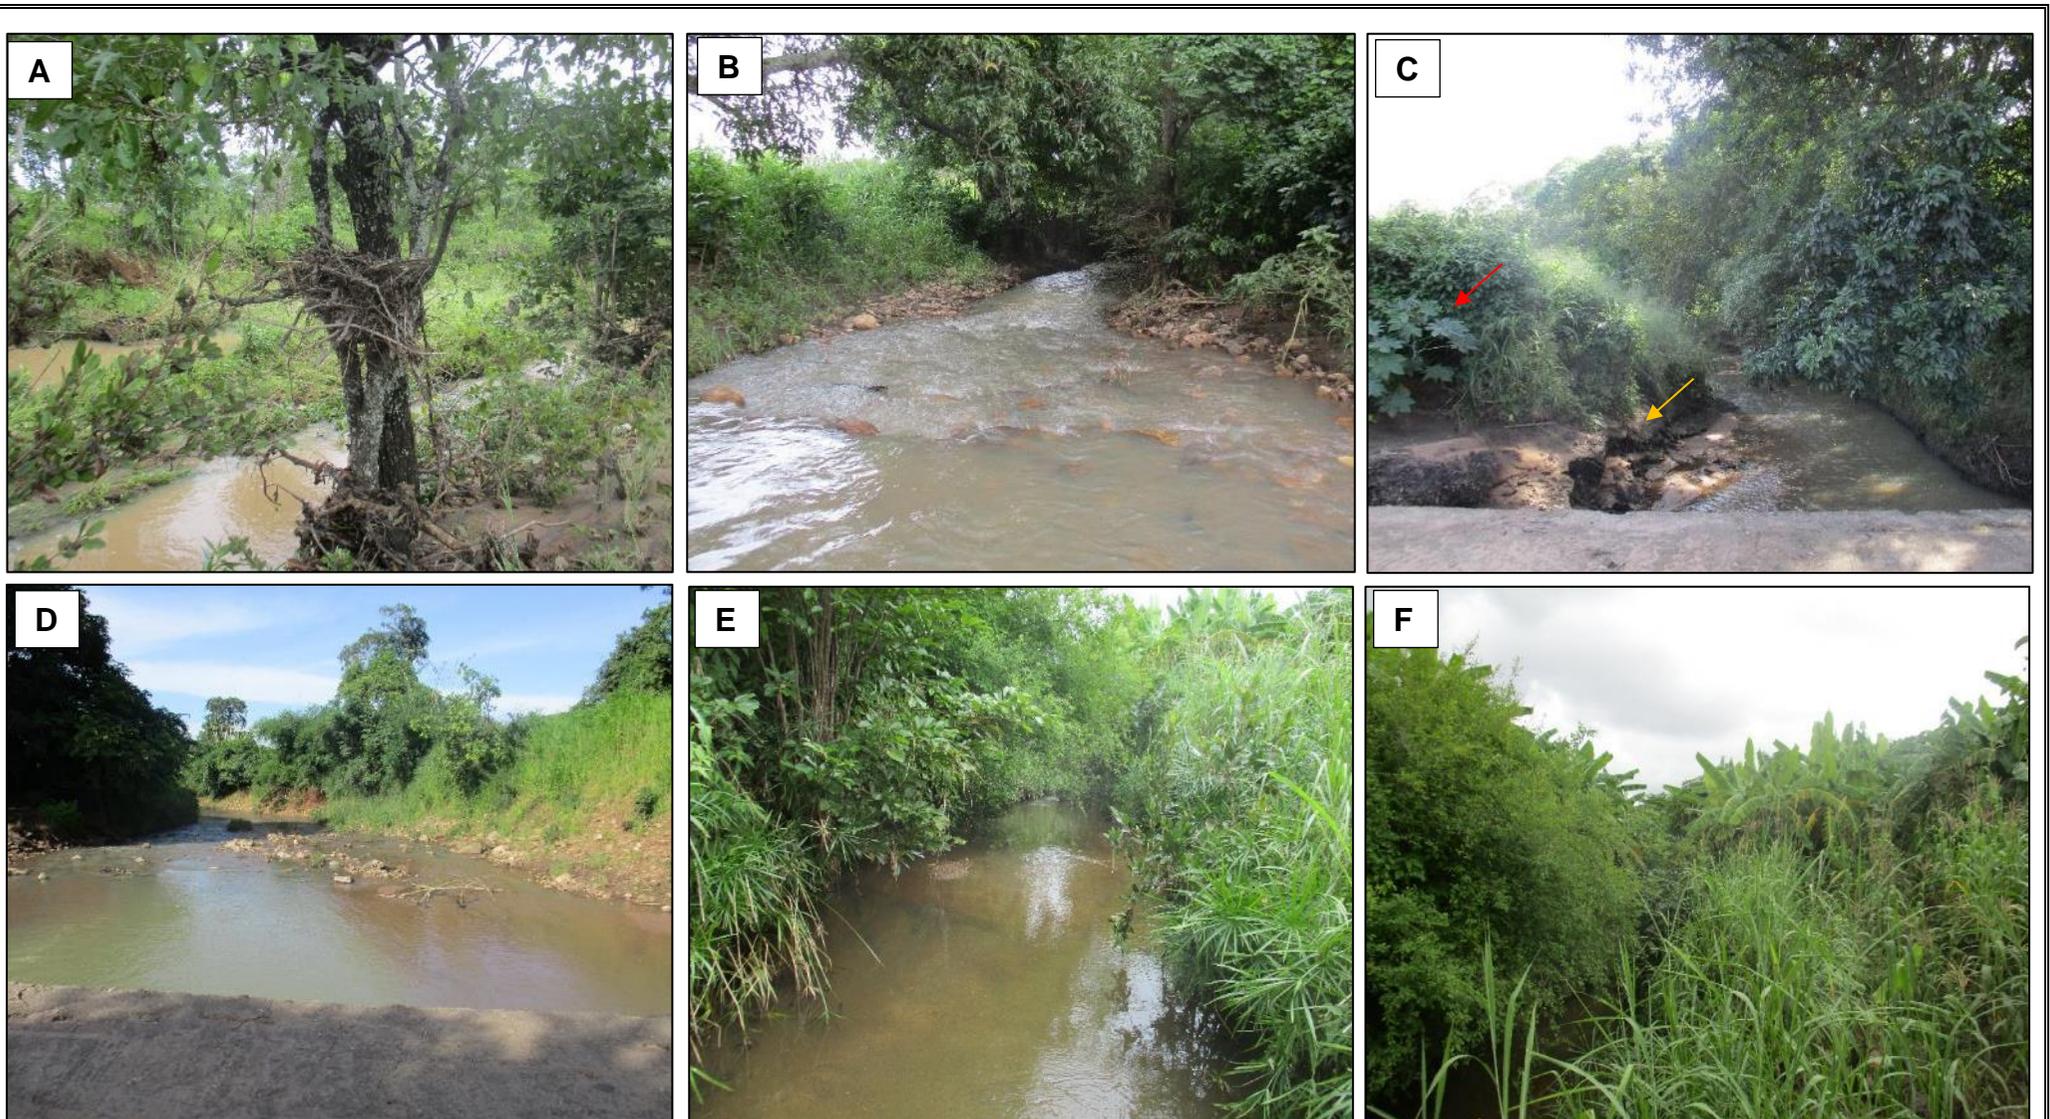
Table 3: Discussion: Riverine systems (excluding the Mtetezi River)

Photograph notes: Photographs of various riverine systems identified within the study area, illustrating the generally turbid water even where the flood waters of the previous days' rain had subsided, as well as the deposition of debris, indicating how high the water had risen (photograph A). Some alien vegetation (*Ricinus communis* – castor oil bush) can be seen in photograph C (red arrow) whilst bank incision is apparent in the same photograph (orange arrow). Photograph F illustrates the proximity of crop cultivation (banana trees) and *Zea mays* (maize) to the river resulting in loss of indigenous vegetation.

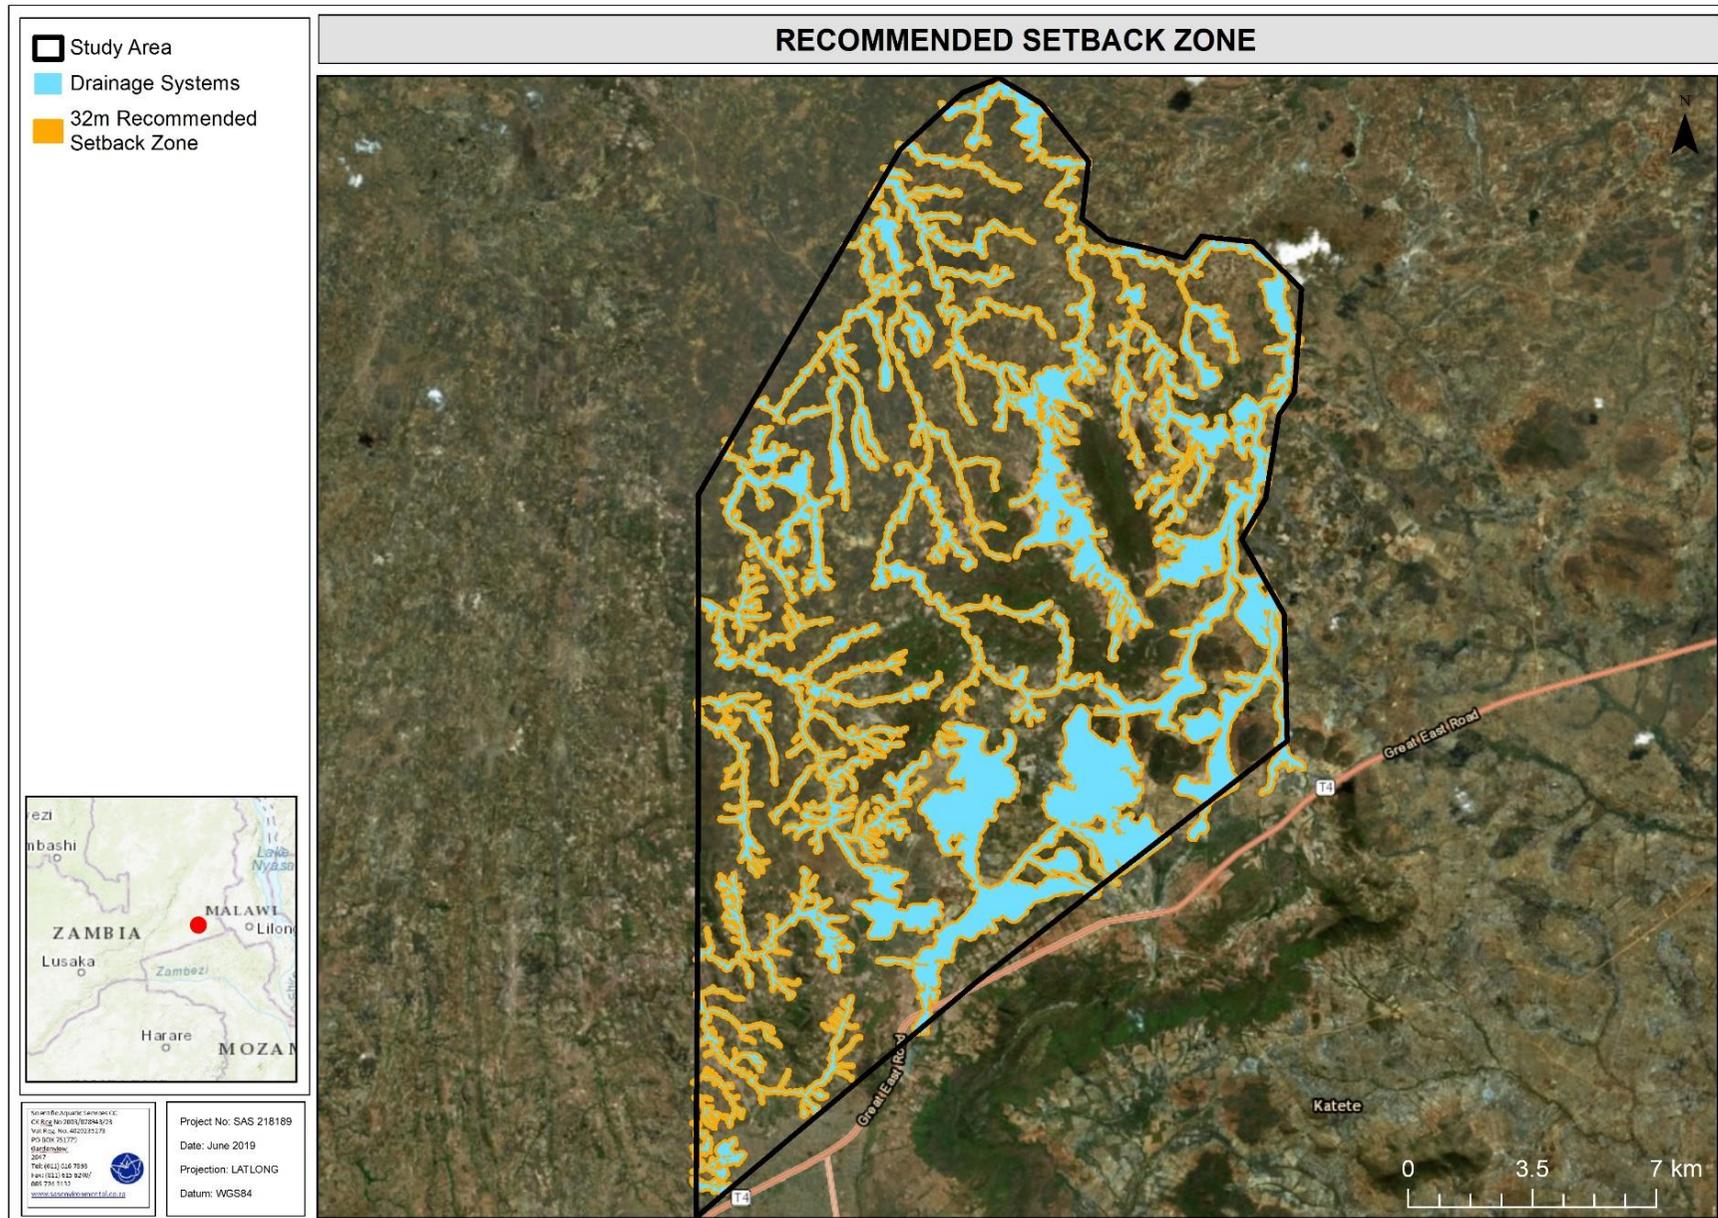
Figure 7: Conceptual depiction of the recommended 32m setback zone (buffer) around the watercourses within the study area.
