**TERRESTRIAL, AQUATIC AND WETLAND ECOLOGICAL
STUDIES TO INFORM THE ENVIRONMENTAL AND SOCIAL
IMPACT ASSESSMENT FOR THE PROPOSED UNIKA WIND
FARM DEVELOPMENT IN THE EASTERN PROVINCE OF
ZAMBIA**

June 2019

Section B: Floral Assessment

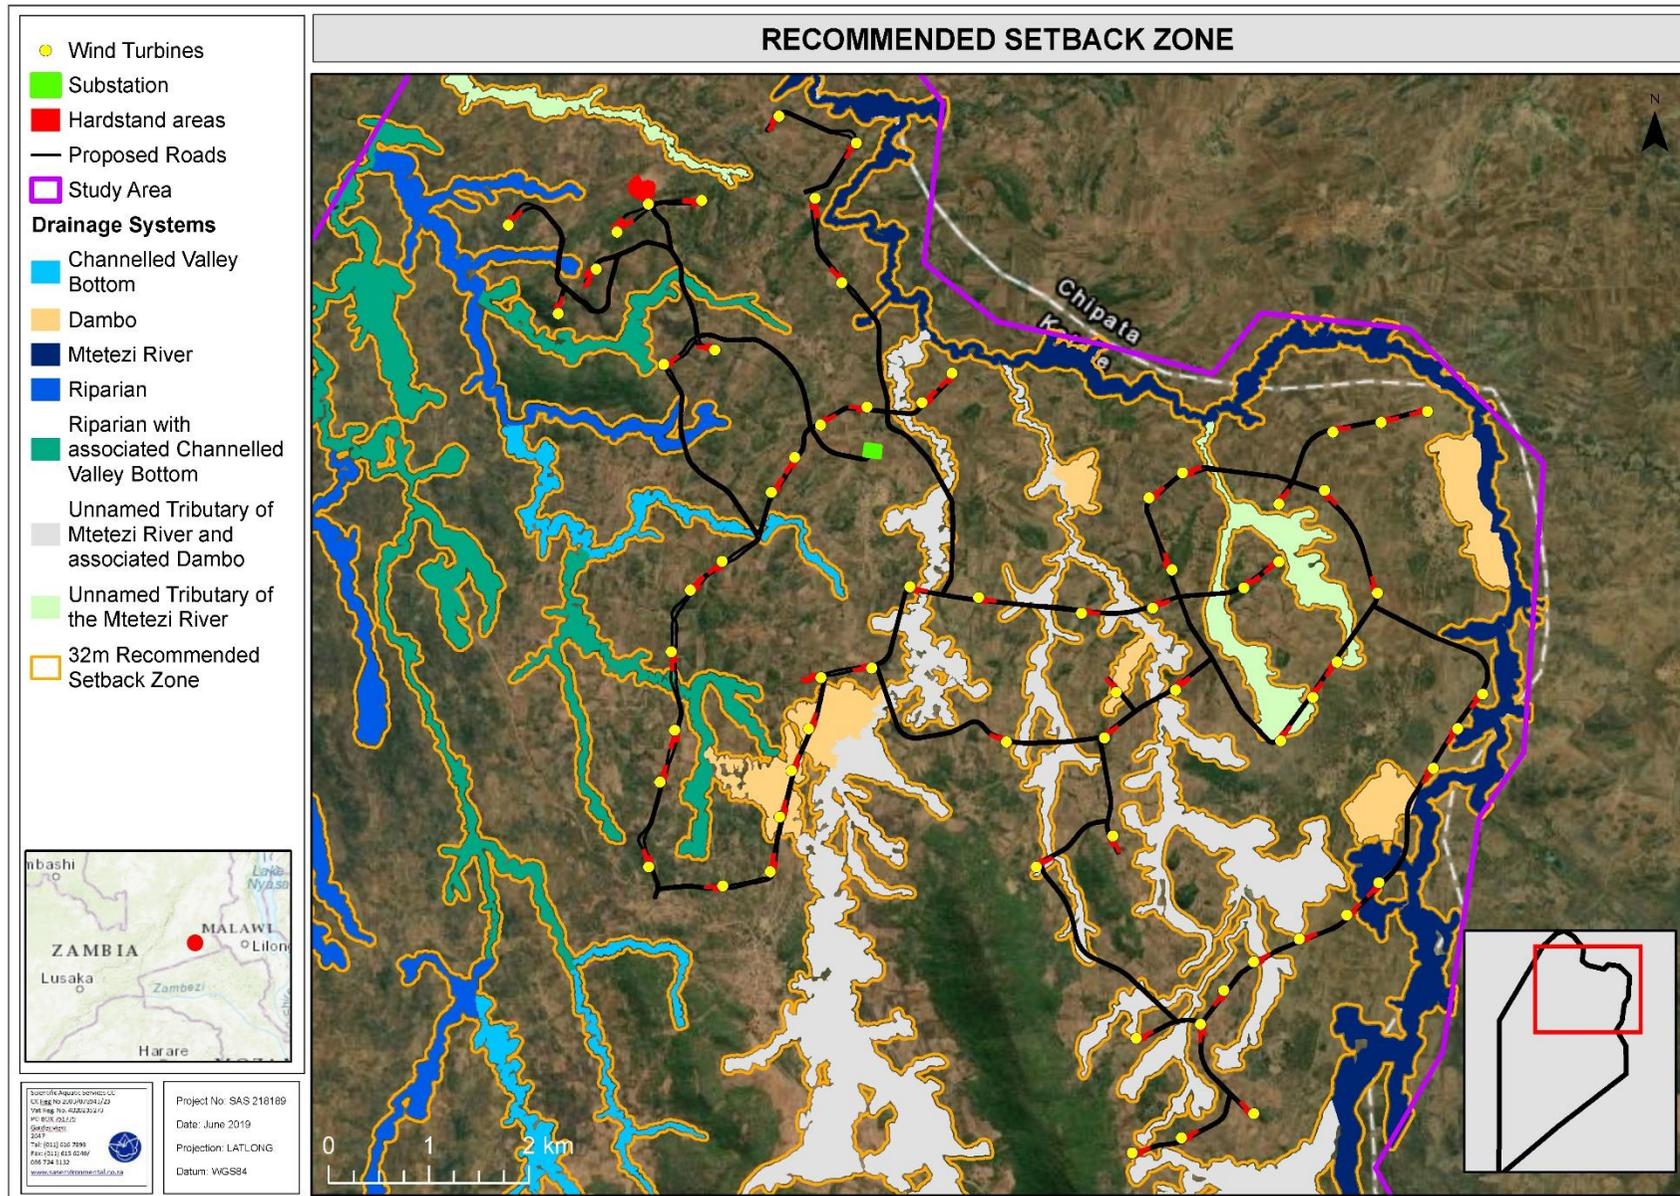
Figure 10: Conceptual depiction of the recommended 32m setback zone (buffer) around the watercourses within the north-eastern portion of the study area, in relation to the proposed turbines and infrastructure as provided in November 2020.
