Natural Resource Inventory  
Town/Village of Mount Kisco, New York

Prepared by Mount Kisco Conservation Advisory Council  
March 15, 2017

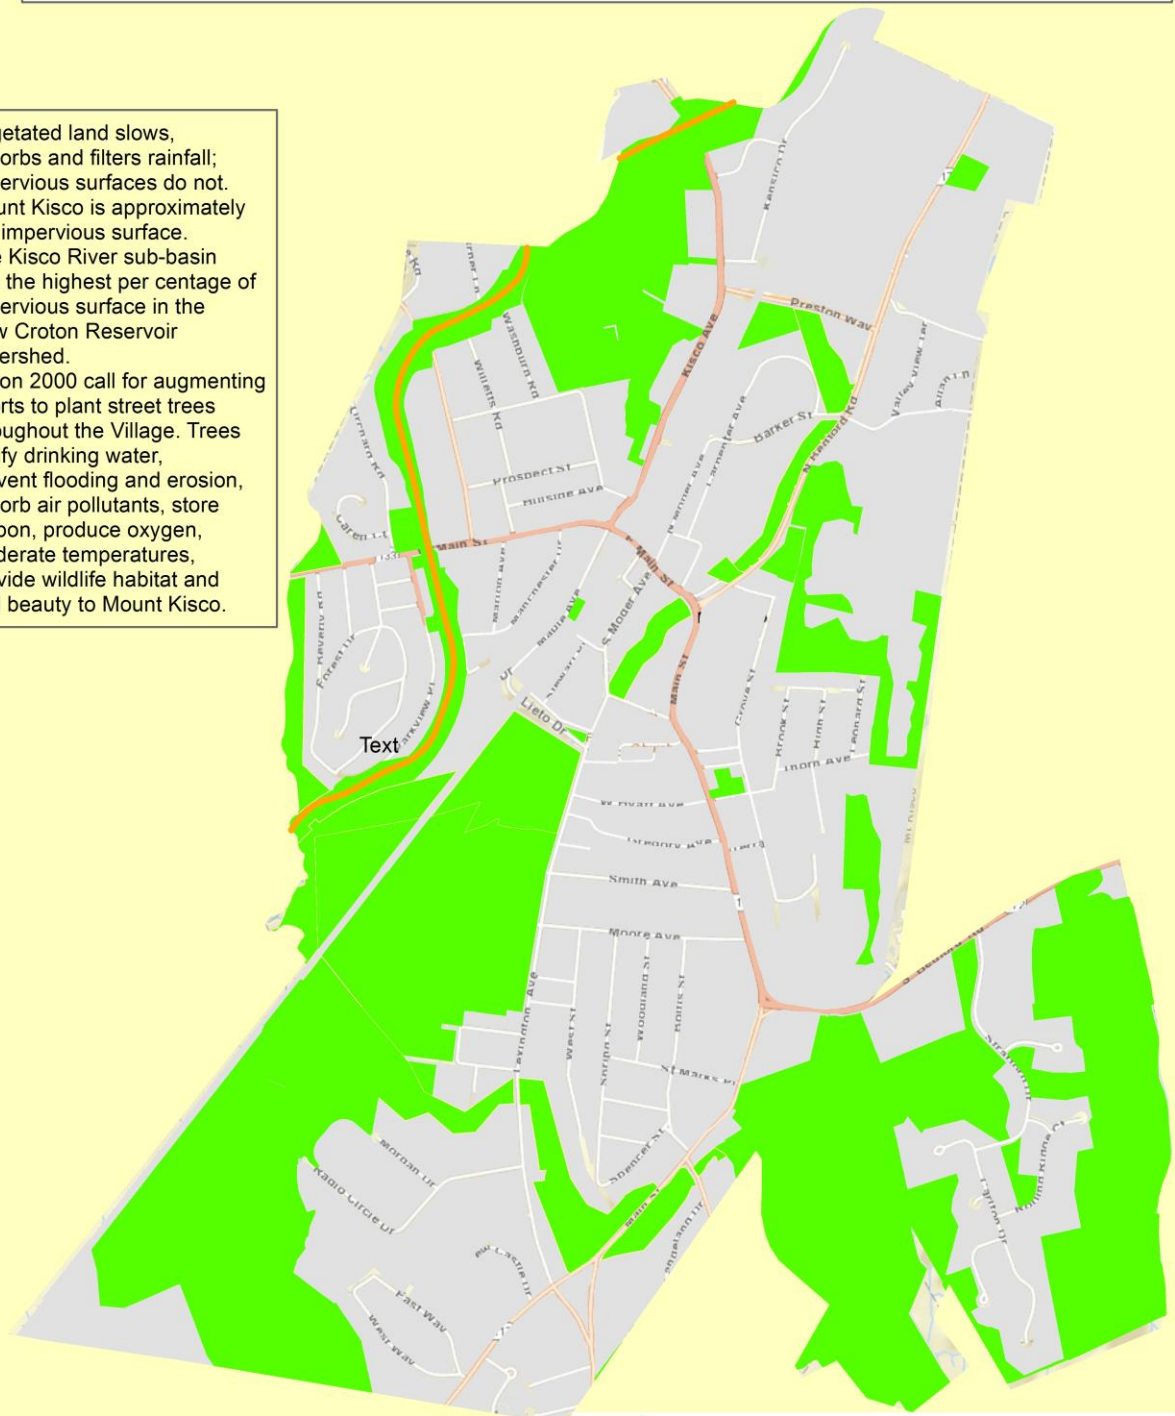
# Mount Kisco Natural Resources Inventory Land Cover Map

Vegetated land slows, absorbs and filters rainfall; impervious surfaces do not. Mount Kisco is approximately 1/4 impervious surface. The Kisco River sub-basin has the highest per centage of impervious surface in the New Croton Reservoir watershed. Vision 2000 call for augmenting efforts to plant street trees throughout the Village. Trees purify drinking water, prevent flooding and erosion, absorb air pollutants, store carbon, produce oxygen, moderate temperatures, provide wildlife habitat and add beauty to Mount Kisco.

Vegetative Cover
  Village of Mt Kisco

Impervious Surfaces

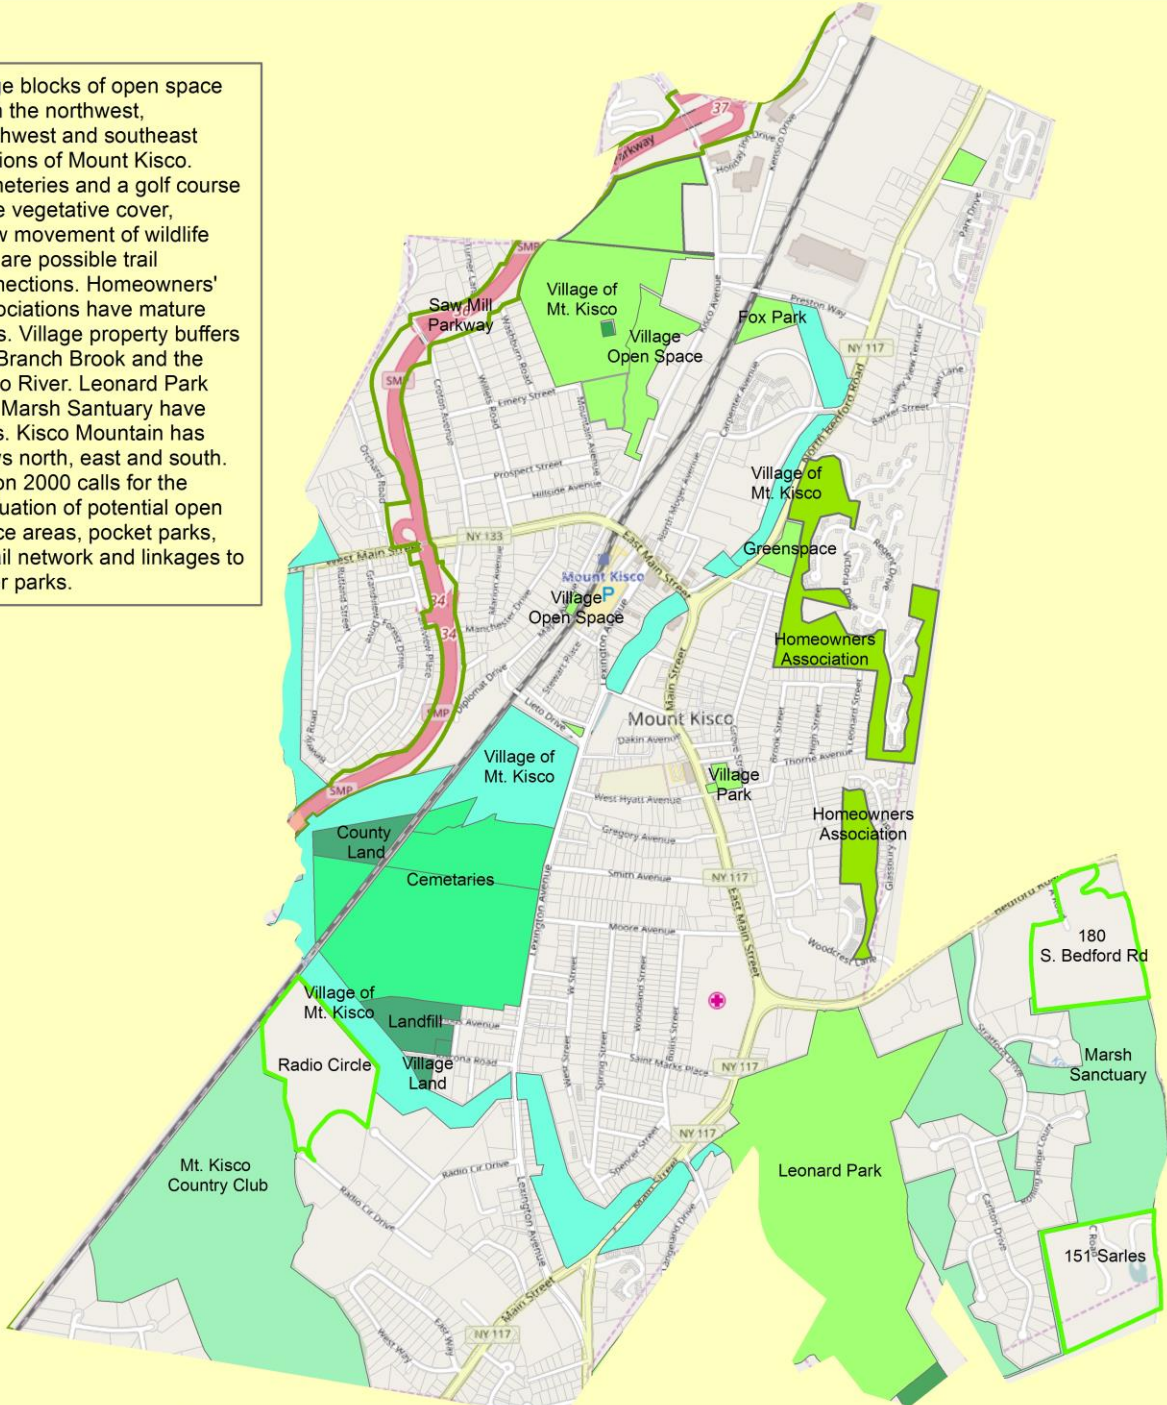
# Mount Kisco Natural Resources Inventory Open Space Street Map

Large blocks of open space lie in the northwest, southwest and southeast sections of Mount Kisco. Cemeteries and a golf course have vegetative cover, allow movement of wildlife and are possible trail connections. Homeowners' Associations have mature trees. Village property buffers the Branch Brook and the Kisco River. Leonard Park and Marsh Sanctuary have trails. Kisco Mountain has views north, east and south. Vision 2000 calls for the evaluation of potential open space areas, pocket parks, a trail network and linkages to other parks.

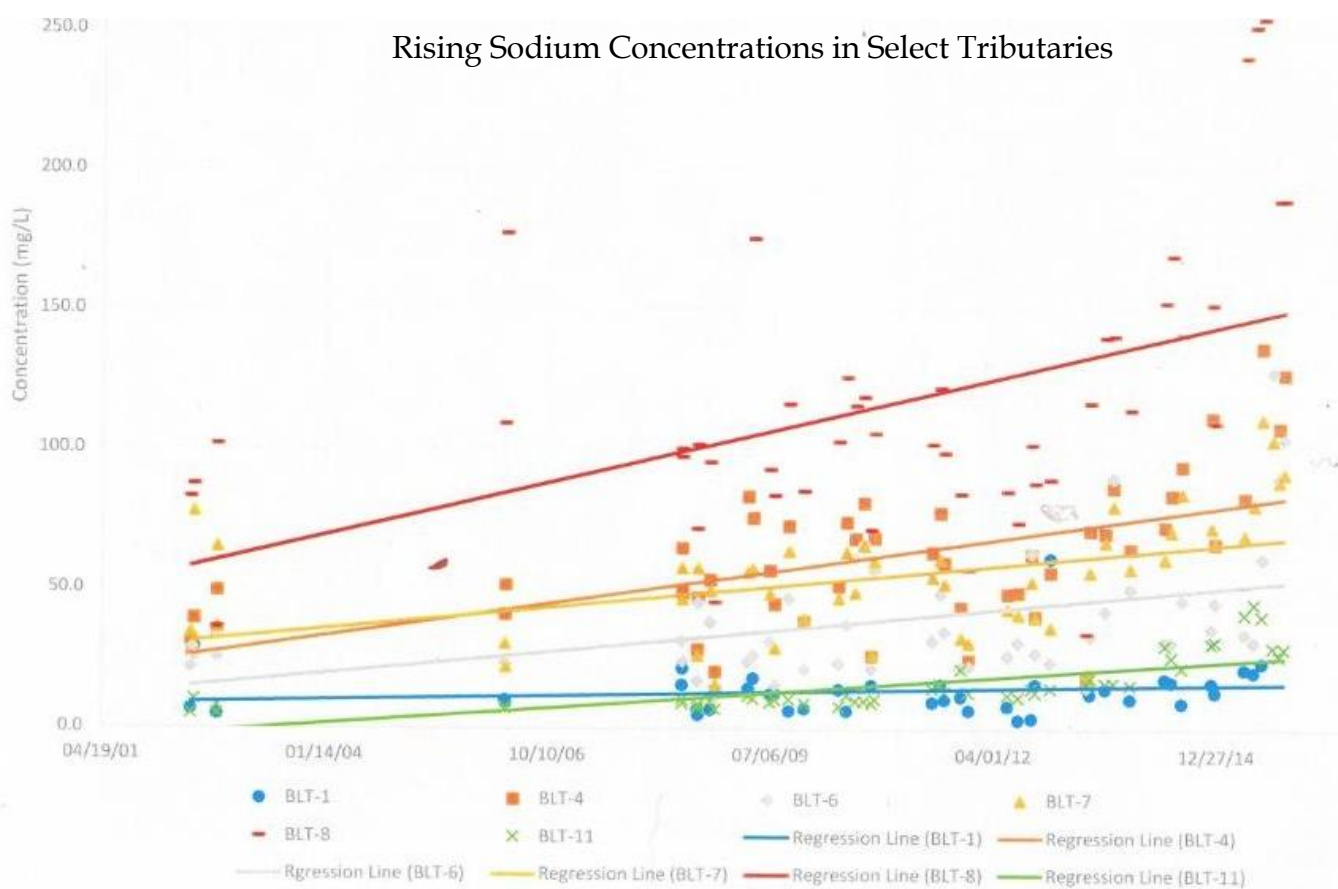
The Chazen Companies  
March 2016

The chart below shows the steadily increasing levels of sodium (salt) since 2004 at the tributary/Reservoir sampling locations. A New York City DEP report found that the Kisco River also has high levels of sodium and chloride due to road salt. <sup>14,15</sup>

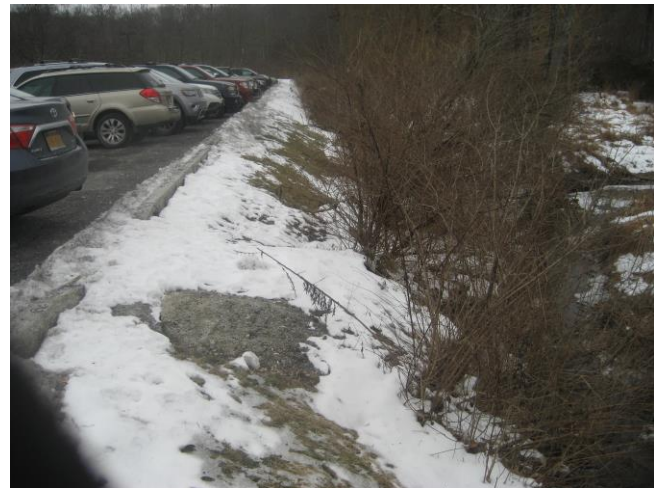
Runoff from MKMG parking lot

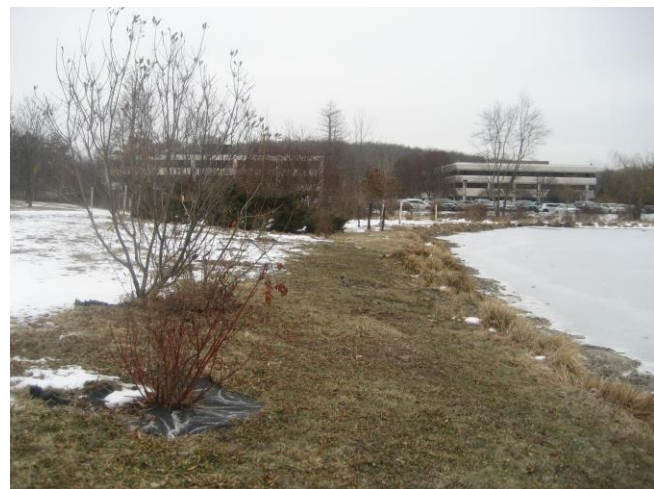
The Watershed Agricultural Council's Trees for Tribes program planted 60 native trees and shrubs along the northwest shore to help filter water and shade and cool the pond in 2010. Despite instructions that the entire area was not to be mown, most of the plantings have been clear-cut by the Town's maintenance crew. Only two pepperbush, a red osier, a willow and a bayberry survive. Several red osier have

Northwest shoreline plantings in winter

been eaten by deer. In addition to killing the native trees and shrubs, mowing of the tall grass surrounding the pond, which normally discourages Canada geese, has allowed geese on the shoreline, resulting in erosion of the bank and deposition of soil and sediment into Wallace Pond.

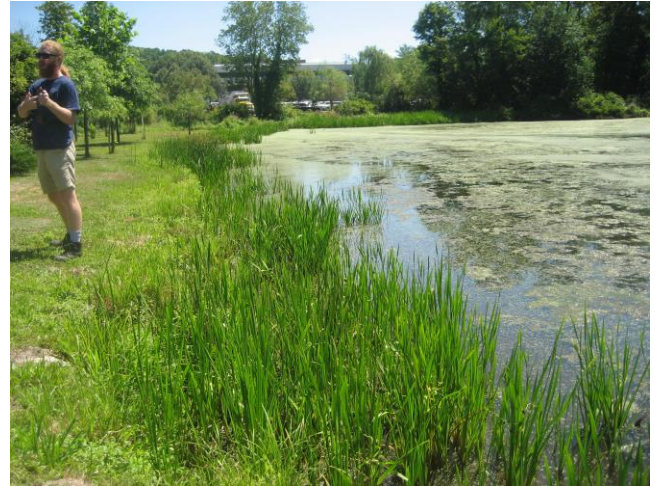
When vegetation has been allowed to grow back, swamp milkweed, bur reed, bulrush and other sedges have grown in along the northwest section of pond.

Northwest shoreline vegetation in summer

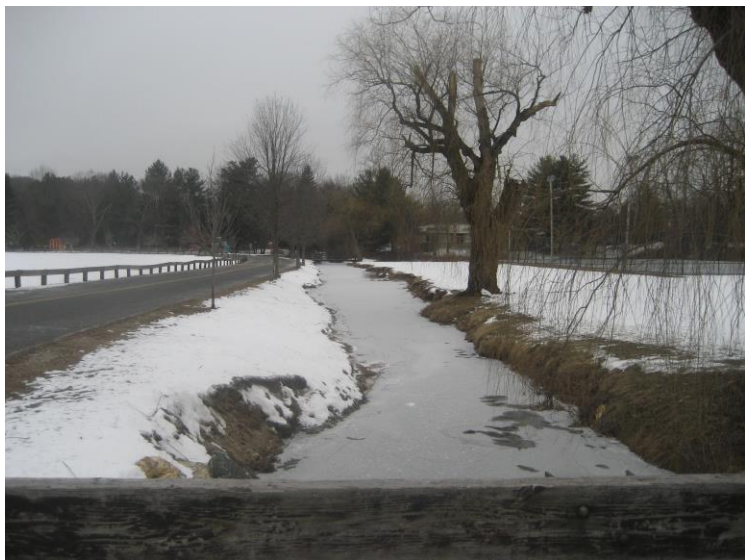
For the next 450 feet of the river, only the western bank is vegetated; the eastern bank has 10 planted red maples but no other vegetation except lawn to the water's edge. Lack of vegetation has led to erosion of the stream bank. See Kisco River at Leonard Park Significant Trees Map on page 68.

Wallace Pond outlet looking south, stream banks do not have vegetation to prevent erosion

16 small red maples have been planted along the eastern edge of the outlet stream. These will serve to stabilize the stream bank and shade and cool the water, providing better habitat for fish and other wildlife as they mature.

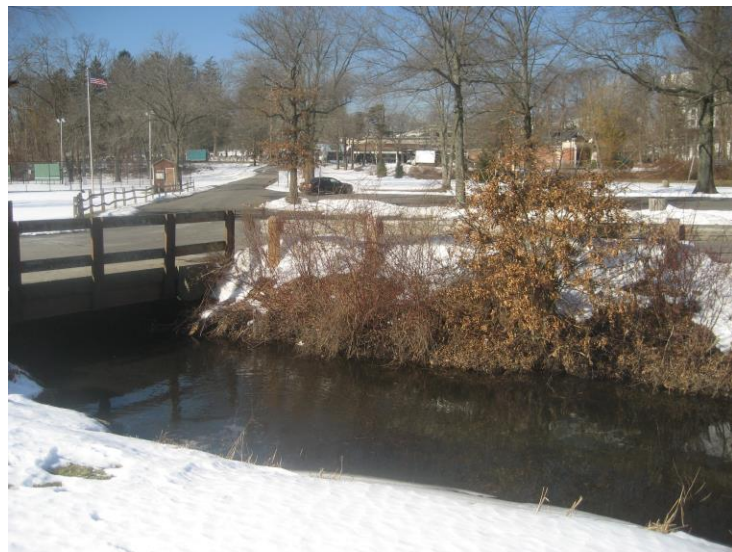
The outlet of Wallace Pond that merges with the Leonard Park tributaries is naturally vegetated for the first 150 feet south of the pond. Trees include young black walnut, pin oak, hawthorn and box elder trees and silky dogwood and invasive multi-flora rose shrubs, all of which protect and stabilize the stream bank.

Wallace Pond outlet looking west with vegetated stream banks

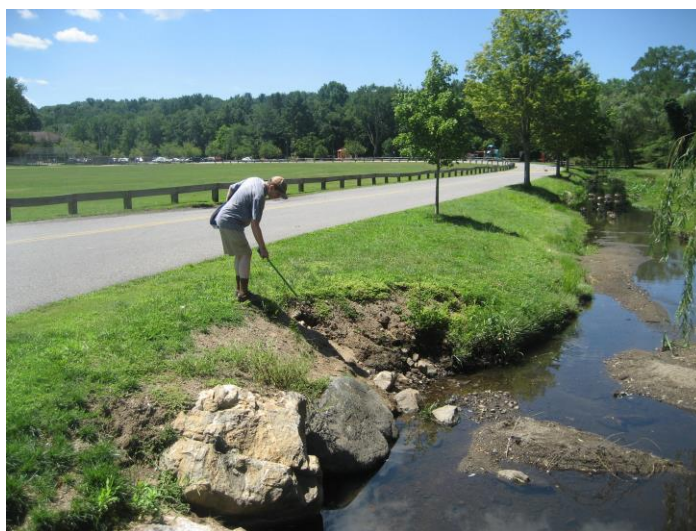
Erosion on eastern side of outlet caused by storm water culvert on west side of outlet

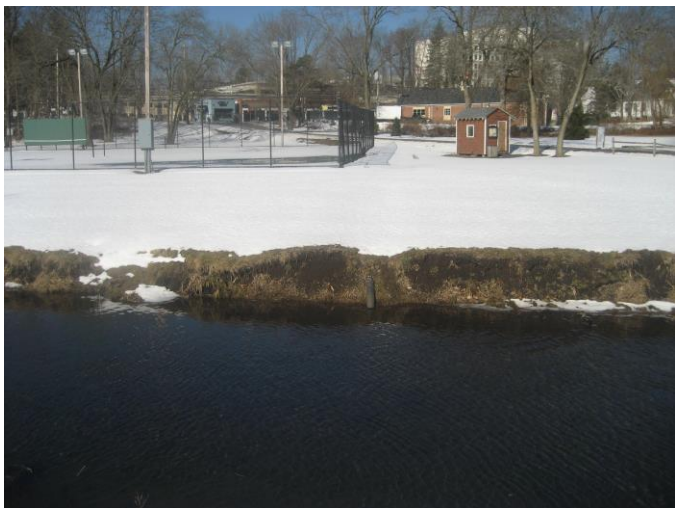
The next 450 feet of the river has no natural vegetation and is mown lawn to the water's edge. Six red maples have been planted on the east side and two large weeping willows grow in the west side. The lack of stabilizing vegetation has resulted in erosion of the stream bank, allowing soil, silt and pollutants to enter the river. See map on page 67.

Looking west at unvegetated stream bank and erosion

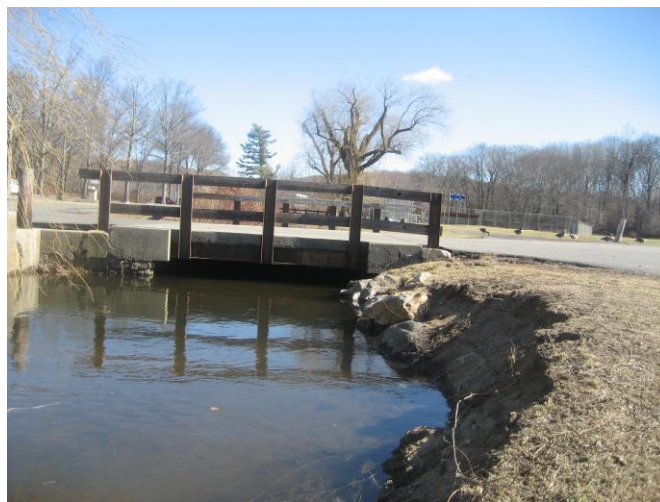
Looking north at unvegetated stream bank and erosion

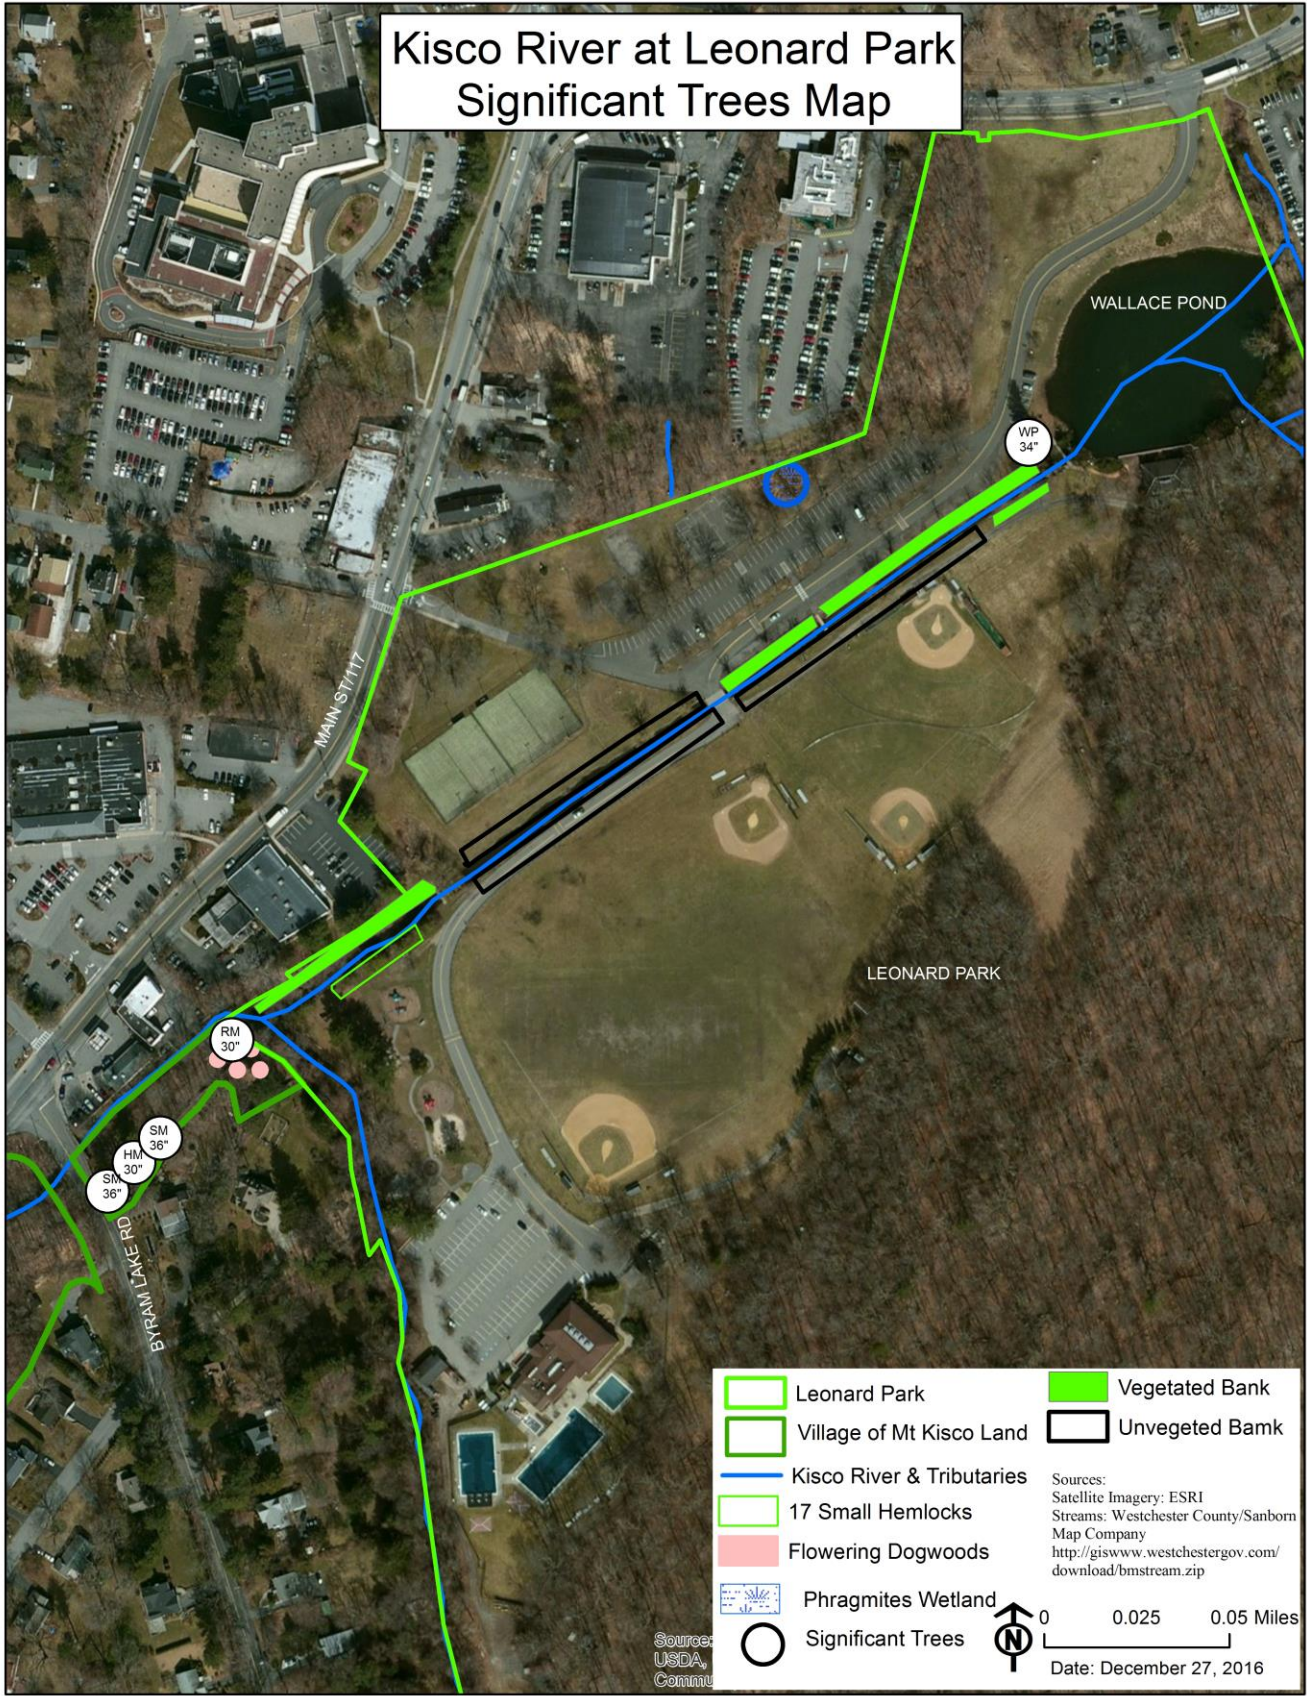
# Kisco River at Leonard Park Significant Trees Map

Leonard Park		Vegetated Bank
	Village of Mt Kisco Land		Unvegetated Bank
	Kisco River & Tributaries		
	17 Small Hemlocks		
	Flowering Dogwoods		
	Phragmites Wetland		
	Significant Trees

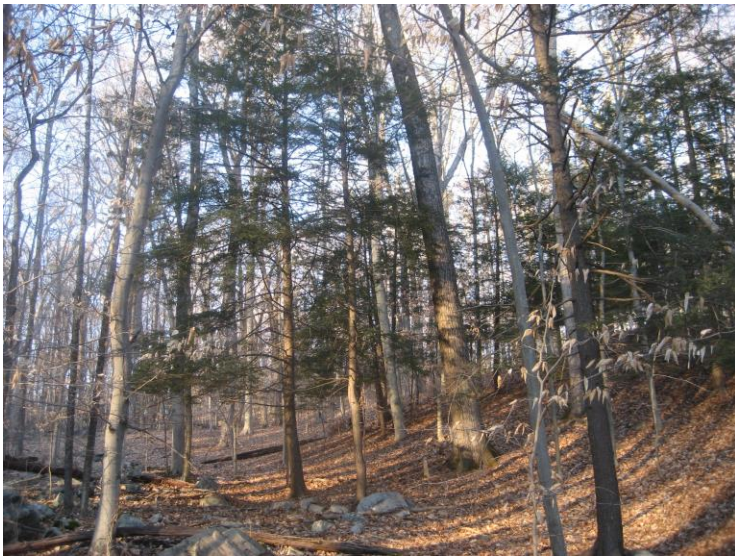
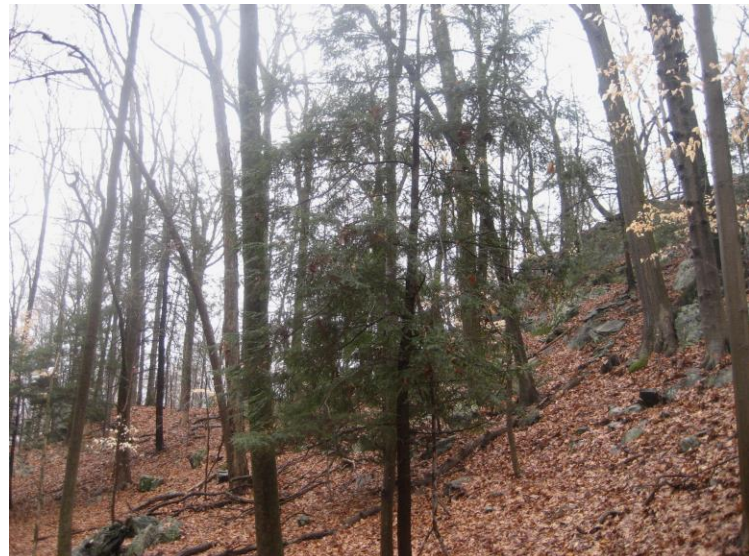
*Many of Leonard Park's hemlock trees are dying from wooly adelgid disease*

Hemlock grove in center of Leonard Park woods

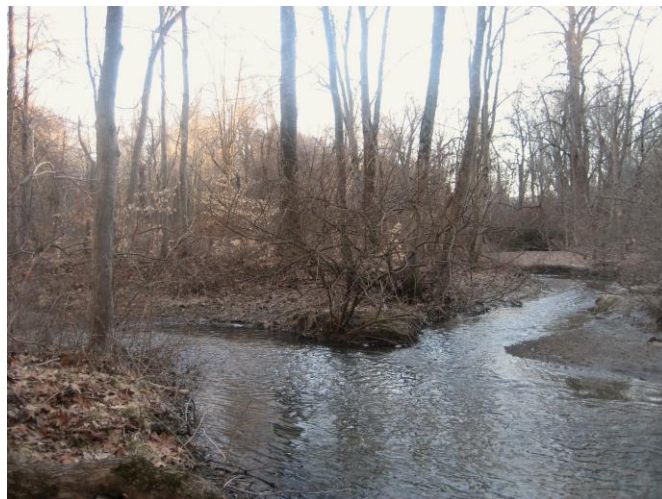
Along the southern edge of the park, tributaries from Seven Springs located 2 miles to the southeast enter and merge with another tributary and then merge with the Wallace Pond outlet stream, forming the Kisco River at the western edge of Leonard Park.

Tributaries merging from Seven Springs

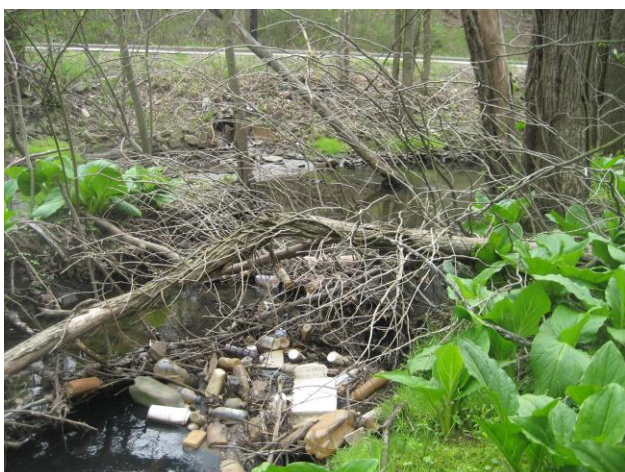
Branch Brook litter

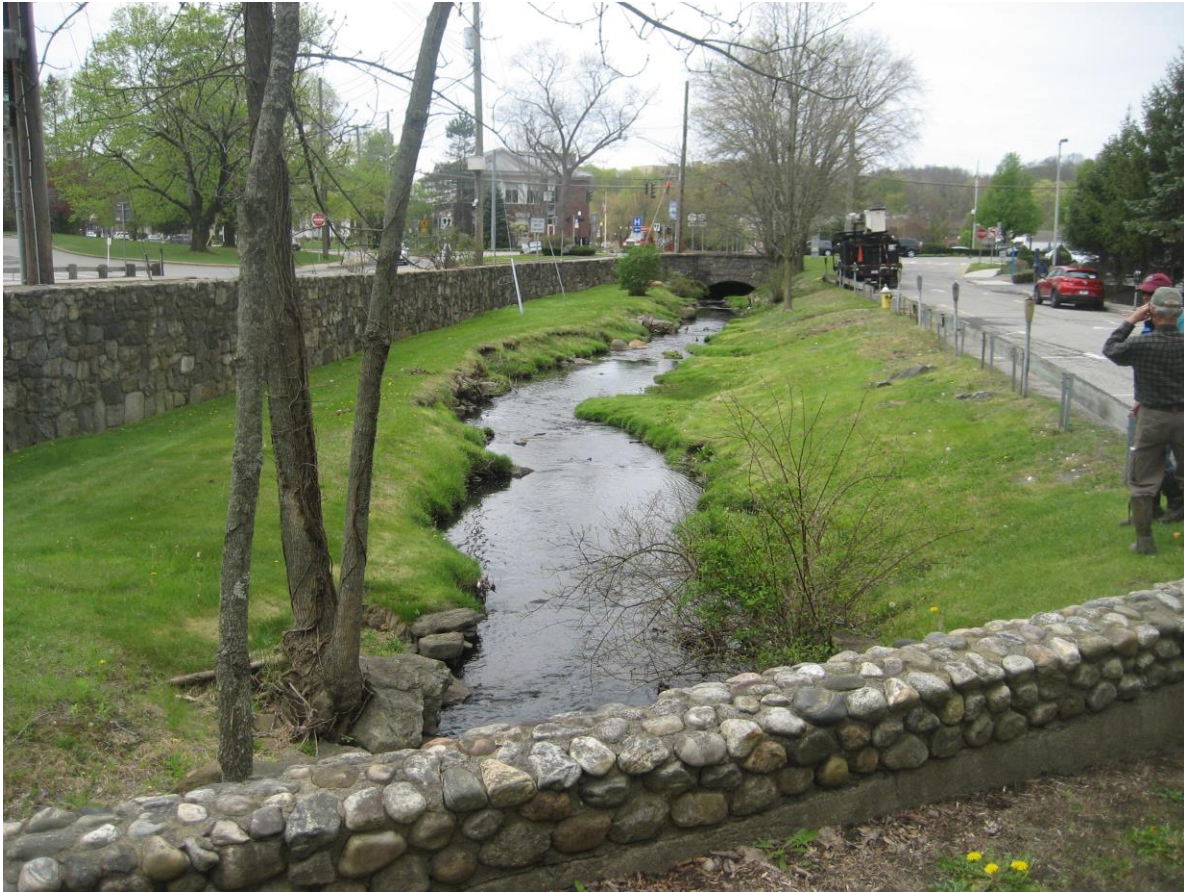
Branch Brook Looking South from Legion Way

As the Branch Brook flows beneath Legion Way, the stream bank is no longer vegetated and is tightly mowed grass with 2 storm water culverts that have eroded the stream bank in at least four sections of the west bank. One or two native silky dogwood, elm, ash, sugar maple, red maple and pin oaks grow here.

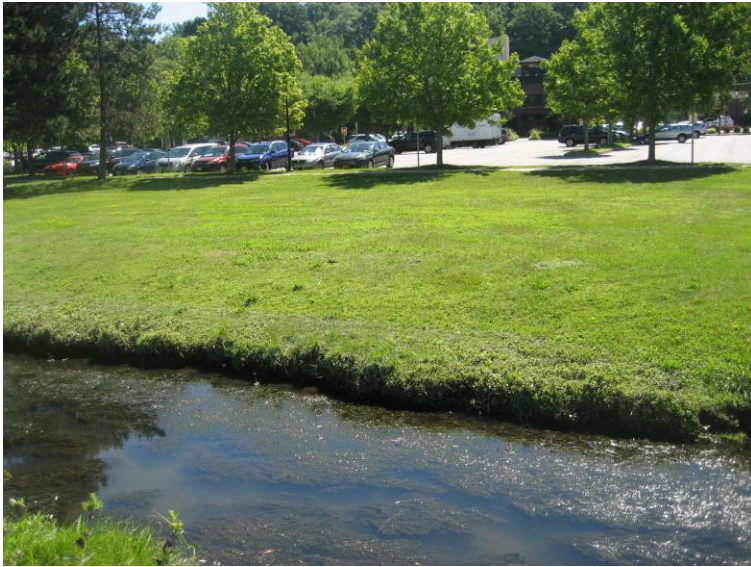
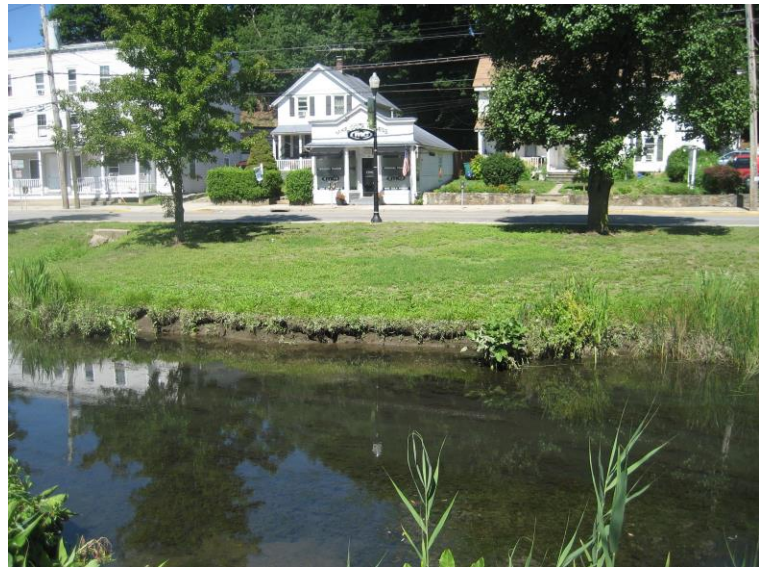
Mowing and bank erosion along Branch Brook at South Moger Avenue.

salt tolerant, that river birch would grow well along the brook without getting too tall and that black willow, pin oak, sycamore, swamp white oak, tupelo and alders would all tolerate the wet conditions along the stream bank. He said the pussy willows and silky dogwood could be planted in late winter using the 'live stake' method of driving the cut stems deep into the stream bank. Village Manager Ed Brancati said that the town will not cut any plantings along the brook and that the town continues to refrain from using any pesticides or herbicides anywhere in Mount Kisco.

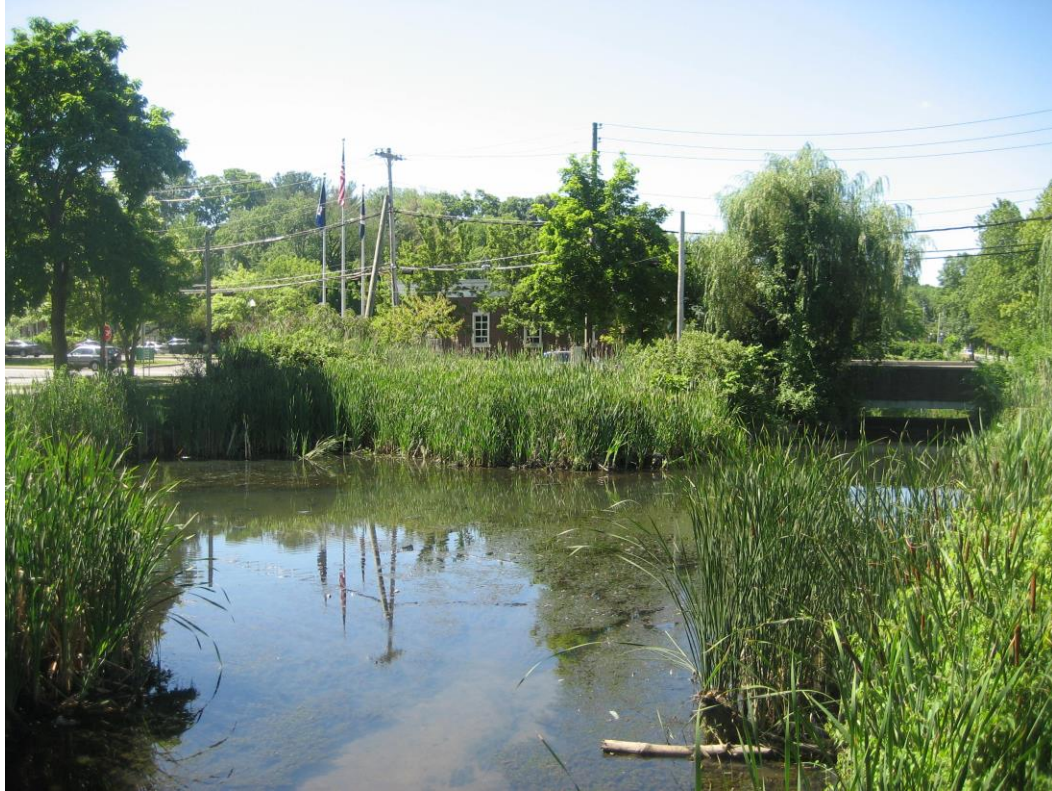
Branch Brook pond just north of South Moger Avenue.  
Phragmites to be removed and replanted with native plants in 2016.

In late 2016 a storm water improvement project was planned for this section of the Branch Brook. It included removing vegetation from overgrown storm water facilities, smothering phragmites around the one large and another small retention pond just north of the Police Station and replacing four equalizing pipe at the Branch brook just south of Leito Drive. Native plants were to replace any plants removed during the construction.

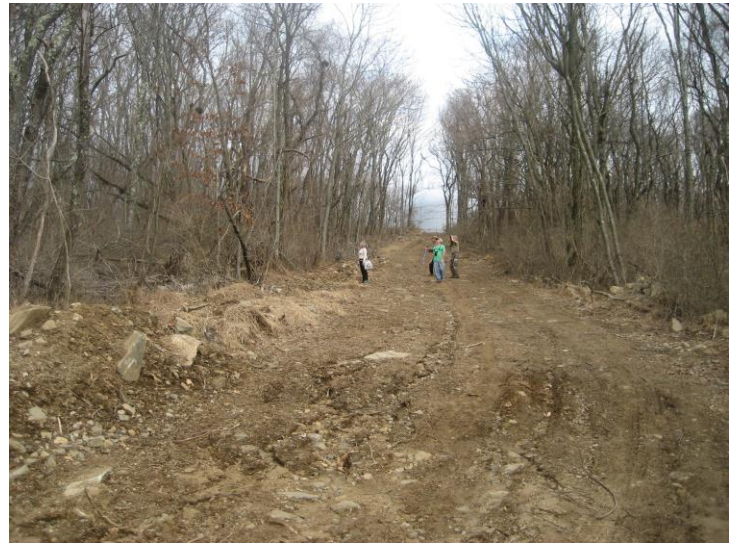
Erosion along water tower road

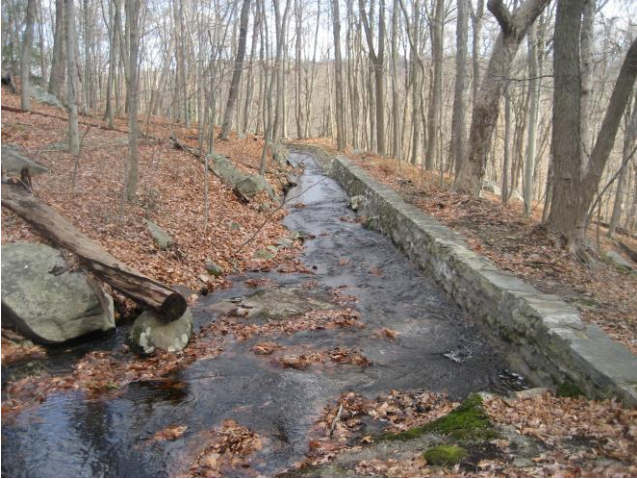
Stream re-directed into sluiceway

The naturally flowing stream flows southeast from the wetland and then is converted to a stone-lined sluiceway that re-directs the water north into Byram Lake.

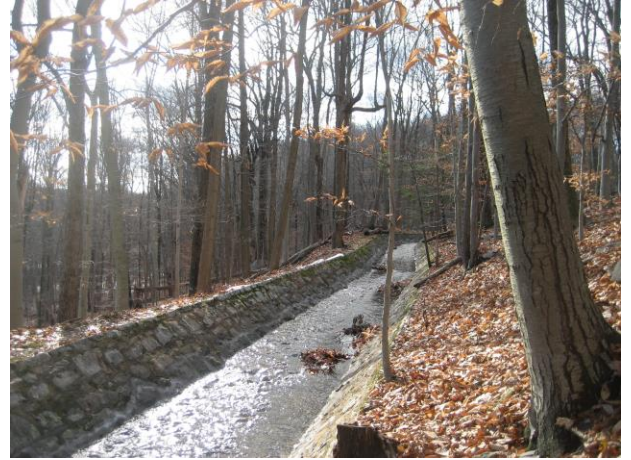
Sluiceway with vegetation on both sides

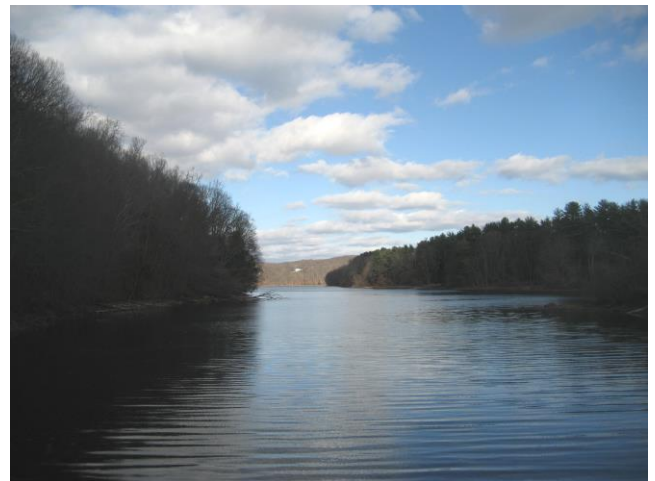
South end looking north at Byram Lake and steep, vegetated western slope

A very steep slope of over 25% runs along the entire west side of Byram Lake, a length of 1.4 miles. Elevations drop sharply from a peak elevation of 680 feet above sea level to 450 feet above sea level at the lake's shoreline. In extremely steep areas elevation drops 200 feet over just a 300 foot distance. Rock outcrops and dead and dying eastern hemlock evergreens dominate this community.

A large, 2-acre area at the top of the cliff on Mount Kisco land has been clear cut recently (aerial photographs from 2013 indicate it to be forested at that time). This are is prone to erosion and/or landslides that will drive sediment into the lake.

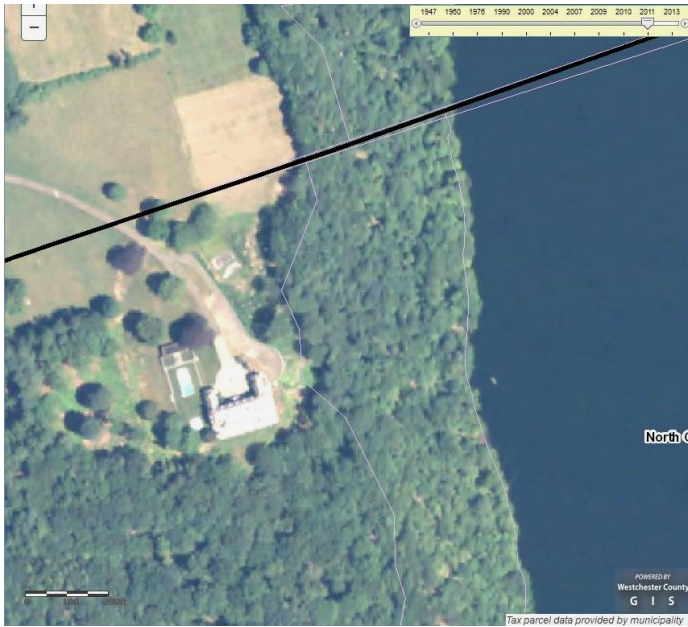
2-acre clear cut on Mt Kisco Water Supply Land.  
2011 photograph on left; 2013 photograph on right.

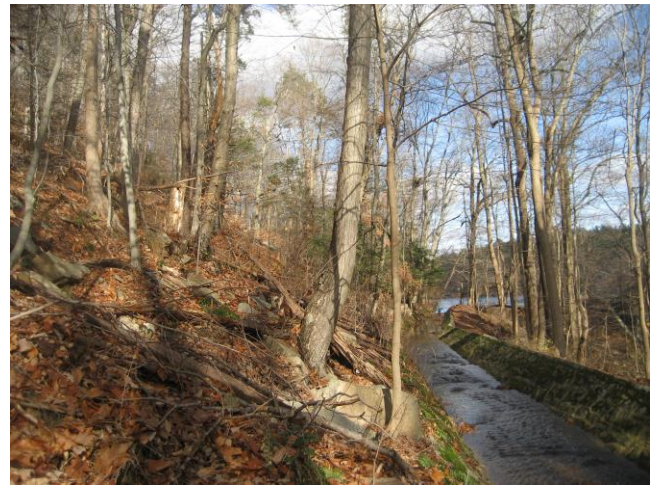
Sluiceway with vegetated steep slope to west

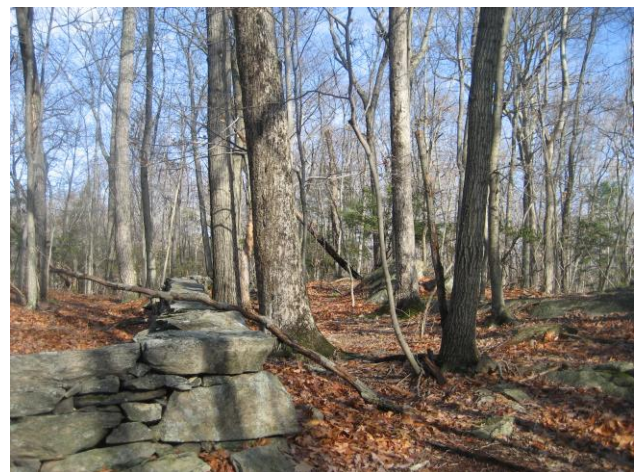
The understory consists of many still living medium sized hemlocks and many downed and dead hemlocks. Wooley adelgid has infected these hemlocks and typically causes death of an entire hemlock grove in as little as six years, as is the case here. Fortunately it appears that oaks and hickories are growing up and replacing the dying hemlocks.

Dead and downed hemlocks on west slope

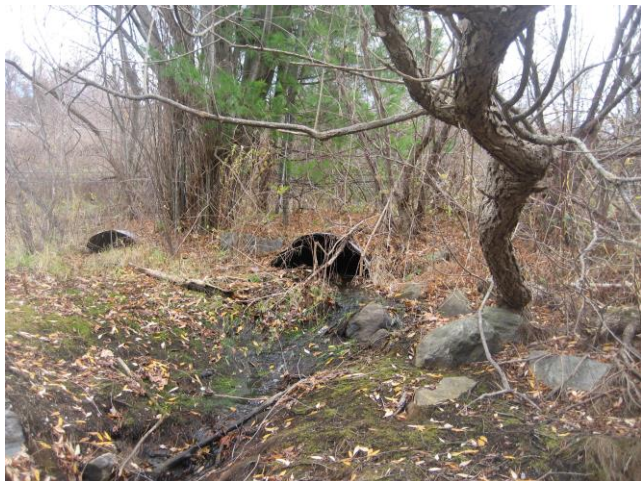
BLT 2 is located at the southeast corner of Byram Lake. Three pipes carry water beneath Byram Lake Road and into the lake. This stream is well-vegetated with red maples, pussy willow trees, alder, winterberry, silky dogwood and blueberry shrubs and path rush and cinnamon fern. Many white pine seedlings indicate future tree growth, protecting the stream.

3 culverts beneath Byram Lake Road at BLT 2, looking east

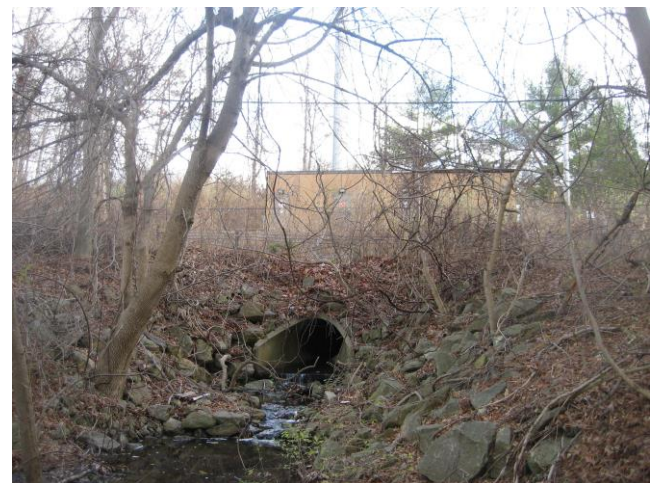
BLT 4 is located just northwest of the former Rene Dubos Center 30-acre property which was acquired by the Town of North Castle, with contributions from Mount Kisco and the Westchester Land Trust, in 2009. Directly east of this tributary is a large amount of impervious surface beneath a cell tower that directs storm water into this culvert. The stream is surrounded by tulip, elm and white pine trees. This is one area of the reservoir that has an abundance of invasive plants. Invasive

Concrete culvert at BLT 4 with cell tower across Byram Lake Road

honeysuckle and invasive multi-flora rose, along with invasive bittersweet vines and invasive garlic mustard, grow along the stream bank. The streambed itself is rock-filled, which slows storm water and prevents erosion. The amount of invasives indicates that this area has been disrupted recently, perhaps when the cellular tower was constructed and paved and storm drains were installed.

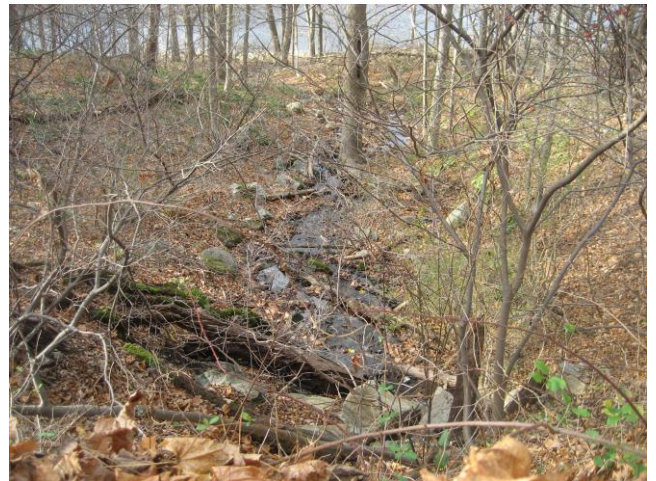
BLT 6 has a high rock headwall that has caved into the stream channel. The stream is surrounded by white ash, shagbark hickory, sugar maples and yellow birch. Shrubs include spicebush; Christmas ferns are abundant.

Collapsed headwall at BLT 6, looking west from road to lake

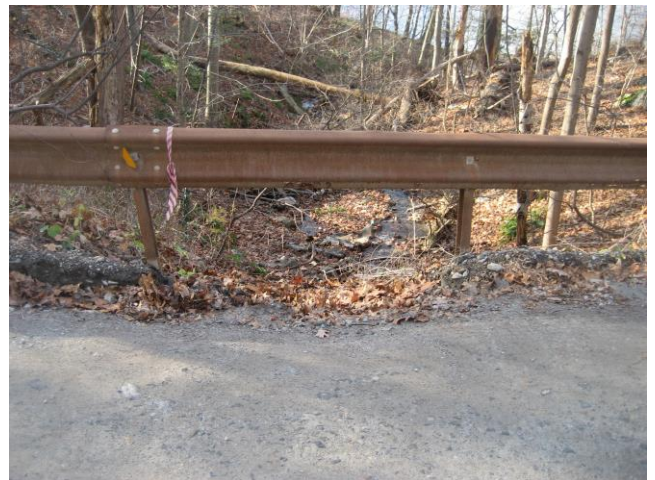
The road has caved in and is releasing storm water and gravel into the stream. The pink and black striped ribbon indicates that the Town of Bedford is aware of this problem.

Looking west at road cave in at BLT 7

- Repair all road cave-ins over the .08 mile stretch of Byram Lake Road
- Repair other road cave-ins along Byram Lake Road
- Insert storm drain at #675 where storm water accelerates down driveway
- Insert storm drain at asphalt/gravel interface at bottom of Byram Lake Road hill where storm water accelerates
- Crown road so water drains away from Reservoir

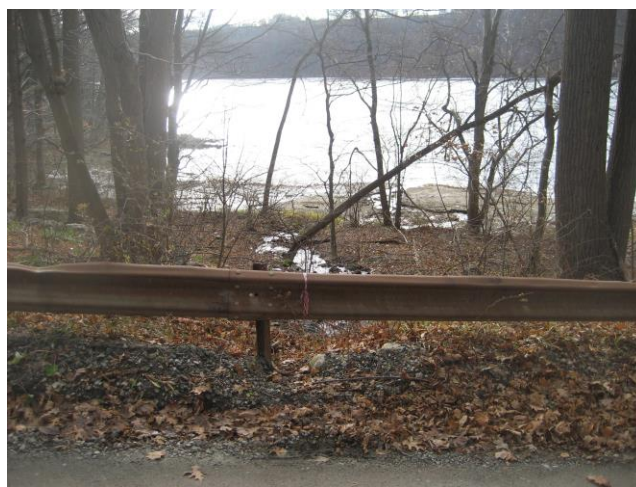
View south to lake at BLT 8. Pink and black ribbon indicates road cave in.

- Reduction of road salt use at interstate 684 and Byram Lake Road
- Repair of cave-ins and shoulders along Byram Lake Road
- Planting vegetative strips between the road and the reservoir
- Paving of parts of the road, installation of catch basins and temporary road closures may be necessary.

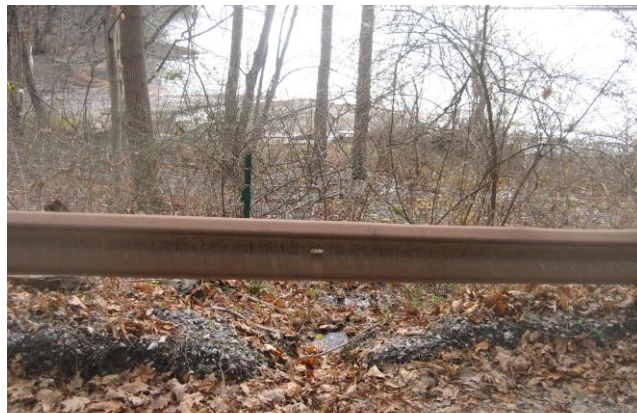
Spring and green stake marking a gauging station at BLT 9

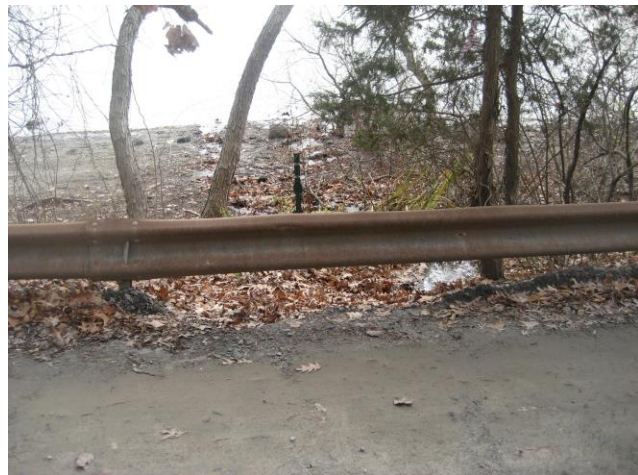
The stream flowing into the lake at BLT 10 is just north of Byram Lake Road and is well-vegetated. A few red cedars are found at the culvert at BLT 10 but the road at BLT 10 has caved in and has no shoulder or cubing. It appears that storm water running down the steep driveway at #607 Byram Lake Road is eroding the road and running off into the lake

BLT 10 with no road shoulder or curbing

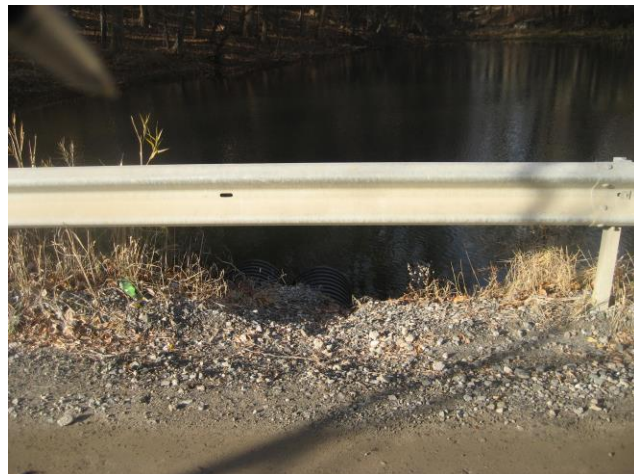
North side of Byram Lake Road is caving into the marsh

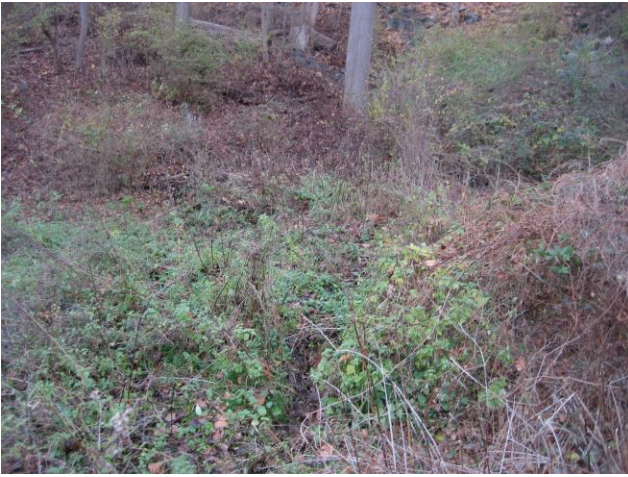
Hillside stream and check dam with culvert

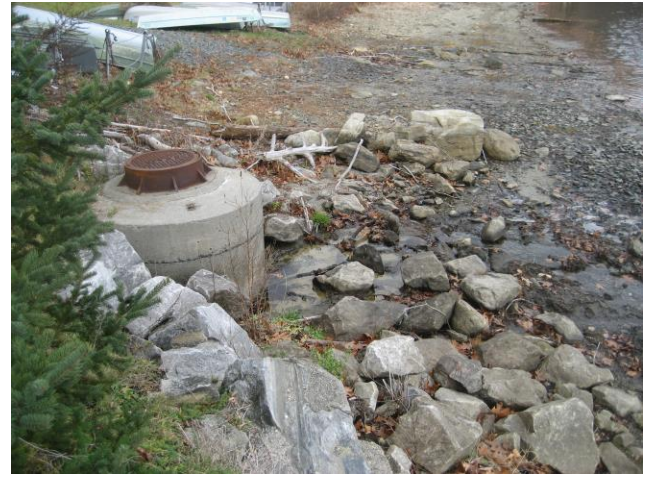
Water released into lake at pump station

BLT 12 is at the pump station. Water drains from the steep hillside on both sides of Byram Lake Road. A crushed stone check dam slows water and pipes it to the manhole covered pipe where it appears to be slowly released into the lake.

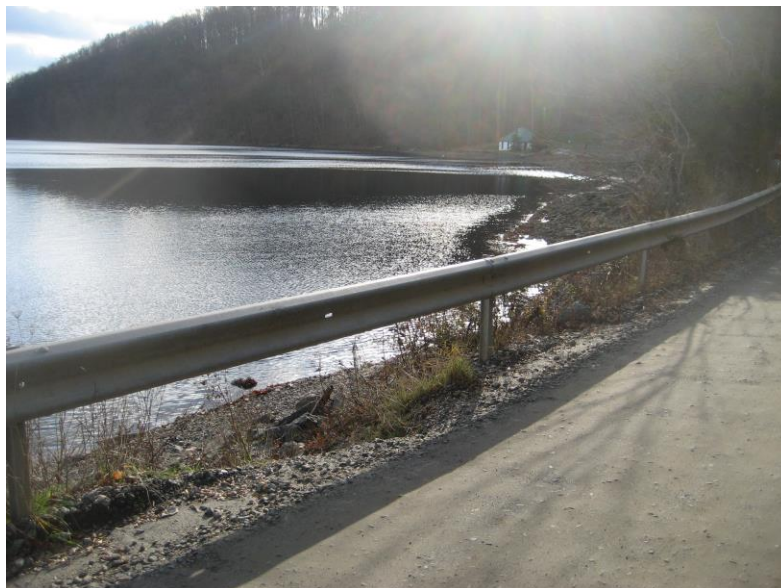
All tributaries to Byram Lake are naturally vegetated with little space for adding vegetation. Byram Lake Road, by contrast, has no shoulder or curbing. For at least .08 miles between BLT 9 and BLT 10 road run-off is going directly into the reservoir. The road is caving in at several other points along the north shore of the reservoir

North end of lake from Byram Lake Road looking southwest.  
Lack of shoulders, curbing or vegetation allows storm water runoff directly into lake.
