Natural Resource Inventory  
Town/Village of Mount Kisco, New York

Prepared by Mount Kisco Conservation Advisory Council  
March 15, 2017

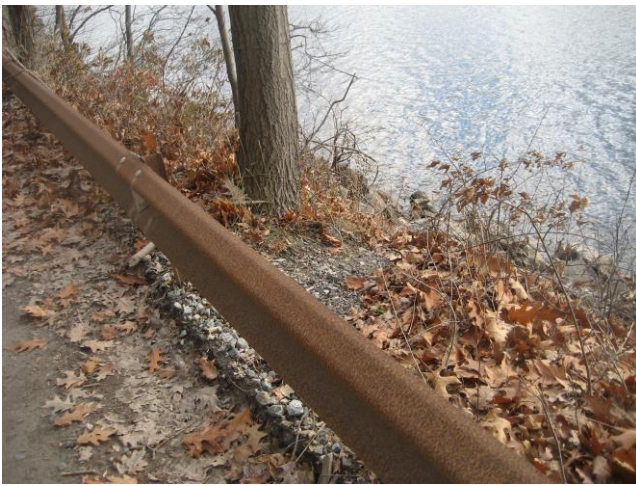
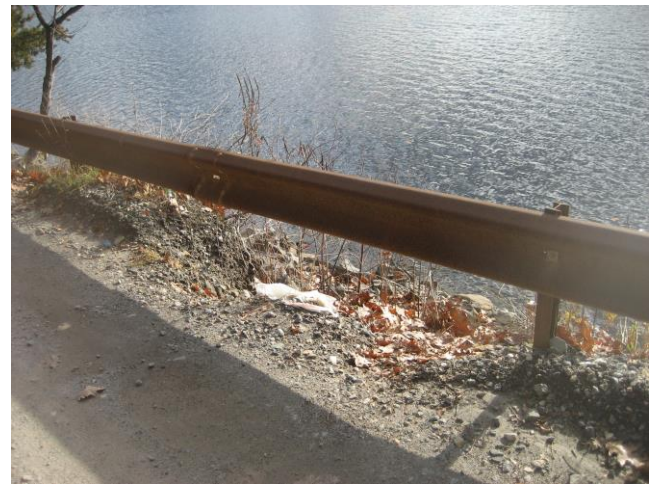
Eroded embankment along Byram Lake Road at north end of lake

- Reduction of road salt use at interstate 684 and Byram Lake Road
- Repair of cave-ins and shoulders along Byram Lake Road
- Planting vegetative strips between the road and the reservoir
- Paving of parts of the road, installation of catch basins and temporary road closures may be necessary.

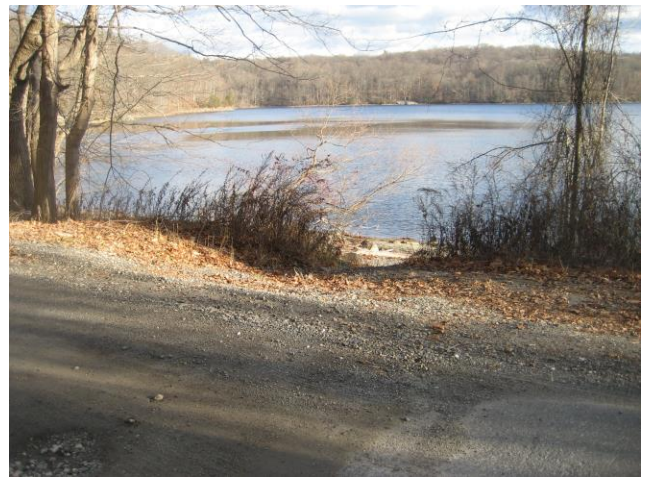
Asphalt/gravel interface at base of Byram Lake Road hill
