Biodeterioration of Polychrome Roman Mosaics

The mosaics from the Roman remains of Itálica, which was founded in 206 BC near present-day Seville, are threatened by the ravages of nature that are destroying these masterpieces from the second century AD. Since the beginning of this century, the exposure of most of the mosaics after excavation has resulted in colonization by pioneering species of lichens and mosses, as well as by subsequent allied plants. The ultimate effect is the complete destruction of the mosaics, with some unfortunate examples being recorded.

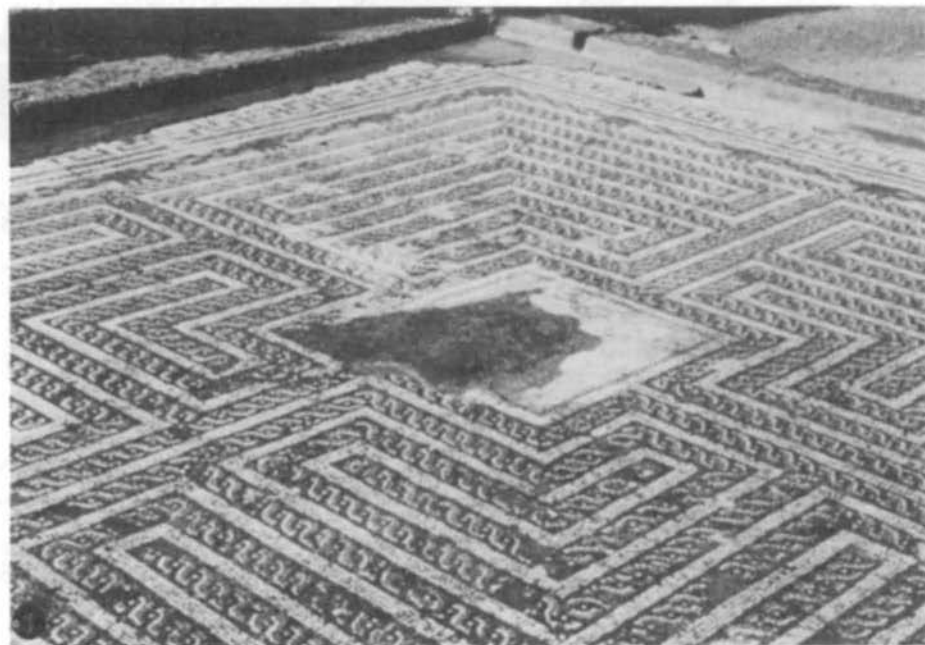
Fig. 1. Mosaic of the Labyrinth.

The mosaic of the Labyrinth (second century AD) is situated in the House of Neptune's Mosaic, which has 8 *opus tessellatum* and 1 *opus fliginum*. This house was excavated in the 1930-31 campaign, and among the restorations documented are those of the foundations and perimeter walls redone in the 1960s. The mosaic has a size of 6.55 × 5.35 m and a total area of 35.04 m². The theme represented is geometrical, with a labyrinth in whose centre are the remains of a figure, which has disappeared. The labyrinth design surrounds the missing central figure. On one of its sides there is a drawing of circles and stars. The mosaic has gaps due to missing fragments, and shows signs of instability, movements, and cracks, with a disintegrated base, poor adhesion between the different strata, and much dampness in the rainy periods of the year (Fig. 1).

YR 6/6, medium light grey N 6 to medium grey N 5, and white N 9. On the borders, there are tesserae which are greyish pink 5 R 8/2 to moderate pink 5 R 7/4. The tesserae are usually from 1.2 to 1 cm² and at a density of 81 tesserae/100 m². The surface with tesserae is 34.58 m² (98.8%), while the missing fragments represent 0.42 m² (1.2%). Adhesion of the tesserae to the base is very poor or non-existent, and the mosaic has numerous bulges over its whole area. In some cases, the tesserae edges are covered with mortar, and in others there are edges eaten away with the mortar lifted and chipped. The surface of the mosaic is not smooth, but has bumps and depressions which retain water in the wet season.

The tesserae are loosened, except those which have been restored. During the winter of 1987, a metallic structure was set up over the mosaic, which was covered at a height of 40 cm from the ground with wood and opaque plastics, leaving the sides open. This caused the appearance of rust stains on the mosaic. There are no reports on the state of conservation before the covering. At present, there is very abundant colonization of the mortars by mosses and of the tesserae by lichens. Gramineae and other vascular plants also appear among the mosses. The mosaic shows a lack of cleaning, increased by the deposit of organic matter and resins from the cypresses which border the paths, and are very close to this mosaic.

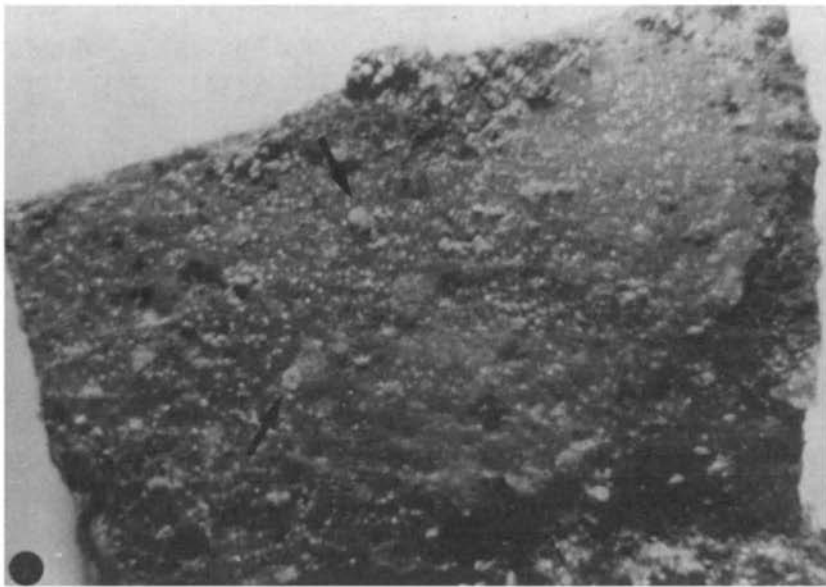
Fig. 4. An endolithic *Caloplaca* sp. on green vitreous tessera. Some apothecia are indicated with arrows. Mosaic of Tellus.

The ceramic tesserae of the Tellus mosaic are colonized by endolithic *Caloplaca* sp., *Lecanora dispersa* and *Verrucaria nigrescens*, the latter colonizing from the mortar.
