Environmental Impact Assessment (EIA) for Central Bank of The Bahamas Demolition Project, New Providence

Prepared by SEV Consulting Group
July 2020

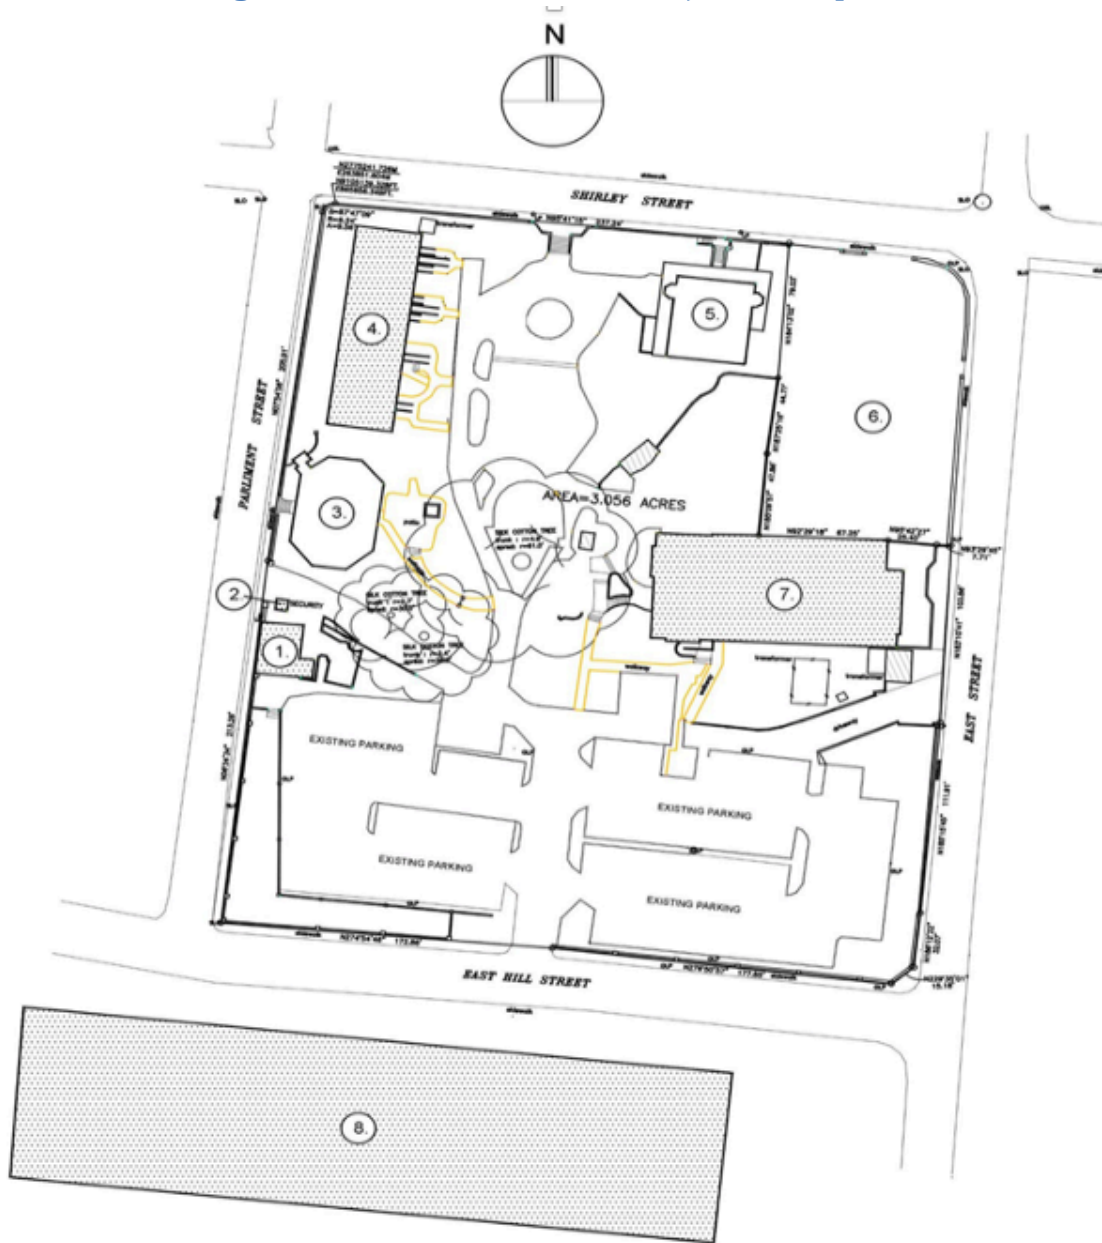
Figure 2-1: CBOB Demolition Project Concept Plan

The objective of this new facility is to provide a modern space for CBOB to conduct its business and act as a landmark structure that will not only serve as the new location of the Bank, but as an impetus for the revitalization of the city of Nassau. The environmental impacts of the construction of the new facility will be assessed in a separate Environmental Impact Assessment. This current EIA deals only with the demolition project. The CBOB Demolition Project involves the demolition of five (5) buildings on either side of East Hill Street on the island of New Providence in The Bahamas (see Map 1). It is being executed by the Central Bank of The Bahamas. The project concept plan is shown below in Figure 2-1.

No	Name of Building
1	Victoria Lodge
2	Security Booth
3	Bahamas National Drug Council
4	HIV-AIDS Centre
5	Curry House
6	Zion Baptist Church
7	Commission of Inquiry
8	Former Post Office

Building Legend	
Building to Remain	
Building to be Demolished

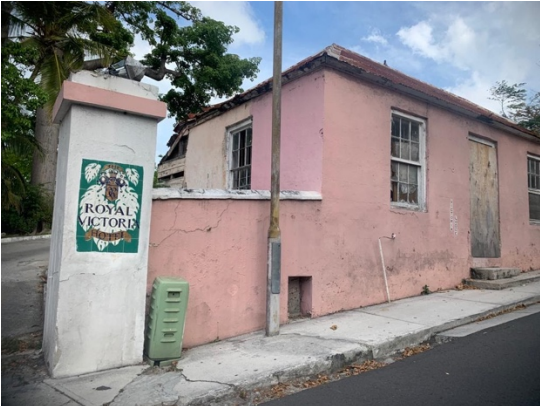
Building No.	Building Name	To be Demolished	Notes	Images
1	Victoria Lodge	Yes	Derelict single-storey building opposite the Security Booth. Location: Near exit to Parliament Street.

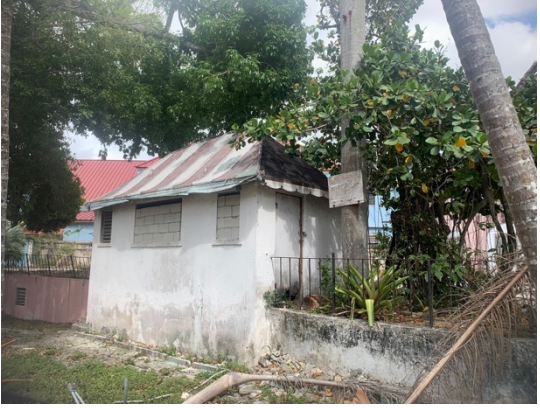
2	Security Booth	Yes	Small single-storey, single room structure located opposite Victoria Lodge. Location: Near exit to Parliament Street.

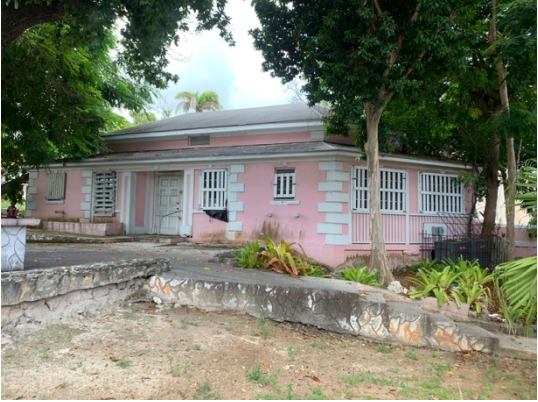
3	Formerly offices of the Bahamas National Drug Council	No	Single-storey structure. Shuttered. BNDC no longer occupies the building.

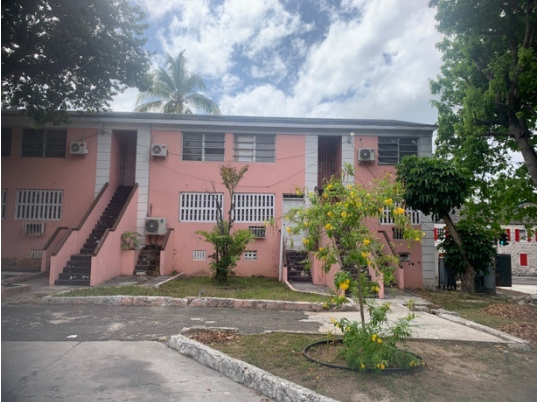
4	Ministry of Health – HIV-AIDS Centre	Yes	Two-storey building with half a basement. Currently used as a treatment facility for patients. Structure in need of maintenance, but does not appear to be in deteriorated condition.

The exception to use is the HIV-AIDS Centre. It is currently being used by Ministry of Health and the patients they service. Ministry of Health is in the process of looking for new facilities to house the Centre that would provide better working conditions for its staff and treatment conditions for its patients. As the Centre treats patients with an immune suppression disease, any existence of mold in the building has the potential to put them at risk for fungal infections.

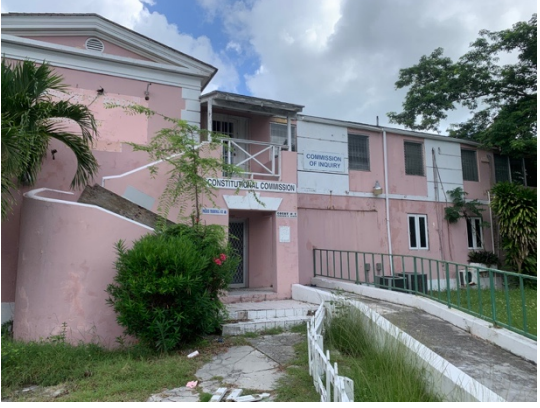
7	Commission of Inquiry	Yes	Derelict three-storey building. Exterior of building shows signs of significant structural deterioration. There are files still stored in the building.

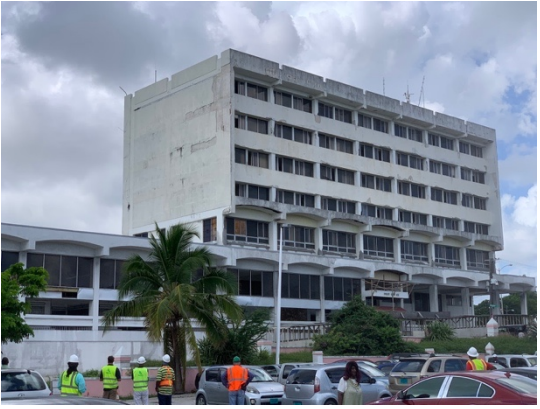
8	Post Office Building	Yes	Building no longer occupied. Building is in 2 parts - main building with 3 levels and a 5-storey addition. Areas include Letter Post Floor, Administrative Block, Parcel Post Counter & Customs Section, General Mail Counter, offices used by Department of Social Services, and offices used by the Attorney-General's Office.

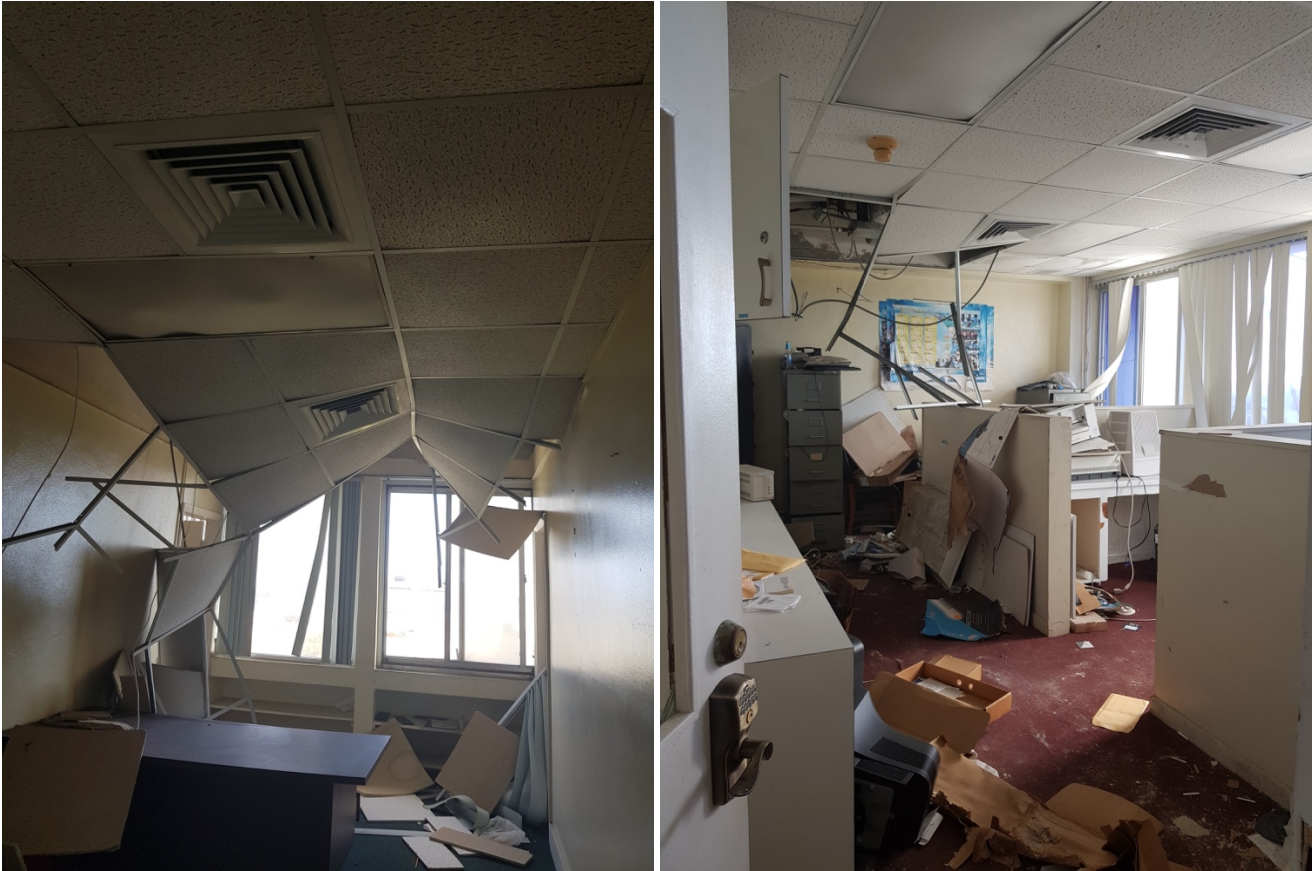
Figure 2-3: Former Post Office

In order to construct the new building, some of the buildings at Royal Victoria Gardens, as indicated, will need to be demolished. Most of these buildings are in great disrepair and could not be salvaged. Since buildings are being demolished for the project, the Government of The Bahamas has requested the Bank's assistance in demolishing the former Post Office as this building is also now uninhabitable and is in severe disrepair. The series of photos below indicate the conditions in the various buildings.
