# ENVIRONMENTAL EFFECTS REPORT

FOR TIMBERLINK AUSTRALIA PTY LIMITED

## Wood Plastics Composites Facility at 331 Old Bell Bay Road, Bell Bay

3<sup>rd</sup> December 2021

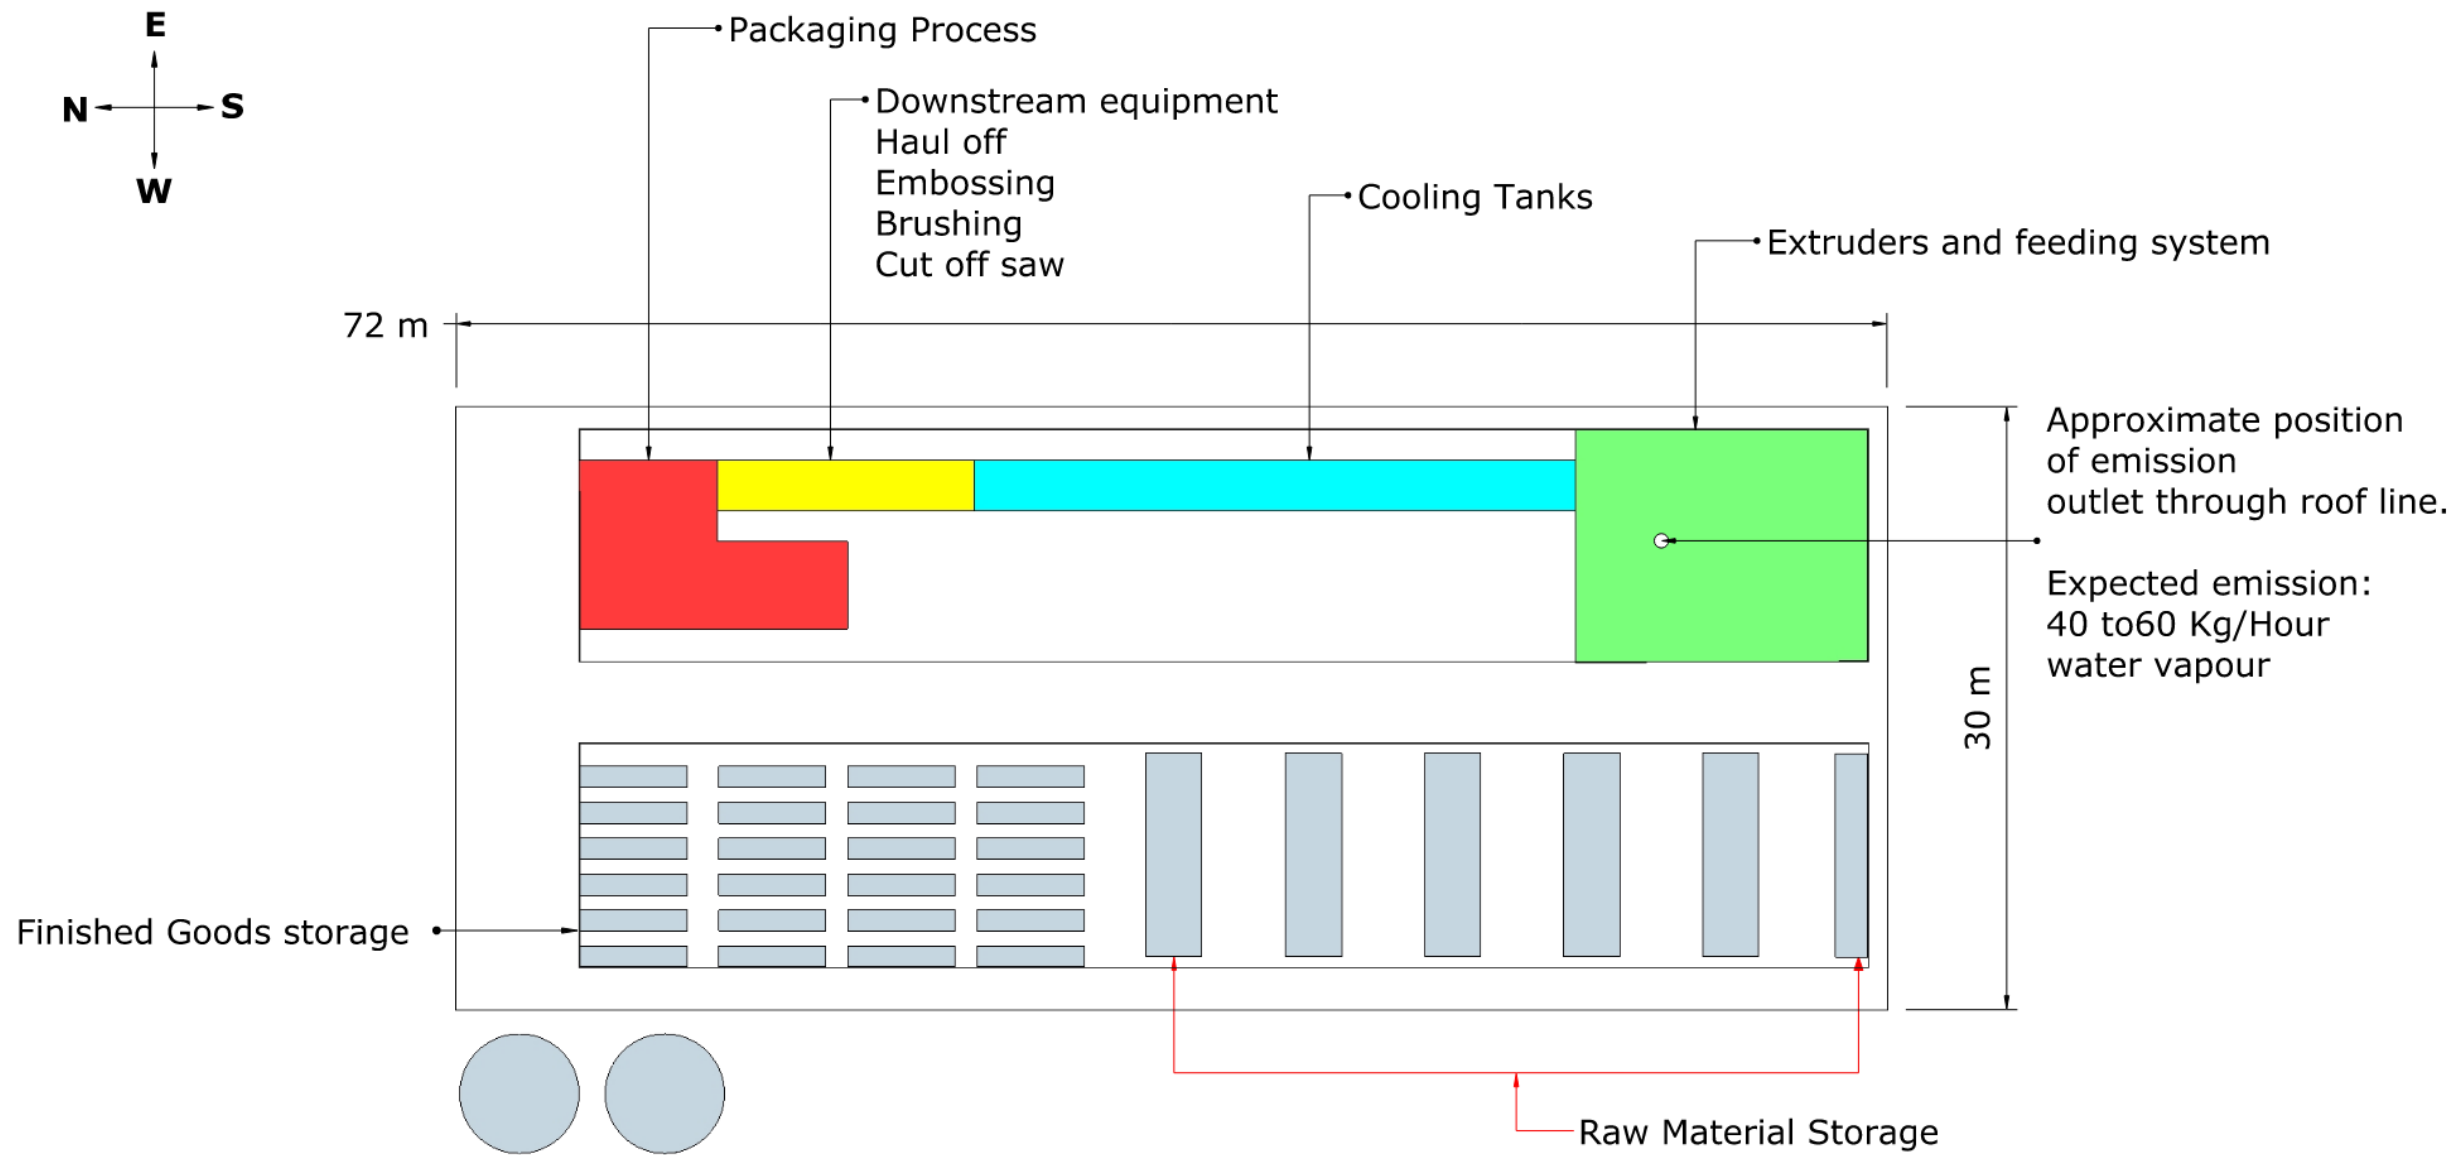
Item: WPC Basic Layout  
 Drawn: LL  
 Drawn Date: 15-09-2021  
 Scale:  
 Sheet 1 of 2

Material	Material State	Stock Holding Kg
Wood Fibre	Pellets	25000
Lubricant	Granules	12000
Coupling Agent	Granules	6000
Capping HDPE Clear Master Batch	Granules	45000

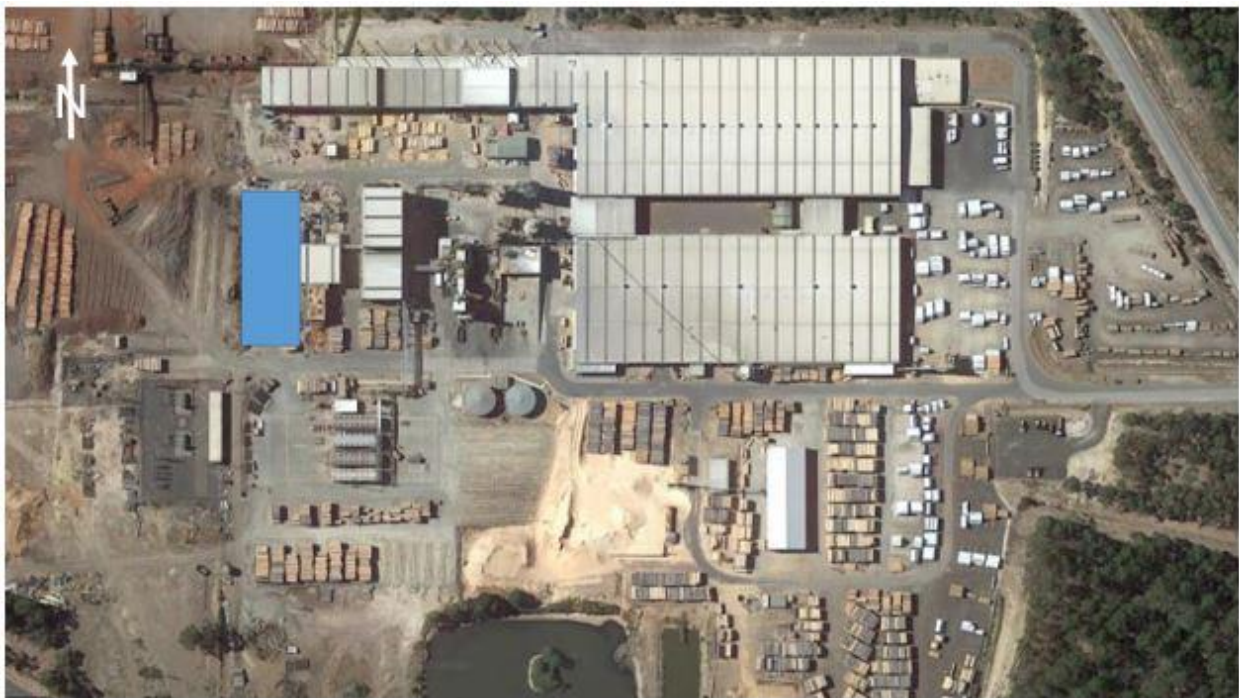
**Figure 3-1: Bell Bay timber mill site layout – including proposed WPC Facility building (shaded blue)**

The proposed WPC Facility will upcycle plastic waste and timber residue to produce the final WPC products. The WPC Facility will be housed in a new proposed building of dimensions 73m long x 30m wide x 8m tall, located on site to the west of the existing maintenance building, as shown in Figure 3-1 below and Attachment B.

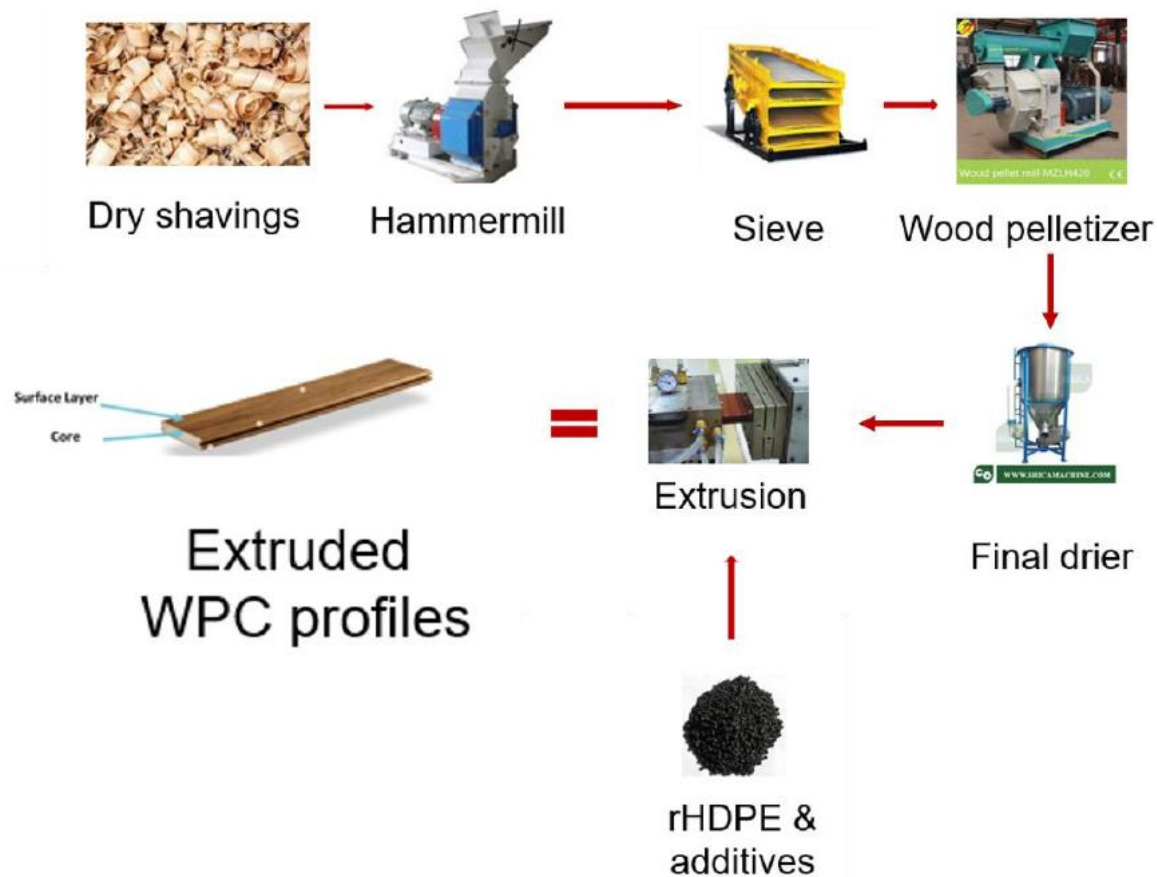
Figure 3-2: WPC Facility process schematic

A schematic of the production process is shown in Figure 3-2. Note that the boundary of works for the current assessment are the inputs to the final drier, the rHDPE (recycled HDPE) through to the end products. The wood pelletizer and upstream operations are not included in this assessment.

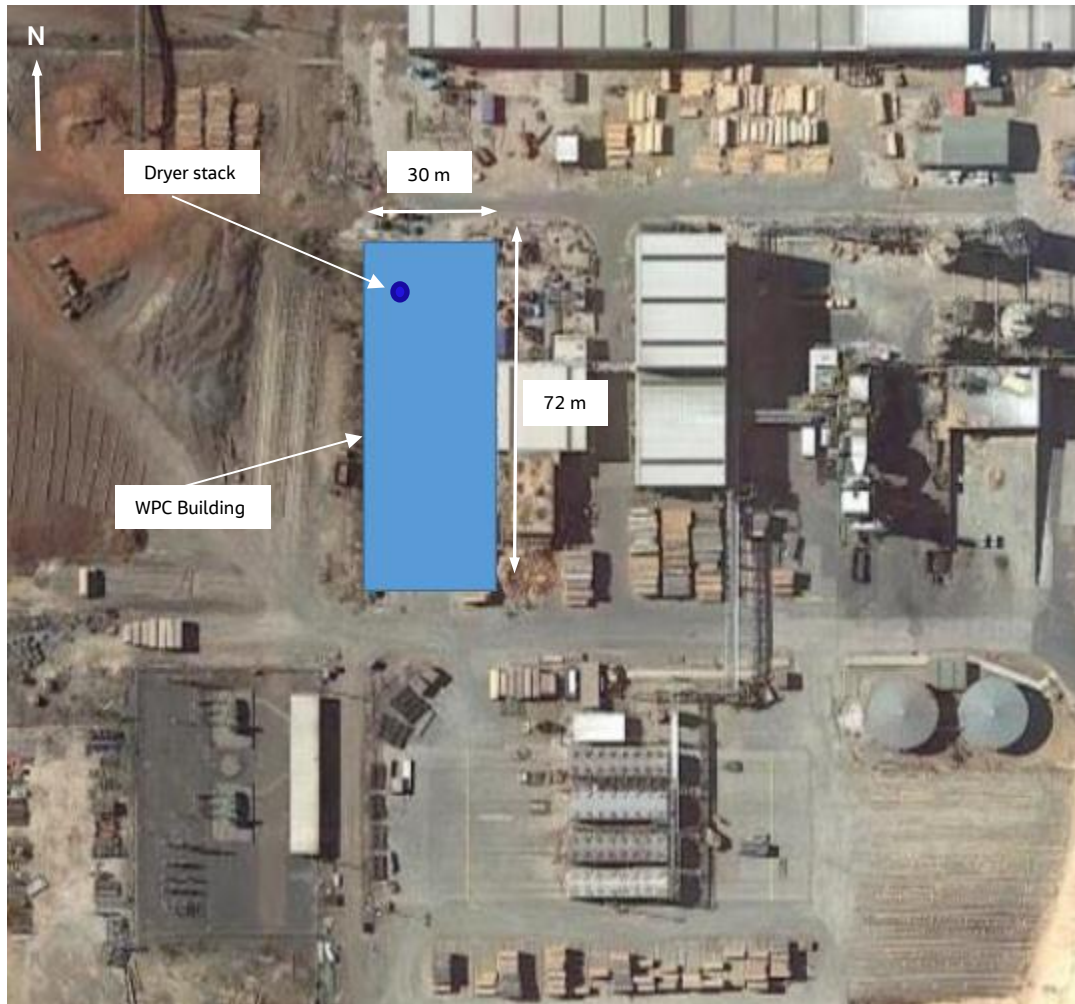
**Figure 6-1: Dryer stack location (approximate) on roof of WPC Facility building**

The dryer is electrically powered and therefore there will be no combustion emissions.

The drier will produce predominantly water vapour emissions, which will be vented to atmosphere via a stack located on the roof, the height of this stack will be 3 to 5 metres above the roof height (roof height is 8 – 10 metres). The rate of moisture release will be approximately 40 - 60 kg/hr. This is very small compared to that for the existing kilns which is approximately 8,500 kg/hr. The total exhaust gas flow rate to atmosphere will be approximately 2,000 m<sup>3</sup>/hr. For a typical stack velocity of 10 - 12 m/s, the dryer stack diameter would be approximately 250 mm internal diameter.
