**Rabie Ridge
Detailed Wetland Assessment and Mitigation Approach**

SEF Reference No: 505436

September 2013

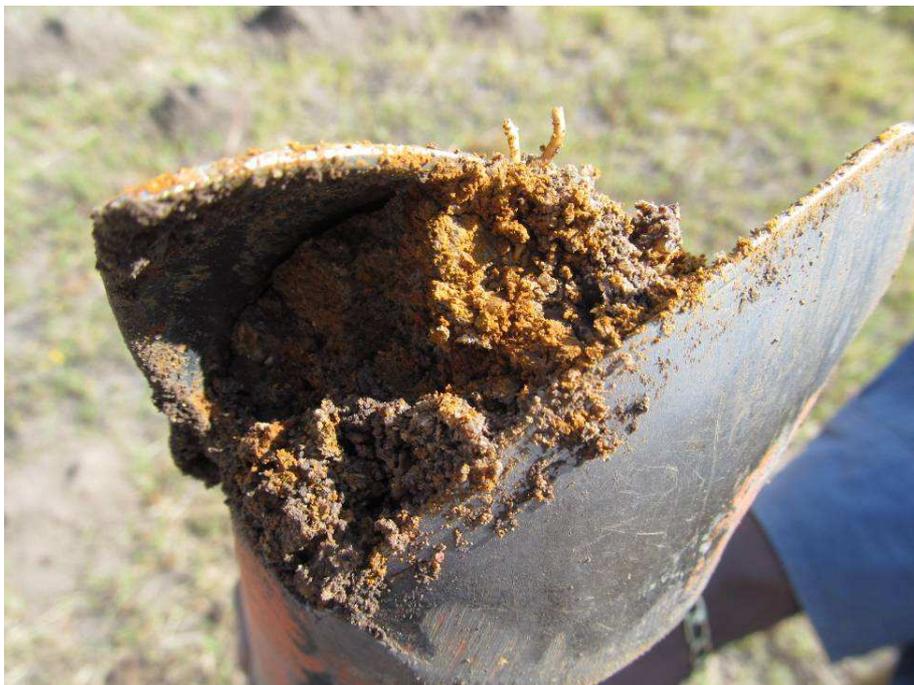
Photograph 1: Plinthic soils located in the hillslope seepage wetlands.

The Dresden soil form was identified within the hillslope seepage wetlands lower down on the slope. It consists of a hydric A horizon, with signs of mottling in the top few centimeters of soil overlying a hard plinthic layer.

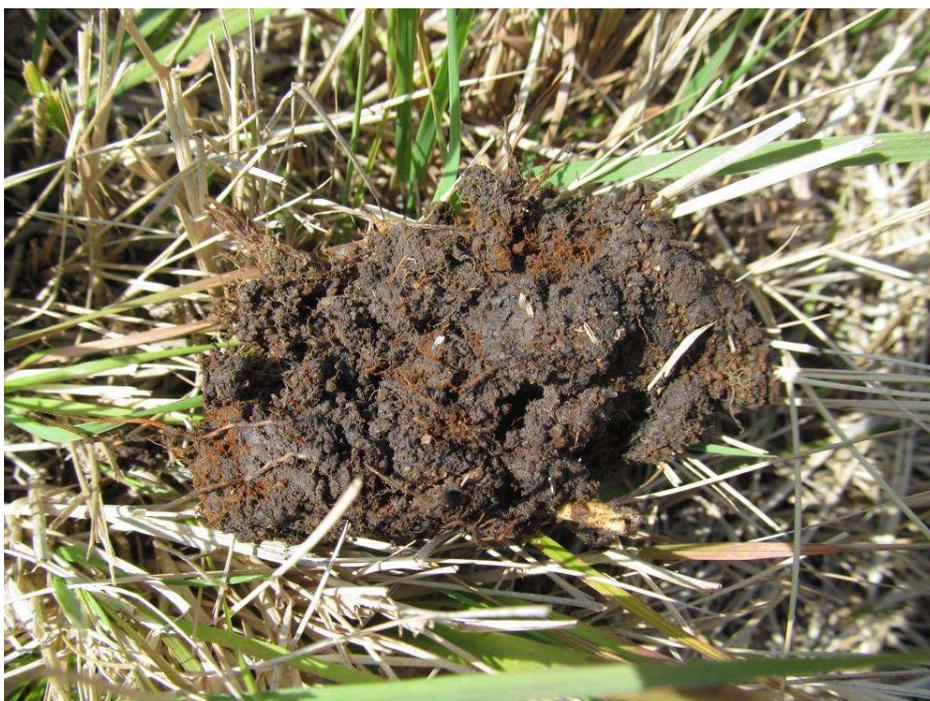
Photograph 2: Plinthic soils with a more clayey A horizon located in the unchannelled valley bottom wetland.

wetland through a distinct increase in clay and organic matter content identified within the A horizon (Photograph 2). Plinthic soils are characterized by their susceptibility to prolonged seasonal wetness due to a fluctuating water table, which creates reducing redox conditions that are expressed as mottles and sometimes Iron (Fe) and Manganese (Mn) concretions. Plinthic soils were also identified as part of isolated hillslope seepage wetlands in the north-eastern area of the study site.

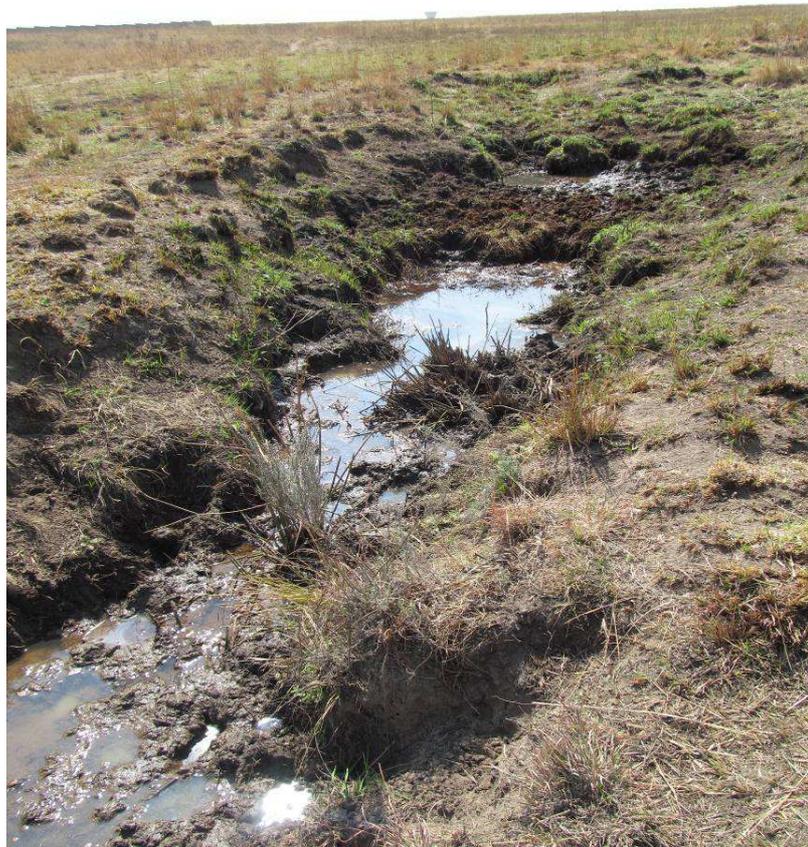
Photograph 3: Wet channel located within a hillslope seepage wetland, thought to be associated with a leaking pipe.

For an area to be considered a wetland, redoximorphic features must be present within the upper 500mm of the soil profile (Collins, 2005). Redoximorphic features are the result of the reduction, translocation and oxidation (precipitation) of iron and manganese oxides that occur when soils are saturated for sufficiently long periods of time to become anaerobic. Only once soils within 500mm of the surface display these redoximorphic features can the soils be considered to be hydric (wetland) soils. According to the DWAF (2005), soil wetness indicators (i.e. identification of redoximorphic features) are the most important indicator of wetland occurrence due to the fact that soil wetness indicators (redoximorphic features) remain in wetland soils, even if they are degraded or desiccated. It is important to note that the presence or absence of redoximorphic features within the upper 500mm of the soil profile alone is sufficient to identify the soil as being hydric (a wetland soil), or non-hydric (non-wetland soil) (Collins, 2005). Redoximorphic features were therefore utilised as a key factor during the current study to classify soils as terrestrial or hydric since there were several boundary soil forms classified (Photograph 3).

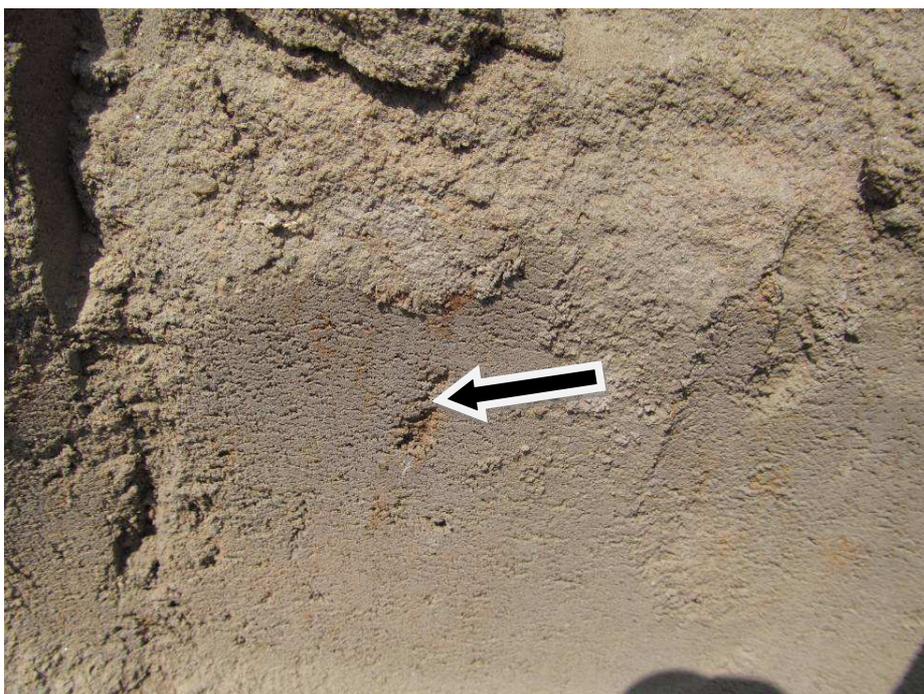
Photograph 4: Redoximorphic features identified in the wetland areas.

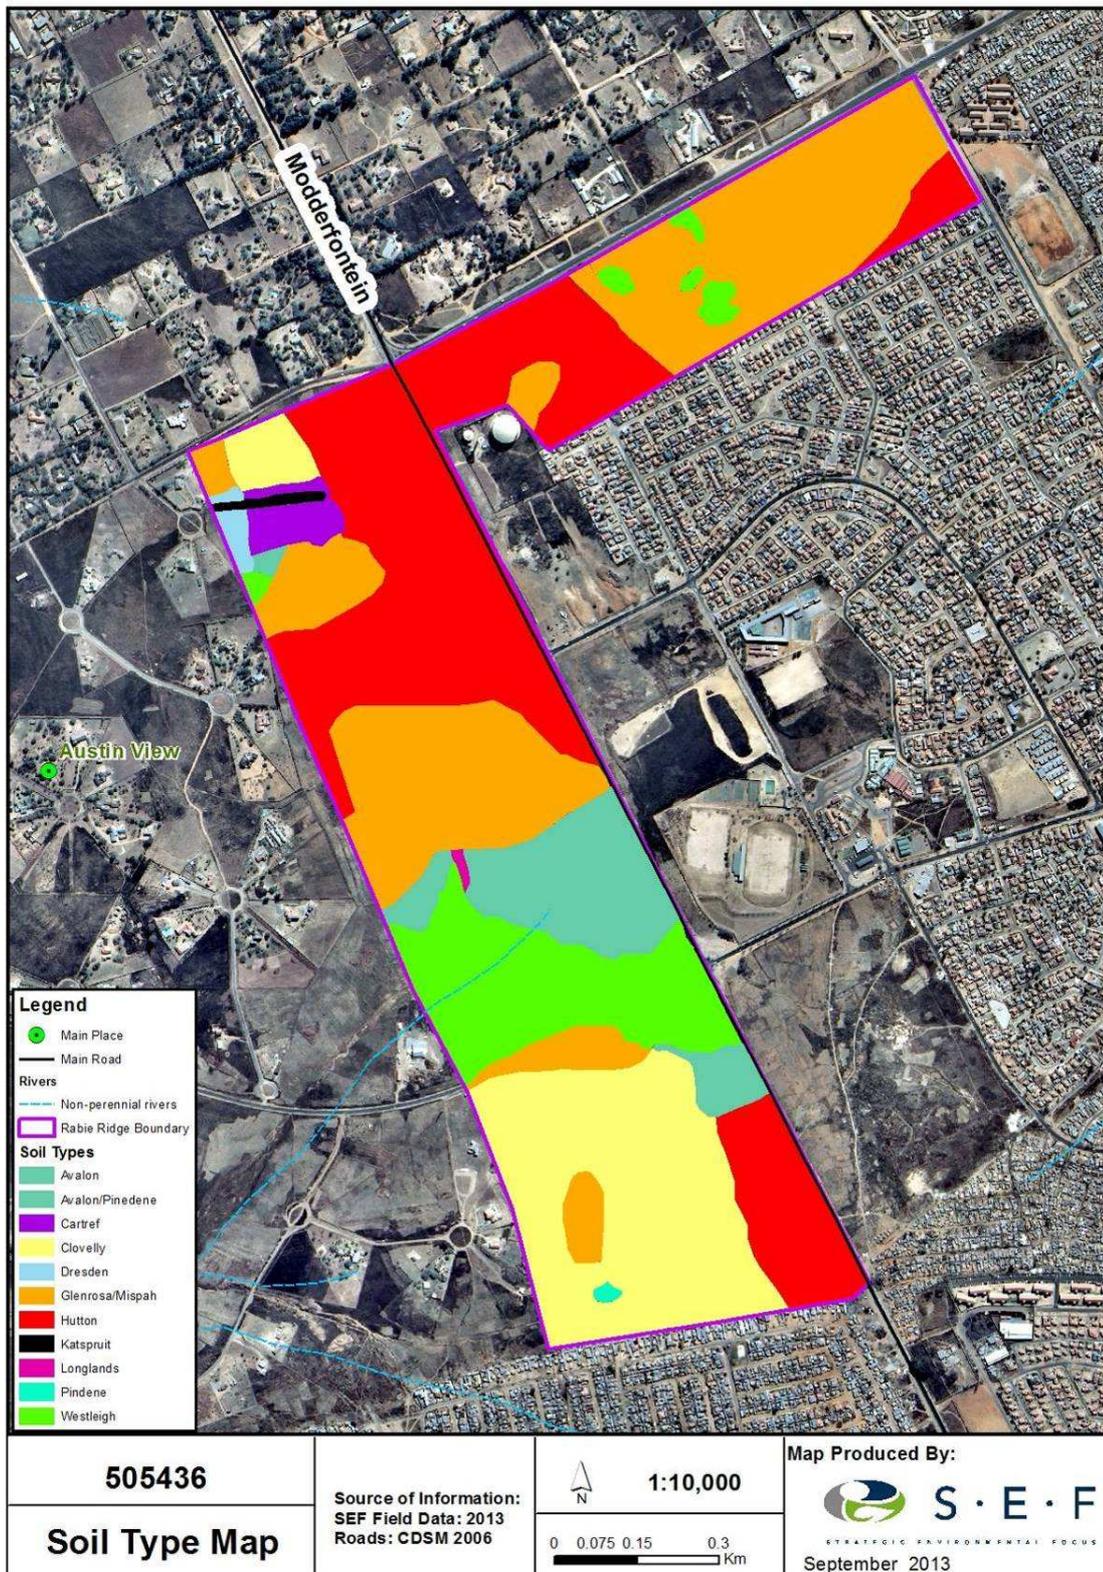
Figure 2: Soil forms identified within the study area

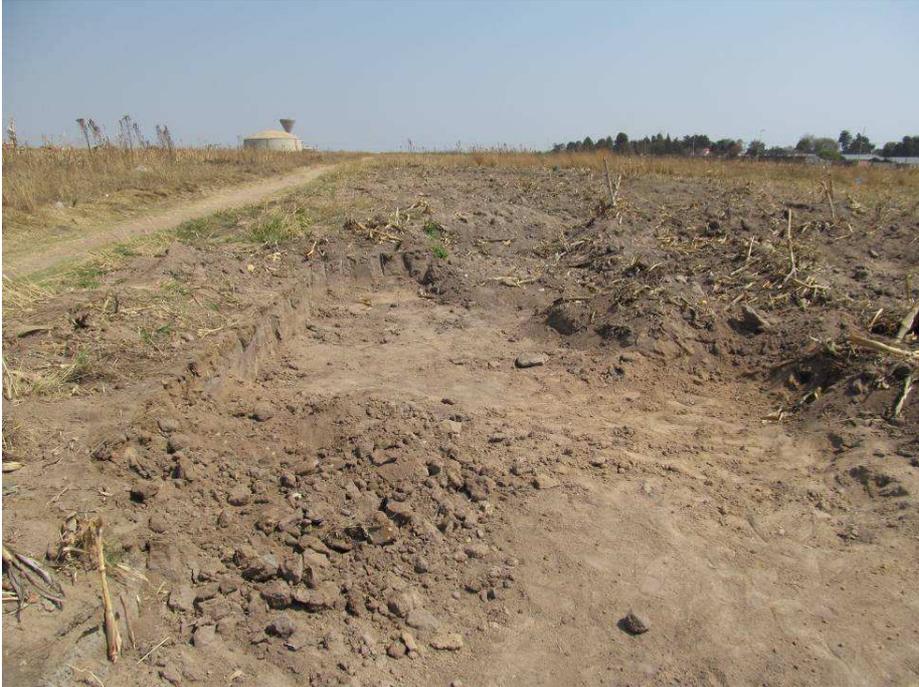
Photograph 5: Large parts of the study area cleared of all hydric and non-hydric vegetation for the cultivation of maize.

Due to successive years of cultivation of maize and associated ongoing practices such as tilling, the disturbed nature of the vegetation on site did not clearly indicate wetland zonation, especially in the hillslope seepage areas (Photograph 4). The majority of hydrophilic vegetation was located within the valley bottom wetland system, which had permanent, seasonal and temporary zones of wetness. The hillslope seepage wetlands were associated with the temporary zones of wetness. Plant species associated with the permanent zone of wetness within the valley bottom wetland were *Persicaria* species (Knotweed / Snakeroot) and the graminoids *Leersia hexandra*, *Eragrostis plana* (Tough Love Grass), *Paspalum dilatatum* (Dallis Grass), *Agrostis lachnanta* (Bent Grass) and *Setaria pallida-fusca* (Garden Bristle Grass). The permanent and seasonal zones included most of the above mentioned species as well as the graminoid *Sporobolus festivus* (Red Dropseed) and indigenous herbaceous plants such as *Senecio serratulooides*, *S. inaequidens* (Canary weed) and *Lobelia erinus* (Wild lobelia). The hillslope seepage wetlands which were associated with the temporary zones of wetness had no obligate wetland species present.

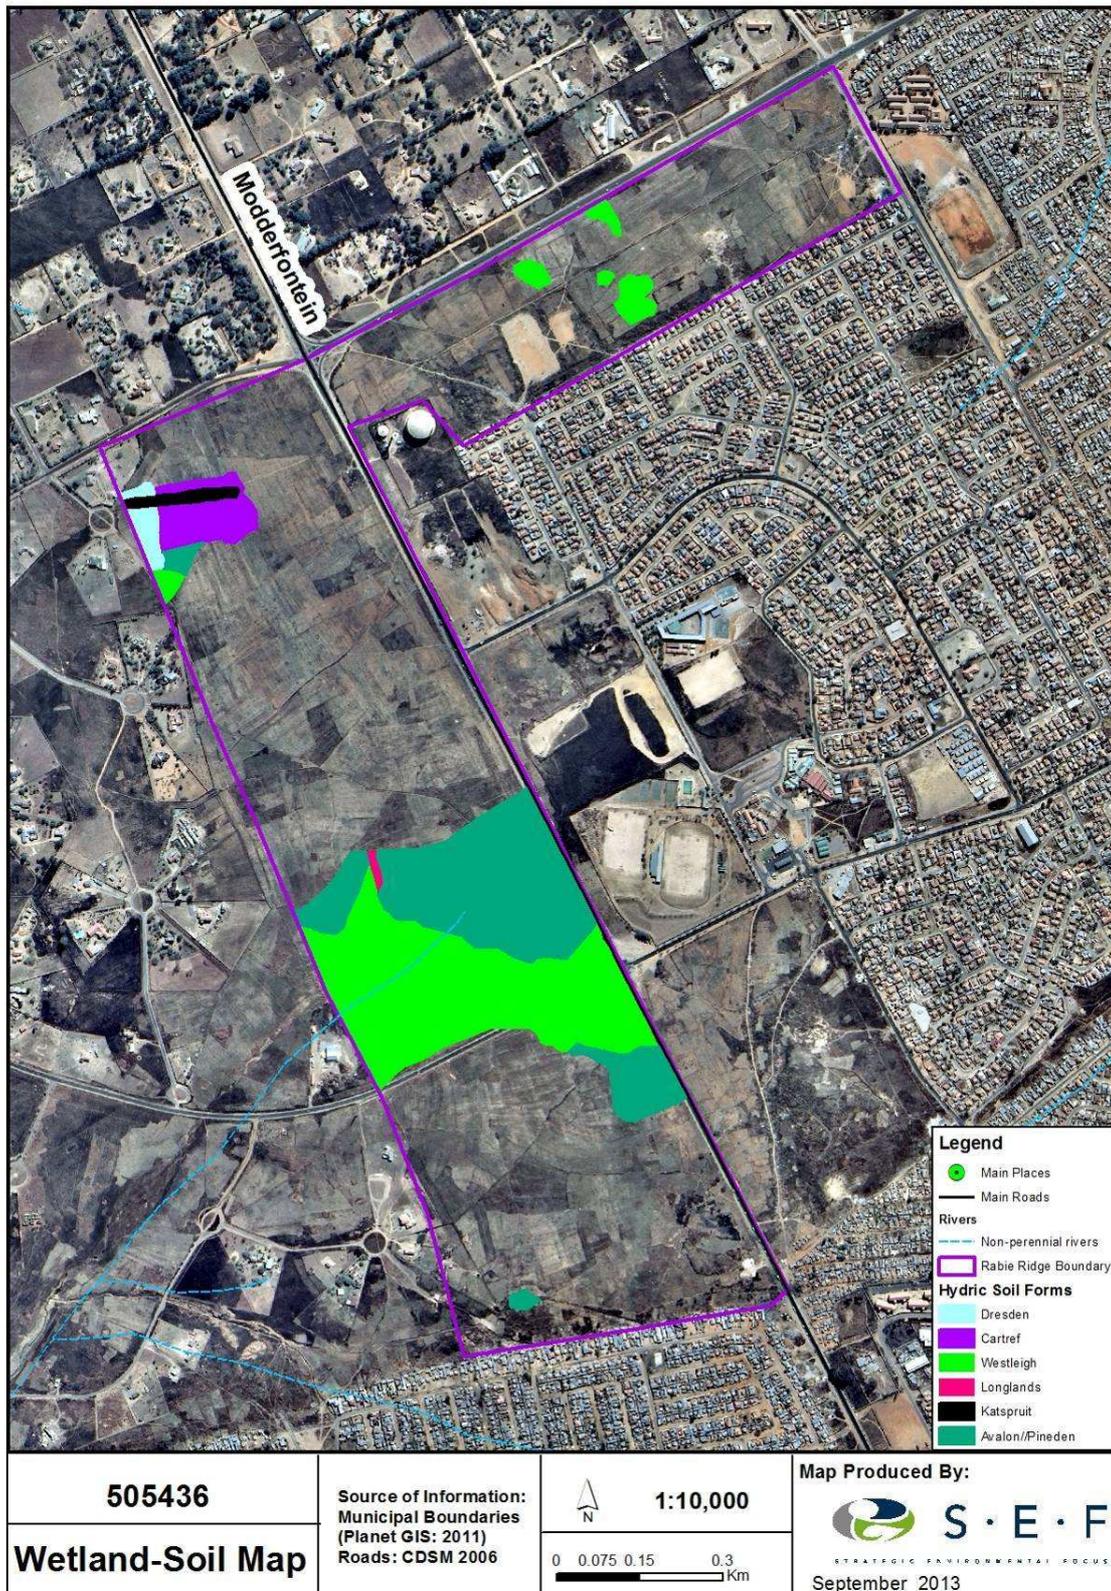
Figure 3: Wetland (hydic) soils identified in the study area

The unchannelled valley bottom wetland and hillslope seepage wetlands which include isolated hillslope seepage wetlands and hillslope seepages which feed into a watercourse, were divided into HGM units according to hydric soil types in order to afford more accurate description of functional potential and mitigation measures, presented graphically in Figure 3 and Figure 4.

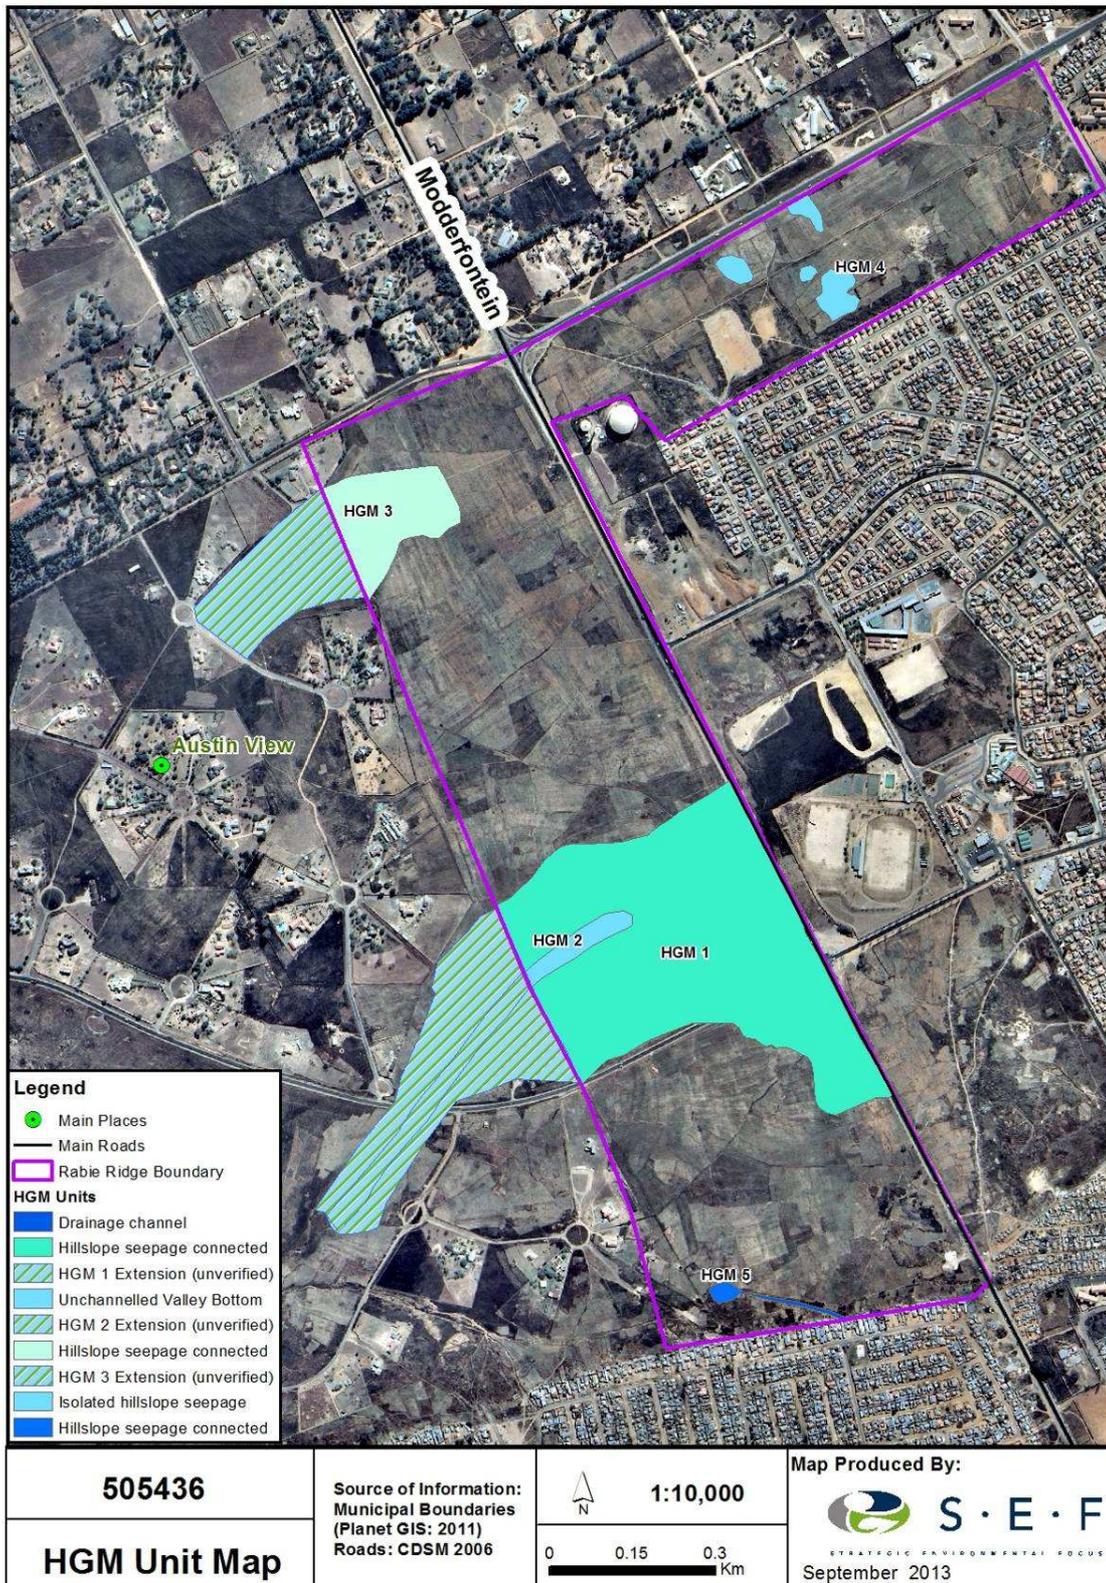
Figure 4: HGM units within the study boundary.

Degradation of wetlands through impacts in catchments or in wetlands themselves has, and continues to result in the reduction and loss of their functional effectiveness and ability to deliver ecosystem services or benefits to humans and the environment (Kotze *et al.*, 2008). The HGM units are discussed in more detail in terms of their functional benefits, their Present Ecological Score and the impacts which affect these. The HGM Units are further displayed in Figure 4.

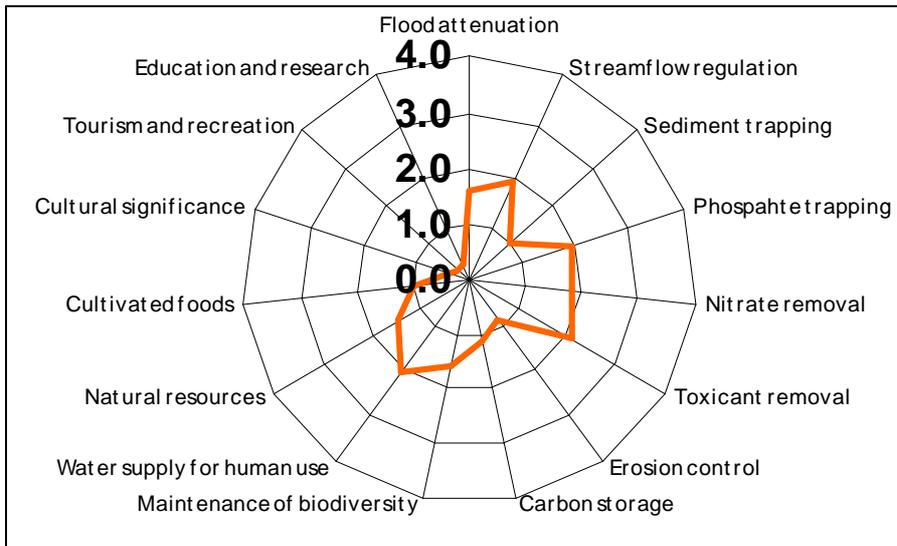
Figure 5: Wetland functionality of the hillslope seepage wetlands connected to a watercourse (SEF, 2010).

A functional assessment of the wetlands was conducted during the previous study (SEF, 2010) using the Wet-EcoServices method. This method showed that the hillslope seepage wetlands connected to a watercourse and the unchannelled valley bottom wetland do perform a number of functions relating to maintenance of biodiversity, water supply, stream flow regulation, sediment trapping, and toxicant and nitrate removal (Figure 5 and Figure 6). The isolated hillslope seepage wetlands (Figure 7) however received low functional scores due to their severely modified nature as a result of farming practices, and the associated tillage on the land, which is leading to the desiccation of these systems. In order to gauge the Present Ecological Status of the wetlands for this assessment a WET-Health Level 2 field assessment was conducted during this assessment. This method was used to identify the wetlands abilities to contribute to ecosystem services within the study area in relation to a benchmark or reference condition.

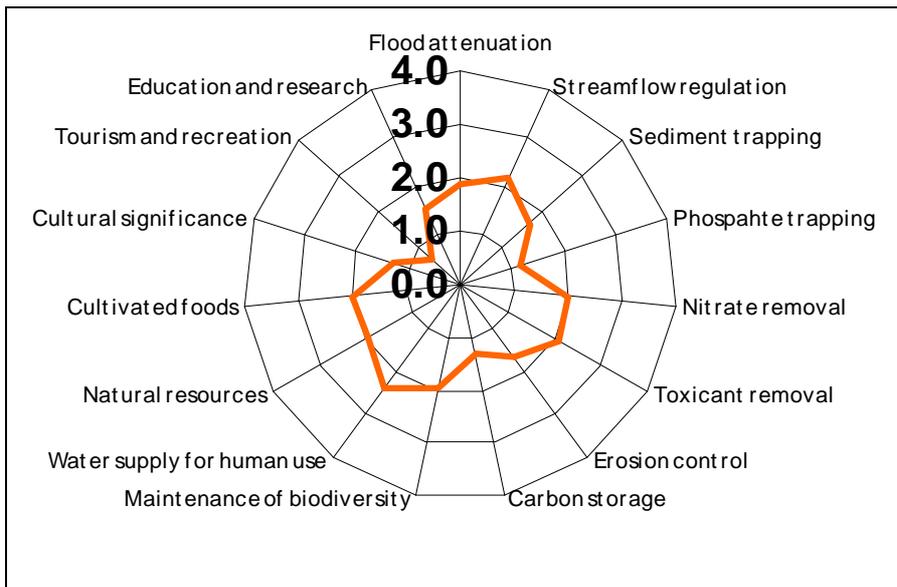
Figure 6: Wetland functionality of the unchannelled valley bottom wetland (SEF, 2010).

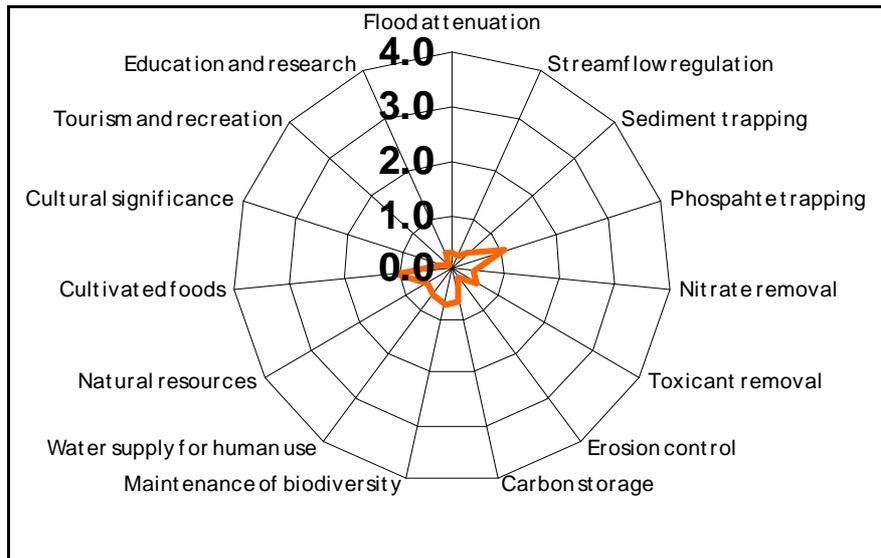
Figure 7: Wetland functionality of the isolated hillslope seepage wetlands (SEF, 2010).

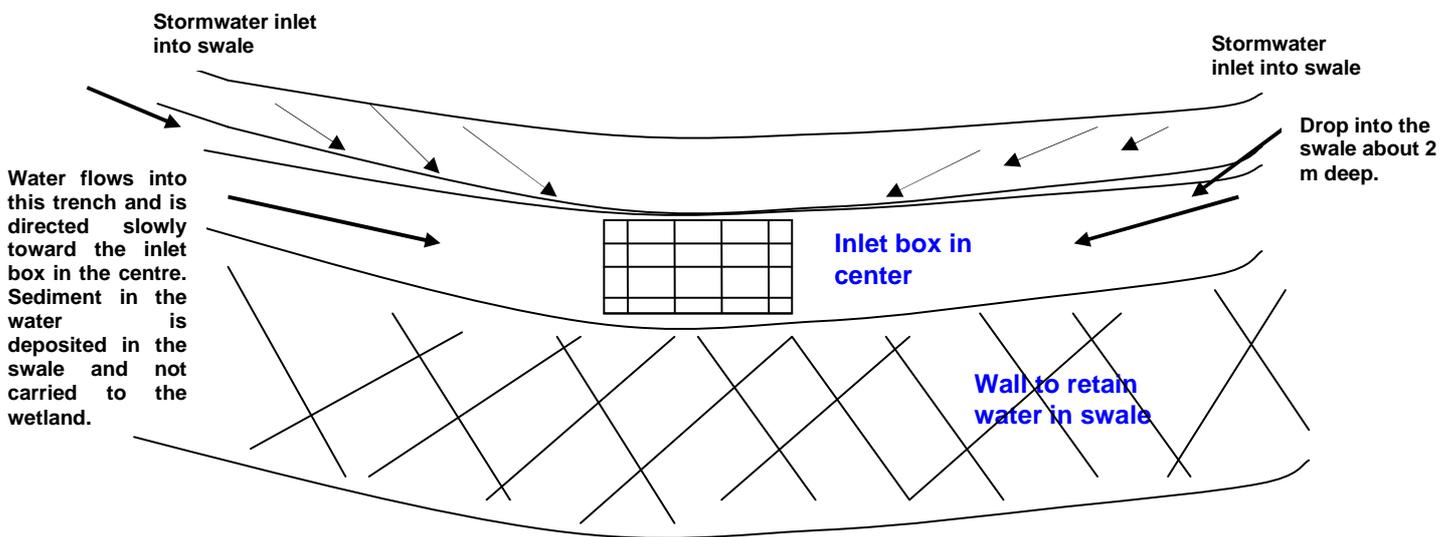
Figure 8: Top view of an example of a swale system.

Swales and attenuation facilities are to be installed along the outer edge of the buffer area of the hillslope seepage wetlands (HGM 1 and HGM 3). The attenuation facility should retain stormwater runoff and then allow the water to diffuse into the wetland at a slower velocity through diffuse release infrastructure, simulating predevelopment geo-hydrological patterns in the catchment. These should help limit further erosion processes from being initiated along the hillslope seepage wetlands, allow for sediment deposition within the swales, re-distribute water more evenly within the seepage areas and eventually re-wet the desiccated wetlands. The higher moisture regime within these seepage wetlands will also subsequently increase the vegetation cover leading to further ecosystem service benefits. A sketch diagram is shown in Figure 8 and Figure 9 as an example of the attenuation and diffuse release infrastructure proposed to be installed along the hillslope seepage wetlands. The stormwater can enter the swale where it will be attenuated and sediment allowed to be deposited. The water will then flow into an inlet box where it can drain out of the swale and into a channel. This channel needs to be separated to divert the flow of water as shown in Figure 6, to evenly spread the water toward the buffer zone (width to be determined in detailed design phase) and wetland. Adjacent to the wetland buffer zone, a 1-2m trench needs to be dug and filled with rock and pebble material to diffuse the release of water. Once water enters this channel it can then infiltrate into the sandy soil profiles found along the hillslope seepage wetlands. This will facilitate the movement of water evenly through the buffer areas and eventually into the hillslope seeps. It should be noted however that the above description of the diffuse release infrastructure is only conceptual and should be appropriately designed by a suitably qualified engineer in collaboration with a wetland specialist.

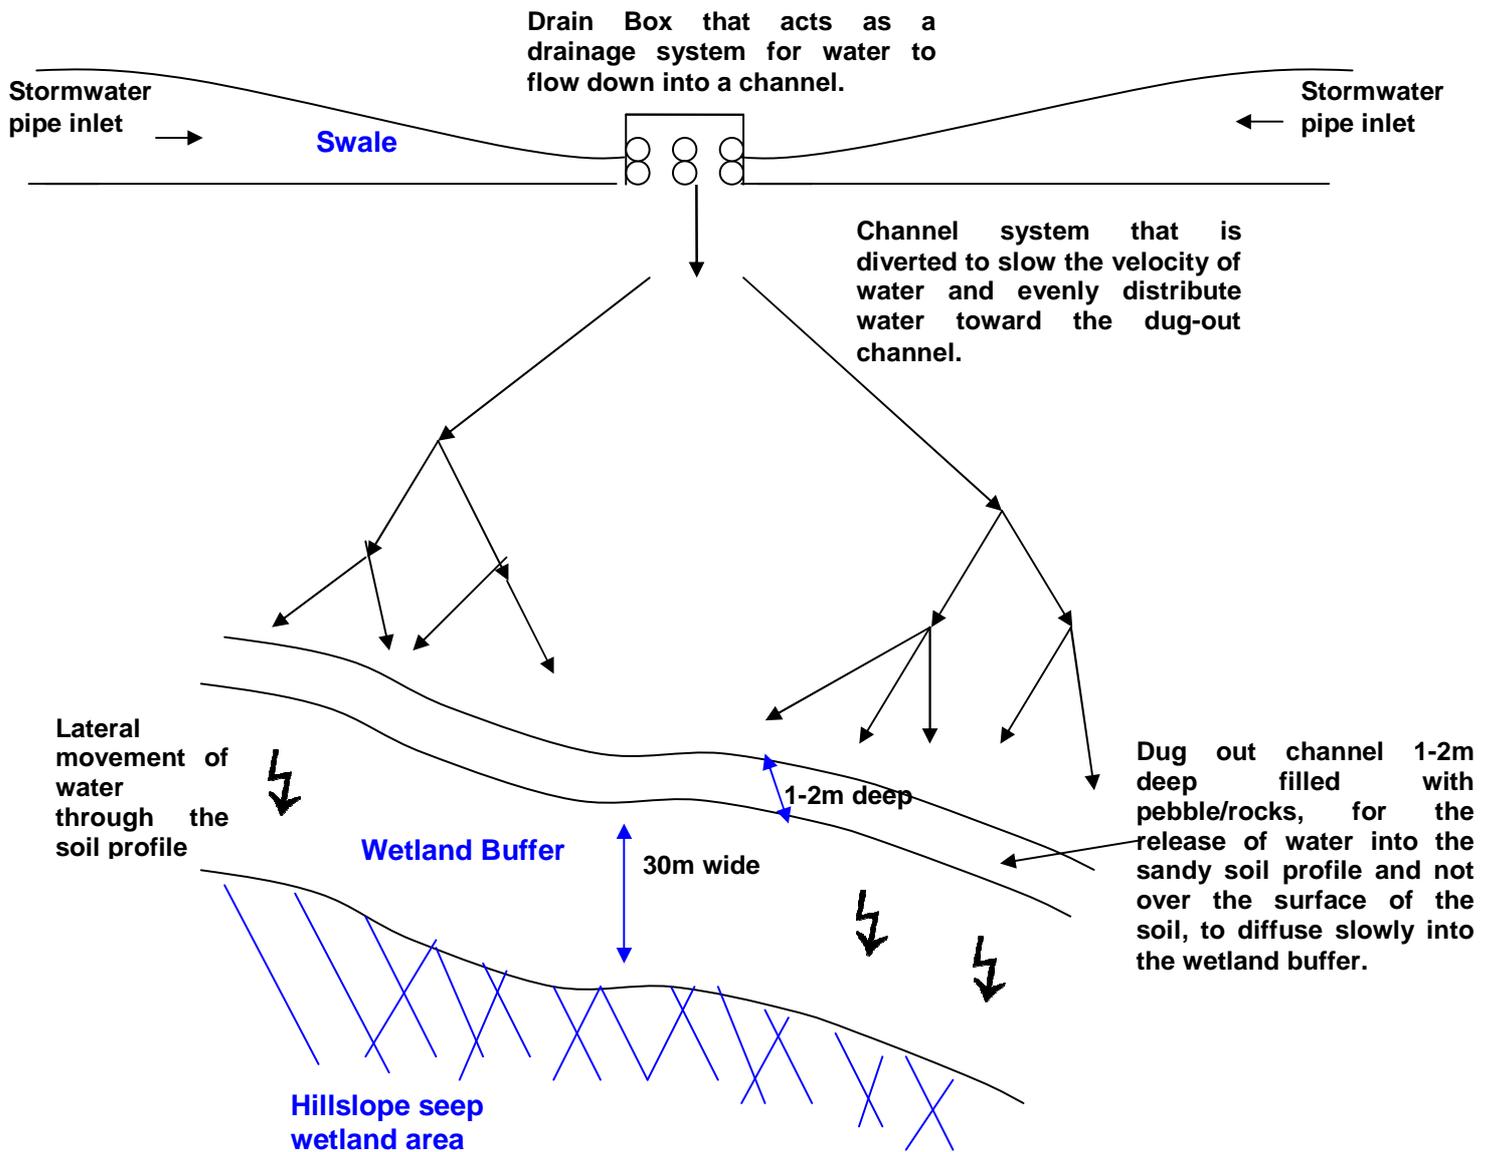
Figure 9: Side view of an example of a swale and associated drainage into wetland buffer.

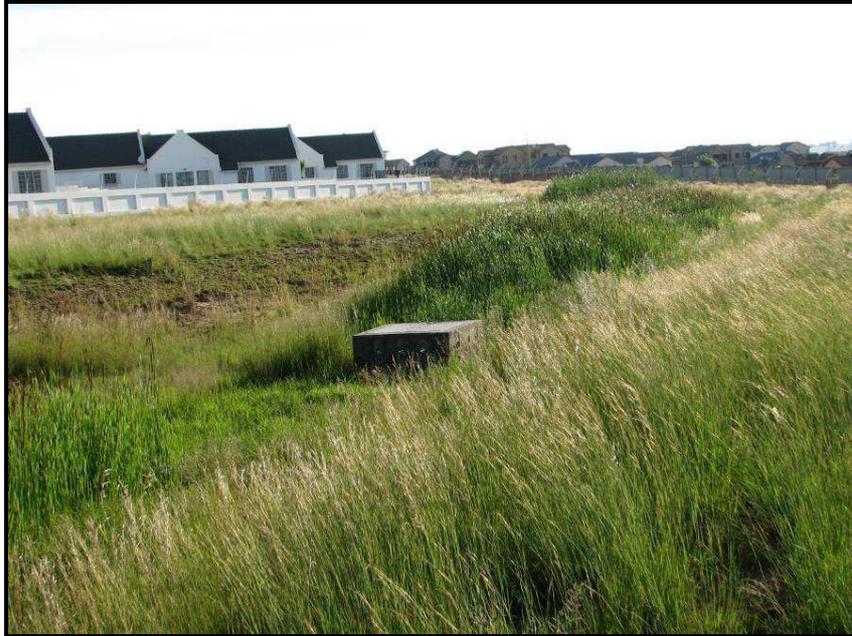
Photograph 6: Example of a swale being used in another development. This swale has been in operation for approximately 5 years and became vegetated within the first year of operation.

The above mentioned swale designs have been used in other development areas and examples of these are shown in Photograph 6 and Photograph 7. These swales and attenuation facilities could be used in the proximity of the wetlands where soft engineering techniques are favourable (whereas deep vertical basins through hard engineering could be utilised within the development footprint, saving on developable space). Each catchment segment should cater for its own stormwater attenuation generated per area, following a hierarchy of release principles developed according to the attenuation facilities catchment size and its position in the landscape relative to the position of the hillslope seepage wetland in order to ensure the longest possible release period

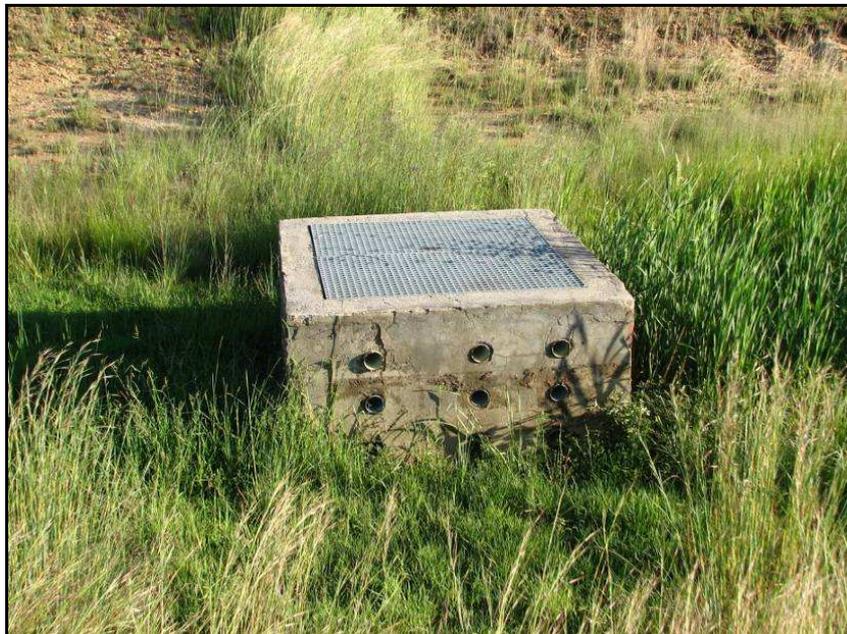
Photograph 7: Example of a drain box used in the swale above. Water drains into this box and then flows out of the swale in a controlled manner. The design of this swale also helps the deposition of sediment out of the stormwater before it enters the wetland system.

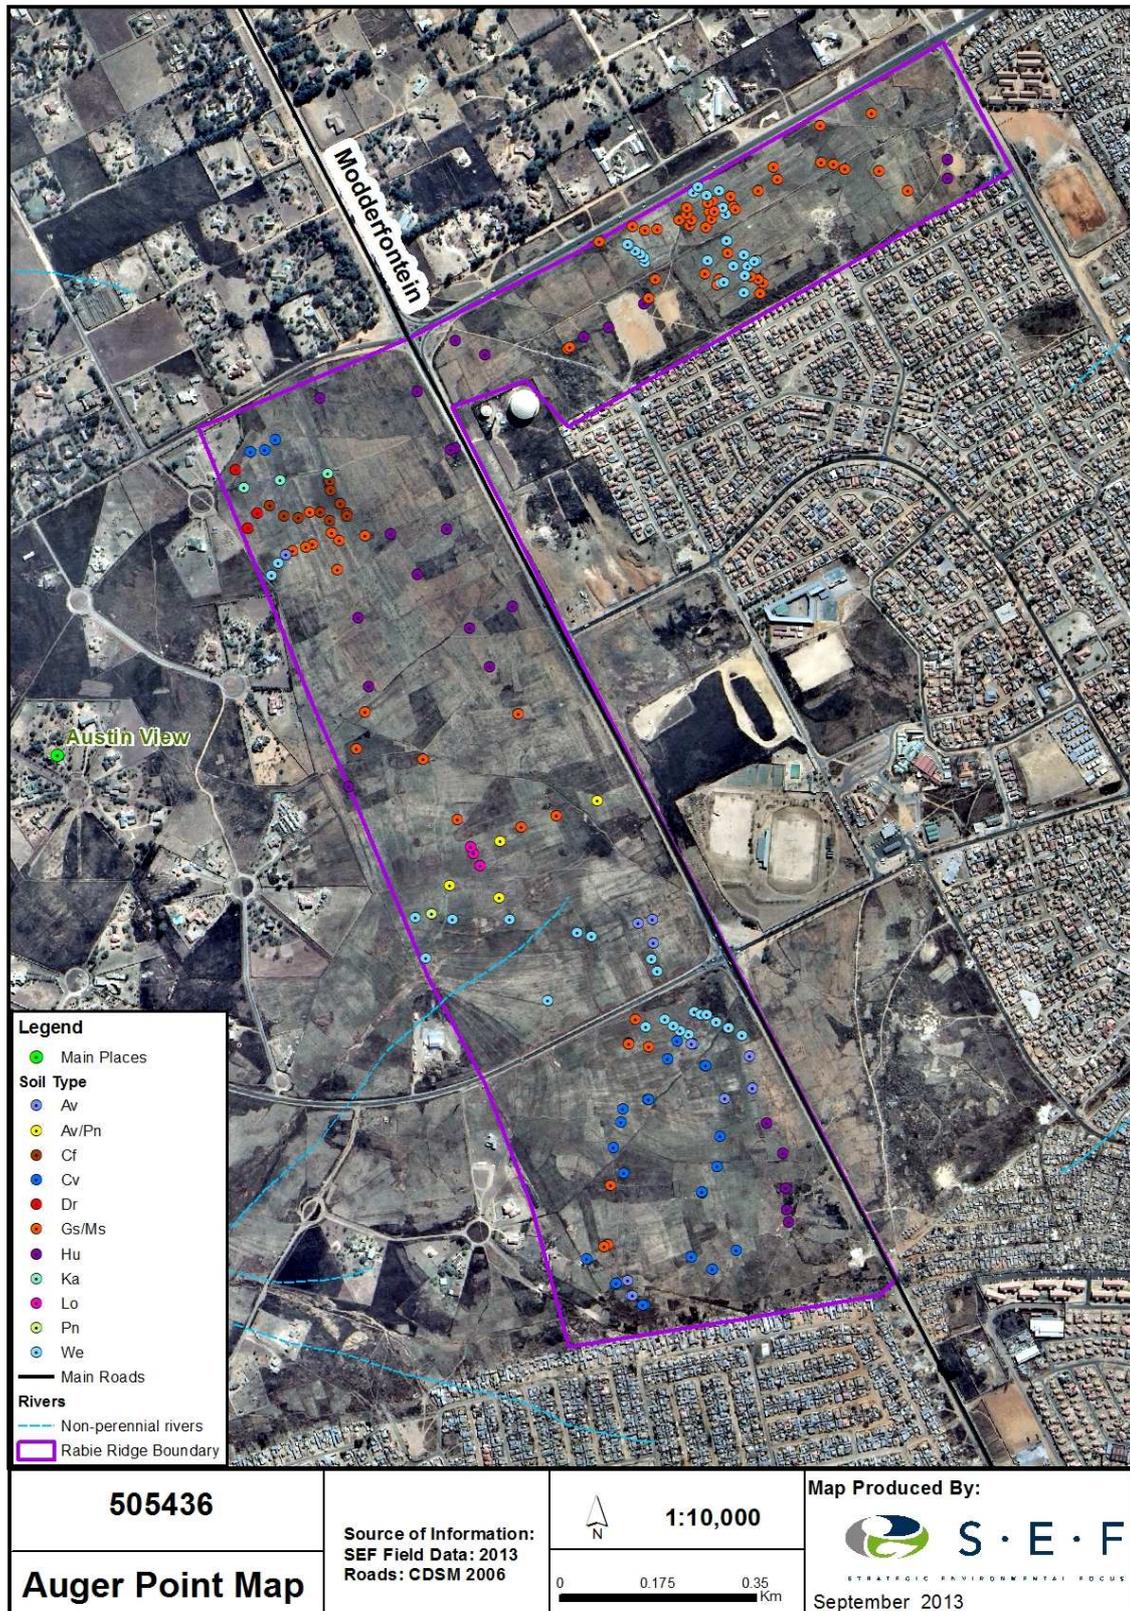
Figure 10: Auger points used to identify soil types.

location captured on a hand-held GPS. The GPS points were then used to compile a detailed soil map, where uniform soil patterns were grouped into map units, with respect to observed characteristics. Augering points made during the current study are shown in Figure 10.
