**Biological colonization on majolica glazed tiles:  
biodeterioration, bioreceptivity and  
mitigation strategies**

Dissertação para obtenção do Grau de Doutor em Conservação e Restauro,  
especialidade Ciências da Conservação

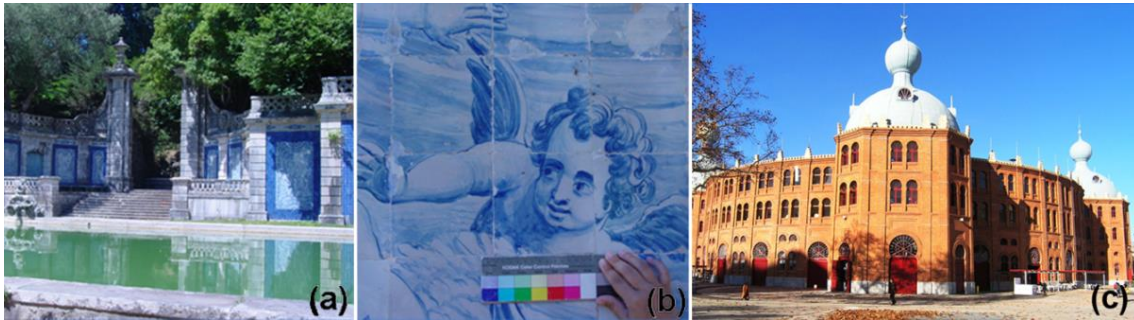
**Fig. 2.1** Ceramic building materials in Portuguese assets: (a) wall tile panels illustrating the aesthetical ornamentation of a garden belonging to a historical building, *Casa da Pesca*, in Oeiras; (b) detail of the 18th century glazed tiles with iconographic illustration from *Casa da Pesca*, Oeiras; (c) bullfight arena in Lisbon (in Portuguese: *Praça de Touros do Campo Pequeno*) built with bricks in the last decade of the 19th century.

Architectural ceramics as building materials are used in the construction of architectural work being applied in masonry, roofing, cladding and ornamentation. Buildings and monuments with ceramic elements, whether in the form of bricks, wall and roofing tiles, architectural statuary or floor tiles can be found throughout the world. This work deals with the biological colonization and biodeterioration of architectural ceramic materials, more specifically, traditional ceramics (clay-based) such as, bricks, roofing and wall tiles. Utilitarian ceramic objects and technical ceramics are not considered. A significant number of architectural ceramic materials are part of our cultural heritage and therefore ought to be preserved since they have historical and artistic value. Fig. 2.1 illustrates examples of glazed wall tiles and bricks on historical buildings from Portugal.

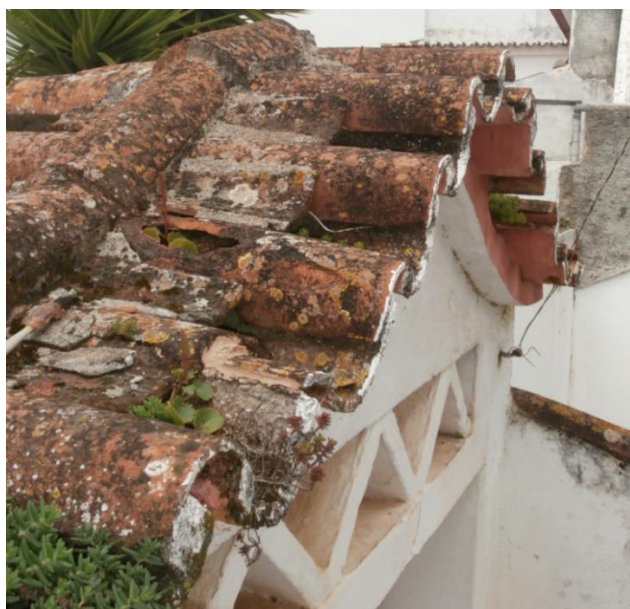
**Fig. 2.5.** Biological colonization of roofing tiles from a house in Alentejo region (south of Portugal).

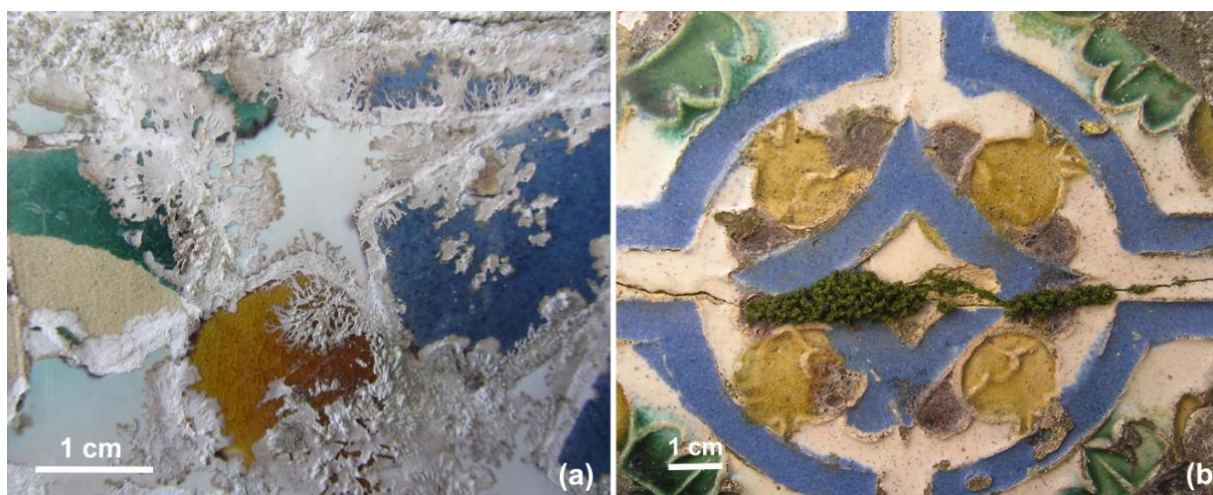
**Fig. 2.6** Biological colonization of glazed wall tiles from the Sintra National Palace (Portugal). (a) Colonization by lichens. (b) Colonization by bryophytes through a fracture of the ceramic body.

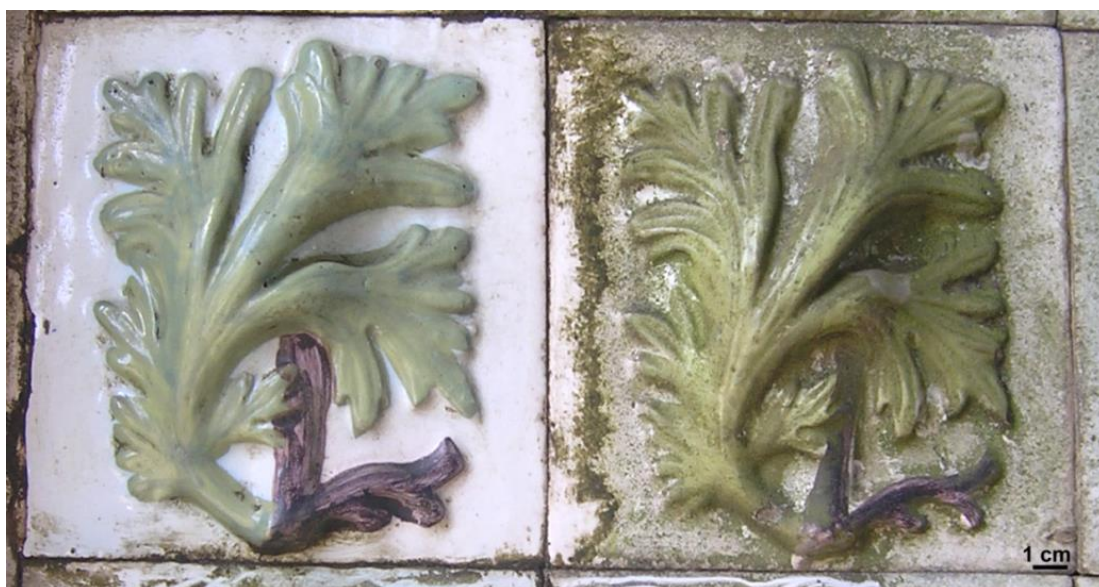
**Fig. 2.7** Glazed wall tiles from Pena National Palace in Sintra (Portugal) showing a tile after the biofilm removal (on the left) and a tile covered by the green/black biofilm (on the right).

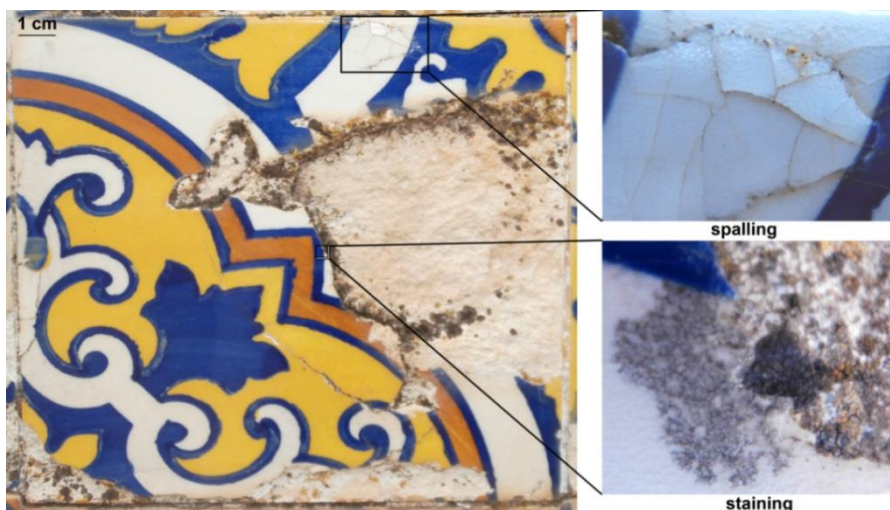
**Fig. 2.8** Biological colonization of glazed wall tiles from private house in the Alentejo district (Portugal) by lichens and a black biofilm with details in macrophotography of the spalling and staining of the glaze.

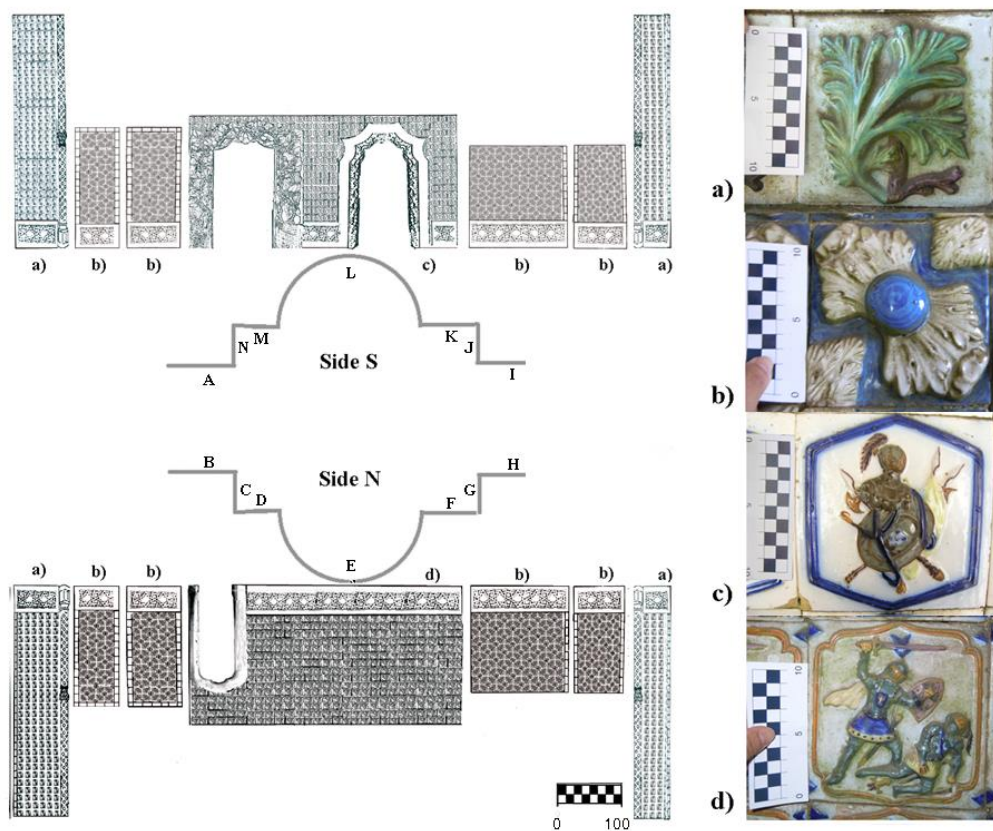
**Fig. 3.1** Scheme of the Triton tunnel passageway with the locations of the panels (A-N) and their tile motifs (a-d). Bar in cm.

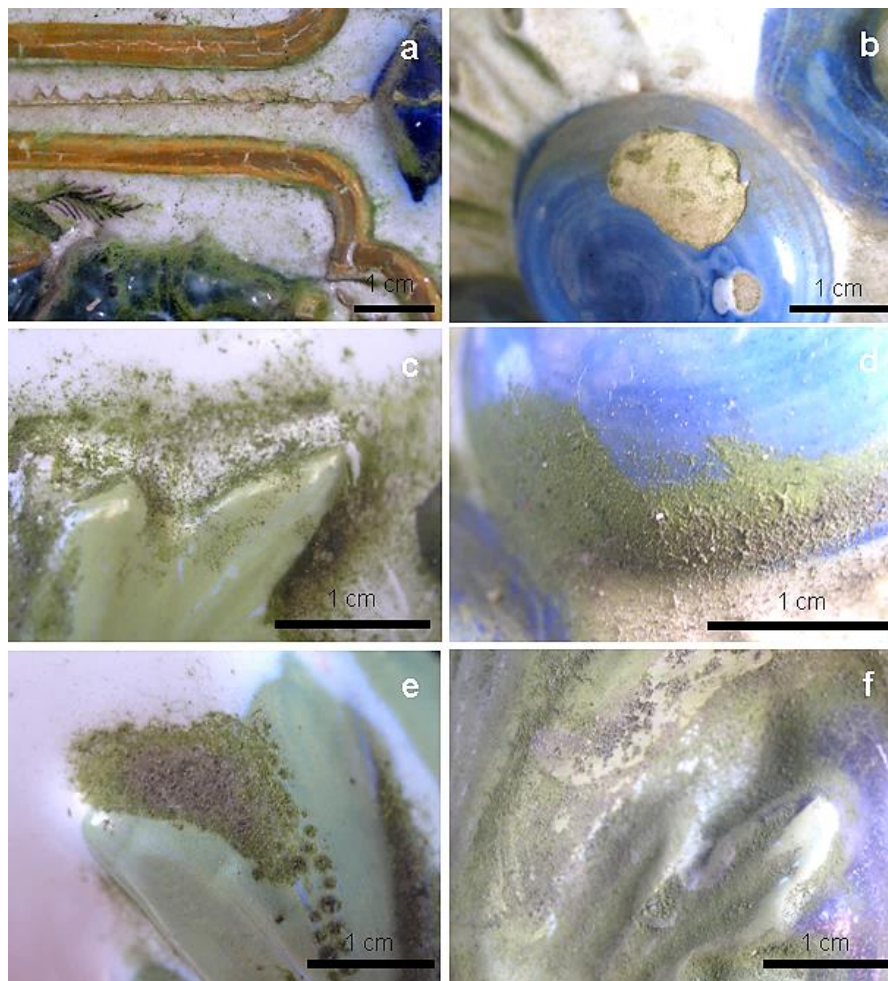
**Fig. 3.2** Detailed image of the decayed tiles. (a) Flaking on the border of a tile. (b) Growth of the biofilm on the ceramic body on a lacuna. (c-f) Preferential growth on the depression areas where green biofilms and airborne particles accumulate.

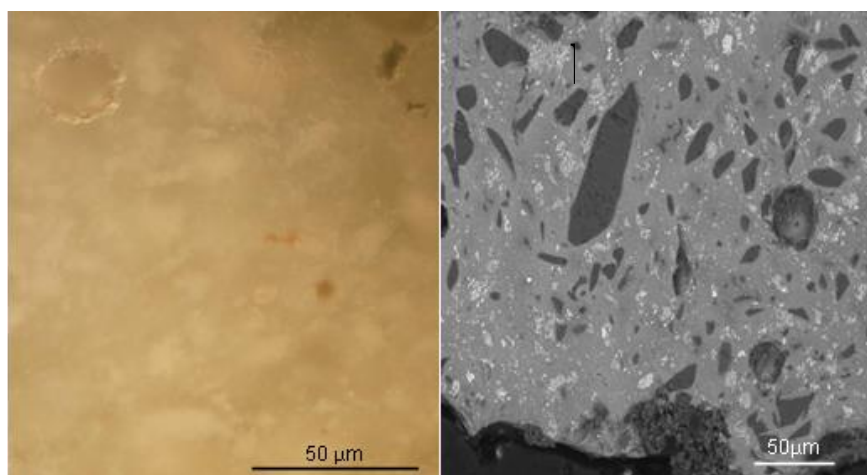
**Fig. 3.3** White glaze cross-section of sample W: (a) observed under optical microscope with white tin oxide crystals distributed on the glassy matrix and (b) backscattered electron image showing several mineral inclusions.

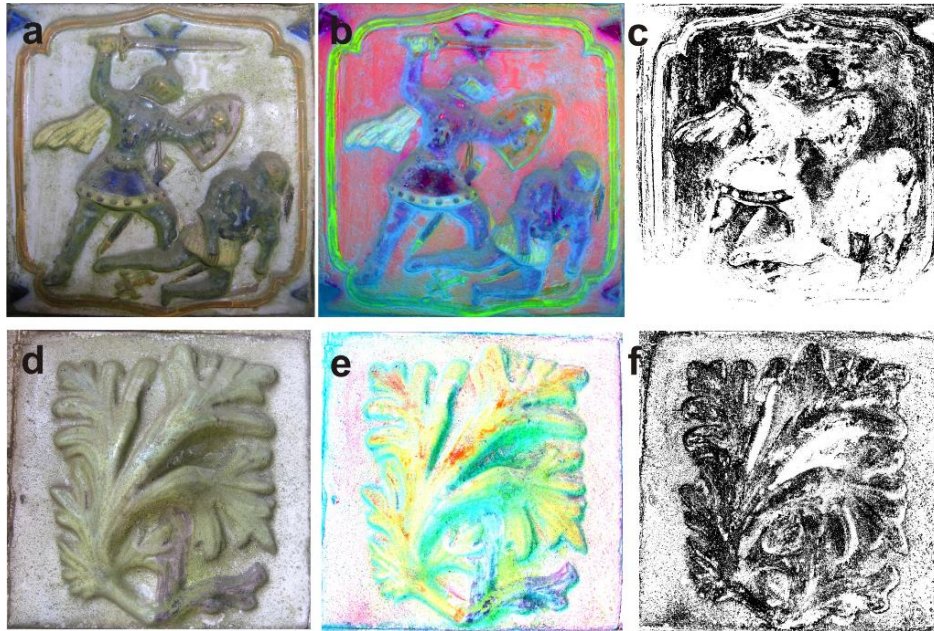
**Fig. 3.4.** Digital image analysis of tile from panel E and H. (a) Original image of one of the glazed tiles of panel E. (b) False-color image obtained from PCA bands. (c) Binary image showing the measured areas. (d) Original image of one glazed tile of panel H. (e) Result of the subtraction of pixel values of two false-color images from PCA bands. (f) Binary image showing the measured areas.

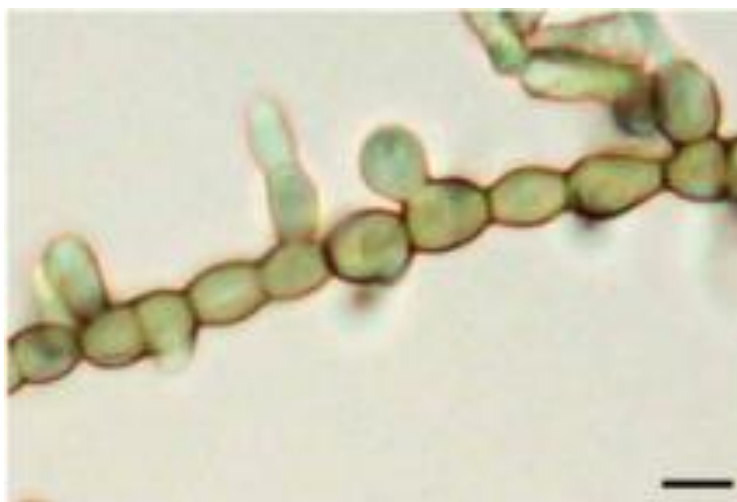
**Fig. 3.6.** Microscopic detail of *Deveresia imbrexigena* Branched chain of arthroconidia, buds developing on the chain of arthroconidia Scale bars = 5  $\mu$ m (Crous et al., 2012).

achieved with the LSU region the morphological features were distinct. Therefore, these sequences clearly represented previously unknown species. The species correspondent to those isolates were primarily distinguished based on DNA sequence comparisons and analysis of the macro- and micromorphological characteristics, being them described and classified in Crous et al (2012), as a new species named *Deveresia imbrexigena* A.J.L. Phillips & M.L. Coutinho (Accession nr. JX915745-52) (Fig. 3.6).

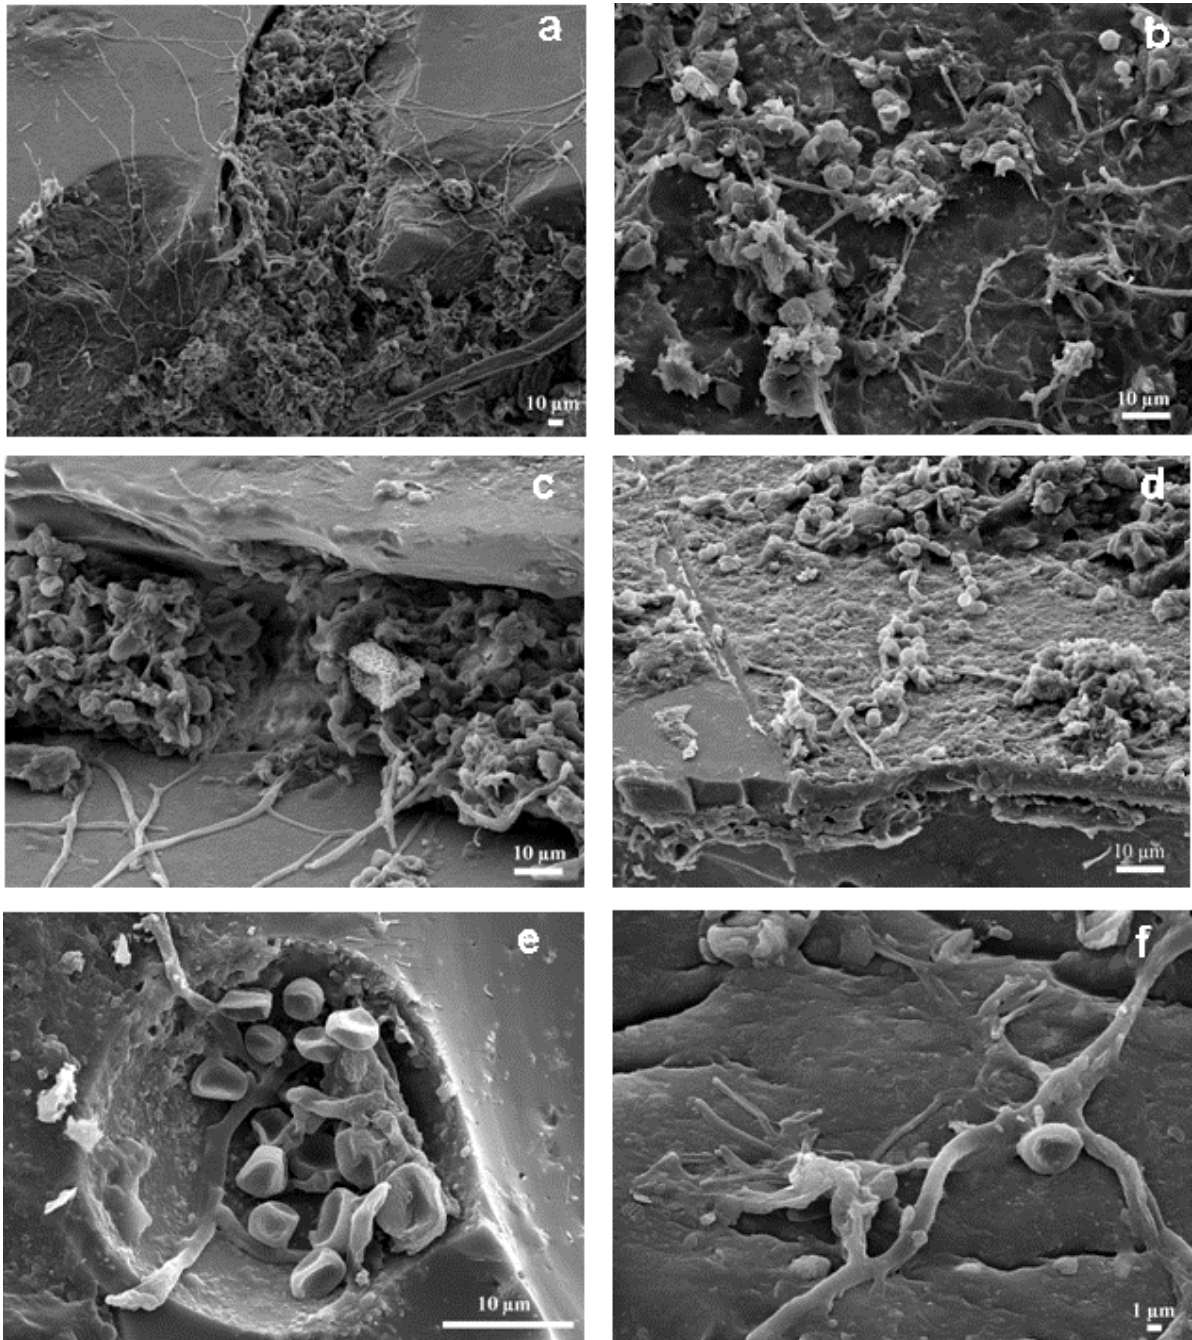
**Fig. 3.9.** FESEM images of biofilm over glaze fragments at different magnifications. (a) Filamentous and unicellular microorganisms can be observed growing on a fracture of the glaze. (b) Surface of the glaze densely colonized. (c) Colonization on a fracture of the glaze. (d) Filaments of moniliform cells compatible with *Nostoc* sp. (e) Filamentous and unicellular microorganisms growing inside a pore or bubble. (f) Microorganisms growing in contact with the substrate.

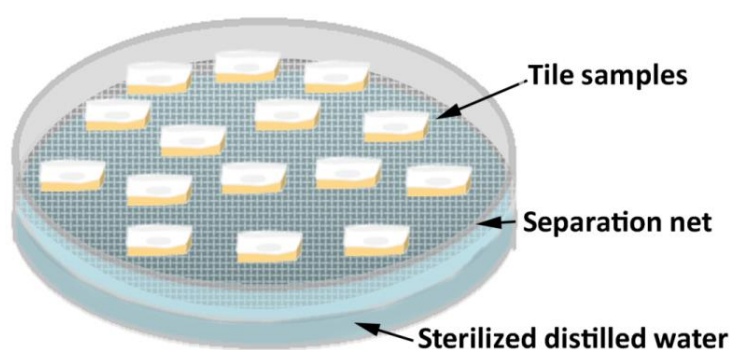
**Fig. 4.1.** Illustration of the experimental set-up. Glass Petri dish ( $\varnothing = 9$  cm) with distilled water at the bottom and a net to separate the water from the glazed tile samples.

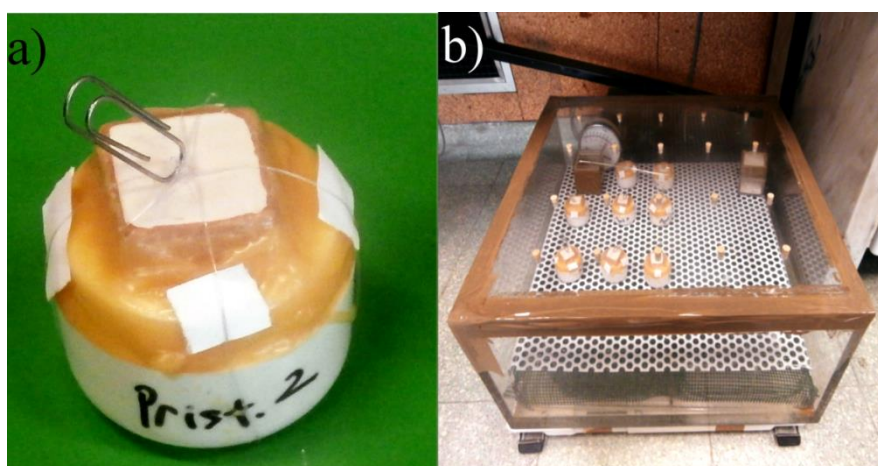
**Fig. 4.3.** Experimental set-up for determination of water vapor permeability, (a) tile sample embedded in wax over a plastic container and (b) chamber used for the experiment with the tile samples inside.

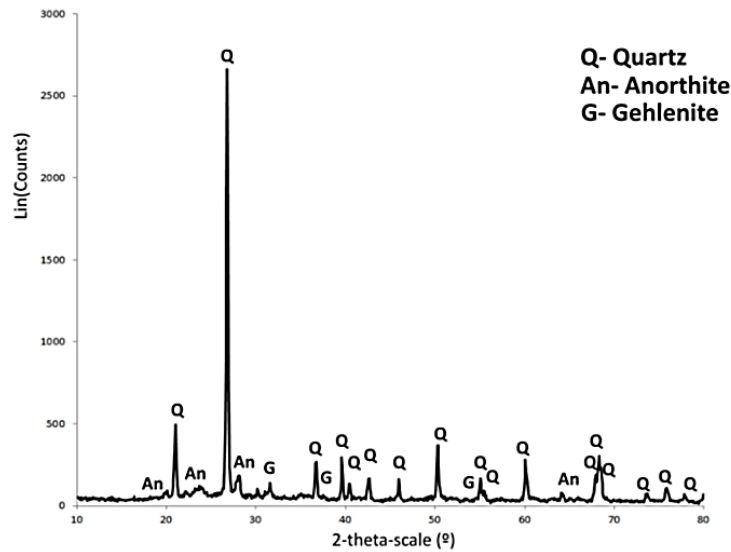
**Fig. 4.4.** Diffractogram obtained by XRD for the fired ceramic body with signalization of the main mineral phases of the tile models.

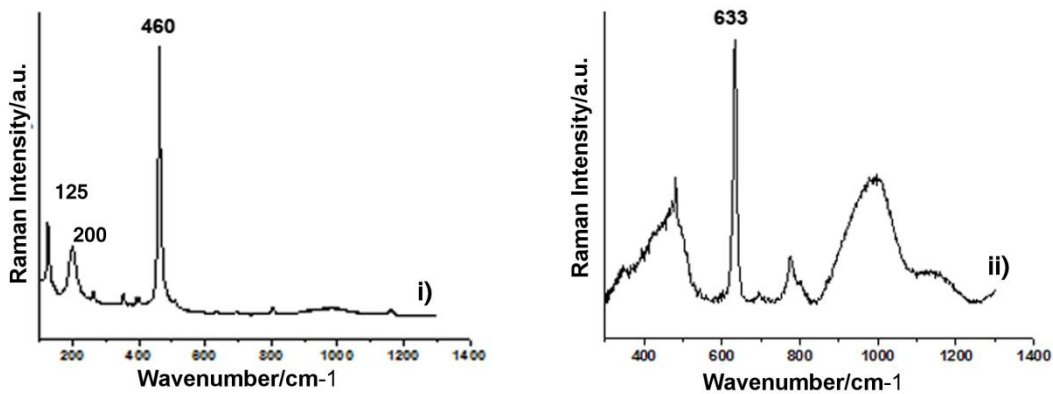
**Fig. 4.5.**  $\mu$ -Raman spectra of (i) quartz and (ii) cassiterite identified on the white glaze of the tile models. Laser excitation 632.8 nm; 100x objective ULWD; laser power was kept at 1 mW.

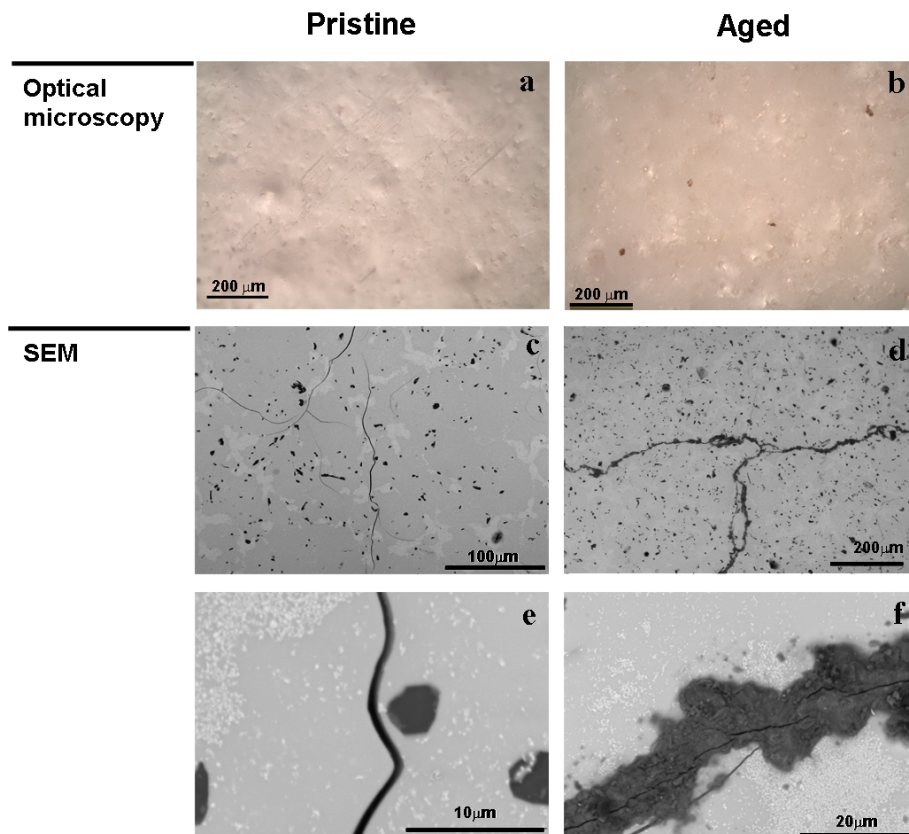
**Fig. 4.6** Microstructure and Surface morphology of representative samples of the pristine and aged glaze tile models before inoculation, observed under optical microscopy (a and b) and two BSE images, one general overview (c and d) and detail of the fissure (e and f).

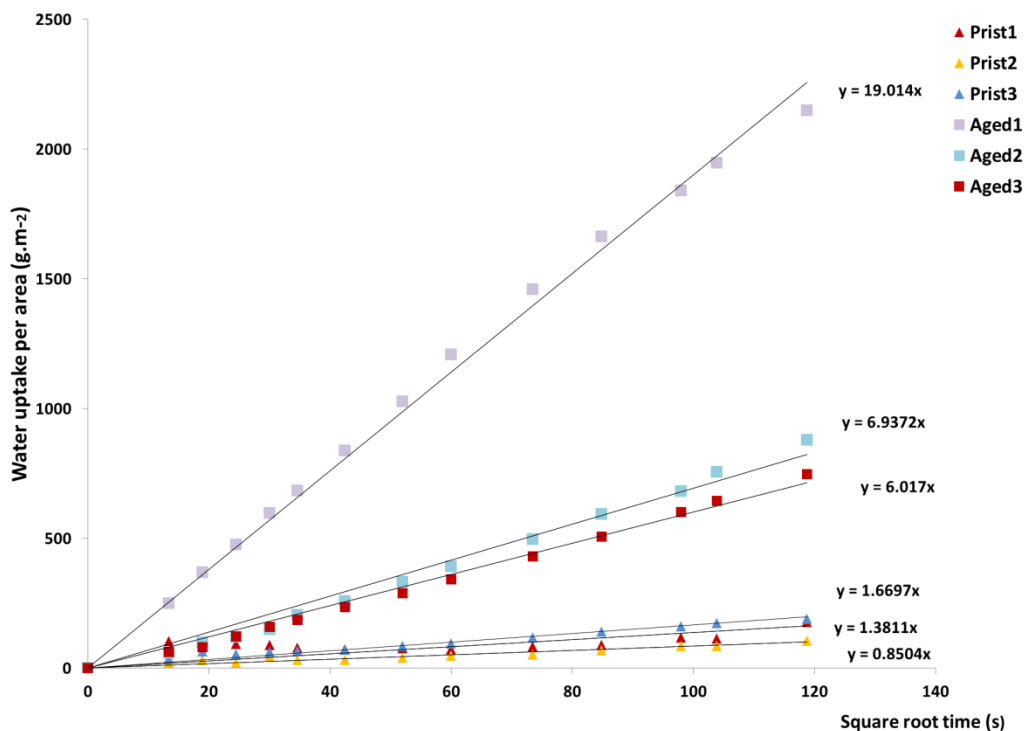
**Fig. 4.7.** Water uptake by capillarity of the pristine (Prist 1-3) and aged (Aged 1-3) tile models through the glaze with linear trendlines and equation with capillarity coefficient value.

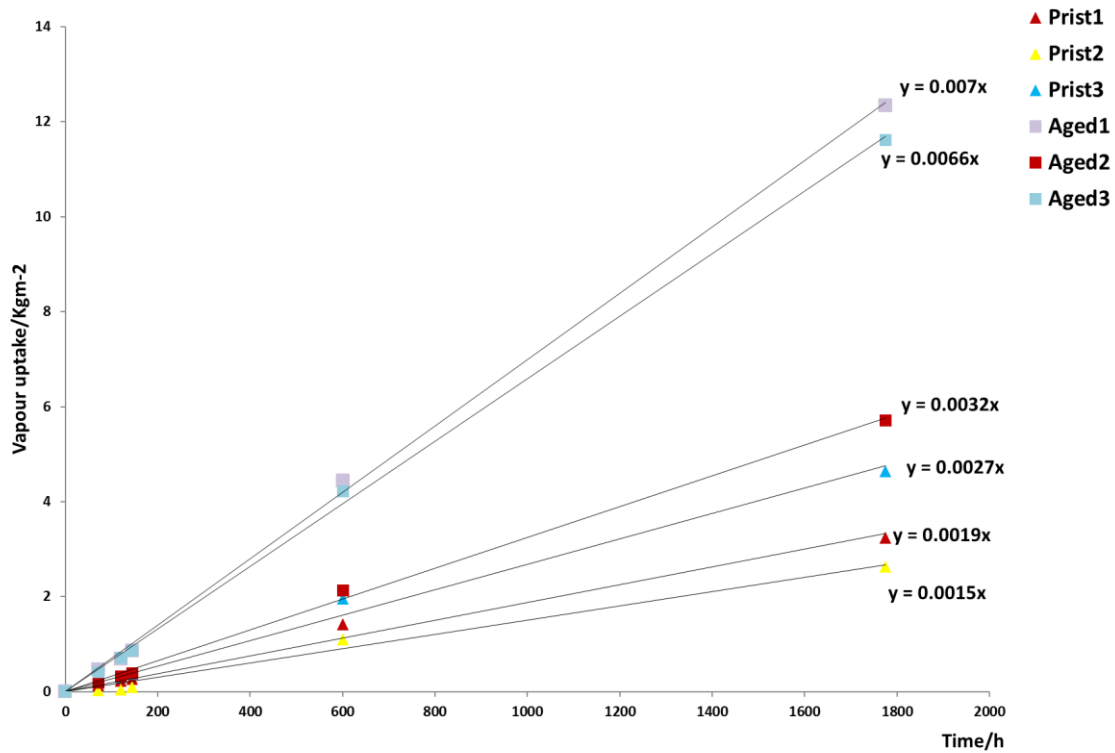
**Fig. 4.8.** Water vapor permeability of pristine (Prist 1-3) and aged(Aged 1-3) tile samples before inoculation with linear trendlines and equation with capillary coefficient values.

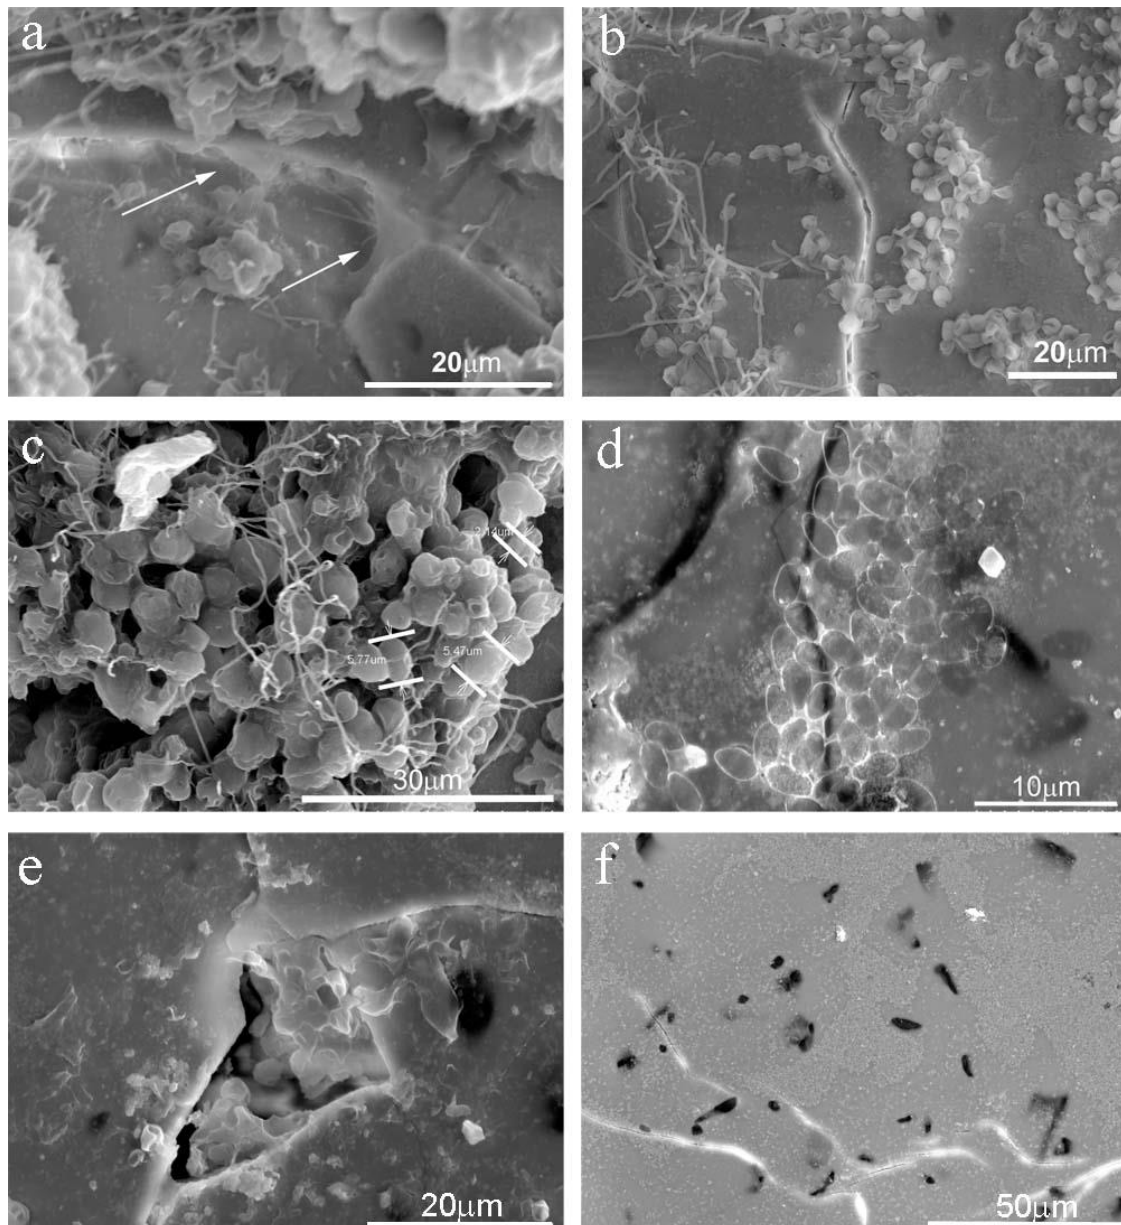
**Fig. 4.12.** SEM images of majolica tile models after inoculation experiments. (a) Growth of microorganisms within a fissure of a pristine model glaze with EPS indicated by arrows. (b) Colonization near a fracture of the aged glaze with penetration EPS into the fracture. (c) oval shapes phototrophic microorganism over a pristine glaze sample (d) and fingerprints of oval shaped cell after removal of the biofilm on the same pristine sample (e) Growth of microorganisms within a surface fracture of a pristine tile. (f) Surface of the control pristine glaze after experiment.

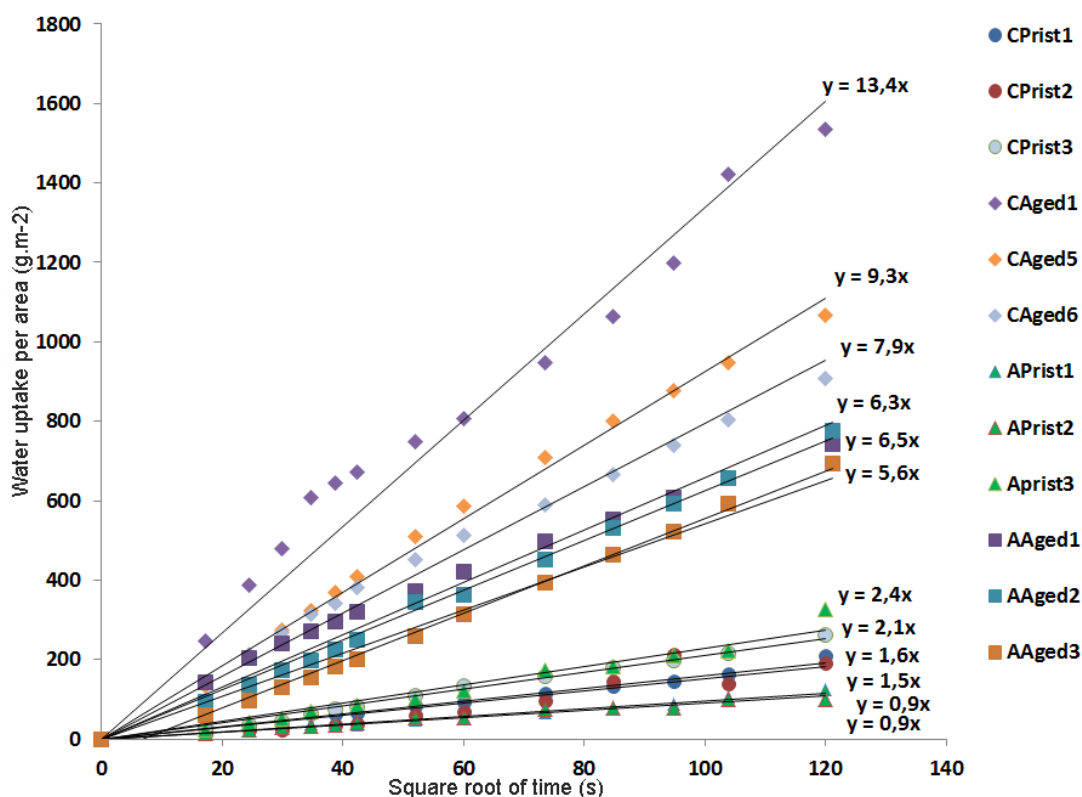
**Fig. 4.13.** Water uptake by capillarity of the pristine and aged inoculated samples (APrist and AAged) and control samples (CPrist and CAged) with linear trendlines and equation with capillary coefficient values.

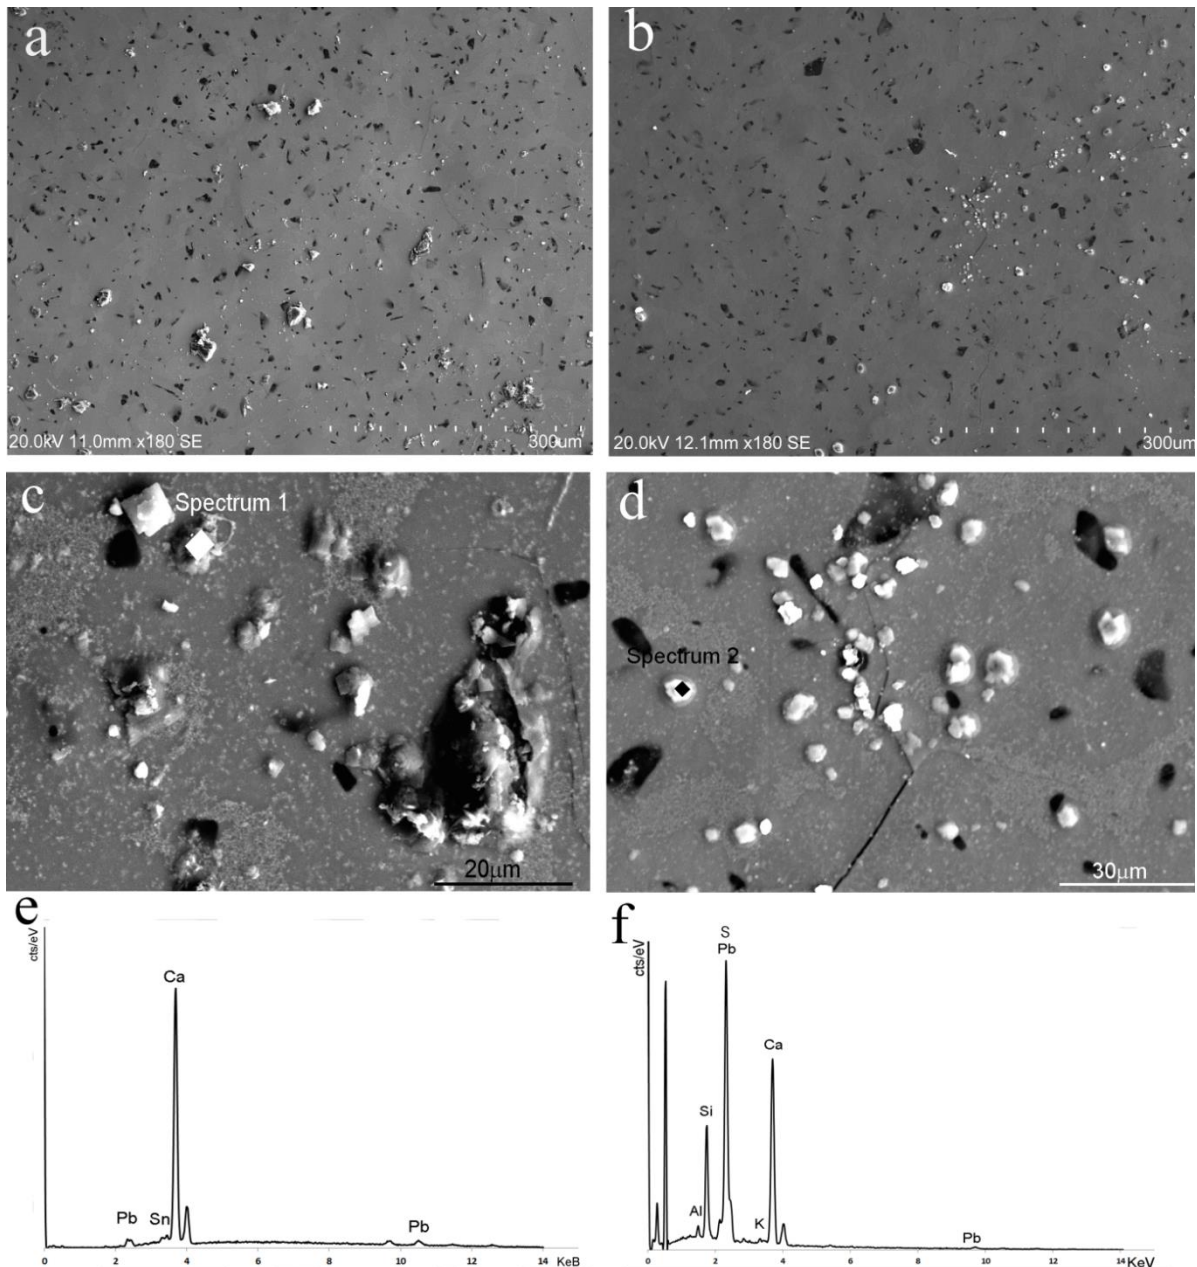
**Fig. 5.6.** SEM images of control glazed tiles after 12 months incubation. (a) crystals on the surface of the glaze of a pristine control sample; (b) crystals on the surface of the glaze of an aged control sample; (c) higher magnification of the crystals shown in (a); (d) higher magnification of the crystals shown in (b); (e) EDS of a crystal indicated as spectrum 1 in (c); and (f) EDS of a crystal indicated as spectrum 2 in (d).

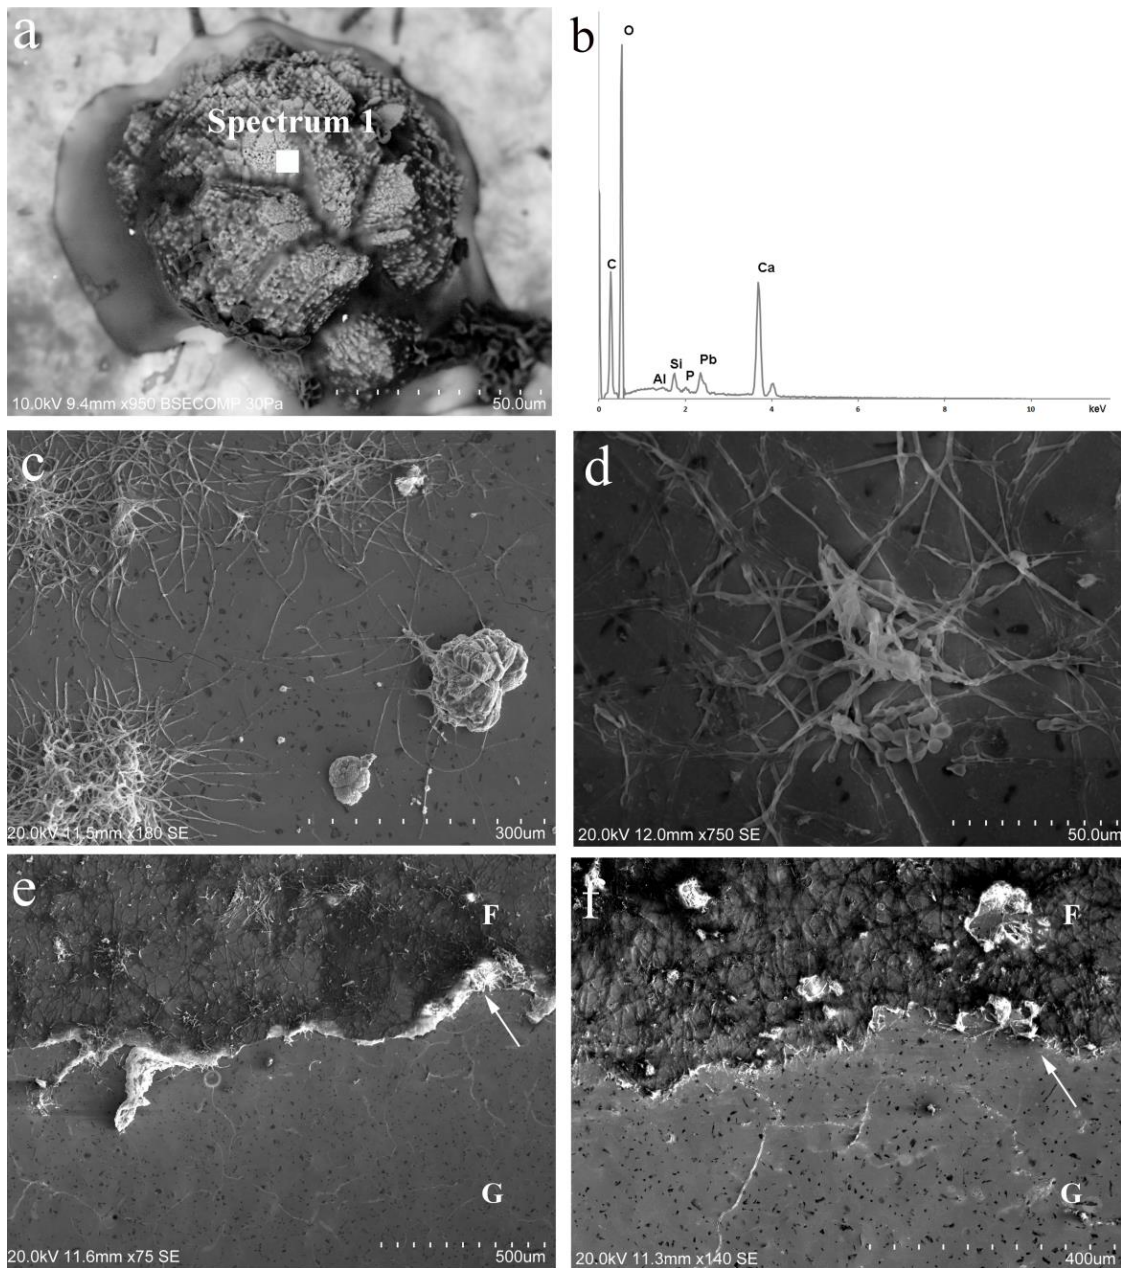
**Fig. 5.7.** SEM images of inoculated glazed tiles after 12 months incubation. (a) VP-SEM BSE image of a crystal on the surface of the glaze of a pristine sample with fungal hyphae covered by a mucilaginous matrix; (b) EDS spectrum of an area signed as Spectrum 1 in (a); (c) crystals on the surface of the glaze of a pristine sample close to fungal biomass; (d) Fungi on the glaze surface on an aged sample; (e) surface of a pristine tile sample with fungal hyphae (F) and clean glaze surface (G) with the interface signed with white arrow; and (f) surface of an aged tile sample with an area covered by fungal hyphae (F) and a cleaned glaze surface (G) with the interface signed with a white arrow.

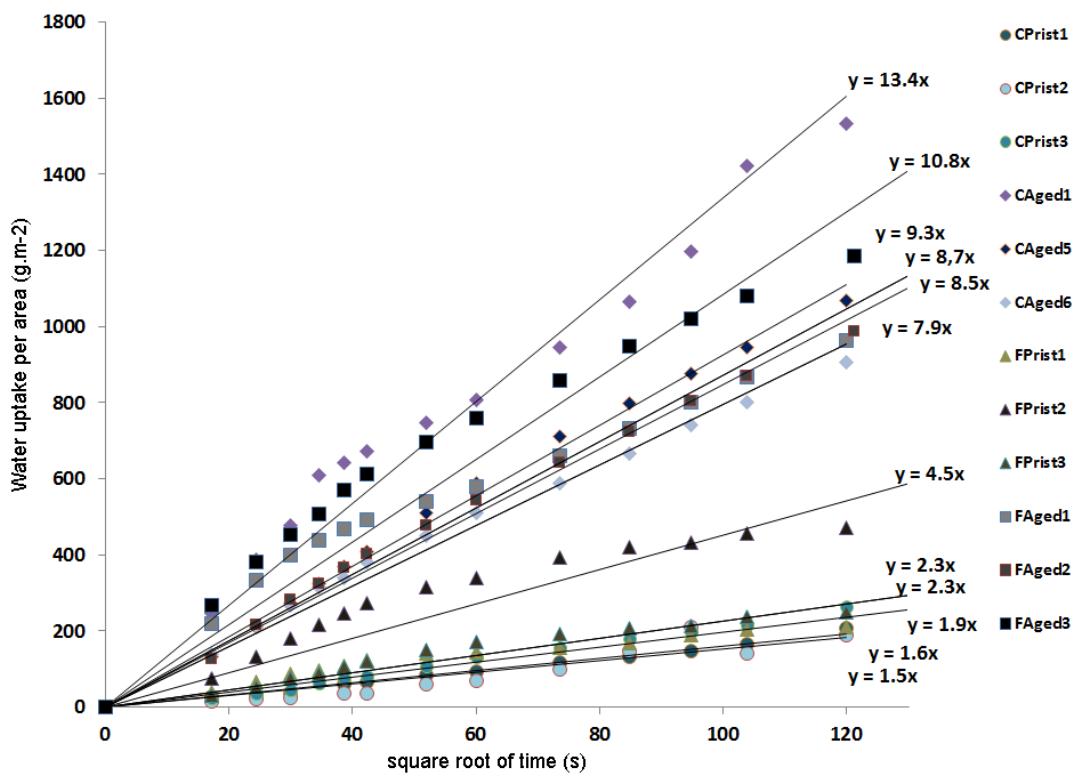
**Fig. 5.8.** Water uptake by capillarity of the pristine and aged inoculated samples (FPrist and FAged) and control samples (CPrist and CAged) with linear trendlines and equation with capillary coefficient values.

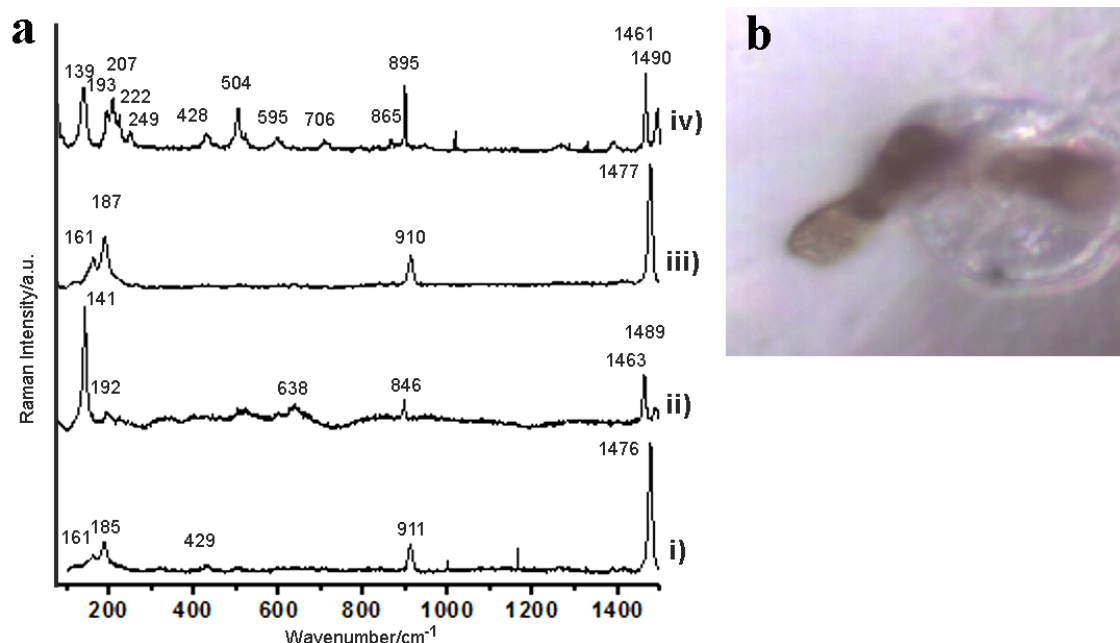
**Fig. 5.9.** Raman spectra and image of crystalline compounds identified over inoculated samples (a) Raman spectra of oxalate crystals over glaze tile samples. (i) Weddellite ( $\text{CaC}_2\text{O}_4 \cdot 2\text{H}_2\text{O}$ ) found on the surface of inoculated pristine glazes (ii) whellite detected on the surface of an inoculated sample (iii) Weddellite ( $\text{CaC}_2\text{O}_4 \cdot 2\text{H}_2\text{O}$ ) detected on the surface of an aged glazes and (iv) pure whellite ( $\text{CaC}_2\text{O}_4 \cdot \text{H}_2\text{O}$ ) powder reference spectra was made in similar conditions to the tiles spectra. (b) microscopy image of the crystals identified in (a(ii)) with a brown fungal structure.

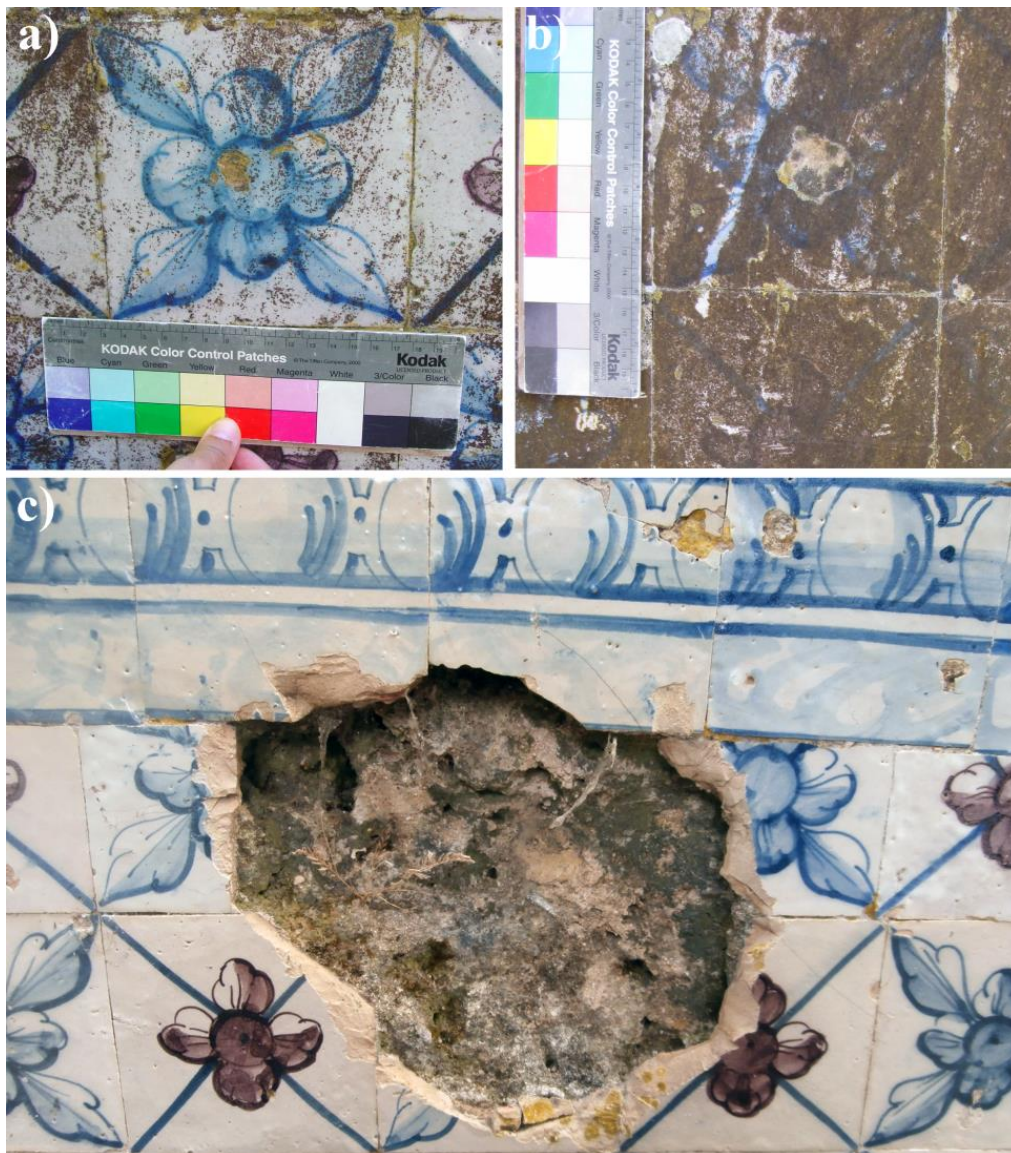
**Fig. 6.1.** Images damage and different pathologies found on the *Casa da Pesca* glazed wall tiles. (a) brown biological colonization, lacunar and detachment of the glaze; (b) severe biological colonization and lacunae of the glaze; and (c) biological colonization, lacunae of tiles and mechanical damage due to theft or vandalism.

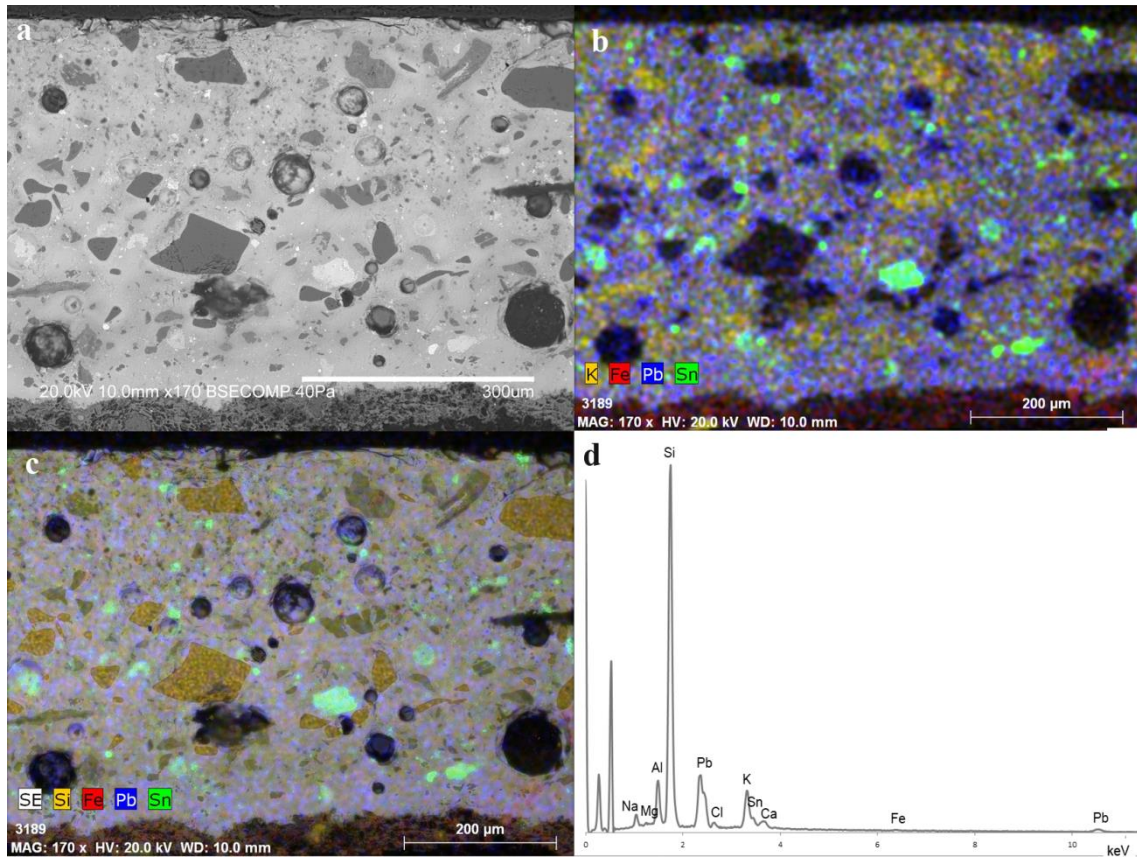
**Fig. 6.3.** VPSEM micrographs of the glaze: (a) SEM image of a glaze cross-section with inclusions; (b) false colored image showing the distribution of the elements K, Fe, Pb and Sn; (c) SE image with mapping of Si, Fe, Pb and Sn; (d) X-ray microanalysis spectrum obtained from a glaze section.
