**Biological colonization on majolica glazed tiles:  
biodeterioration, bioreceptivity and  
mitigation strategies**

Dissertação para obtenção do Grau de Doutor em Conservação e Restauro,  
especialidade Ciências da Conservação

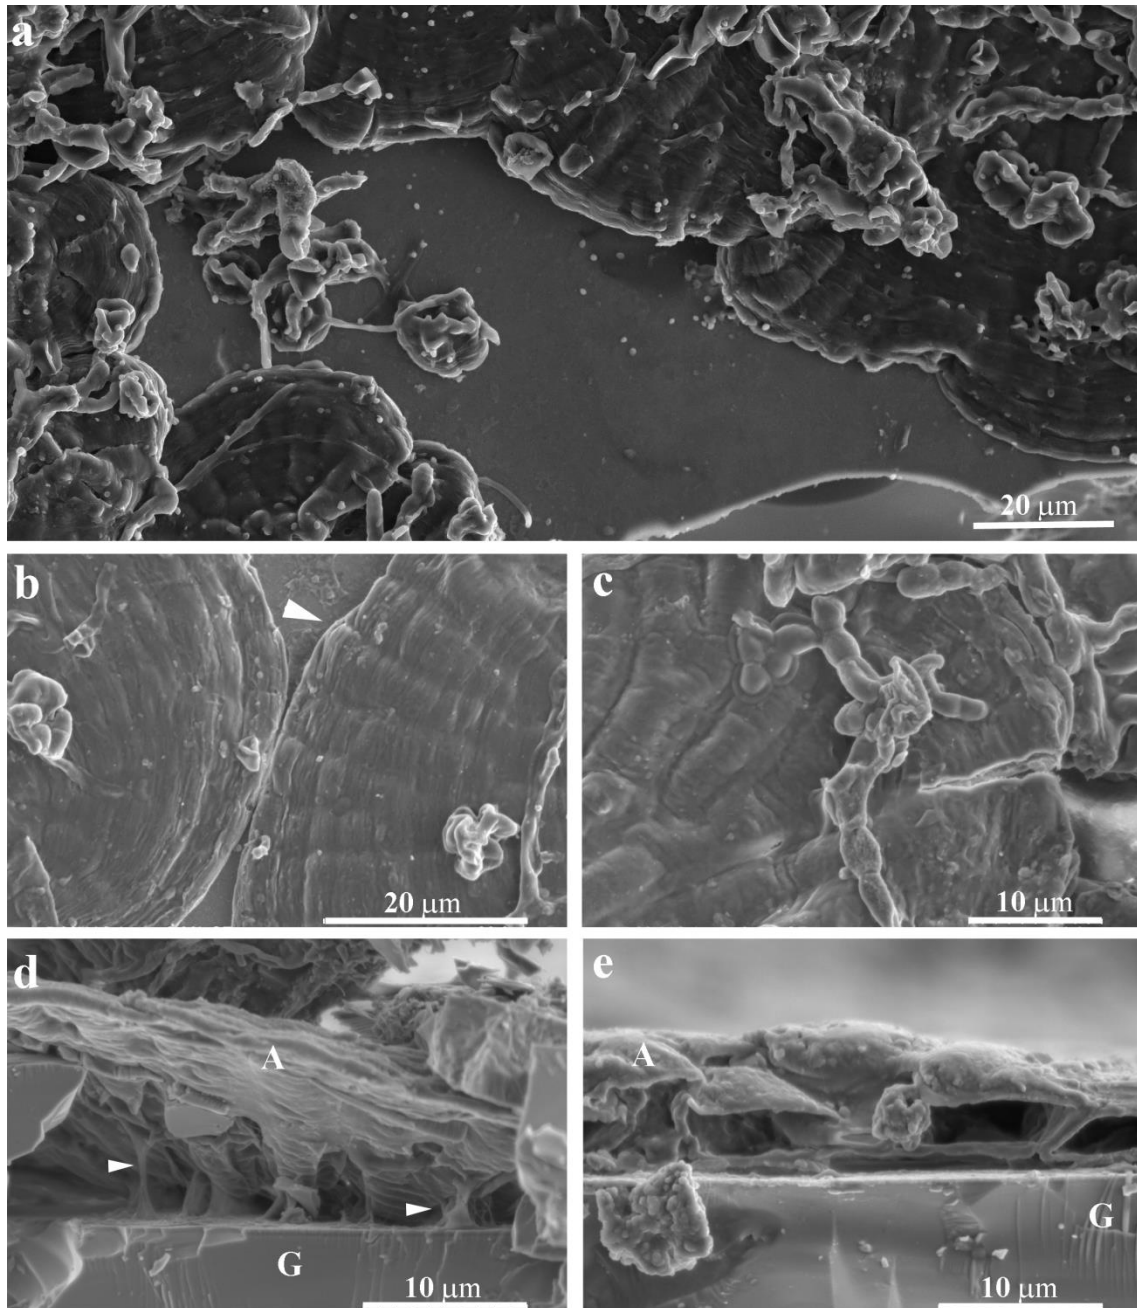
**Fig. 6.6.** SEM images of the biofilm over the glaze: (a) algae and fungal hyphae over the surface of the glaze; (b) algal thalli with the characteristic margin indicated with arrow over the glaze surface; (c) algae and fungal hyphae; (d) glaze section (G) with algae (A) and glaze fragments attached to EPS (arrows); and (e) section displaying algae (A) and glaze (G).

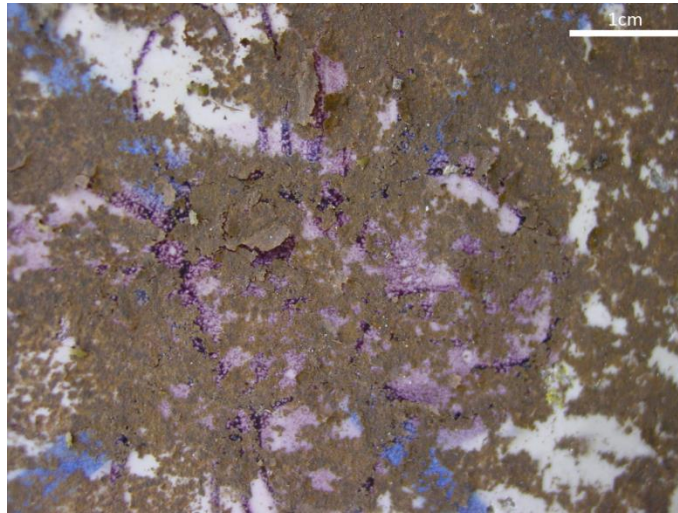
**Fig. 6.8.** Flaking-off and detached biofilm in the TiO<sub>2</sub>-treated area 6 months after treatment.

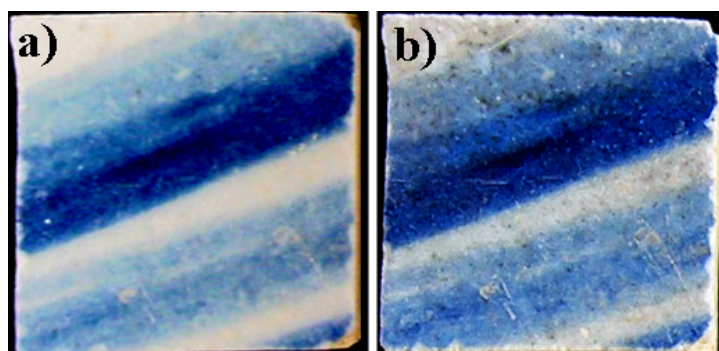
**Fig. 7.9.** Image of tile sample from tile 1BW (a) before and (b) after the coating.

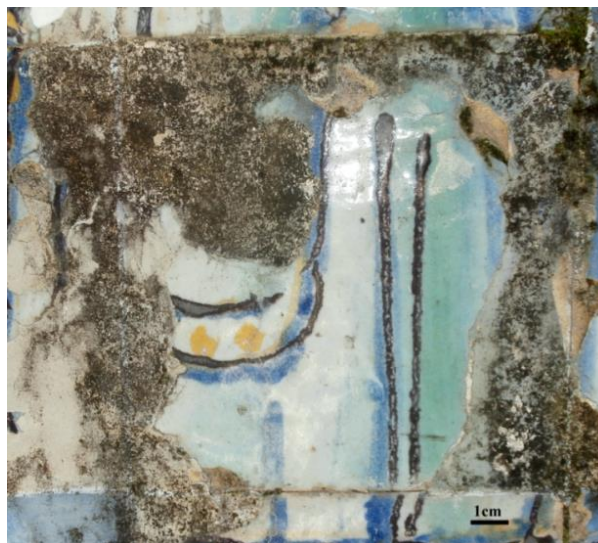
**Fig. 8.3** Microbial colonization on the filling paste of glazed tiles from *Marques de Fronteira* Palace (Lisbon, Portugal).

Finally the restoration treatments and the presence of restoration materials on tiles can sometimes alter tile bioreceptivity or become a source of contamination. The use of organic-based materials for the integration of lacunae, such as organic based filling pastes or adhesive resins can sometimes lead to contamination of tiles by microorganisms. Although the presence of areas without glaze can readily be colonized, the application of materials with high bioreceptivity might also result in a risk of colonization for the substrate. Fig. 8.3 was taken at *Marquês de Fronteira* Palace (Lisbon) and shows colonization of the filling paste. Therefore, the application of treatment should always take into account the bioreceptivity of the material and the environmental conditions in which it will be used. Giacomucci et al., (2011) reported microbial colonization of tiles by microorganisms after a treatment with involved the application of an acrylic resin over the glaze surface.
