PROPOSED CONSTRUCTION OF 13 DAMS AND ASSOCIATED ORCHARDS TO ACCOMMODATE THE DEVELOPMENT OF DECIDUOUS FRUIT PRODUCTION ON SEVERAL FARMS PART OF THE GUBENXA VALLEY TRUST IN THE GUBENXA VALLEY AREA OF SAKHISIZWE LOCAL MUNICIPALITY IN THE CHRIS HANI DISTRICT OF EASTERN CAPE.

DRAFT ENVIRONMENTAL IMPACT ASSESSMENT REPORT

Report No: J2020-03-DEIR

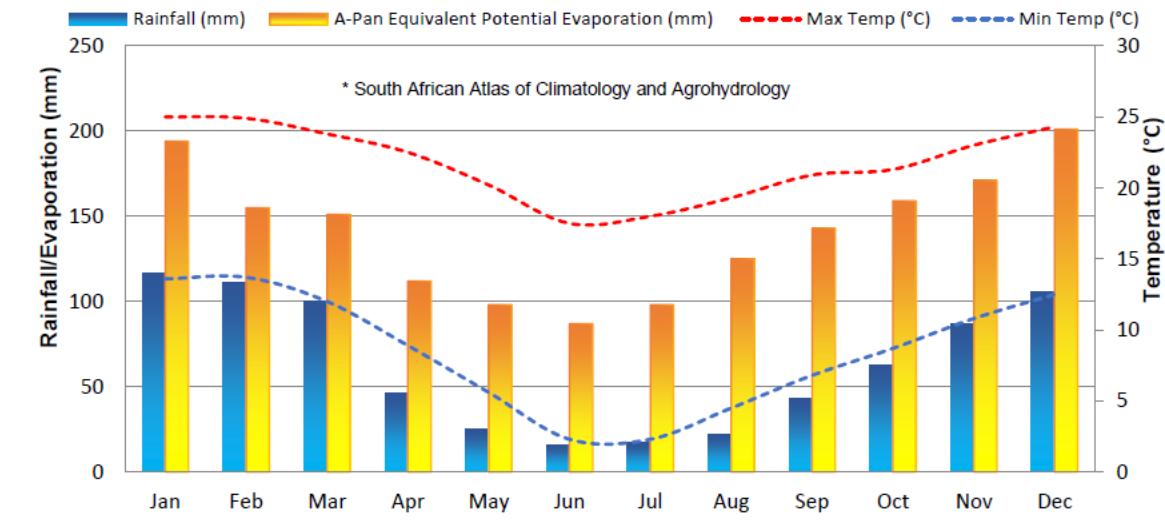
The average climate for the site is presented in Extract 3 using the outcome of the investigation into rainfall and evaporation for the site. The combination of rainfall (Pegram, 2016) and evaporation and temperature (Schulze and Lynch, 2006) result in a warm temperate climate (fully humid with warm summers) according to the Köppen-Geiger climate classification.

Extract 3: Average Monthly Climate For The Site

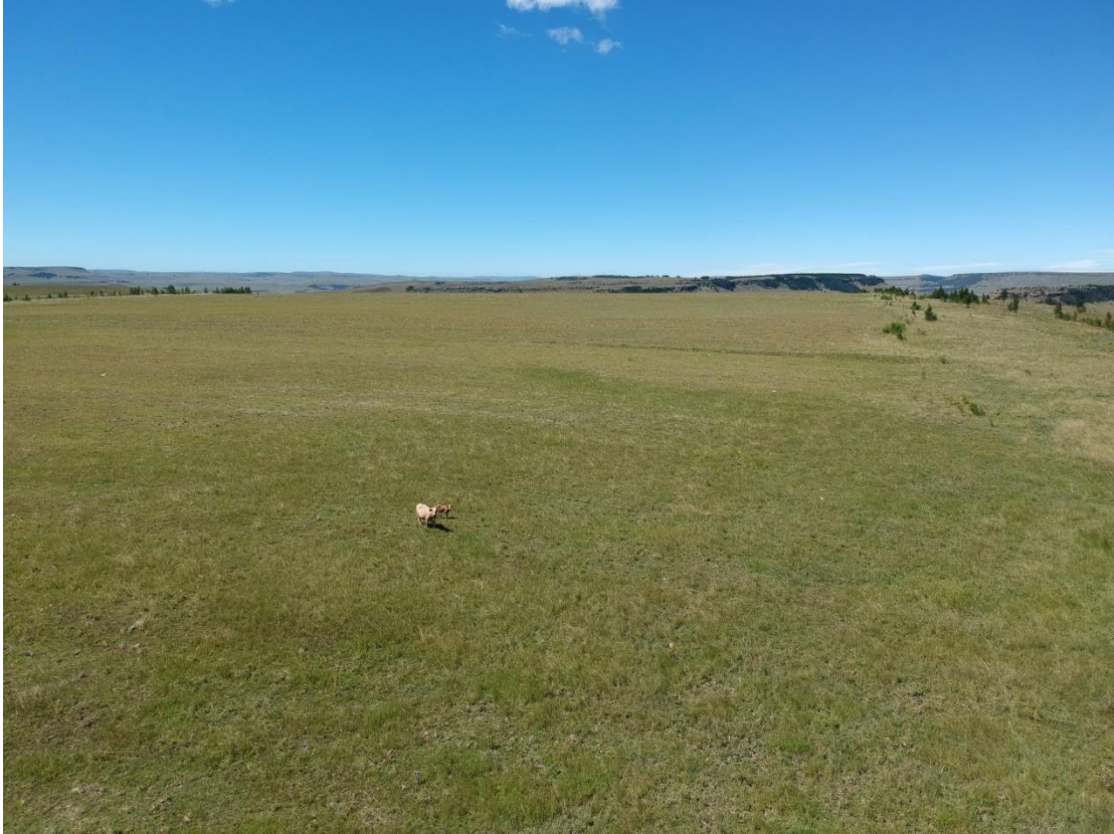
Figure 25: Overview of grassland vegetation (often well grazed)

The dominant vegetation in the area is grassland, comprised of graminoid dominated vegetation with a wide diversity of herbaceous and geophytic forbs (**Figure 25 and Figure 26**). Grazing is variable across the area. Dominant grasses include *Themeda triandra* and *Tristachya leucothrix*, *Diheteropogon filifolius*, *Elionurus muticus* and *Eragrostis capensis*. Shrub and herbaceous elements include the genera *Helichrysum*, *Senecio*, *Berkheya*, *Conyza*, *Chrysocoma*, *Felicia* and *Euryops* as well as a range of geophytic species belonging to the Iridaceae, Oxalidaceae and Orchidaceae.

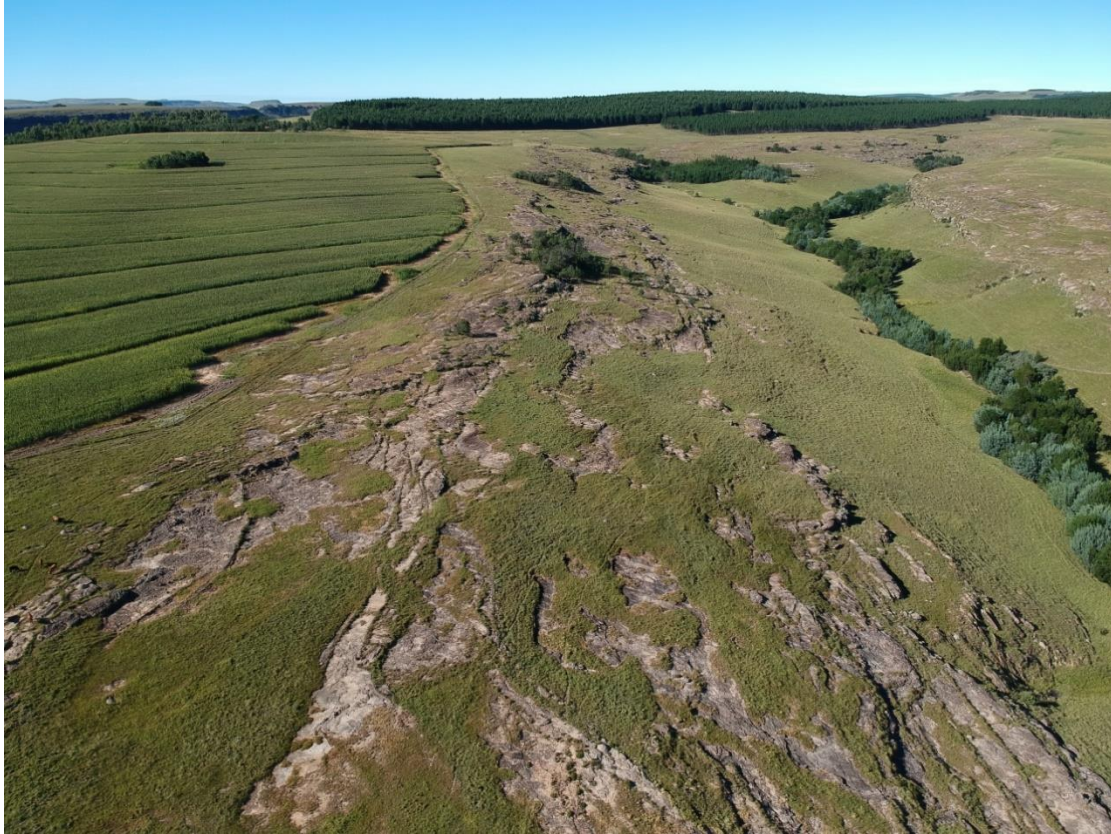
Rocky outcrops exist within some orchards and are deemed unsuitable for orchards and are not likely to be affected as they cannot be ploughed and are therefore likely to be left intact. Several succulent and geophytic species are common in rocky outcrops, as well as small trees and shrubs, being fire-protected refuges. Refer **Figure 27**

Figure 27: Rocky outcrop ridge providing a fire refuge for succulent plant species and fauna (reptiles).

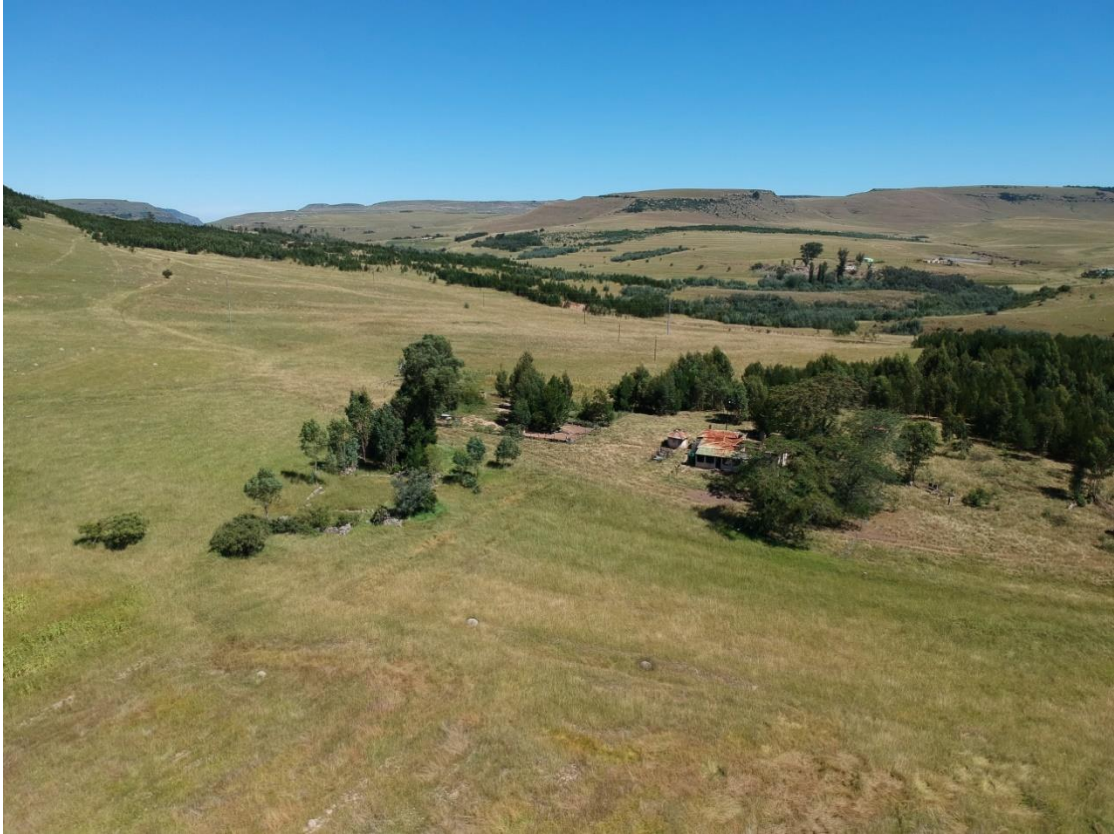
Where areas have been historically disturbed but have been left for sufficient time, a secondary grassland regenerates (**Figure 28**). This secondary grassland is generally significantly less diverse compared to intact grassland.

Figure 28: Overview of secondary grassland habitat

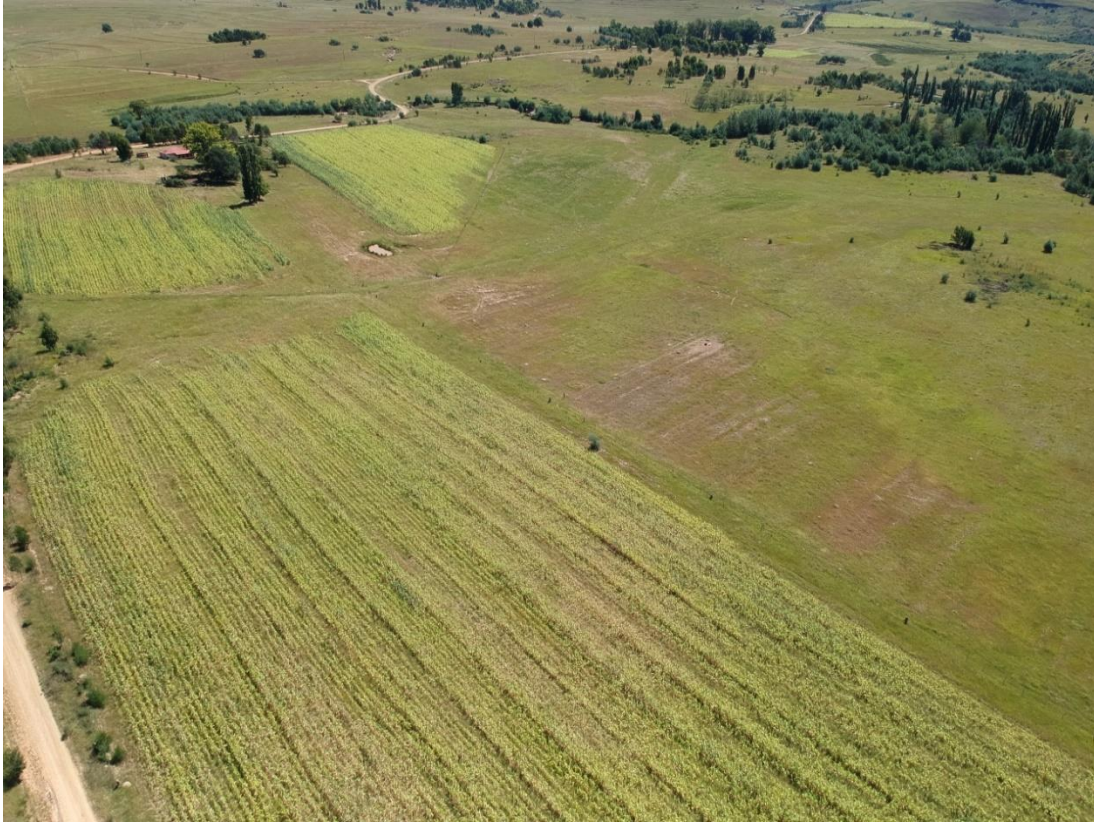
Large areas of cultivated lands are present, the most common crop being maize (**Figure 29**). Where left fallow for a short period of time, weed species tend to proliferate followed by a slow grassland succession process.

Figure 29: Overview of typical cultivated areas

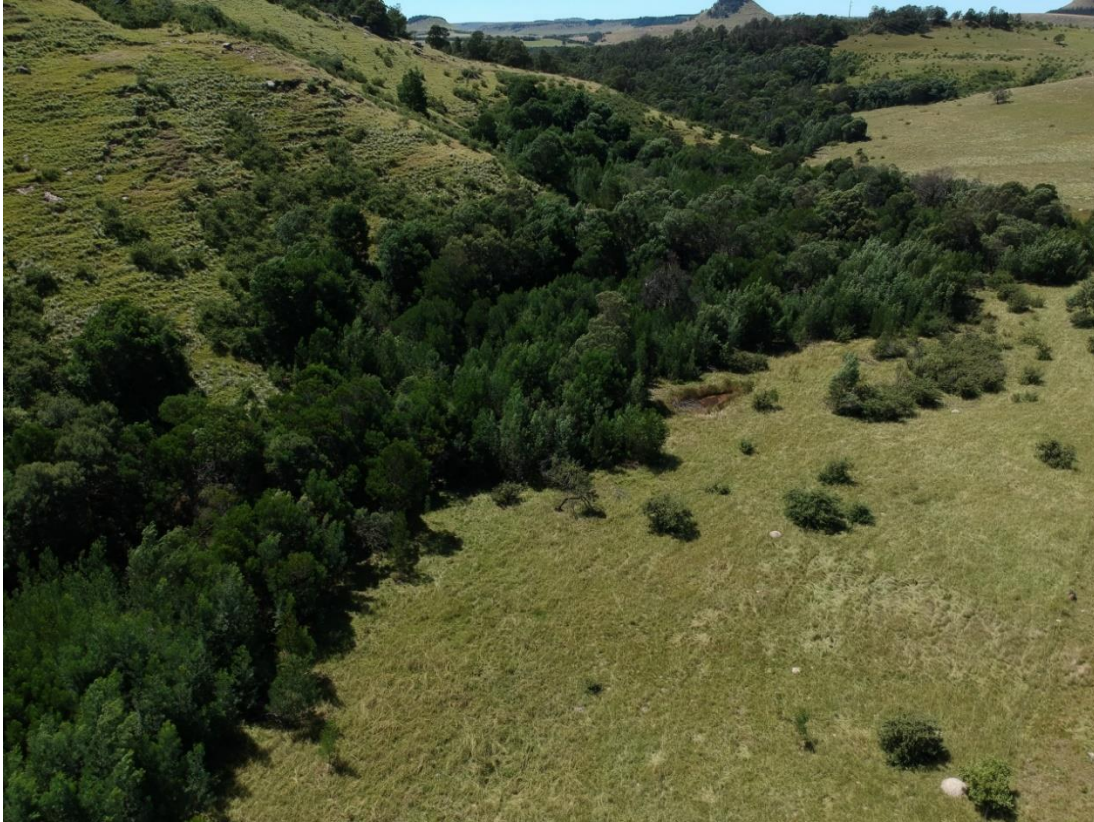
Dense wattle infestations are common along watercourses, but generally localised to a few watercourse rather than all watercourses (**Figure 30**)

Figure 30: Overview of typical watercourse with dense invasive alien infestation (Wattle)

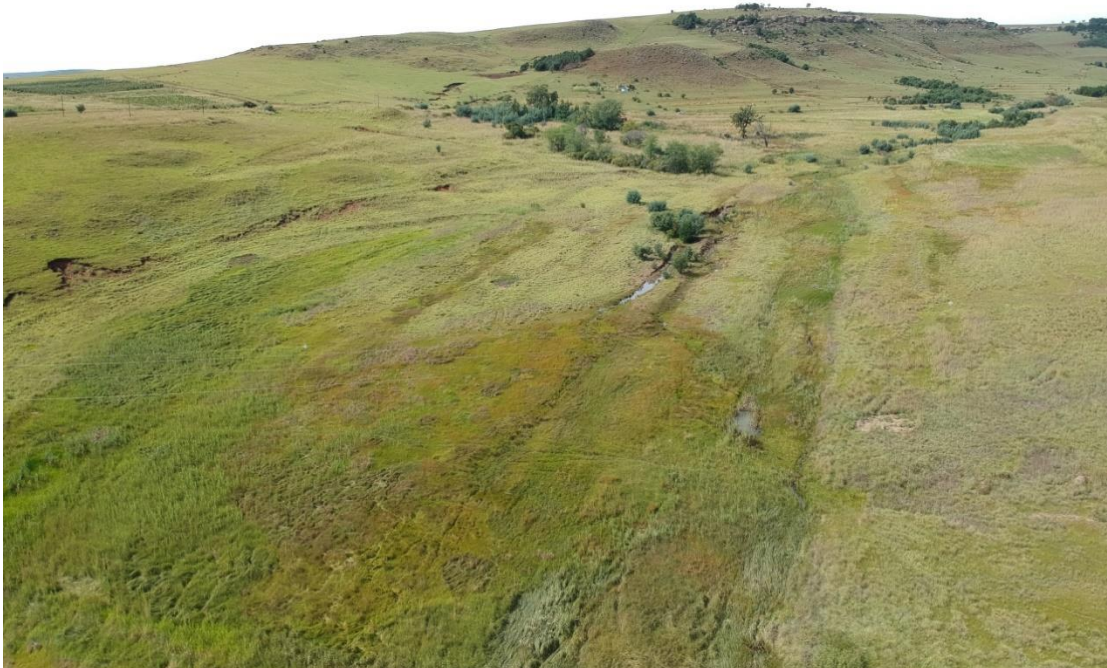
Wetlands are scattered throughout the area and are generally dominated by grass species (**Figure 31**).

Figure 31: Overview of typical aquatic areas with watercourse and surrounding grassy seeps (non-invaded).

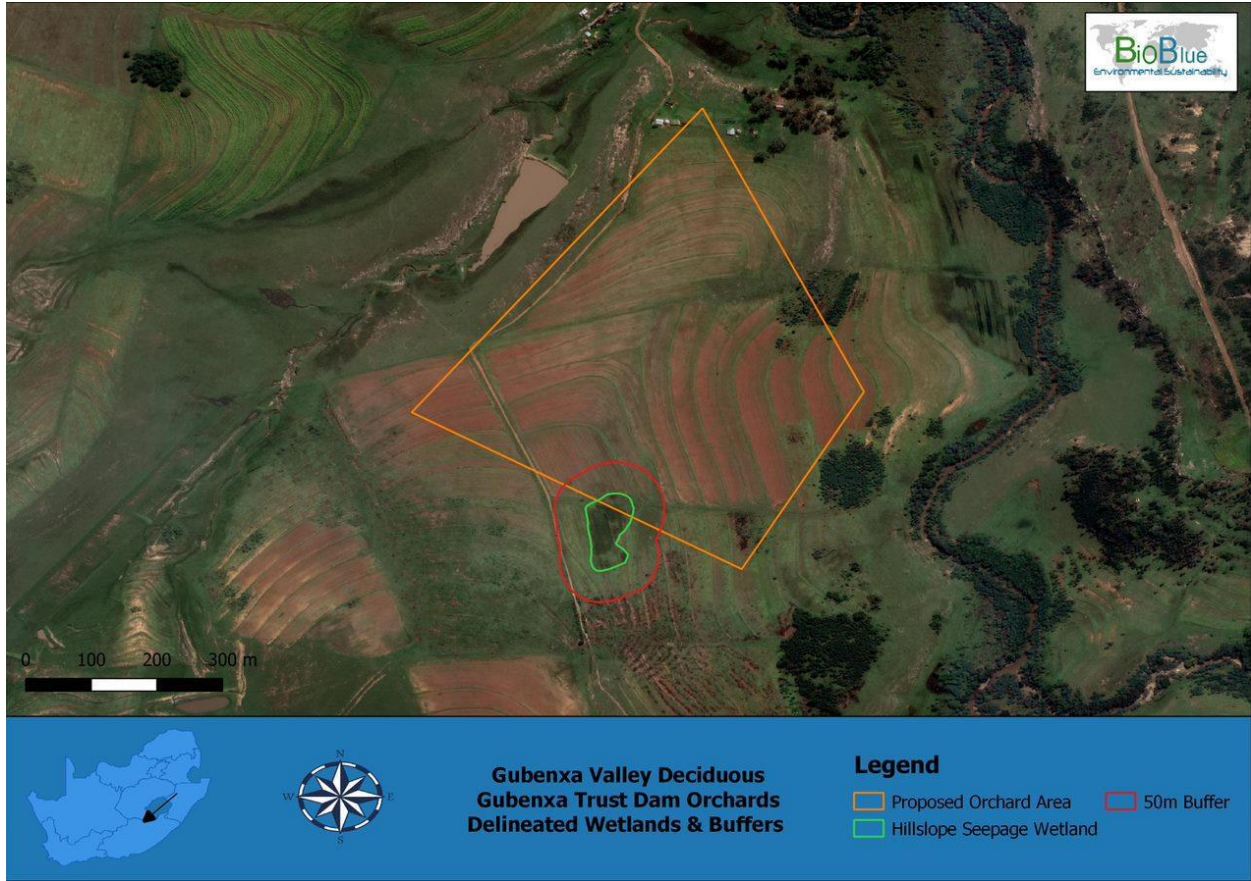
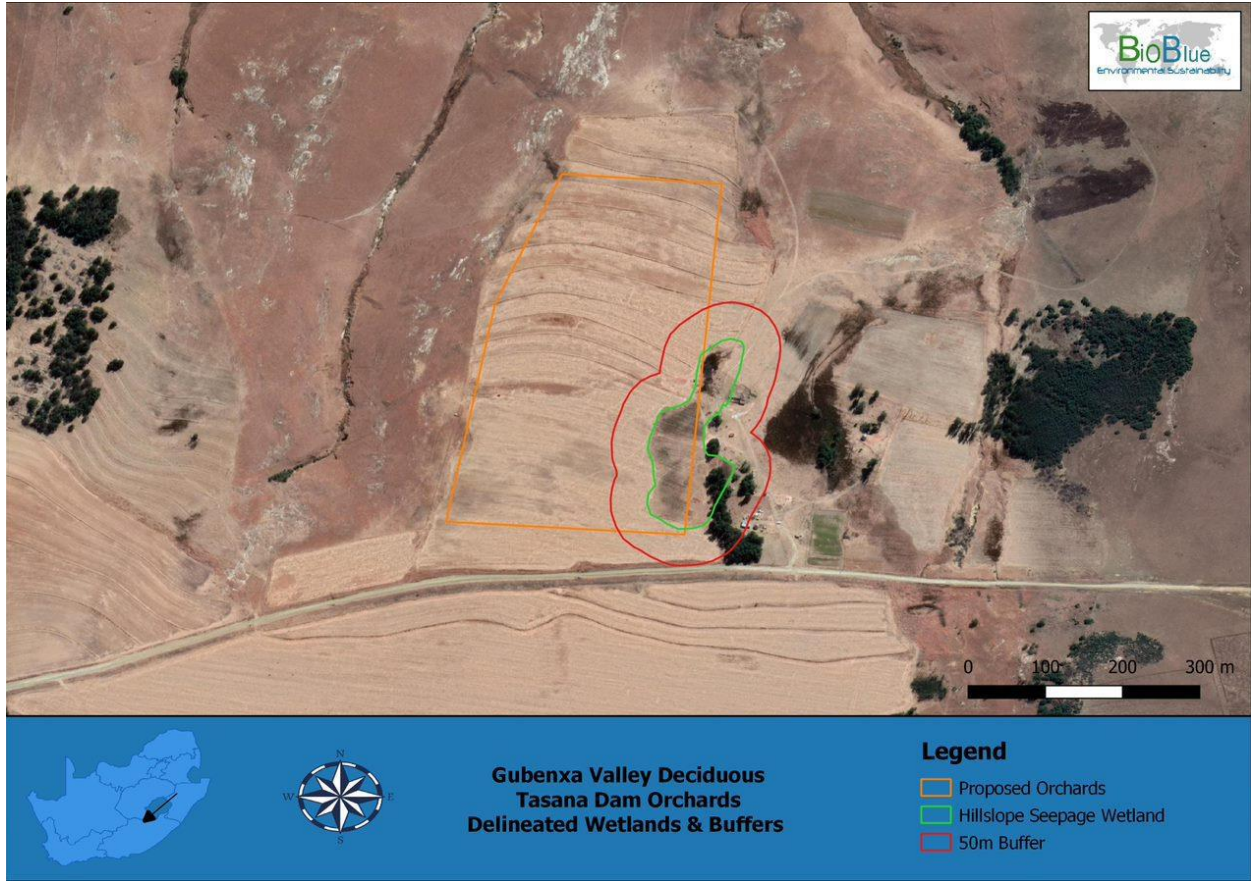
18 orchards are characteristic of wetlands either on their boundary, in the defined 50m buffer that was prescribed by the aquatic specialist or some with Hillslope Seepage wetlands following drainage lines between two orchards. It is not anticipated that planting will not take place on the wetland areas due to the soil not being compatible for orchards and these areas will be excluded. Refer to **Figures 32 to 45** for the orchards that comprises wetland features or their associated buffers.

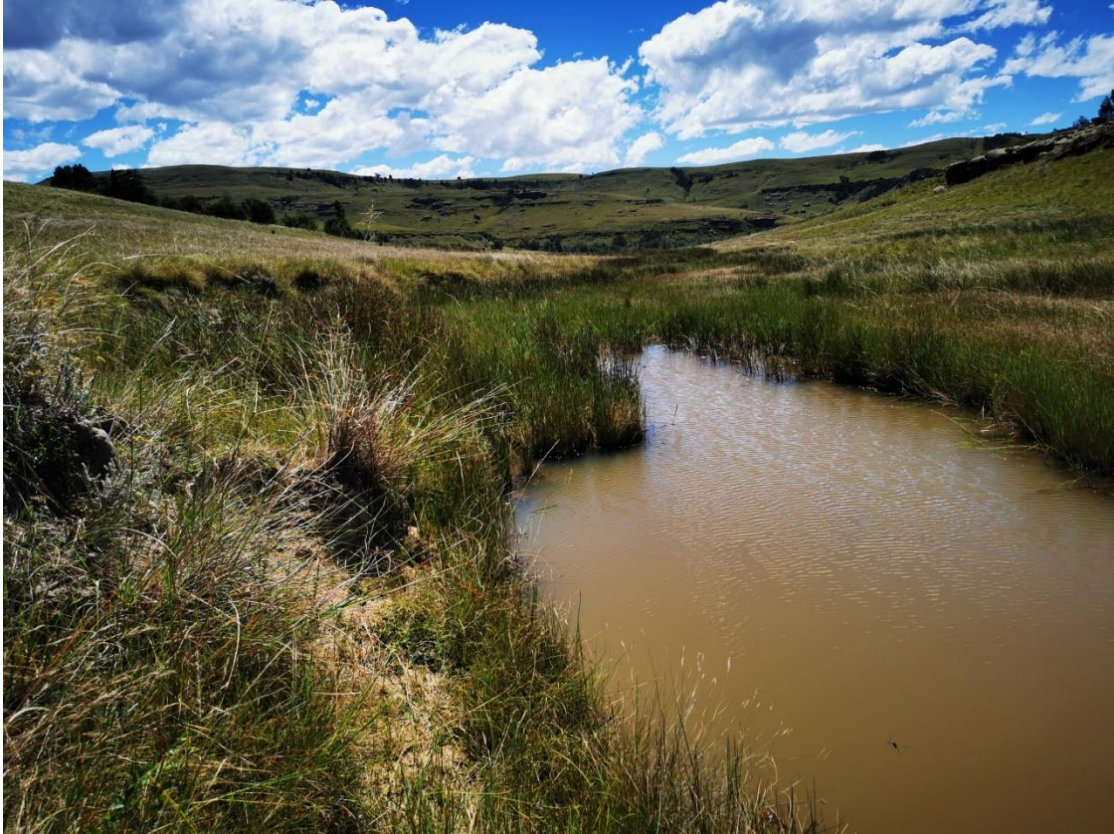
Riparian vegetation along watercourses is generally comprised of several sedge species and (Figure 46) are found along the banks of perennial and non-perennial watercourses.

Figure 46: Overview of typical watercourse with riparian fringe consisting primarily of sedges

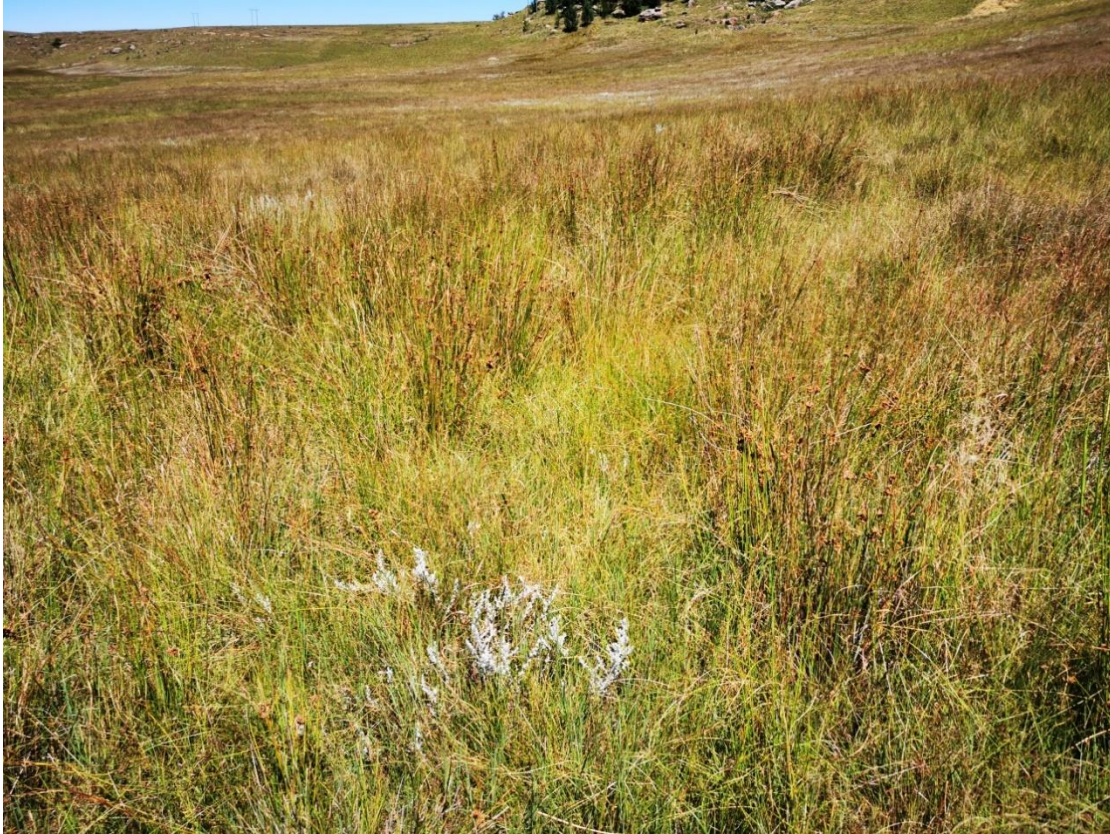
Grassland seeps are prevalent in the area, similar in composition to wetlands but are free-draining into downstream watercourses (**Figure 47**).

Figure 47: Typical seep area in proximity to watercourse with grasses and sedges and seasonal water.

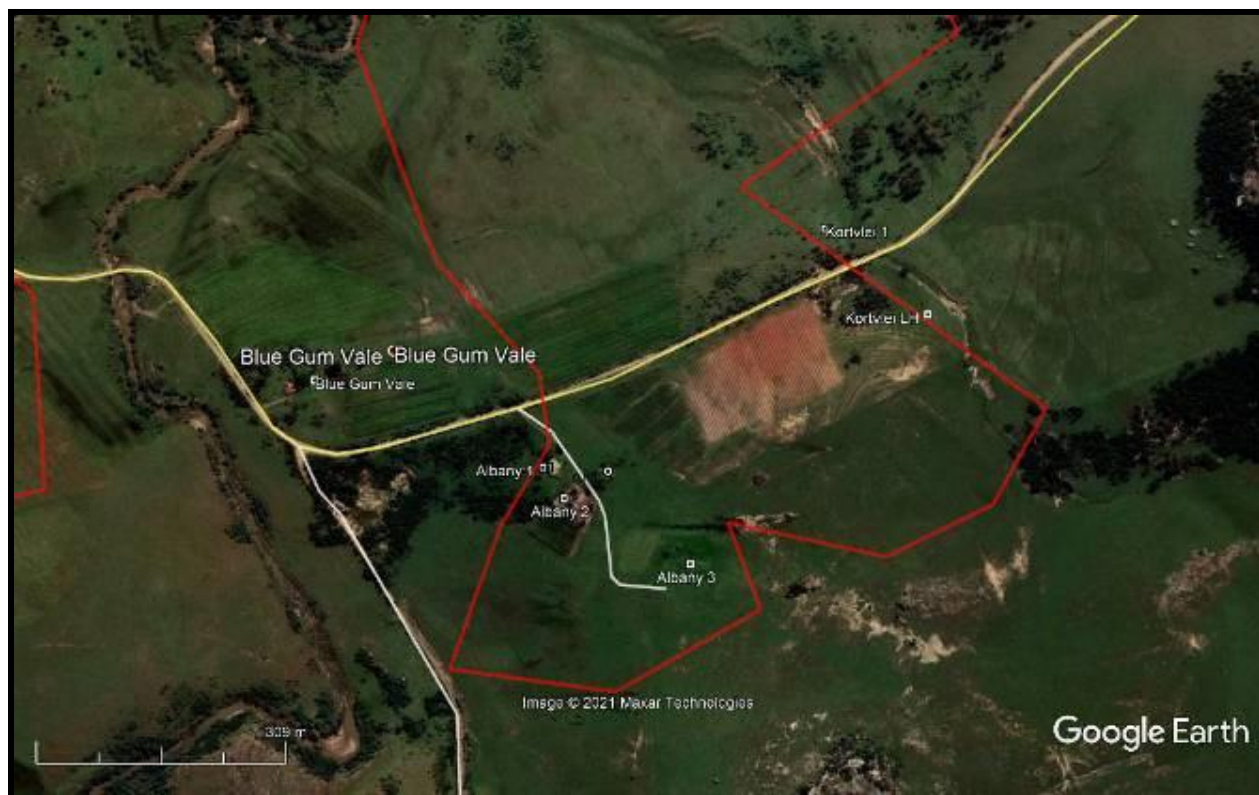
Figure 54: Location of Built Structures and Ruins at Qangule Orchard

Table 28: Table showing location of built structures at Qangule Orchard
