AGARICA

Mykologisk tidsskrift utgitt av Norges sopp- og nyttevekstforbund

Spesialutgave – Soppskader i bygg og trekonstruksjoner

Special issue – Fungal damages in buildings and wooden constructions

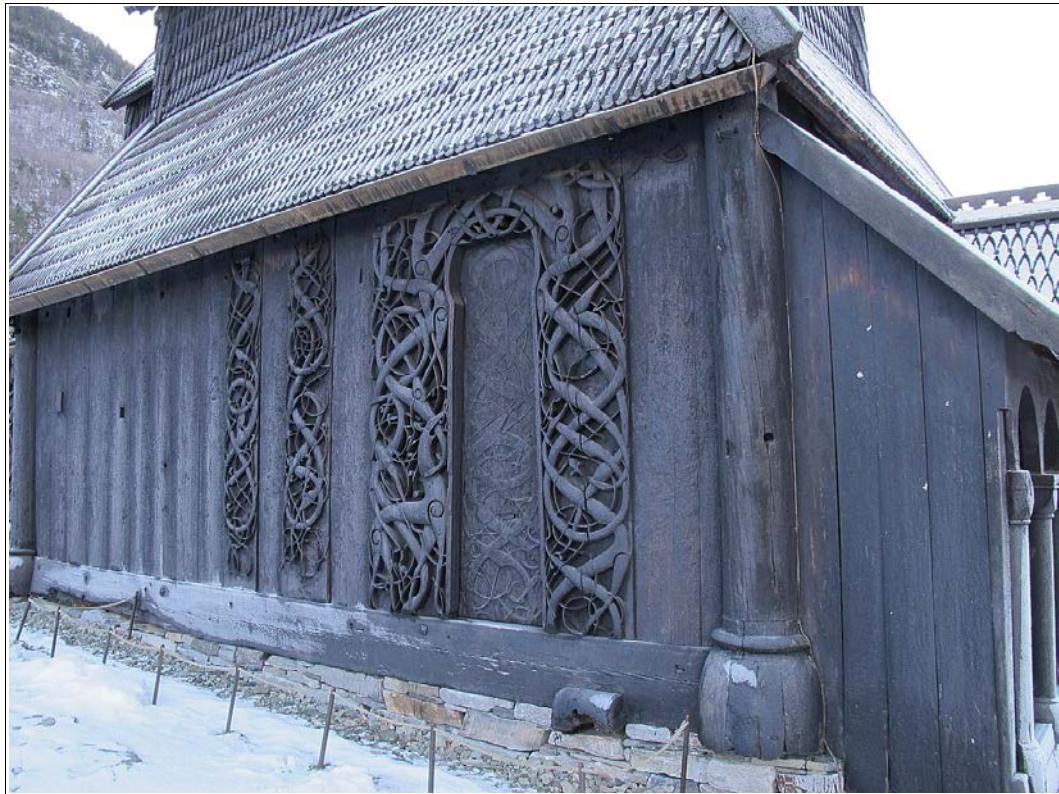
Figur 1. Nordportalen på Urnes stavkirke er fremdeles uten råtesoppskader, etter ca. 1.000 års eksponering for vær og vind!

The North gate at Urnes Stave Church is still, after almost 1.000 years of exposure to out-door climate, without any decay problems! Photo: Mycoteam as.

er flere grunner til at disse bygningene er blitt borte, både planlagt rivning, brann og råtesoppskader. Selv om det har vært gjort en del reparasjoner og utskiftinger viser de gjenværende kirkene likevel at treverk i Norge også kan ha meget lang levetid – særlig hvis det står beskyttet for nedbør og ikke har direkte bakkekontakt (Fig. 1).

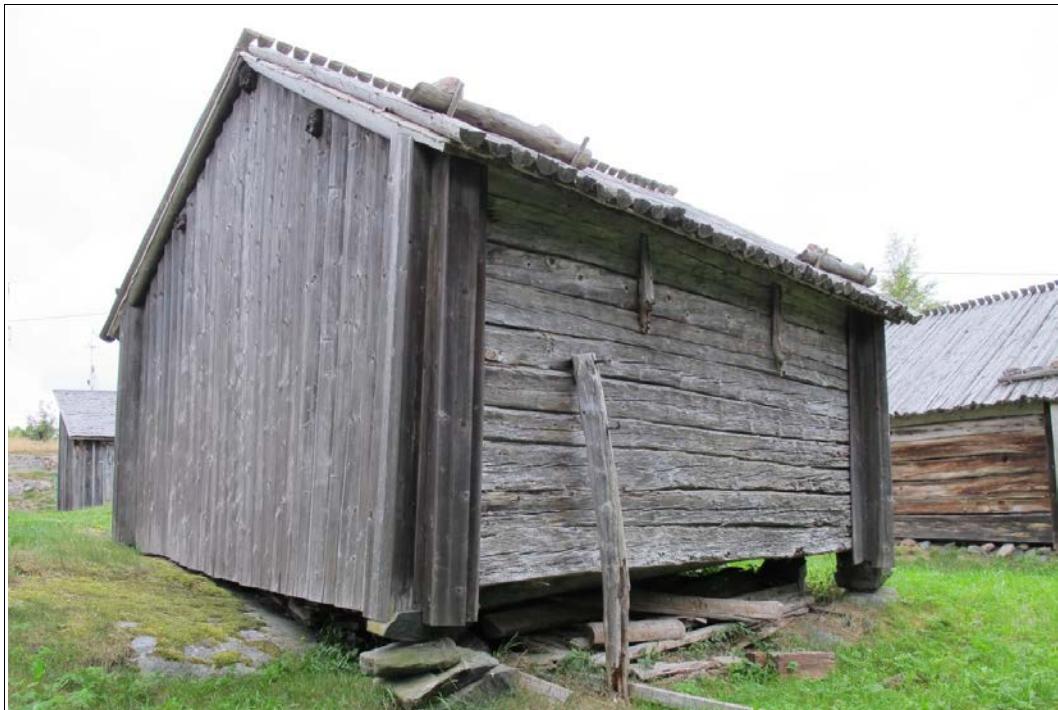
Figur 2. Delvis bruk av kledning gir en god beskyttelse av de mest fuktbelastede delene av lafteveggene.

Etter hvert ble konstruksjonene forbedret ved at man beskyttet tømmerveggene med et offerrsikt i form av ulike typer av kledning og overflatebehandlinger (Fig. 2). Konstruktiv beskyttelse i form av takrenner og nedløpsrør gjorde også at husene ble mindre utsatt for råtesoppskader.

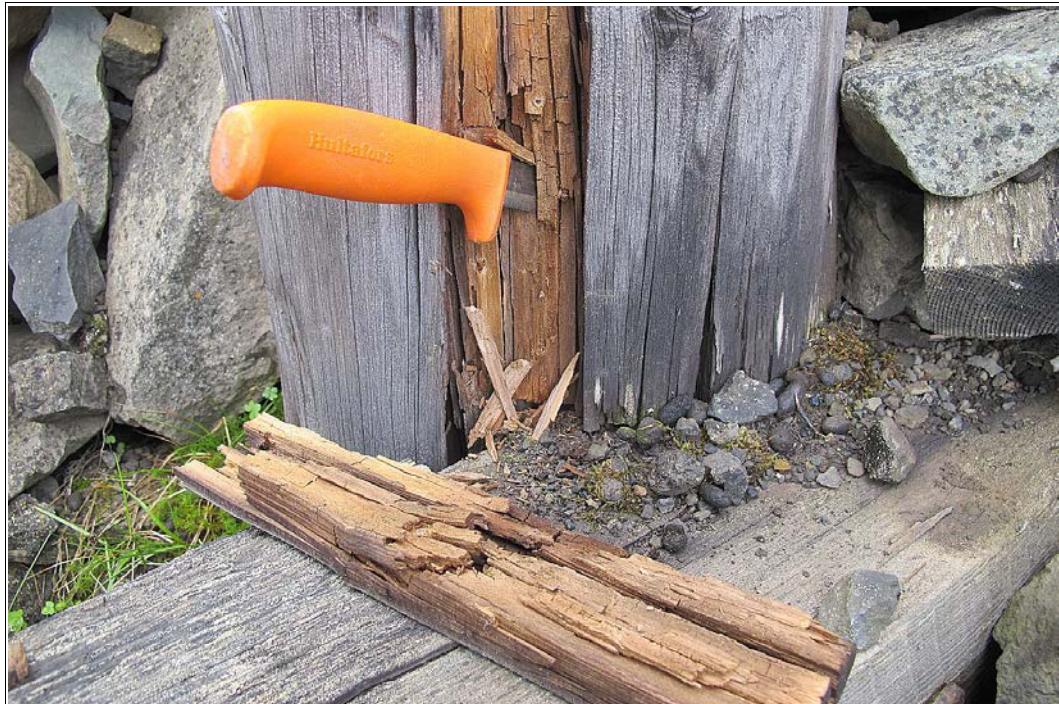
Figur 3. Det ytre sjiktet av treverk er uskadet mens de indre delene er sterkt nedbrutt.

The outer wooden cells are sound while the inner part is heavily decayed. Photo: Mycoteam as.

Fordi de økologiske forholdene kan variere sterkt over små avstander, kan forskjellen mellom friskt virke og en etablert skade ofte være noen få millimeter. Dette er vanlig å registrere i forbindelse med tømmervegger. Et godt eksempel er råteskadene som er observert på Svalbard, der det rett under en uskadet overflate kan være omfattende råtesoppskader (Mattsson 2010) (Fig. 3). I slike tilfeller er det vanskelig å oppdage skaden uten å gjennomføre en destruktiv undersøkelse.

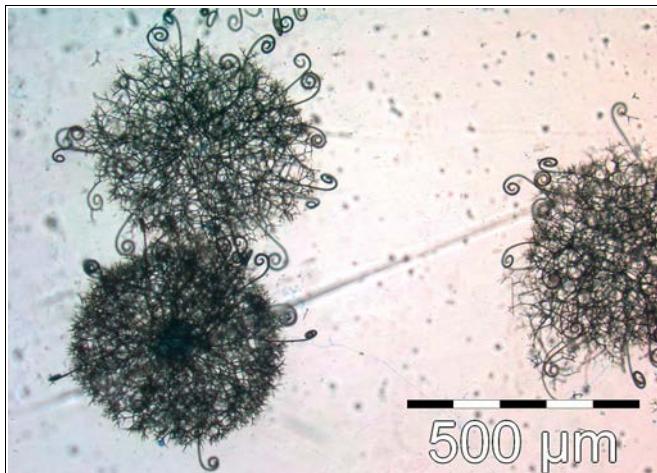
Figur 4. Svart kjellermugg (*Myxotrichium chartarum*) er vanlig å finne i utlektede kjellervegger.

The mould fungus *Myxotrichium chartarum* is commonly found in thermal insulated basement walls. Photo: Mycoteam as.

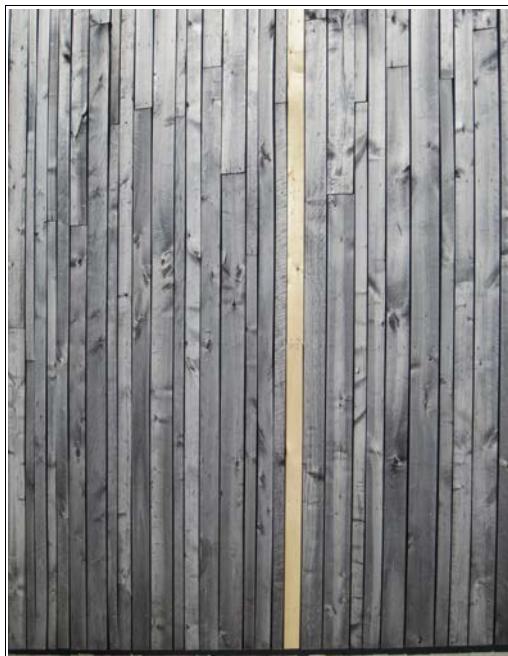
Figur 1. Ubehandlet osp som utvendig kledning.
Untreated Aspen as cladding in an external wall.
Photo: Lone Ross Gobakken.

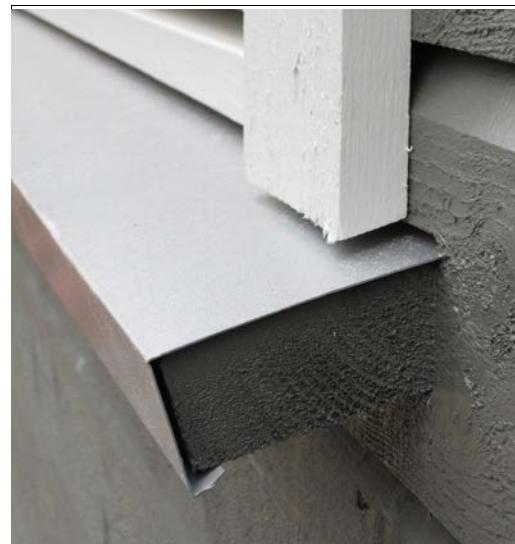
Figur 2. Konstruktiv beskyttelse – beslag på vannbrett under vindu, behandling av endeved, avstand mellom endeved og vannbrett.

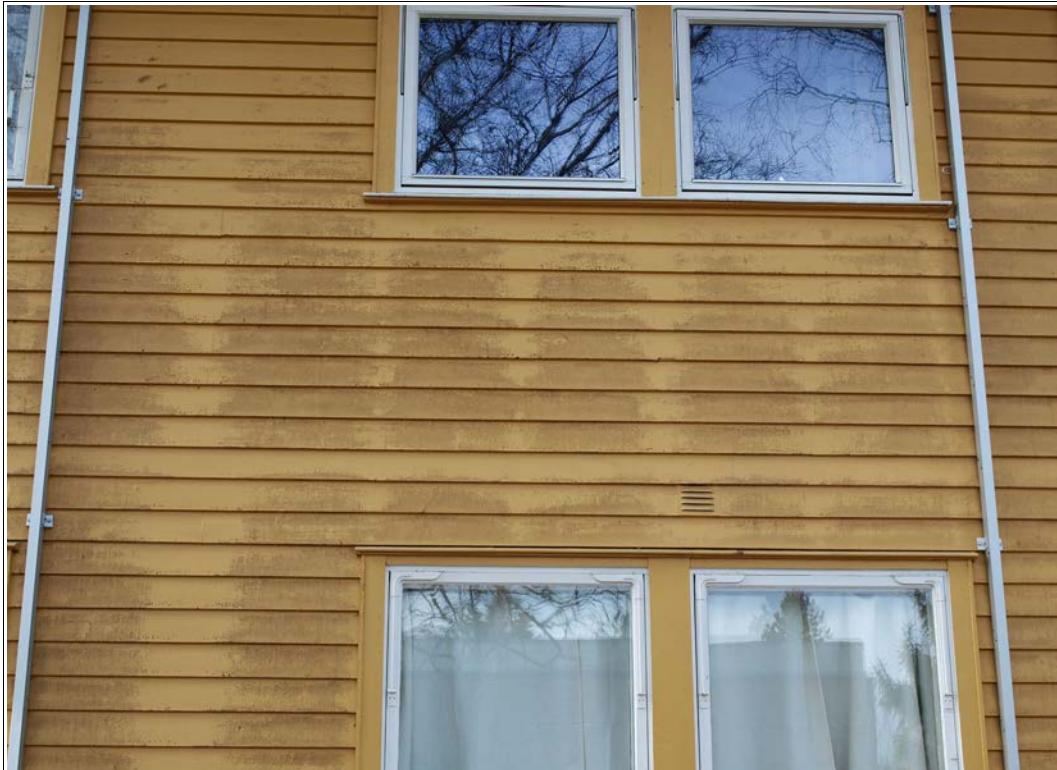
Figur 3. Svertesopp på malt trefasade.

Blue stain fungi on coated wooden facade. Photo: Lone Ross Gobakken.

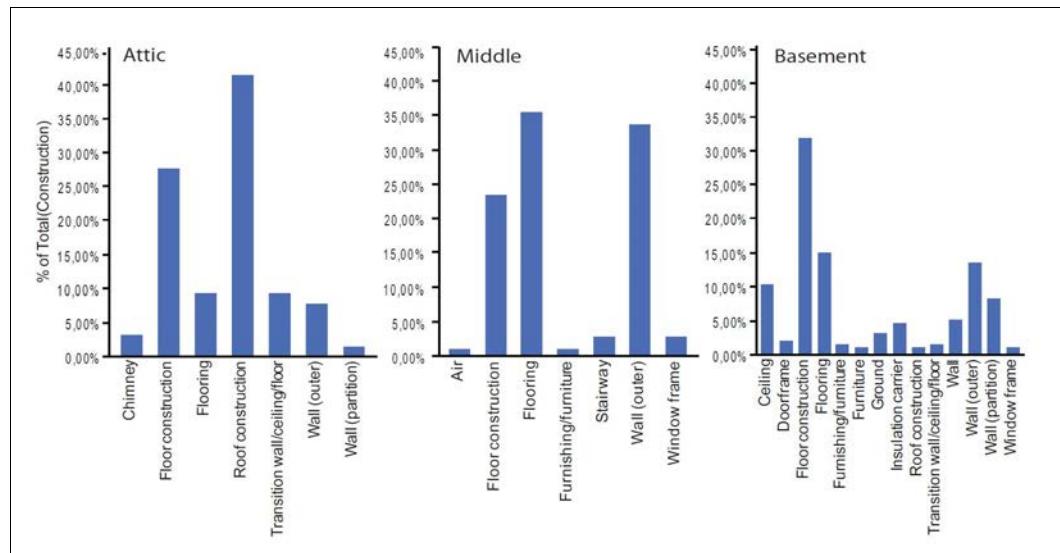
Figure 1. Construction in samples collected in Attics, Middle and Basements. Around one third of the samples are collected in floor constructions in all three locations. In attics, the largest amount of samples (42%) are collected from roof constructions.

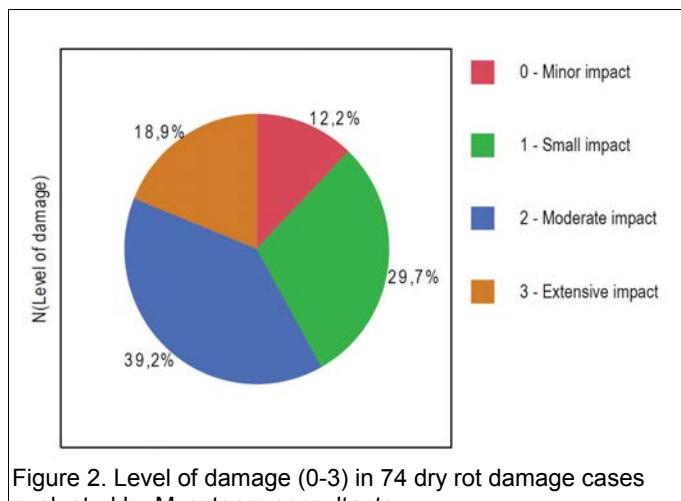
Figure 2. Level of damage (0-3) in 74 dry rot damage cases evaluated by Mycoteam consultants.

The severity of the damage cases is shown in Fig. 2. Twelve percent of the cases had minor impact. The majority of the cases had small (30%) or moderate (40%) impact. Only 18% of the cases had extensive impact. The level of damage was compared to the part of the building concerned (attic, basement or “middle”, i.e. everything in between) in a contingency analysis. No significant influence

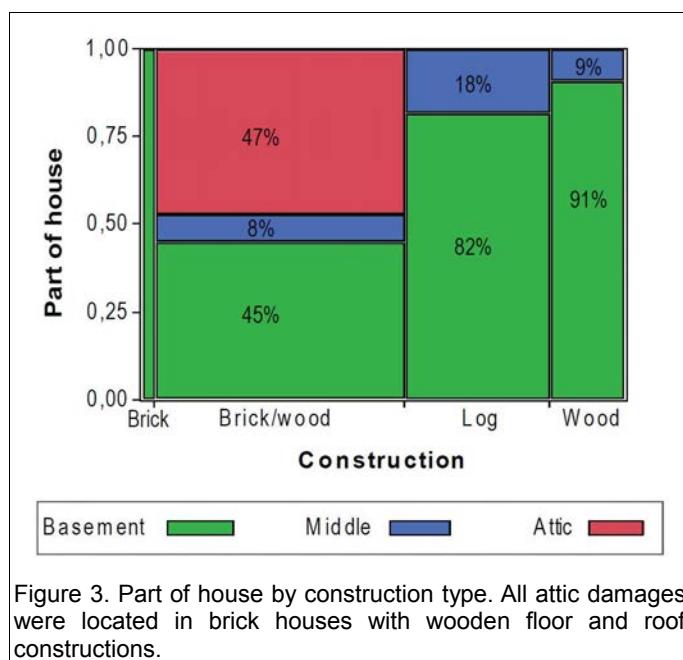
Figure 3. Part of house by construction type. All attic damages were located in brick houses with wooden floor and roof constructions.

Most of the damage cases (52%) occurred in brick buildings with wooden floor and roof constructions. Thirty percent of the cases occurred in log houses, 15% in other wooden houses and only 3% in houses that were reported to be purely brick constructions. There was a significant correlation between building type and part of house ($\text{Prob}>\text{ChiSq}=0.0008$). In brick houses with wooden floor and roof constructions, attic and basement damages comprised almost equal proportions (47% and 45%, respectively) and 8% of the damages were found in the middle of the houses. In log houses more damages were located in basements (82%) than in the middle of the houses (18%), and no damages were found in attics. In wooden houses, the majority of the damages (91%) were located in basements,

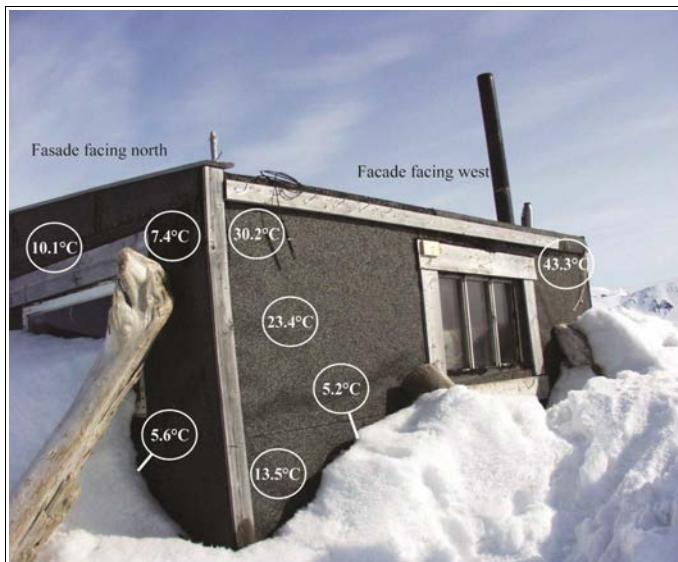
Figure 2. The temperature on the surface of the outer facade (towards north and west) had large variation. Photo: Johan Mattsson.

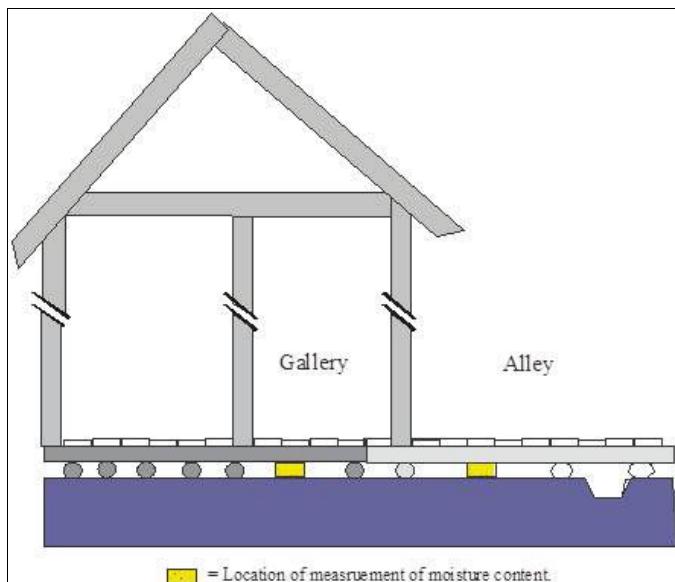
Figure 3. Wood moisture content was measured in sound wood samples installed under wooden pavement boards in the gallery and in the alley (marked with yellow).

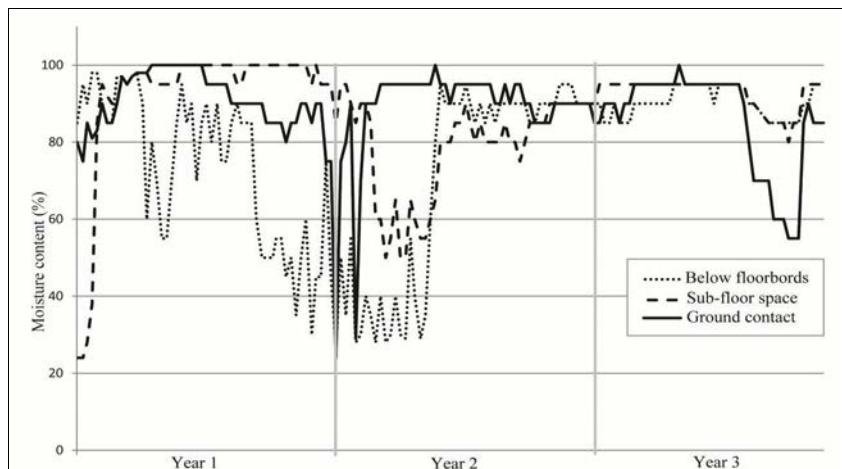
Figure 4. Wood moisture content in the three different positions at the alley test site over a period of three years.

The moisture content was above 20% through the whole investigation period in the samples in all levels in the alley test site (Fig. 4). The wood moisture content was only insignificantly affected by fluctuation in air temperature and precipitation through the year. The parallel measurements in the gallery showed that the samples in soil contact were the only samples that had constant moisture content above 20% (Fig. 5). Samples from the other two positions had moisture content around 20%. The samples just below the floorboard had lower wood moisture content than the samples in the sub-floor space. Both positions are above ground, but there were

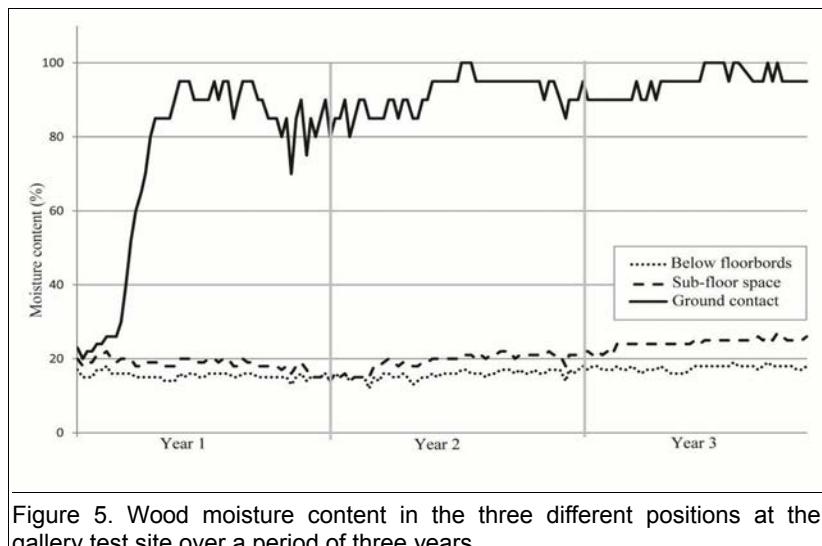
Figure 5. Wood moisture content in the three different positions at the gallery test site over a period of three years.

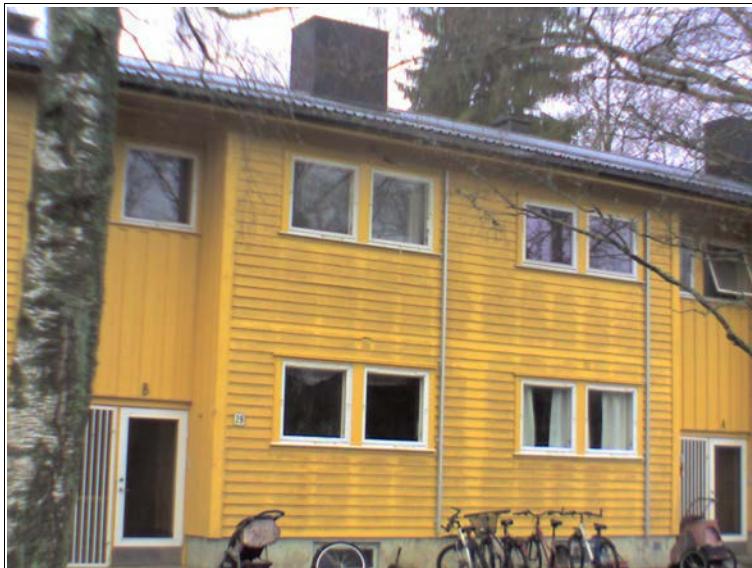
Figure 6. Mould growth on coated wooden cladding on a residence house in Ås. Photo: Precision Technic Nordic.

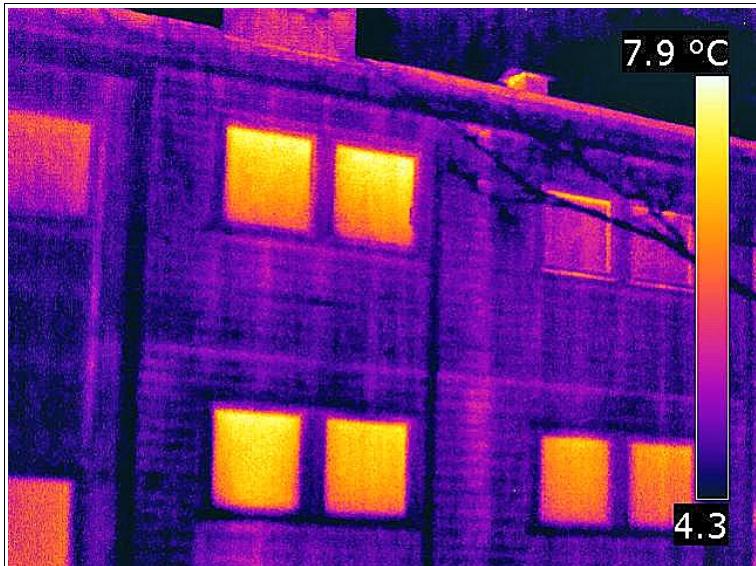
Figure 7. Thermograph image of the same section of the wall as in Fig. 6. Photo: Precision Technic Nordic.

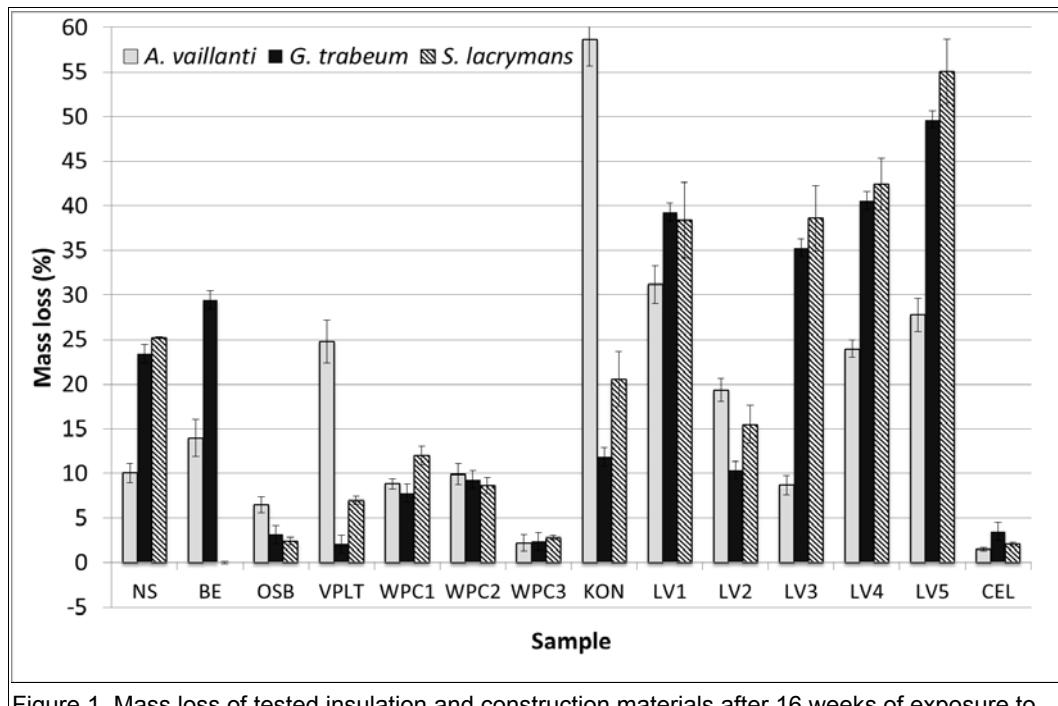
Figure 1. Mass loss of tested insulation and construction materials after 16 weeks of exposure to brown rot fungi.

(Figs. 1 and 2). The greater mass loss of hemp insulation exposed to brown rot fungi was to be expected, since hemp fibres contain between 60% and 70% cellulose (Kymalainen and Sjoberg 2008), which is the most important source of energy for brown rot fungi. Even greater differences were measured in the moisture content of hemp insulation. The moisture content of samples exposed to *G. trabeum*, *T. versicolor* and *P. ostreatus* was below 16%. However, the moisture content of hemp insulation exposed to *A. vaillantii*, *S. lacrymans* and *H. fragiforme* was more than 10 times higher (Table 2). The reasons for this difference presumably originate in the degradation mechanism of the various fungal organisms tested. For example, it is well documented that water is a by-product during cellulose degradation by *S. lacrymans* (Schmidt 2006), which is reflected in a higher moisture content.

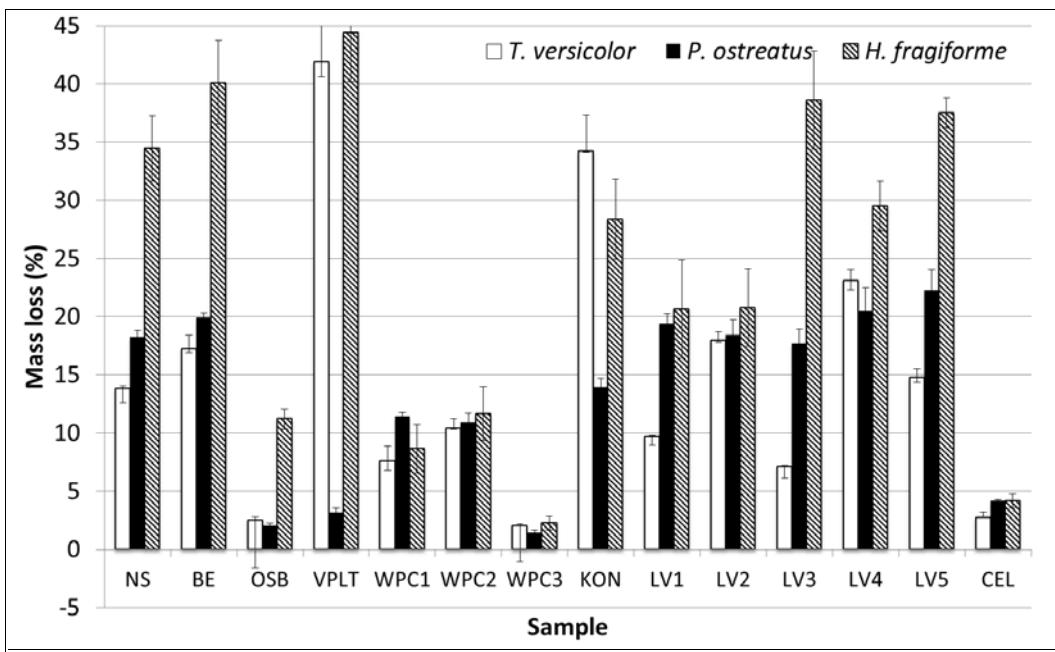
Figure 2. Mass loss of tested insulation and construction materials after 16 weeks of exposure to white rot fungi.

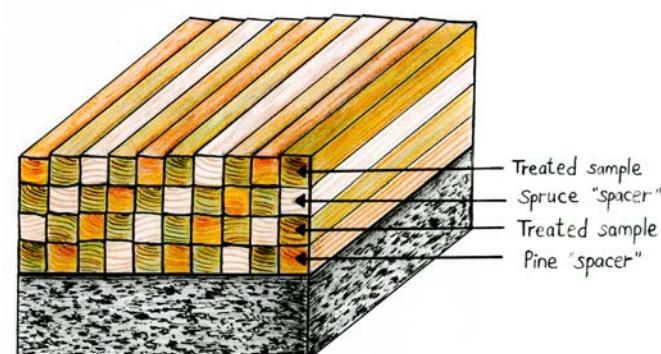
Figure 1. General setup of the block-test. Illustration by Sigrun Kolstad.

For this study, the block-test (Pfeffer et al. 2008) for use class 3 was used (Fig. 1). The samples were exposed from 2004 to 2008 in

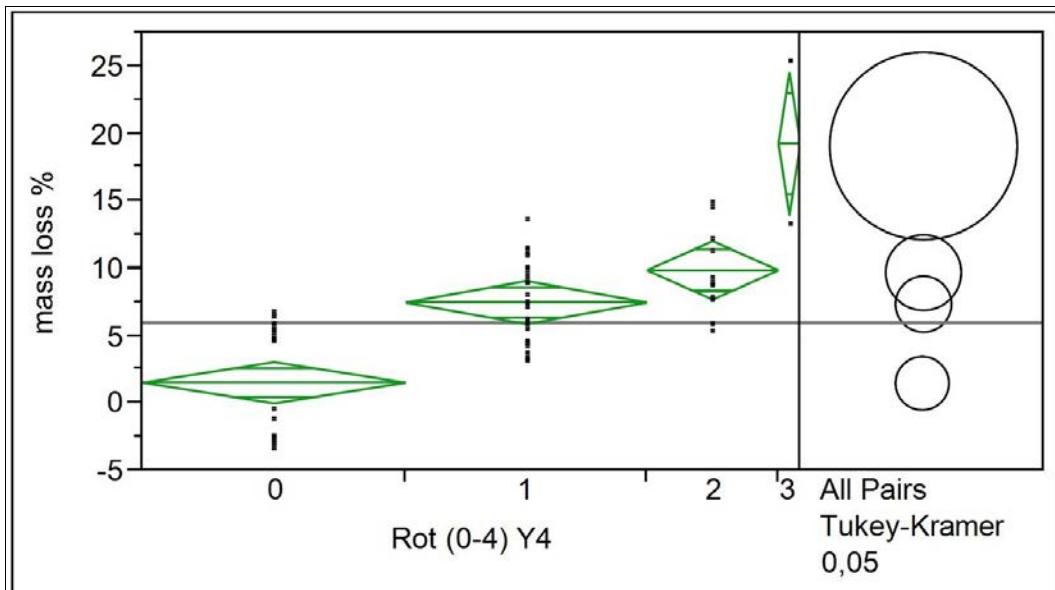
Figure 2. One-way analysis of mass loss after 4 years in % by pick-test, all treatments.

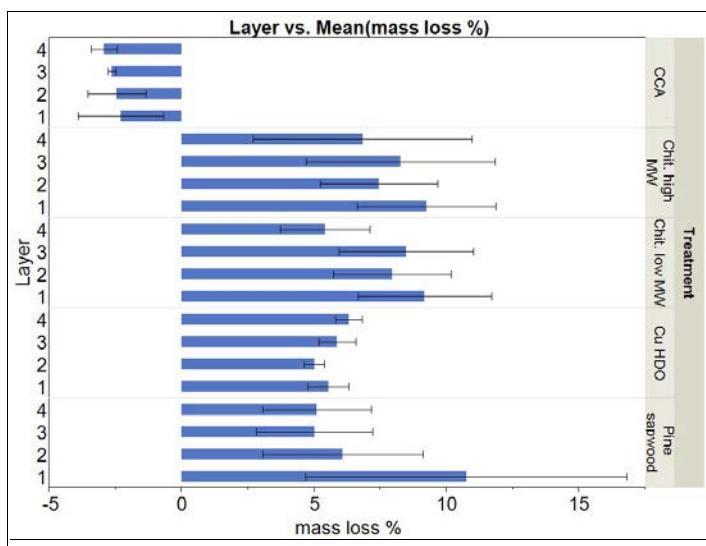
Figure 3. The bottom layer (1) had higher mass loss than the other layers and no significant differences were found between layer 2, 3 and 4. Each error bar is constructed using 1 standard deviation from the mean.

In Fig. 3 are mean mass loss of the different layers in the block illustrated. Except the untreated samples in the bottom layer (significant increase in decay), and the top layer of the chitosan LMW

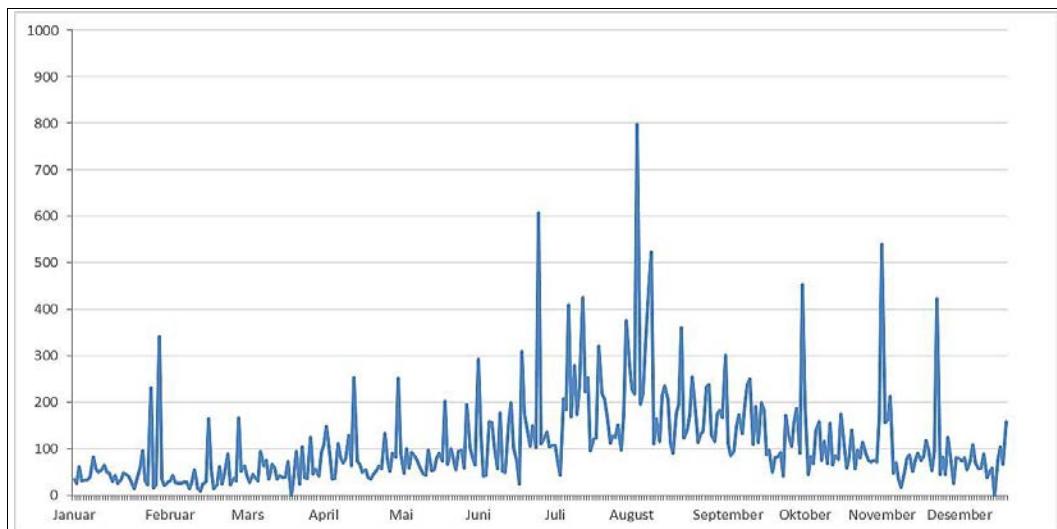
Figur 1. Grafisk fremstilling av gjennomsnittlig kde (kolonidannende enhet)/m³ pr. dag. Mengden muggsoppsporer er basert på 3 års prøvetaking av uteluft (n = 5876).

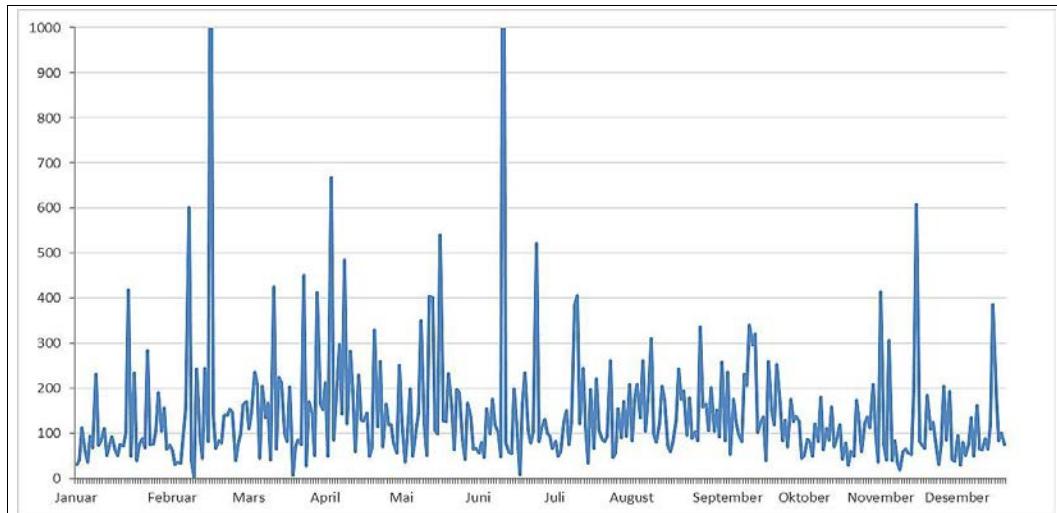
Figur 2. Grafisk fremstilling av gjennomsnittlig kde/m³ pr. dag. Muggsopp mengder basert på 3 års prøvetaking av inneluft (n = 6100).

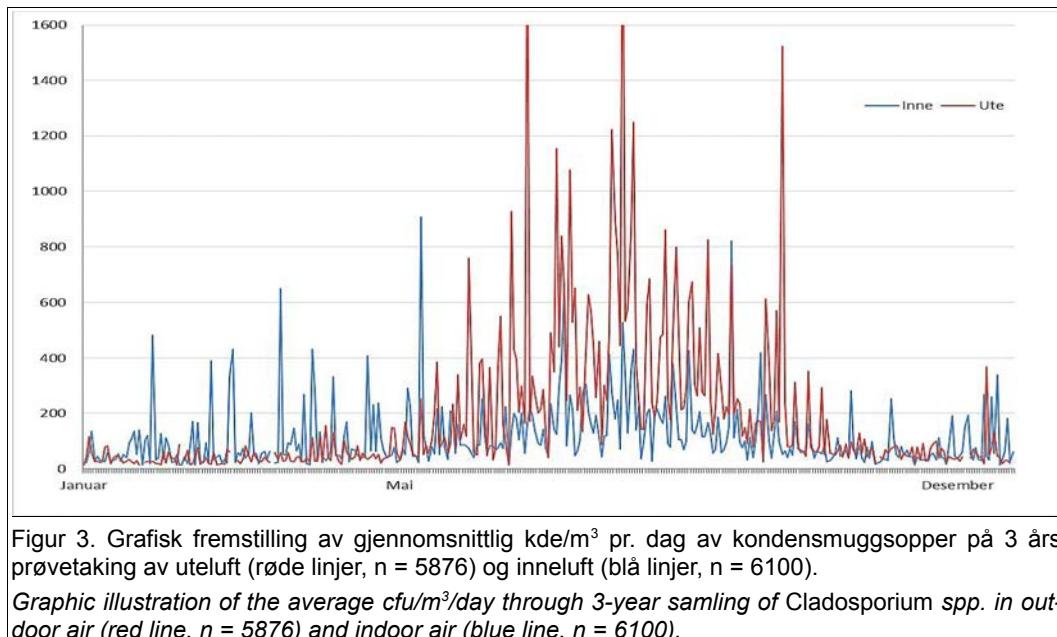
Figur 3. Grafisk fremstilling av gjennomsnittlig kde/m³ pr. dag av kondensmuggsopper på 3 års prøvetaking av uteluft (røde linjer, n = 5876) og inneluft (blå linjer, n = 6100).

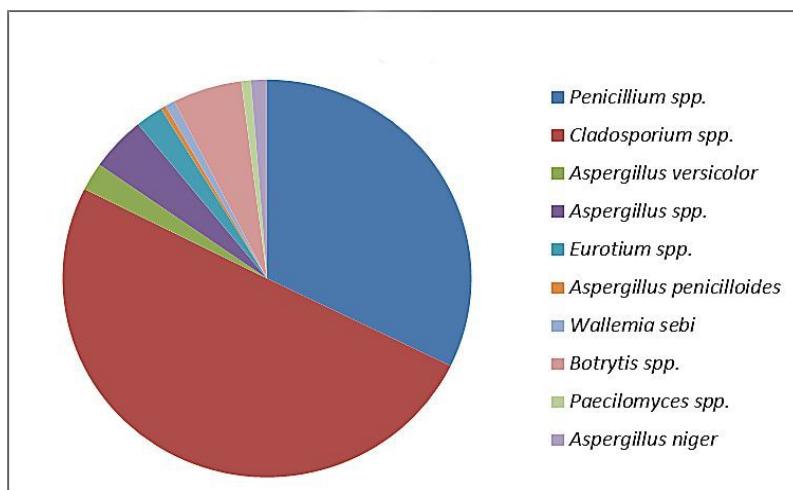
Figur 5. Relativ fordeling av de ti vanligst forekommende muggsopp-slekten og arter i uteluft.

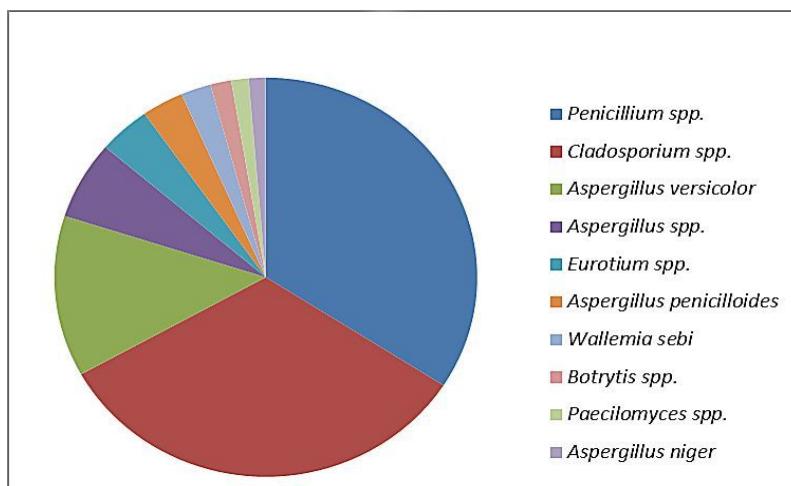
Figur 6. Relativ fordeling av de ti vanligst forekommende muggsopp-slekten og arter i inneluft.

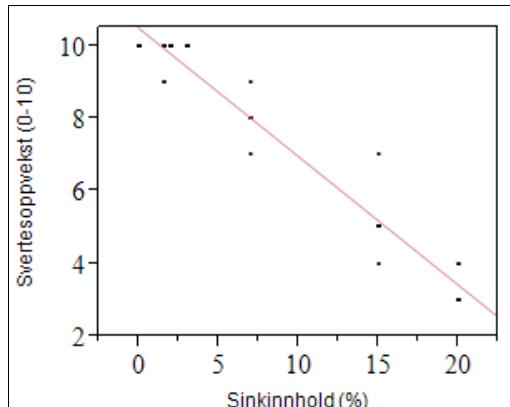
Figur 1. Svertesoppvekst korrelert med sinkinnhold i de syv linoljemalingene ($R^2=0,9508$).
Mould growth rating correlated with amount of zinc in the seven linseed oil paints ($R^2=0,9508$).

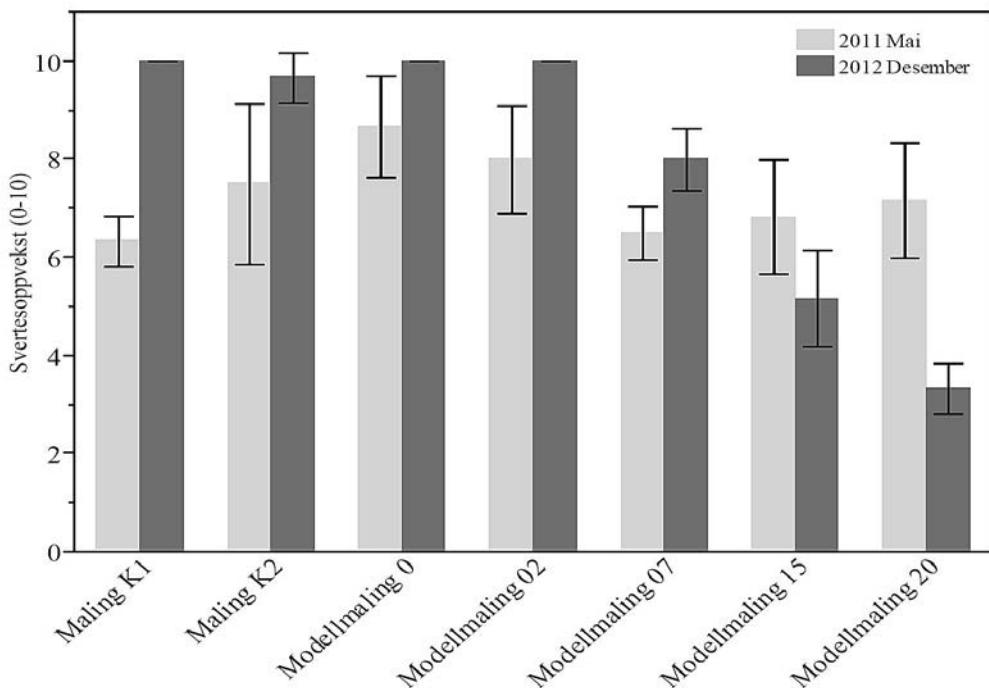
Figur 2. Svertesoppvekst på testmalingene etter 8 måneder og 27 måneder utendørs eksponering.
Mould growth rating for the test paints after 8 and 27 months outdoors exposure.

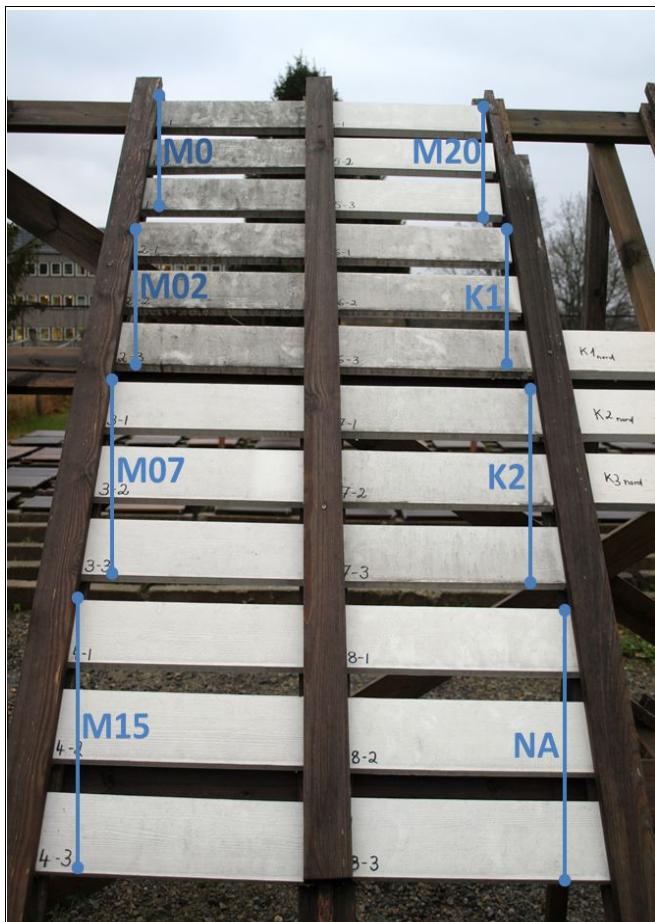
Figur 3. Svertesoppvekst på testmalingene etter 13 måneder utendørs eksponering. M0=modellmaling 0, M02=modellmaling 02, M07=modellmaling 07, M15=modellmaling 15, M20=modellmaling 20, K1=maling K1, K2=maling K2, NA=prøvepaneler ikke med i testen.

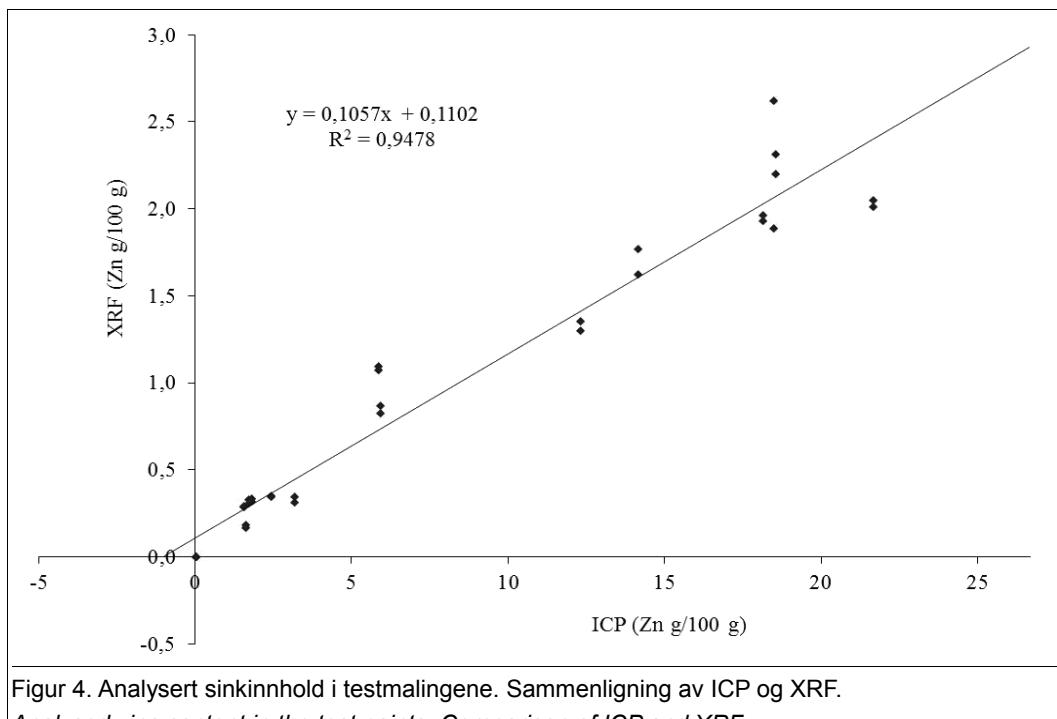
Figur 4. Analysert sinkinnhold i testmalingene. Sammenligning av ICP og XRF.

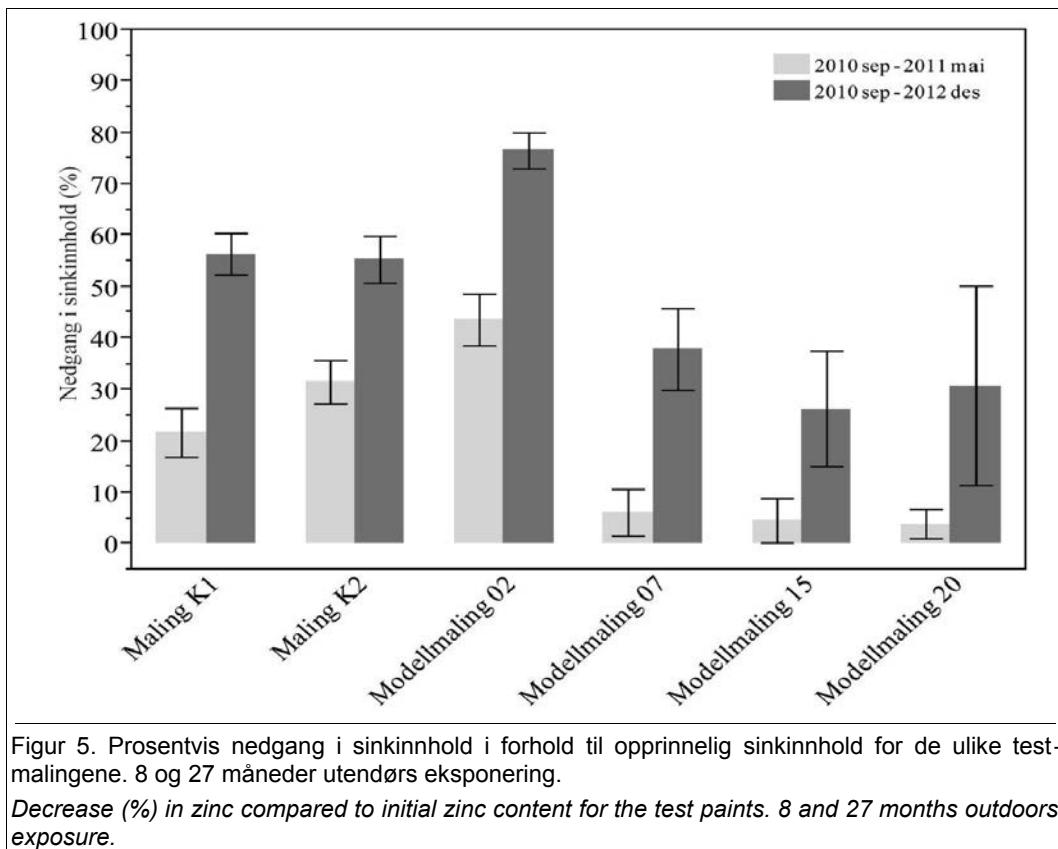
Figur 5. Prosentvis nedgang i sinkinnhold i forhold til opprinnelig sinkinnhold for de ulike testmalingene. 8 og 27 måneder utendørs eksponering.

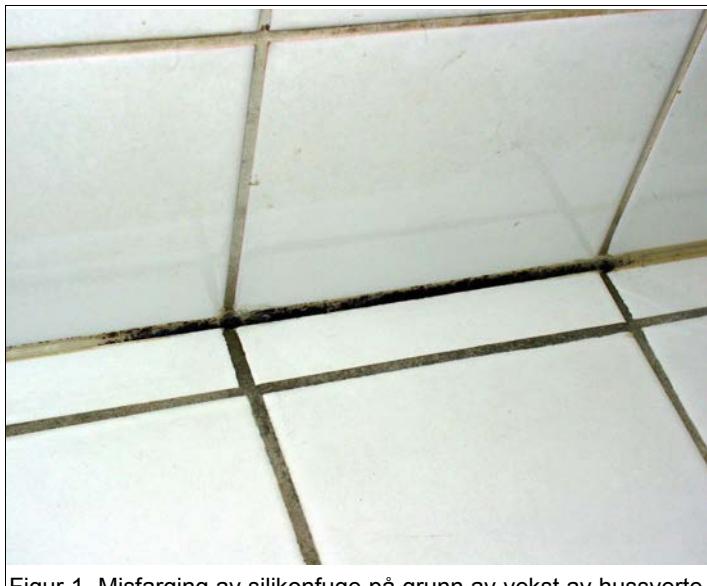
Figur 1. Misfarging av silikonfuge på grunn av vekst av hussverte-mugg.

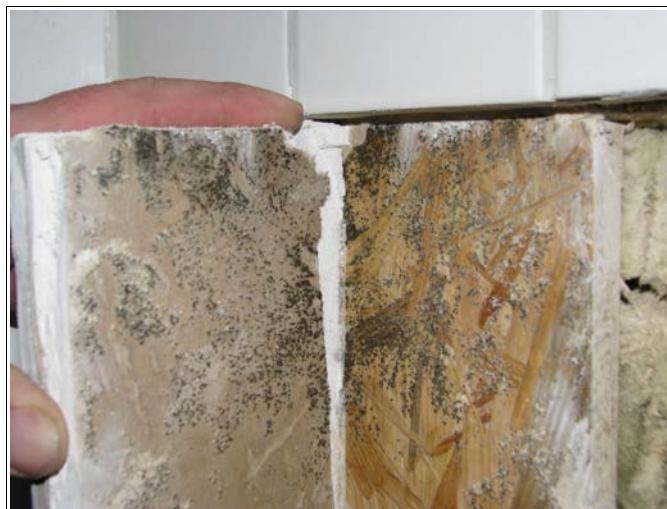
Figur 2. Kraftig vekst av raggråtemugg i en dusjvegg.
Extensive growth of *Chaetomium globosum* in a shower wall.
Foto: Mycoteam as.

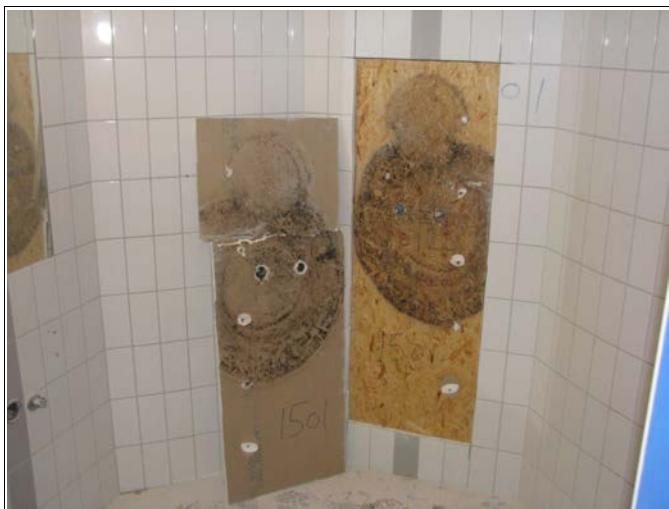
Figur 3. Karakteristisk muggsoppskade i avdekket dusjvegg.
Characteristic mould damage in exposed shower wall. Foto:
Mycoteam as.

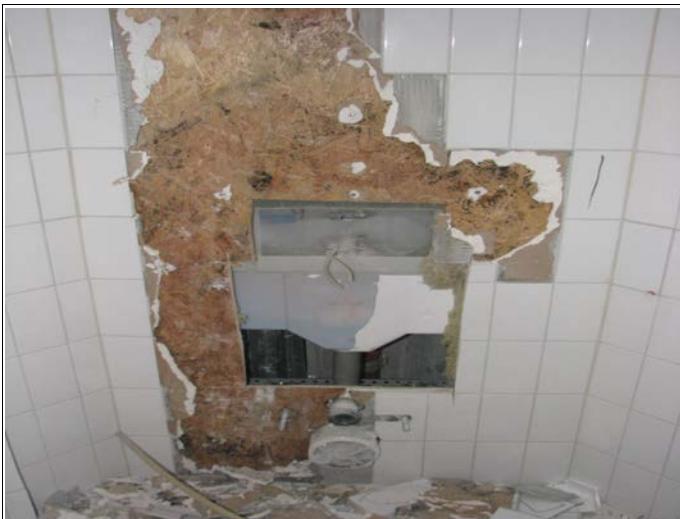
Figur 4. Lekkasje på innebygget toalettsisterne og vekst av svart vannskademugg var vanlig forekommende i de undersøkte badene.
*Leakage of built-in toilet cistern and growth of *Stachybotrys chartarum* was commonly encountered in the surveyed bathrooms.* Foto: Mycoteam as.

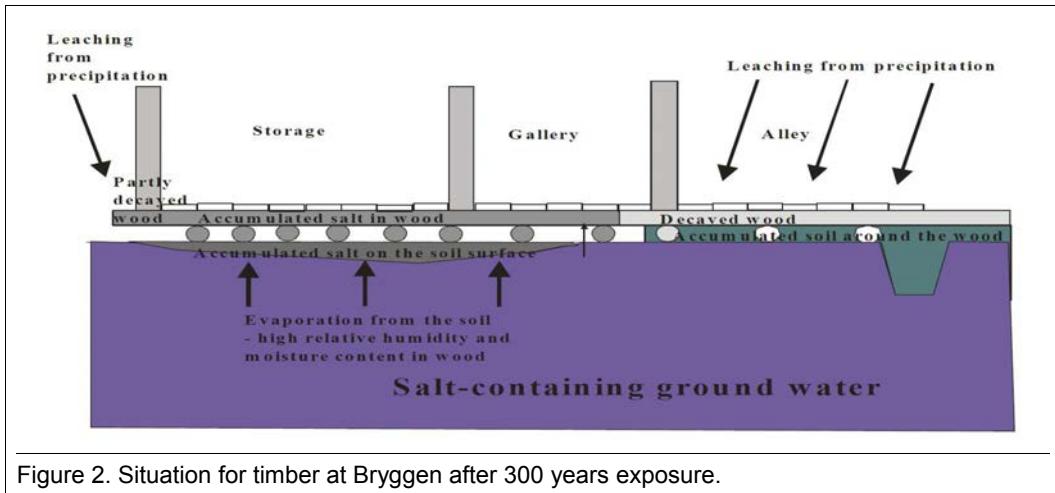
Figure 2. Situation for timber at Bryggen after 300 years exposure.

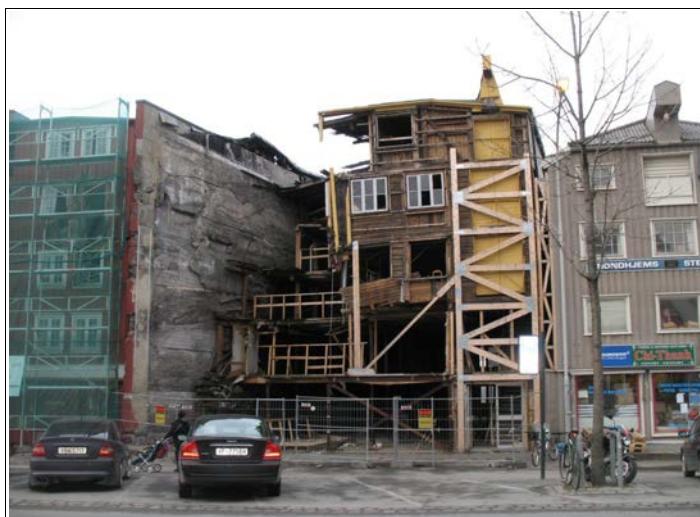
Figure 3. Fjordgata 76, Trondheim, 11 months after the fire. Photo: Mycoteam as.

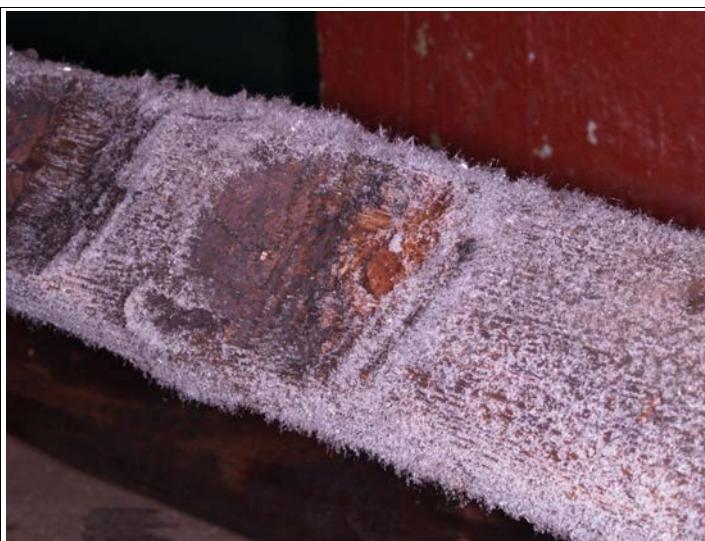
Figure 4. Accumulated salt crystals on wooden surfaces in a crawlspace under buildings at Bryggen in Bergen. Photo: Mycoteam as.

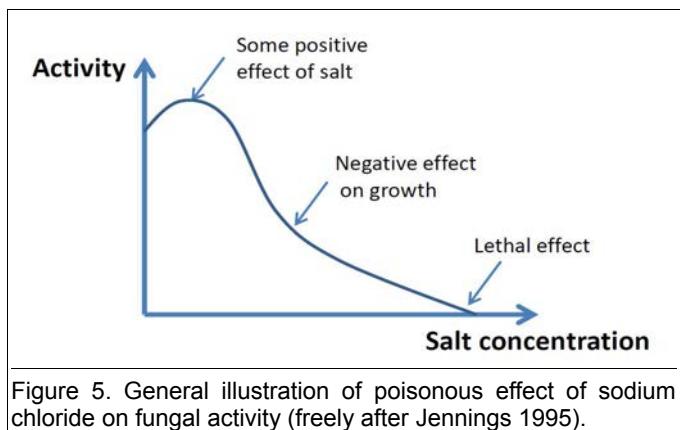
Figure 5. General illustration of poisonous effect of sodium chloride on fungal activity (freely after Jennings 1995).

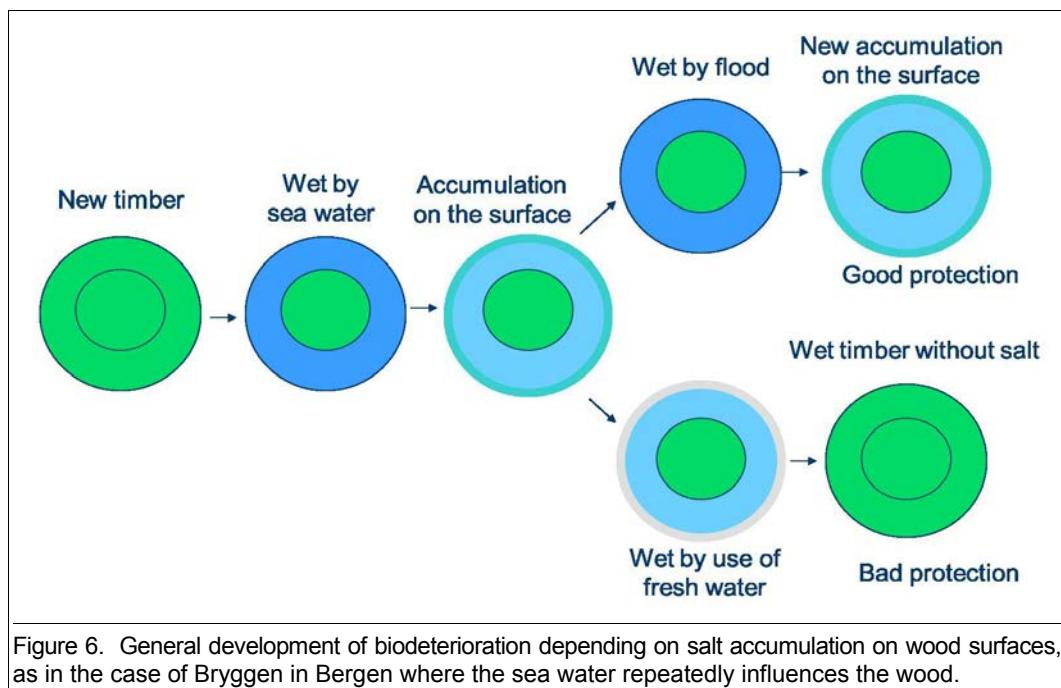
Figure 6. General development of biodeterioration depending on salt accumulation on wood surfaces, as in the case of Bryggen in Bergen where the sea water repeatedly influences the wood.
