AGARICA

Mykologisk tidsskrift utgitt av Norges sopp- og nyttevekstforbund

Spesialutgave – Soppskader i bygg og trekonstruksjoner

Special issue – Fungal damages in buildings and wooden constructions

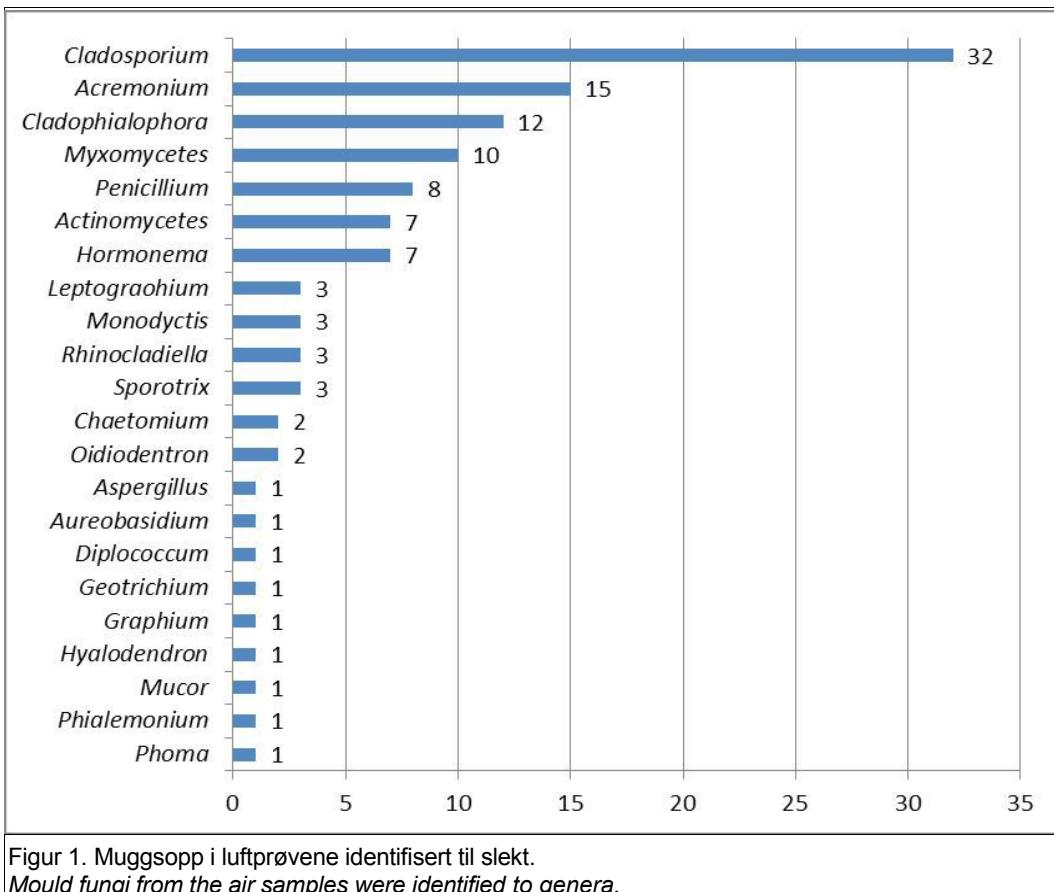
Figur 1. Muggsopp i luftprøvene identifisert til slekt.
Mould fungi from the air samples were identified to genera.

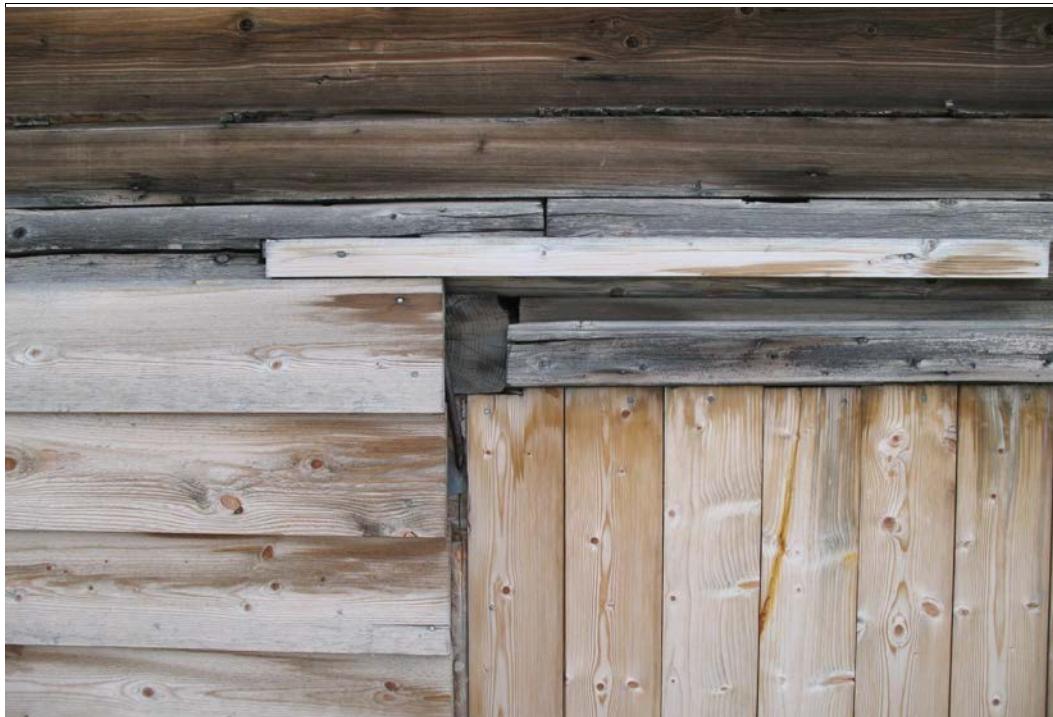
Figur 2. Vekst av svertesopp skjer gradvis på nye trematerialer, særlig i forbindelse med direkte fuktbelastet treverk.

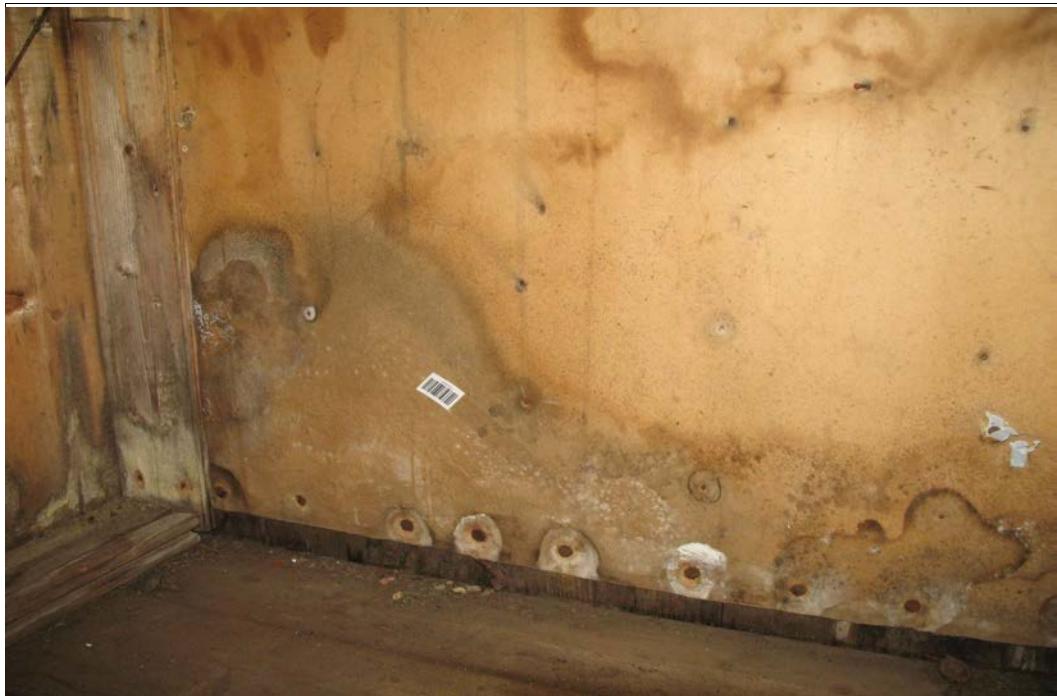
Figur 3. Muggsoppskaden er godt etablert der det er en kombinasjon av stor fuktbelastning og gunstig temperatur, det vil si langs nedre del av veggen.

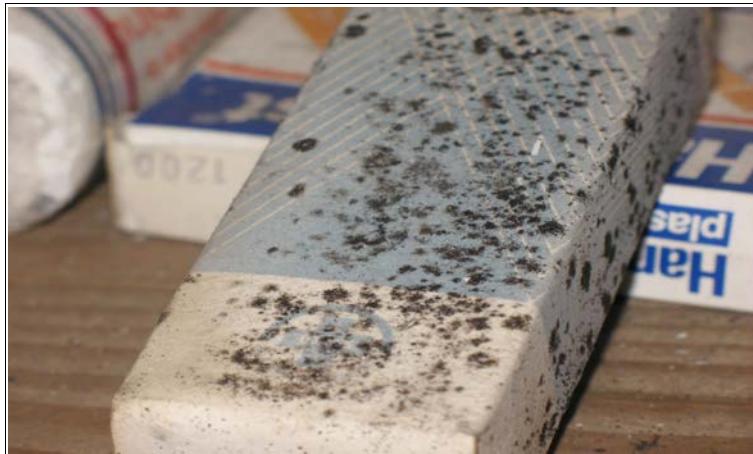
Figur 4. På grunn av høy relativ luftfuktighet i bygninger uten permanent oppvarming, kan det vokse kondensmuggsopper (*Cladosporium* sp.) på ulike overflater.

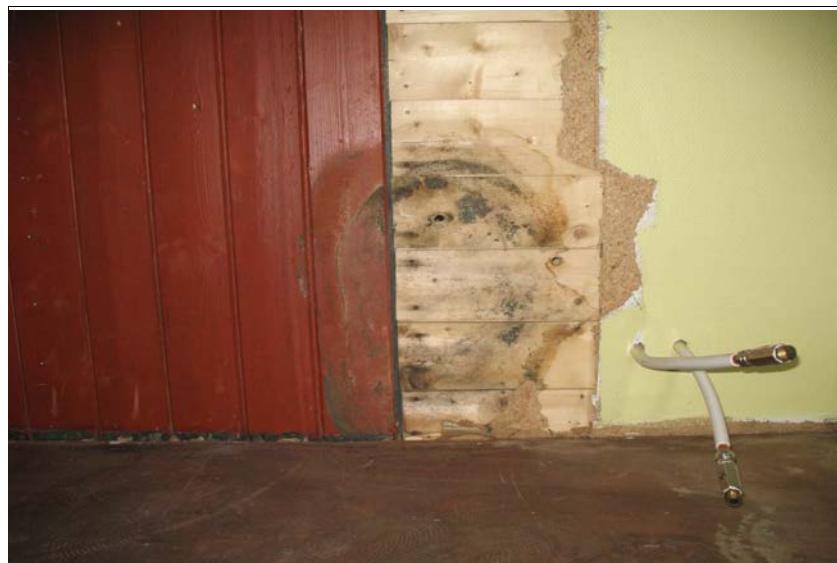
Figur 5. I forbindelse med enn vannlekkasje ble det en lokalt kraftig vekst av raggråtemugg (*Chaetomium globosum*).
