TELEVISION

SERVICING.VIDEO.SATELLITE.DEVELOPMENTS

FEBRUARY 2000 £2.80

February 2000

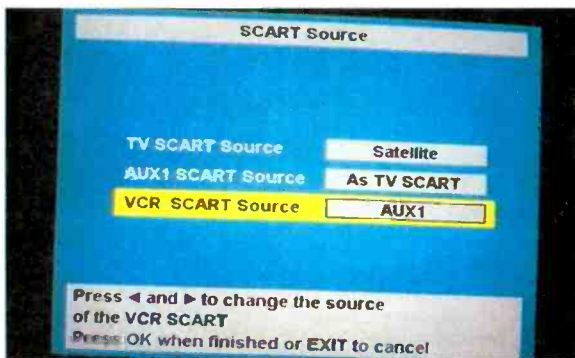
Photo 10: Scart video output display.
