TELEVISION

JULY 1996 £2.35

**Servicing the
Mitsubishi
Euro 6 chassis**

Fault Reports TVs, VCRs, Camcorders and Satellite

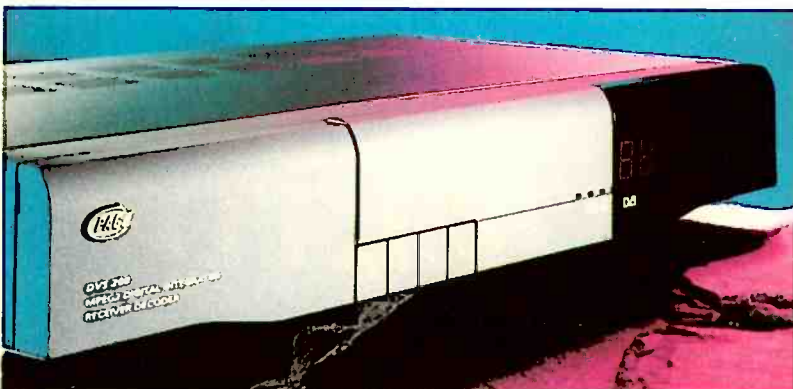
The Pace DVS200 MPEG-2 digital integrated receiver-decoder.

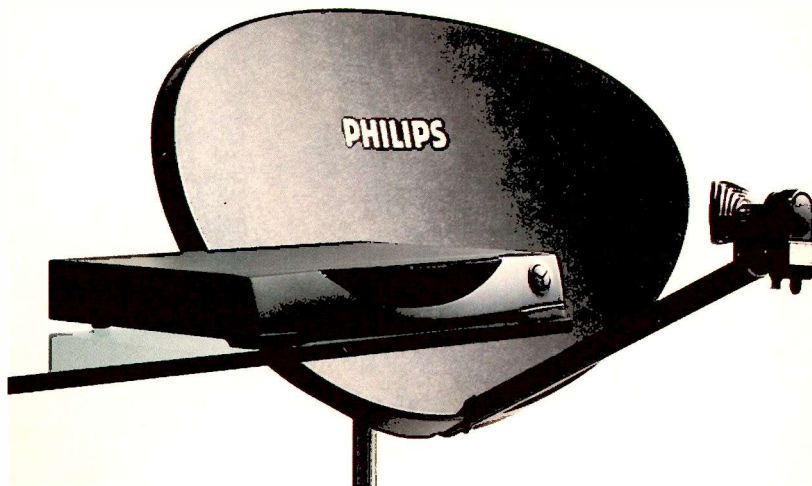
The Philips STU3510 satellite receiver, shown with the Philips SD8610 elliptical satellite dish.

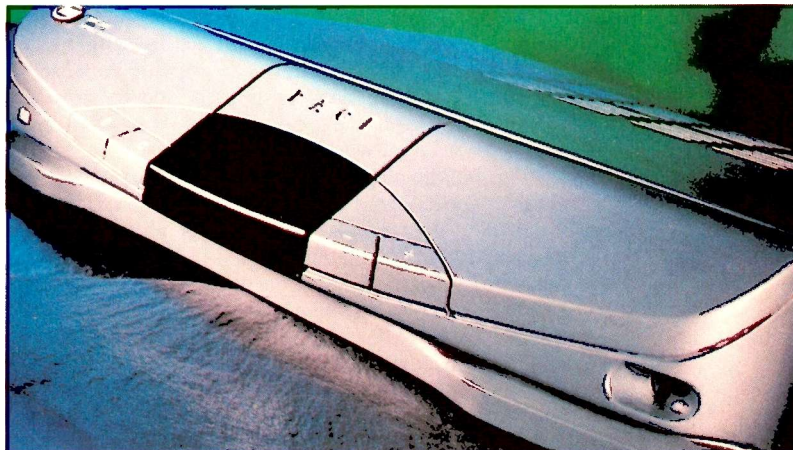
The Pace DVC200 MPEG-2 digital set-top box, which is designed for use with cable TV systems. It can download software off-air and has a modem return path for interactive services.

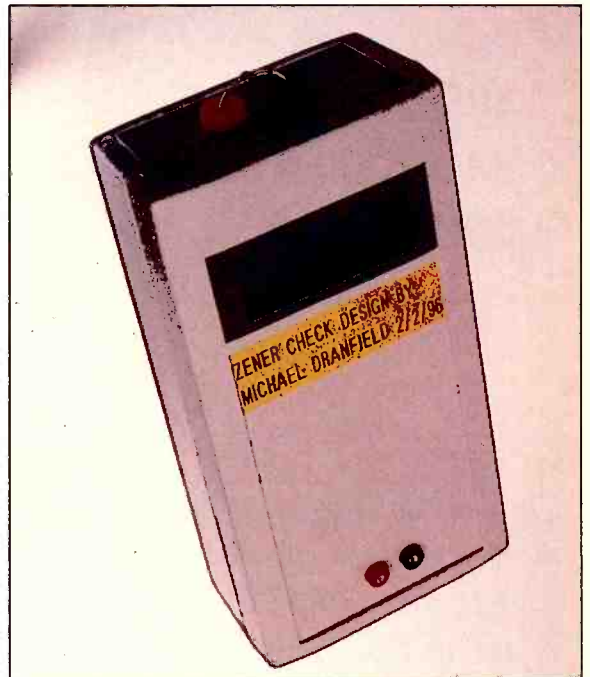
The circuit of the tester is shown in Fig. 1. It employs a single-transistor oscillator that runs at approximately 3kHz. Mains transformer T1 is used in reverse: its centre-tapped 4.5-0-4.5V winding is the oscillator transistor's load, the 0-240V winding stepping up the voltage to feed bridge rectifier BR1. When pushbutton switch PB1 is pressed, a voltage starts to build up across the rectifier's reservoir capacitor C4. This build up continues until the zener diode being tested starts to conduct. The conduction point is the diode's zener breakdown voltage, and is displayed directly by the LCD panel. R2 limits the current flowing through the diode to about 5mA.

The display device is a digital LCD voltmeter module that's available from Maplin. It has a maximum read out of 199.9V, which is not a problem since zener diodes with a higher breakdown voltage are rarely used. R3 and R4 calibrate the meter: the LCD module has a built-in preset for fine adjustment.

Approximately 350V is developed across C4. If the unit is run without a zener diode in circuit the display will over-range, displaying a one. No damage will be done to the display, but if you wish you can limit the test voltage at approximately 200V by connecting a 1.2M Ω resistor across C4.

Fig. 1: Circuit diagram of the tester. Do not connect the negative side of C4 to the battery's negative terminal, as the LCD panel won't work in this condition.

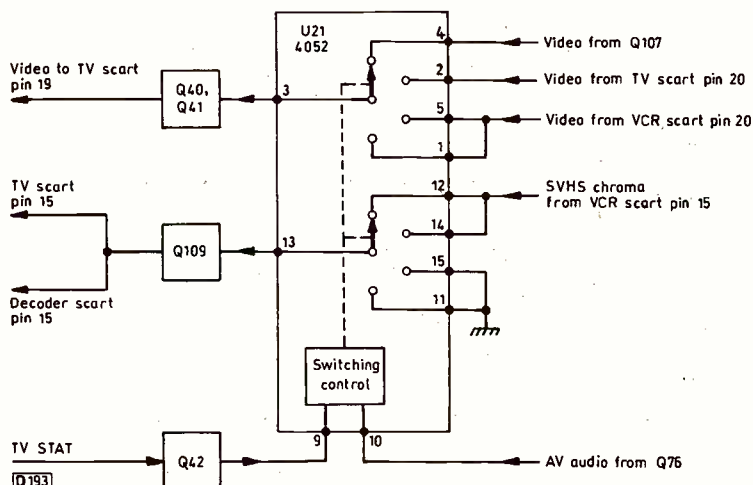
Fig. 8: Block diagram showing the video signal source selection arrangement.

Note that the satellite TV video feed may consist of video from the AV1 or AV2 (auxiliary and decoder) scart sockets, selected by U26 (see Fig. 6 last month). Also that it's not possible to view satellite TV via the TV scart socket and send audio and video from the VCR scart socket to the modulator for an RF link to another room simultaneously.
