# Hose break on a mobile tank containing agricultural ammonia

12<sup>th</sup> May, 1969

Les Grandes Armoises (08)

Agricultural anhydrous ammonia (fertilizer)  
 Mobile tank  
 Hose  
 Maintenance / repairs

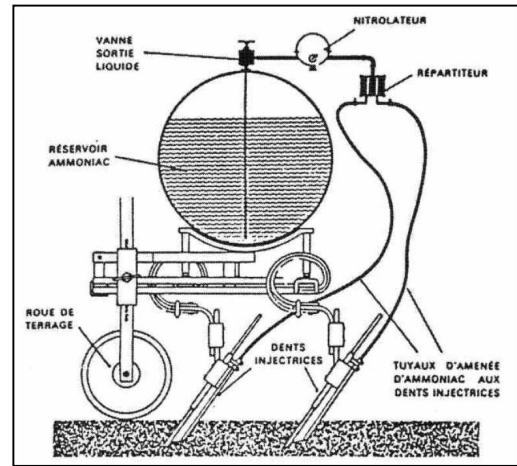
Sketch of an incorporator

The facility was composed of a stationary tank of pressurised liquid ammonia used as the primary means of storage during fertilisation campaigns, along with 2 mobile tanks hitched to a tractor. An "incorporator" attached to the tractor served to inject the ammonia in liquid phase directly into the soil.

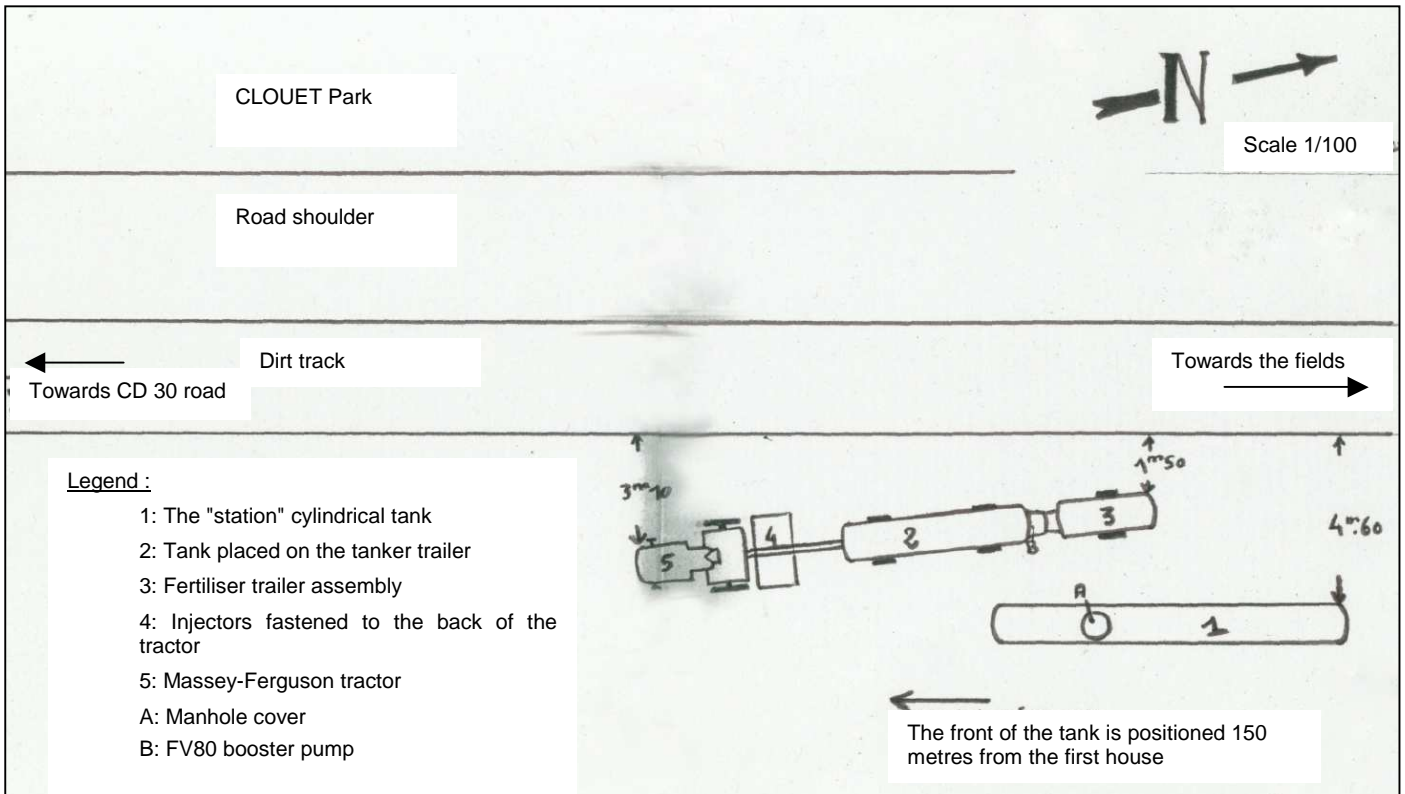
The stationary tank (marked no. 1 on the sketch), built in 1966, had a capacity of 7,176 litres, a length of 9.45 m and a 1-m diameter. Its maximum service pressure was equal to 20 bar, with the most recent equipment test under pressurised conditions dating back to December 19, 1966. Its 8-mm thick shell was composed of 6 elements. Filled just 2 days prior, the shell was nearly full. The tank was owned by the industrial firm that performed the installation on behalf of the contracting farmer. The tank and its accessories (manometer, safety valve, etc.) were in good working order [3].

The mobile tank (indicated as no. 2 on the sketch), also built in 1966 and installed onto a farm trailer, featured a capacity of 3,680 litres for a maximum service pressure of 20 bar. This assembly was in good condition as well and belonged to the farm. The most recent equipment inspection by the industrial firm was logged on 15 February, 1968 [3].

The "fertilising trailer" set-up (no. 3 on the sketch) was cylindrical with a dimension of 2.10 m and hitched to tanker trailer no. 2. It was pressurised (at 6 bar, according to the manometer) yet not connected to any pipes. The larger trailer was used as a backup in the fields, while the smaller one was more convenient during actual spreading operations.

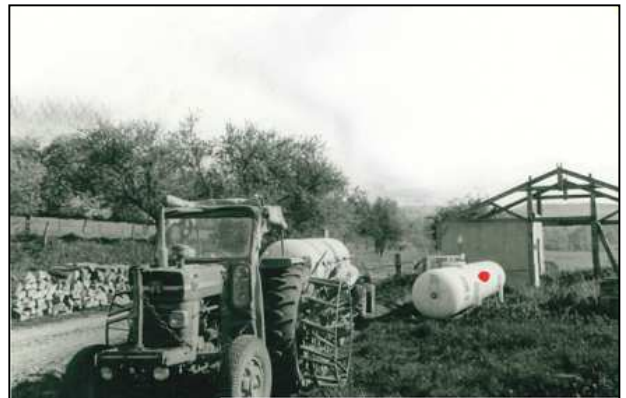
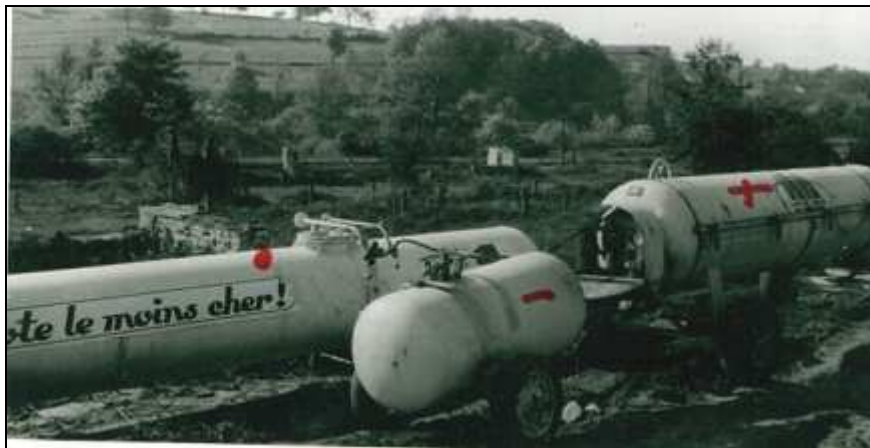
Red dot = stationary tank assembly (no. 1), red line = "working" trailer (no. 3), red cross = tanker trailer (no. 2)

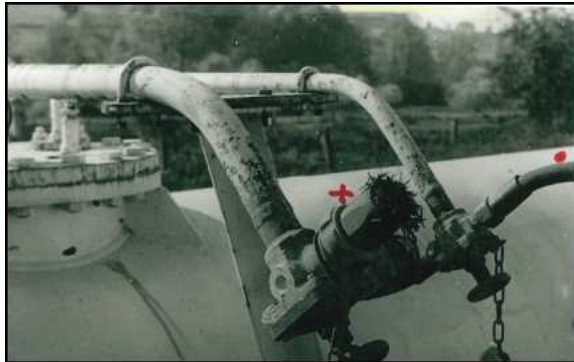
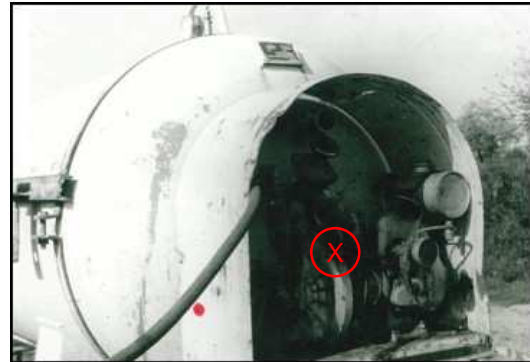
"Station" valves (cross = broken liquid hose, dot = gas hose); valves on the booster side in back of the tanker trailer (2)

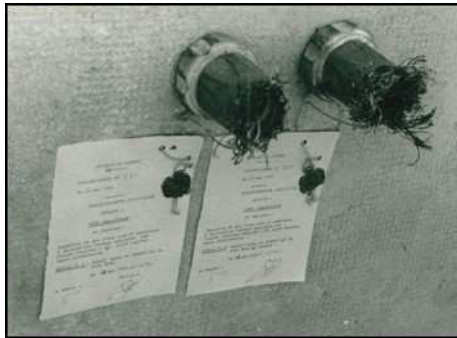
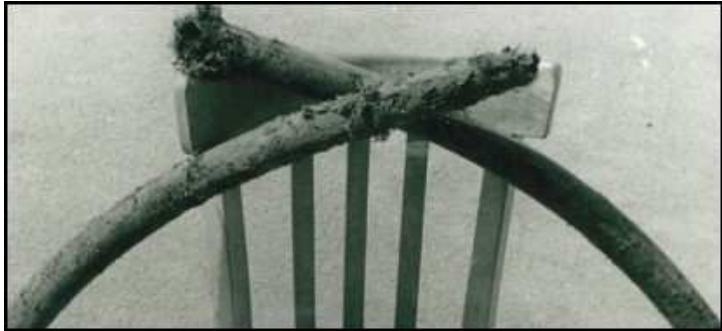
The liquid transfer pipe was in a poor state of repair: decomposed fabric in spots, the metal braid completely worn away and rusted.

The pipe burst at the level of the end fittings and moreover revealed a 4-cm burst hole at mid-length of the section.

This pipe had obviously been exposed to adverse weather conditions<sup>1</sup> and displayed signs of erosion due to rubbing as if it had been dragged along the ground [1].

The firm would have notified the farmer of the defective condition of the hose during an exchange held 3 days prior to the accident; the farmer had planned on changing this hose at the end of the growing season [3].

The firm responsible for the installation redesigned its plans and layout (protection of depots by a fence, sufficient distance from population centres, etc.) and modified its handling instructions. The equipment involved was gradually replaced by a new set-up featuring safety devices for dealing with the event of a hose break (e.g. a check valve).
