# Mindijup Silica Sand Mine

## Mine Closure Plan

TT Sand Pty Ltd T/A AustSand Mining

Revision 5

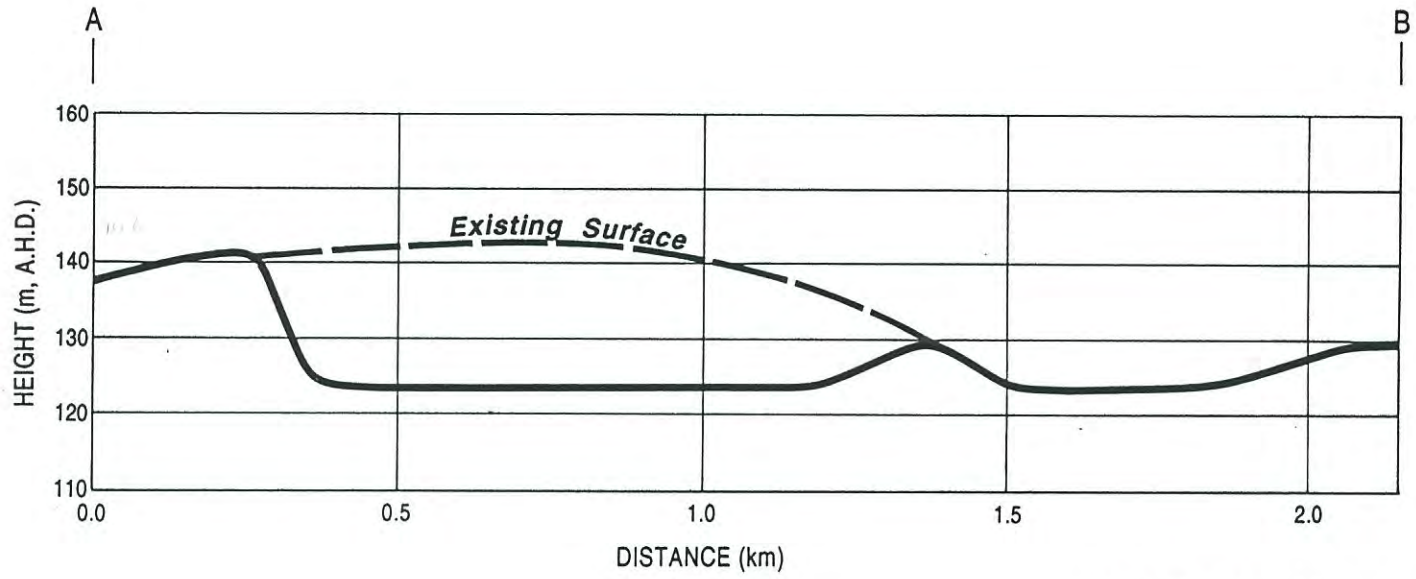
VERTICAL SCALE 1 : 100  
HORIZONTAL SCALE 1 : 12 500

**PRE AND POST  
SURFACE PROFILES**

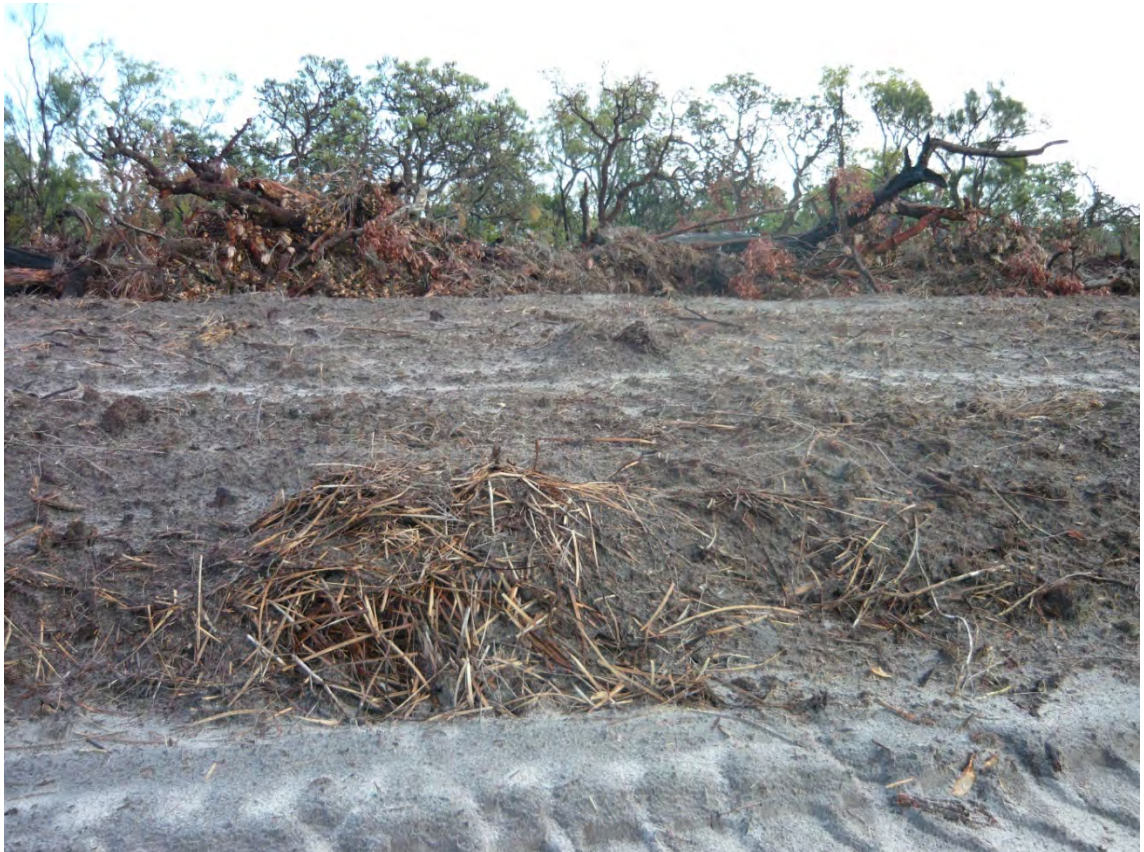
Plate 1 Topsoil and vegetation stockpiles

A layer of topsoil exists in the top 200 mm of the soil profile and is identified by the presence of organic material and a darker colour relative to the siliceous sands (Plate 1).

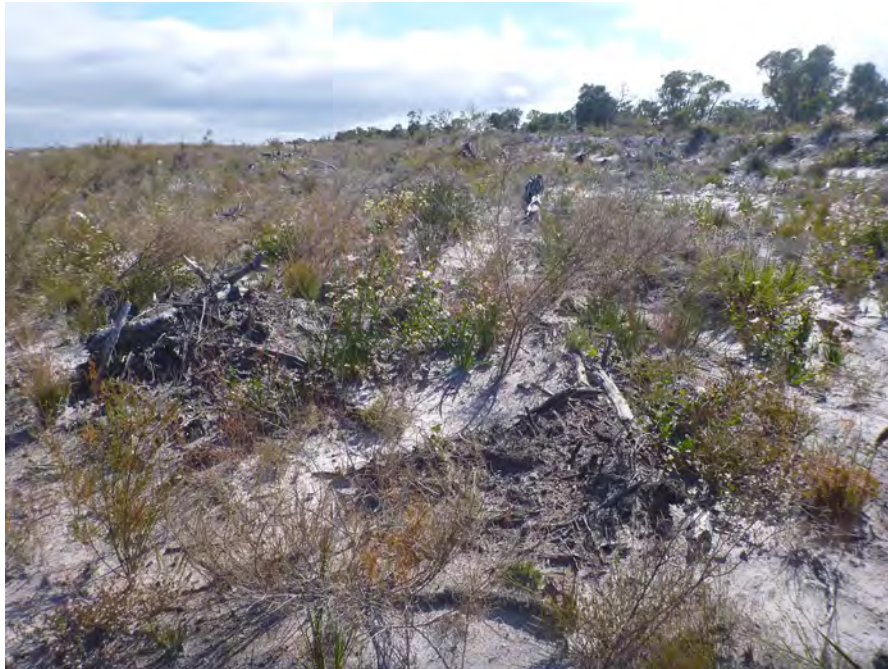
Images in Plates 2 and 3 of developing rehabilitated vegetation is shown below from the 2021 rehabilitation monitoring.

**Plate 2** *Rehabilitation date 2017 (MQ17 2021)*

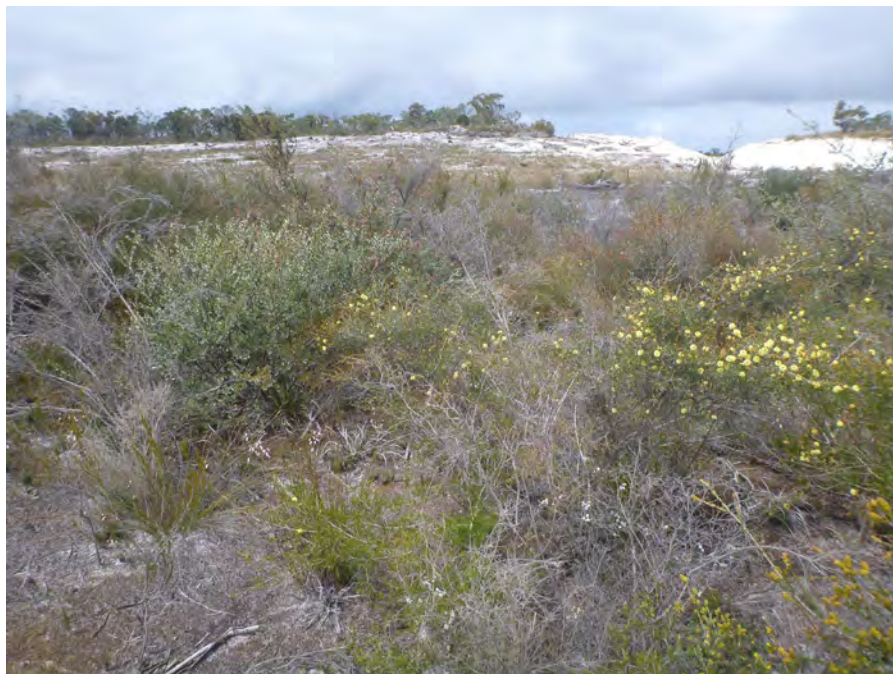
**Plate 3** *Rehabilitation date 2012 (MQ08 2021)*
