**LUMWANA COPPER PROJECT**

**ENVIRONMENTAL IMPACT ASSESSMENT**

**JULY 2005**

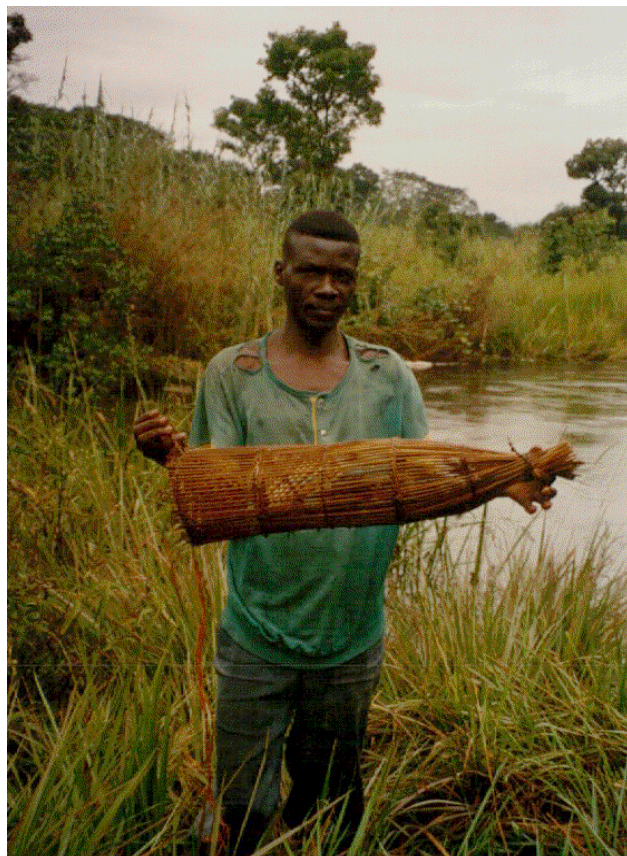
Plate 3-1:

Locally made wickerwork fish traps are used for fishing in the Lumwana East River and Malundwe and Chimiwungo Streams (see Plate 3.1). The fish traps are set to trap fish moving downstream with the current. This type of fish trap does not catch large numbers of fish and therefore does not adversely affect fish stock levels. Fishing is usually practiced in the dry season when the river levels are low.

Aquatic monitoring site Mal/AQF-02 - East Lumwana River.

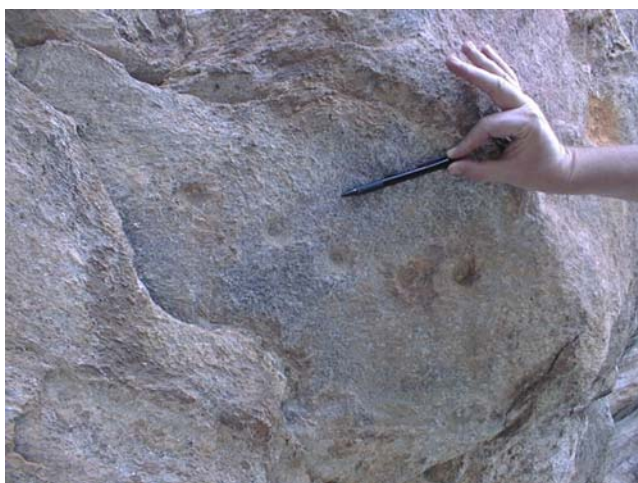
Plate 3.5: Rock Engravings at Lumwana Archaeological Site 2

This site is located just to the north of Site 1 and consists of 13 pock markings arranged in a circular pattern (see Plate 3.5). The engravings have not been affected by any human disturbance. No surface finds were made and there was no evidence of any local traditions associated with the site.

A 7 metre high rock shelter on the Lumwana East River (Cultural Heritage Site 2) is the only geomorphological feature of note identified in the project area.

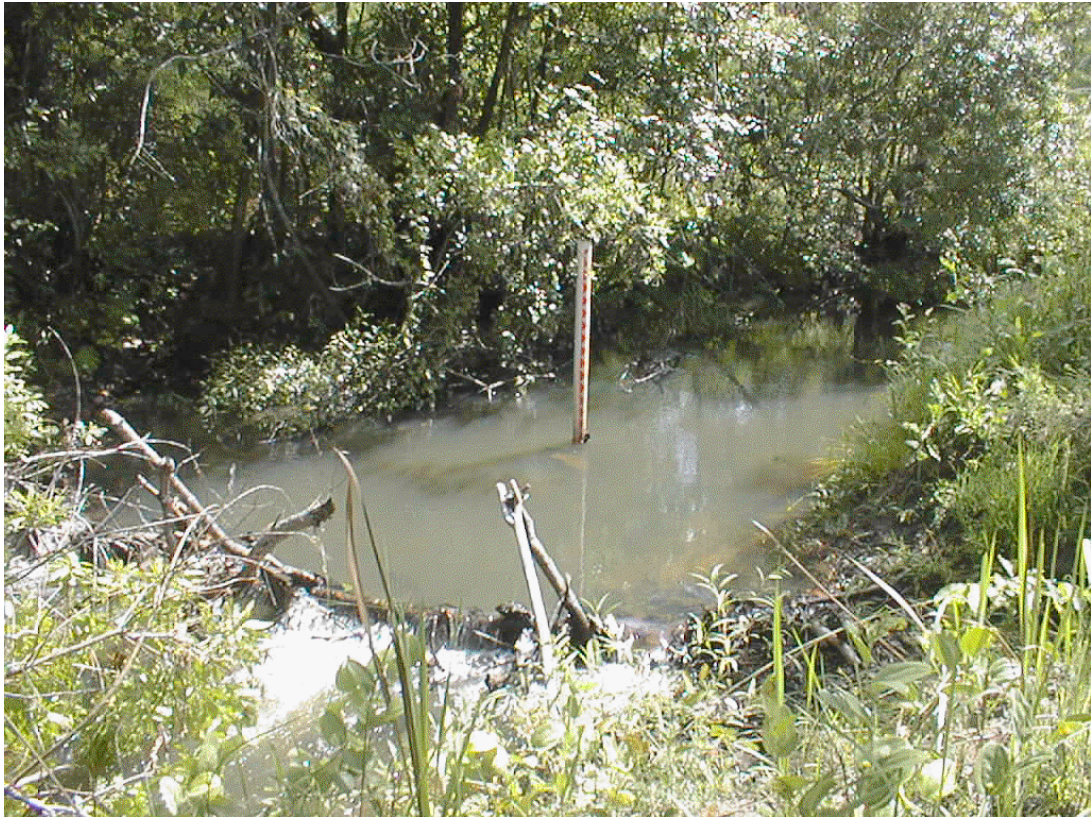
<b>STREAM NAME :</b> Malundwe Stream	<b>LOCATION:</b> Close to confluence with the Lumwana East River						
<b>STATION #:</b> Mal/AQF-04	<b>STREAM CLASS:</b> 4						
<b>FORM COMPLETED BY:</b> Henry Chikwala and Nyundo Armitage							
<b>DATE:</b> 26/01/02							
<b>TIME:</b> 09:50 hrs							
<b>UTM E:</b> 369212 <b>UTM N:</b> 8647264	<b>REASON FOR SURVEY:</b> Lumwana Copper Project - EIA						
<b>SITE PHOTOGRAPH:</b>
