DISCUSSION CALENDAR

AGENDA REPORT SUMMARY

Subject: Resolution No. 2018-36: Design Review for the new Los Altos Community Center

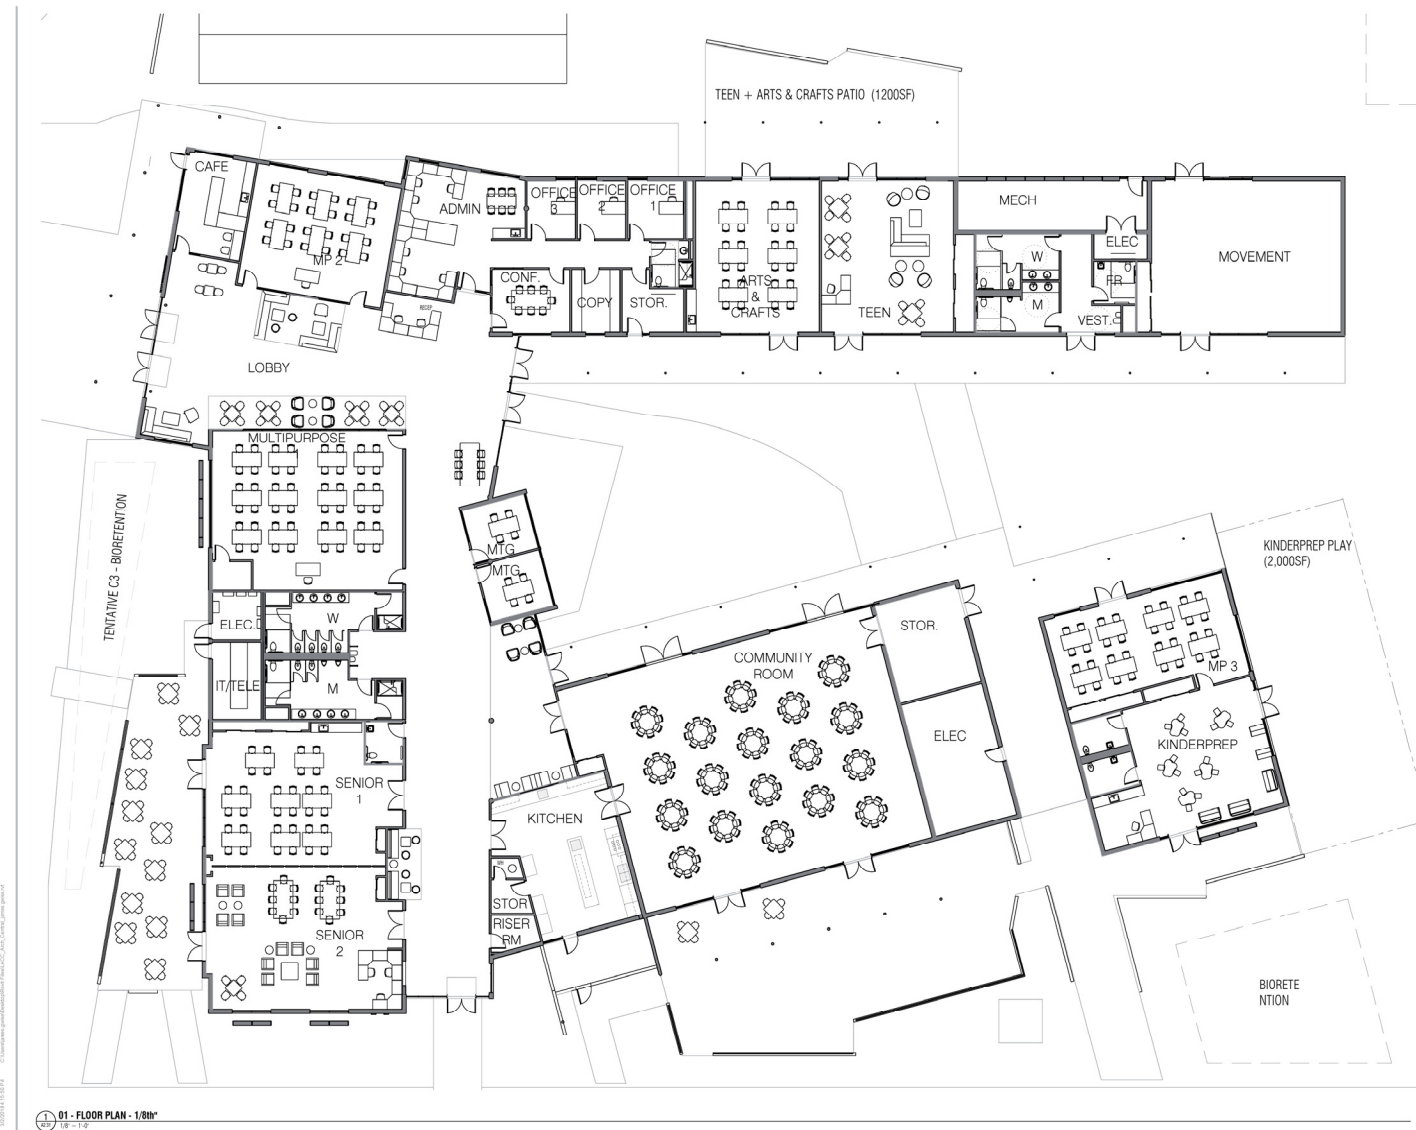
FIGURE 1: PROJECT SITE PLAN

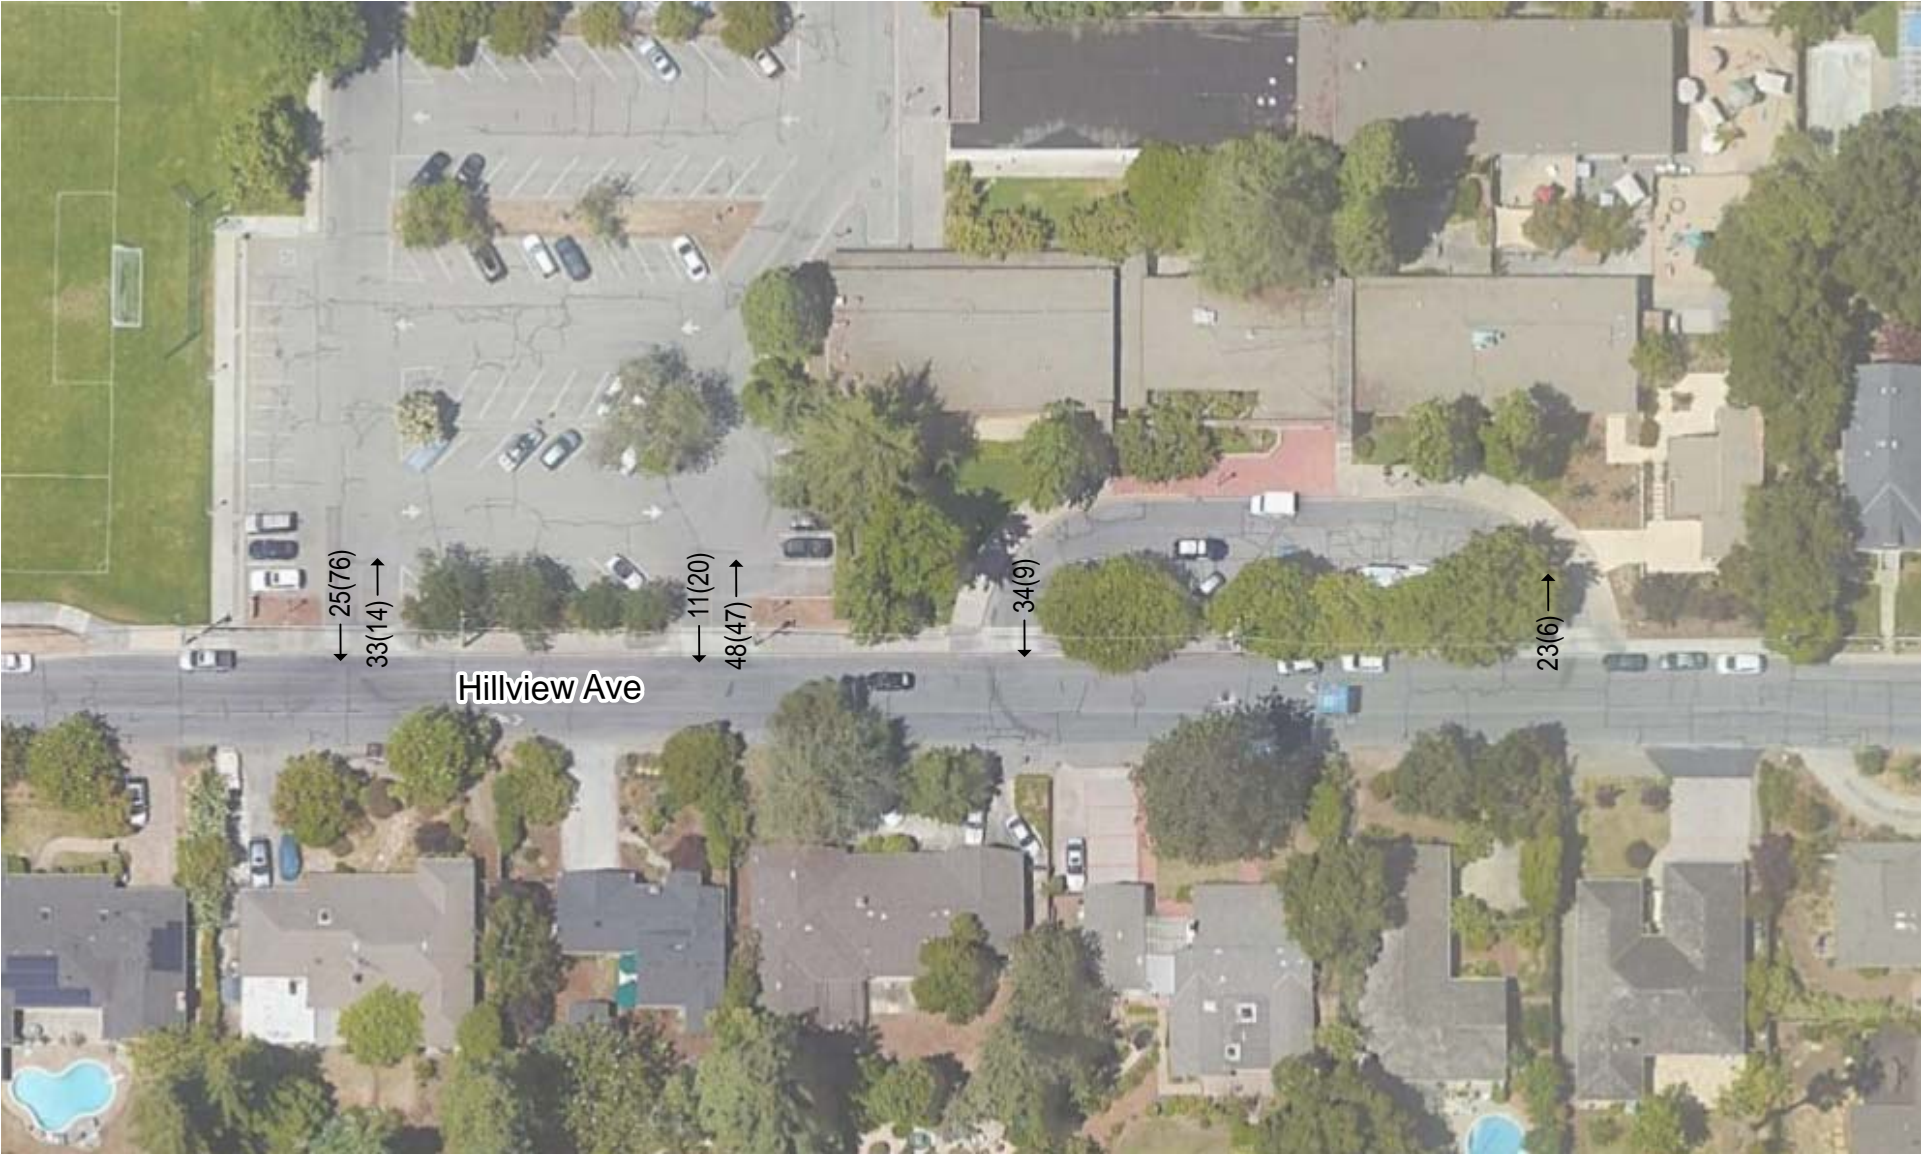
AM Peak Hour: 8:15 AM - 9:15 AM
PM Peak Hour: 5:00 PM - 6:00 PM

Figure 1
Peak Hour Volumes

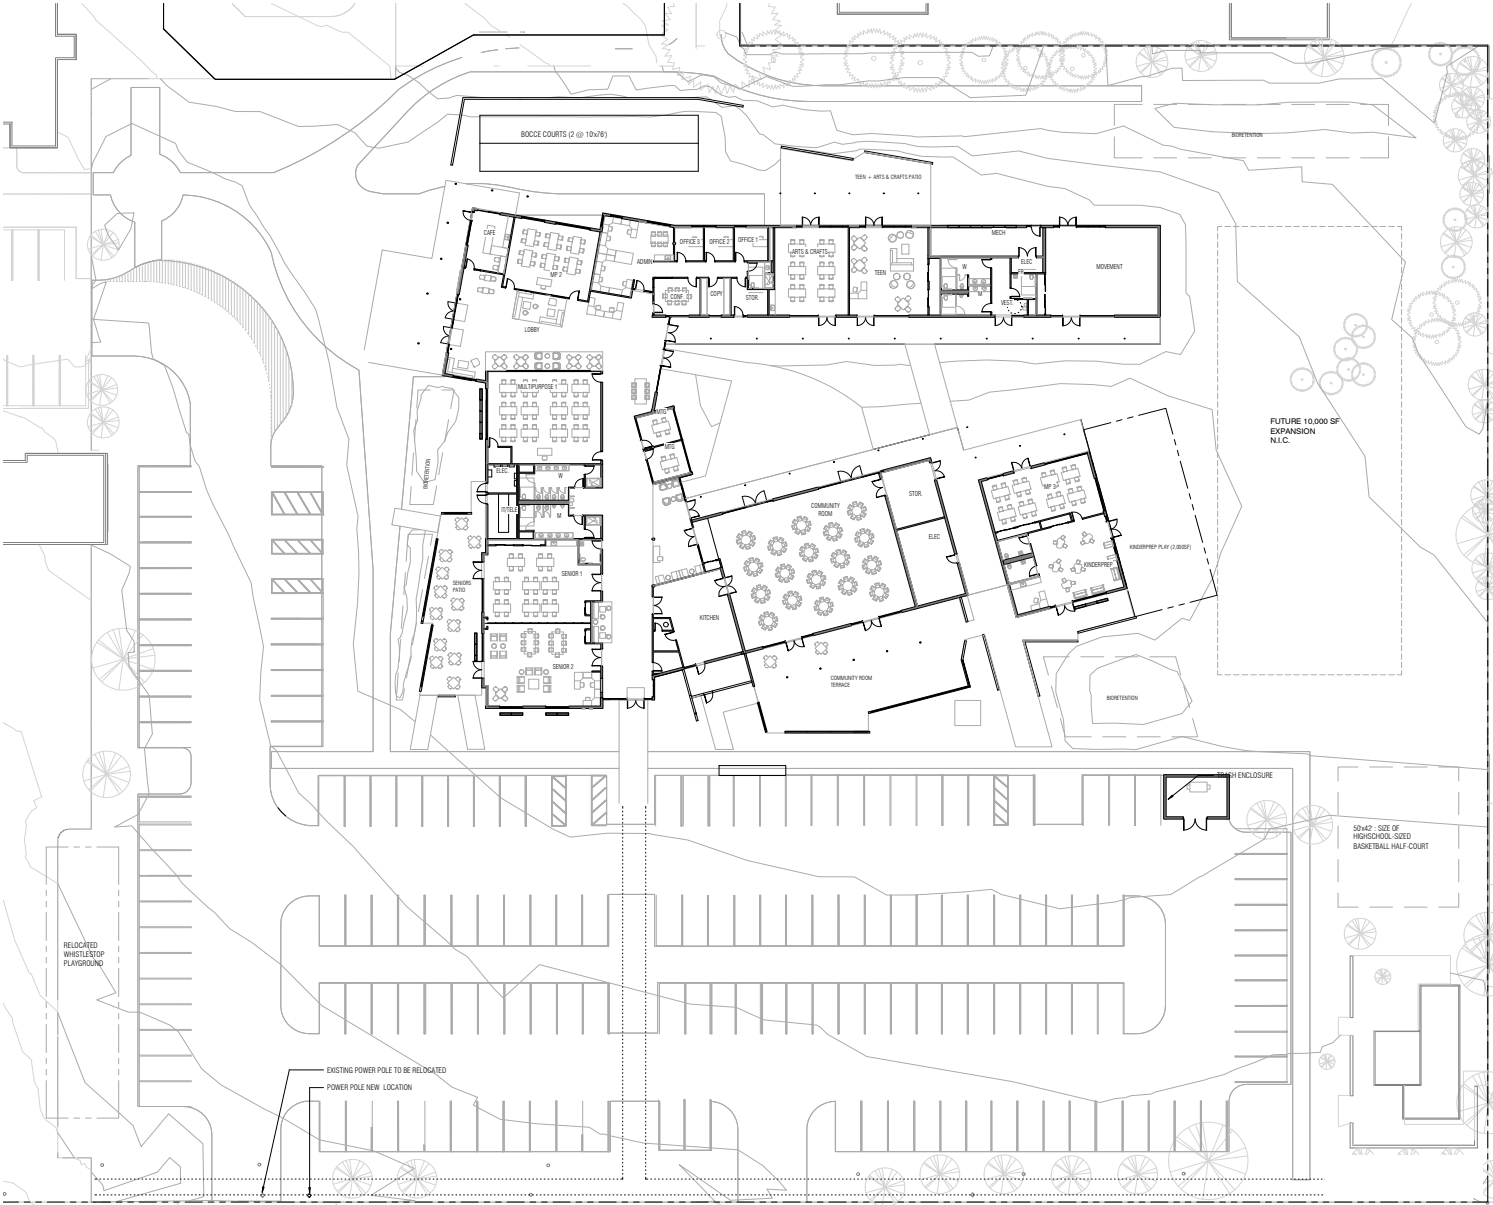
Figure 2
Proposed Site Plan
