# Widgiemooltha Pits

## Preliminary Clearing Impact Assessment and Vegetation Management Plan

July 2017

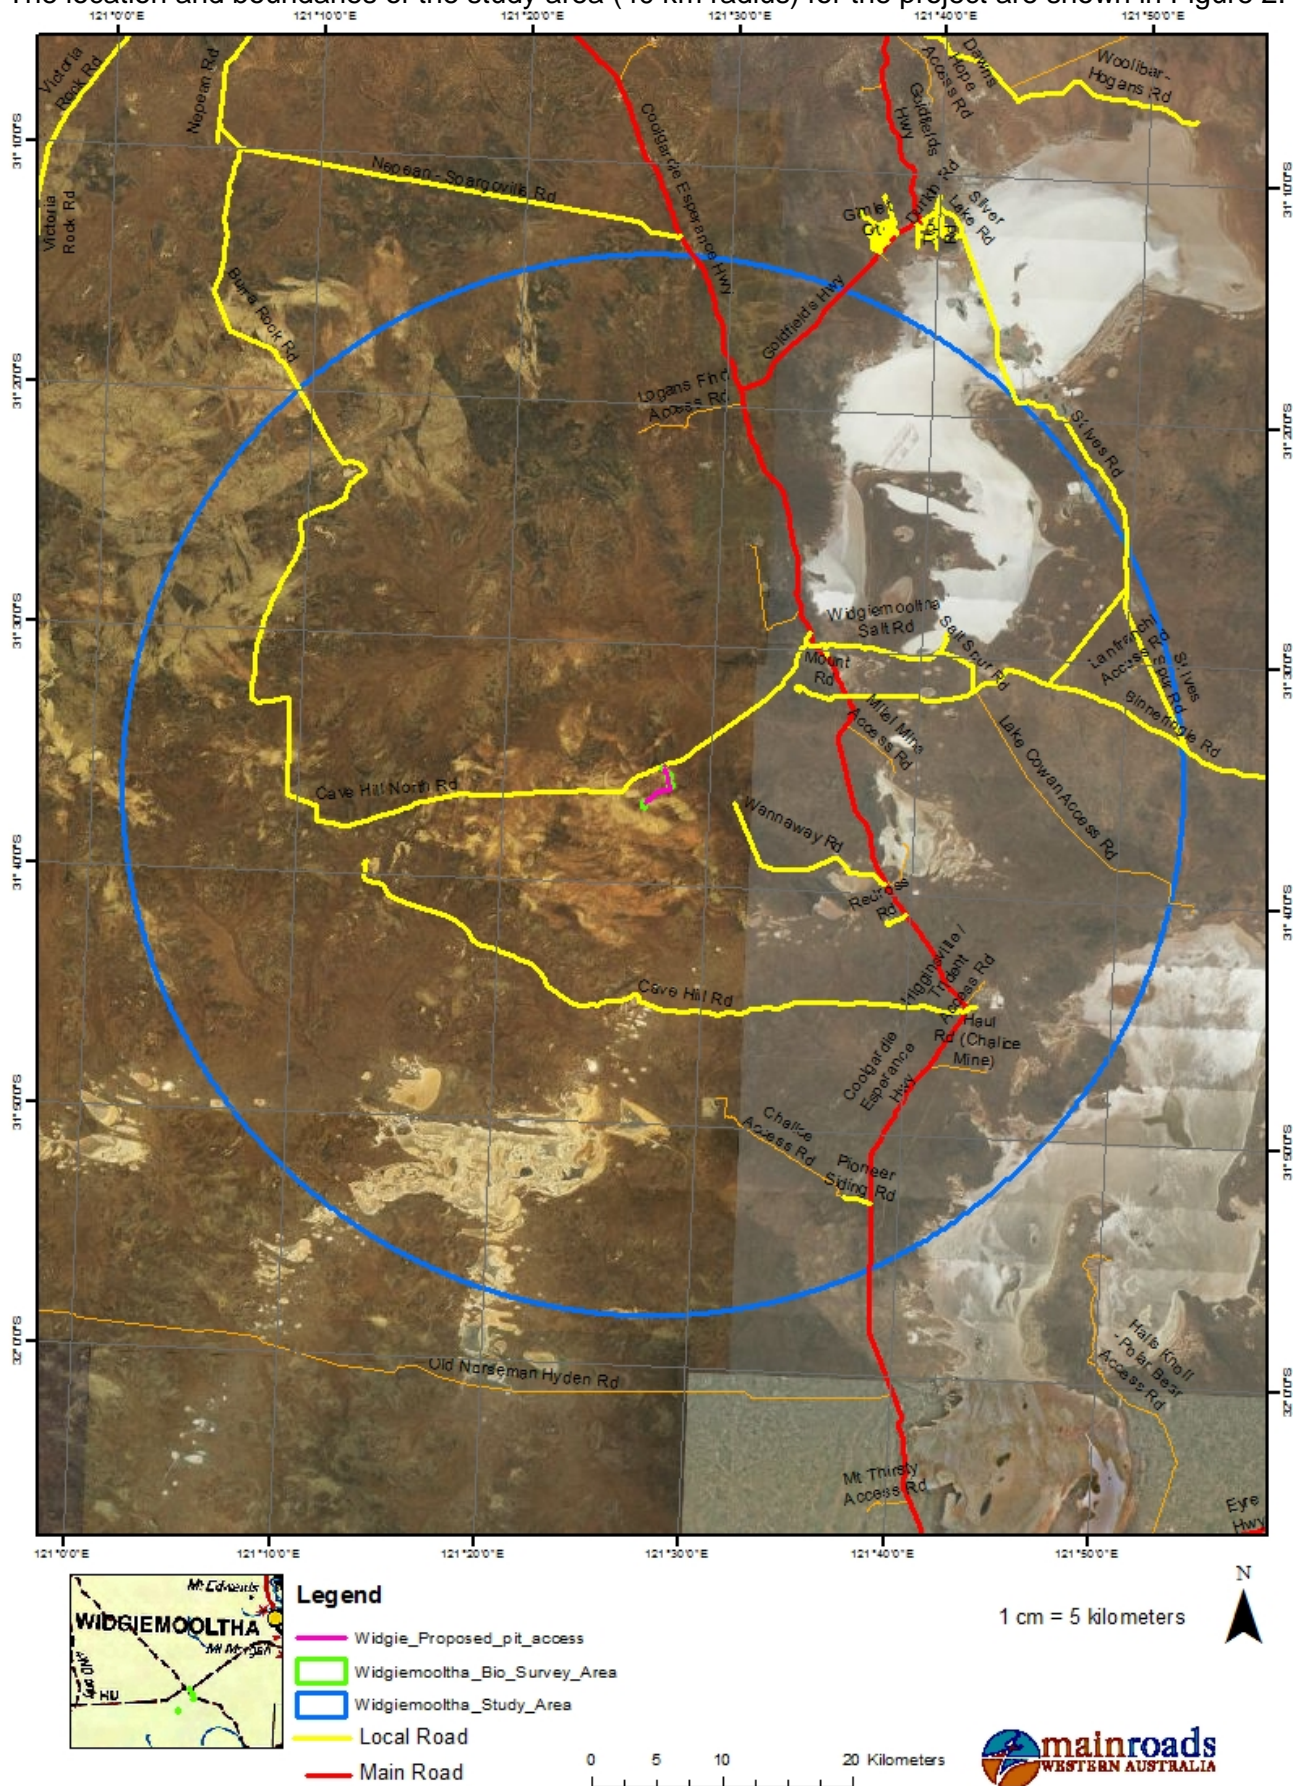
Figure 2. Project Location and Study Area

The location and boundaries of the study area (40 km radius) for the project are shown in Figure 2:

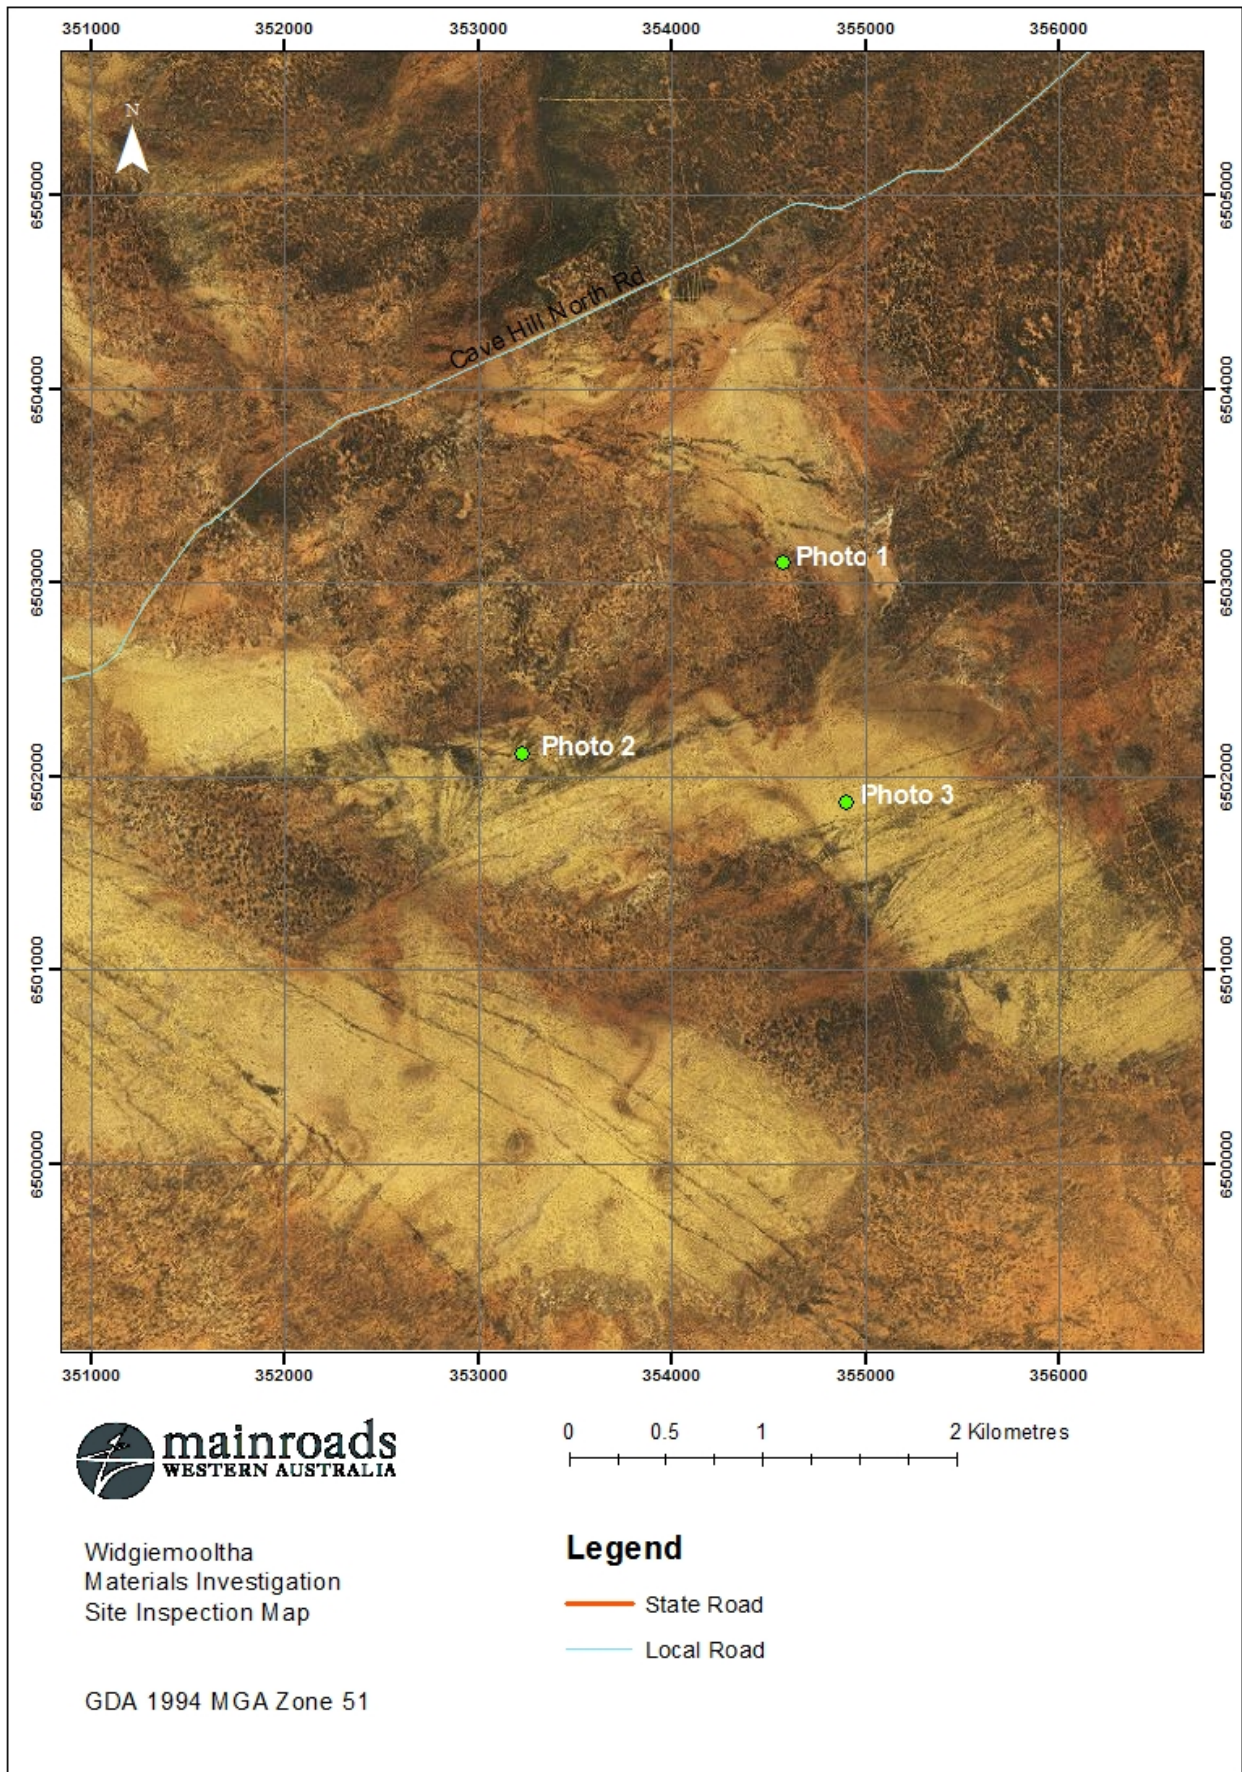
Map 1. Site Inspection Map

Vegetation condition (Keighery, 1994) varied from Good to Excellent comprising mixed shrublands of *Acacia*, *Eremophila* and *Grevillea* with scattered *Eucalypts*. Evidence of past fires with large number of vegetation deaths. Topography was low gently undulating sandy gravel plains. Area appears to have limited past disturbance except for some previous minerals exploration. No terrestrial fauna was observed during the site visit though bird species were observed traversing the area.

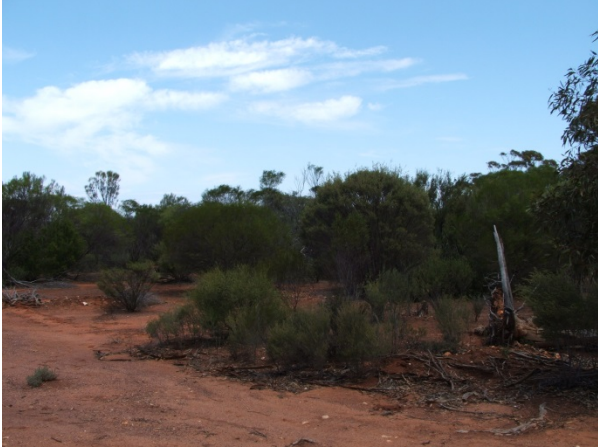
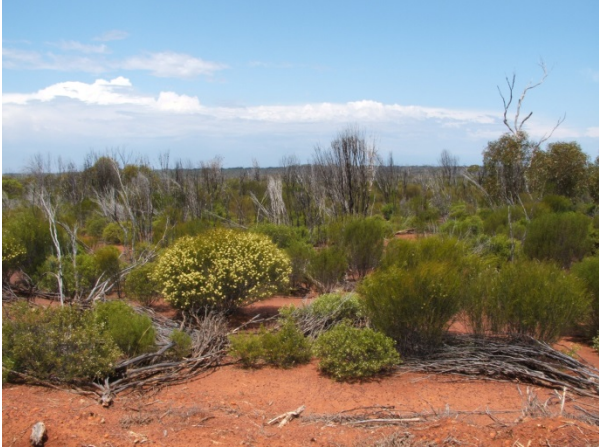
<p>Photo 1. Looking southwest at mixed shrubland with scattered <i>Eucalypts</i>. Site representative of vegetation in local area which is a plain with sandy gravel soils. Vegetation Good to Excellent (Keighery, 1994).</p>	<p>Photo 2. Looking south into mixed shrubland of <i>Acacia</i>, <i>Eremophila</i> and <i>Grevillea</i> species in Good condition (Keighery, 1994). Lots of vegetation death due to previous fires. Site representative of vegetation in local area which is a plain with sandy gravel soils.</p>

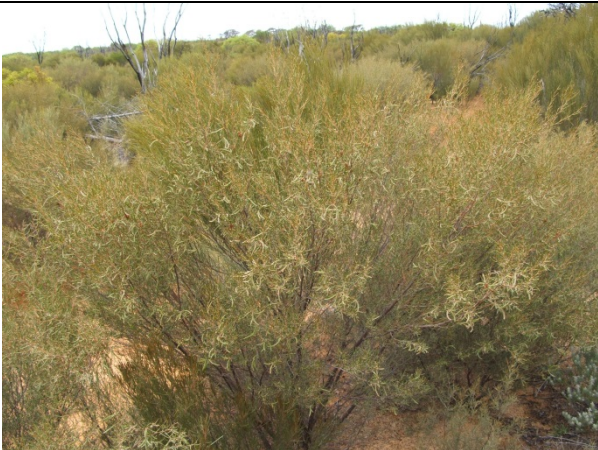
<p>Photo 3. Looking south into mixed shrubland of <i>Acacia</i>, <i>Eremophila</i> and <i>Grevillea</i> species in Good condition (Keighery, 1994). Lots of vegetation death due to previous fires. Site representative of vegetation in local area which is a plain with sandy gravel soils.</p>
