NAHANT MARSH EDUCATION CENTER

MASTER PLAN

OCTOBER
2022

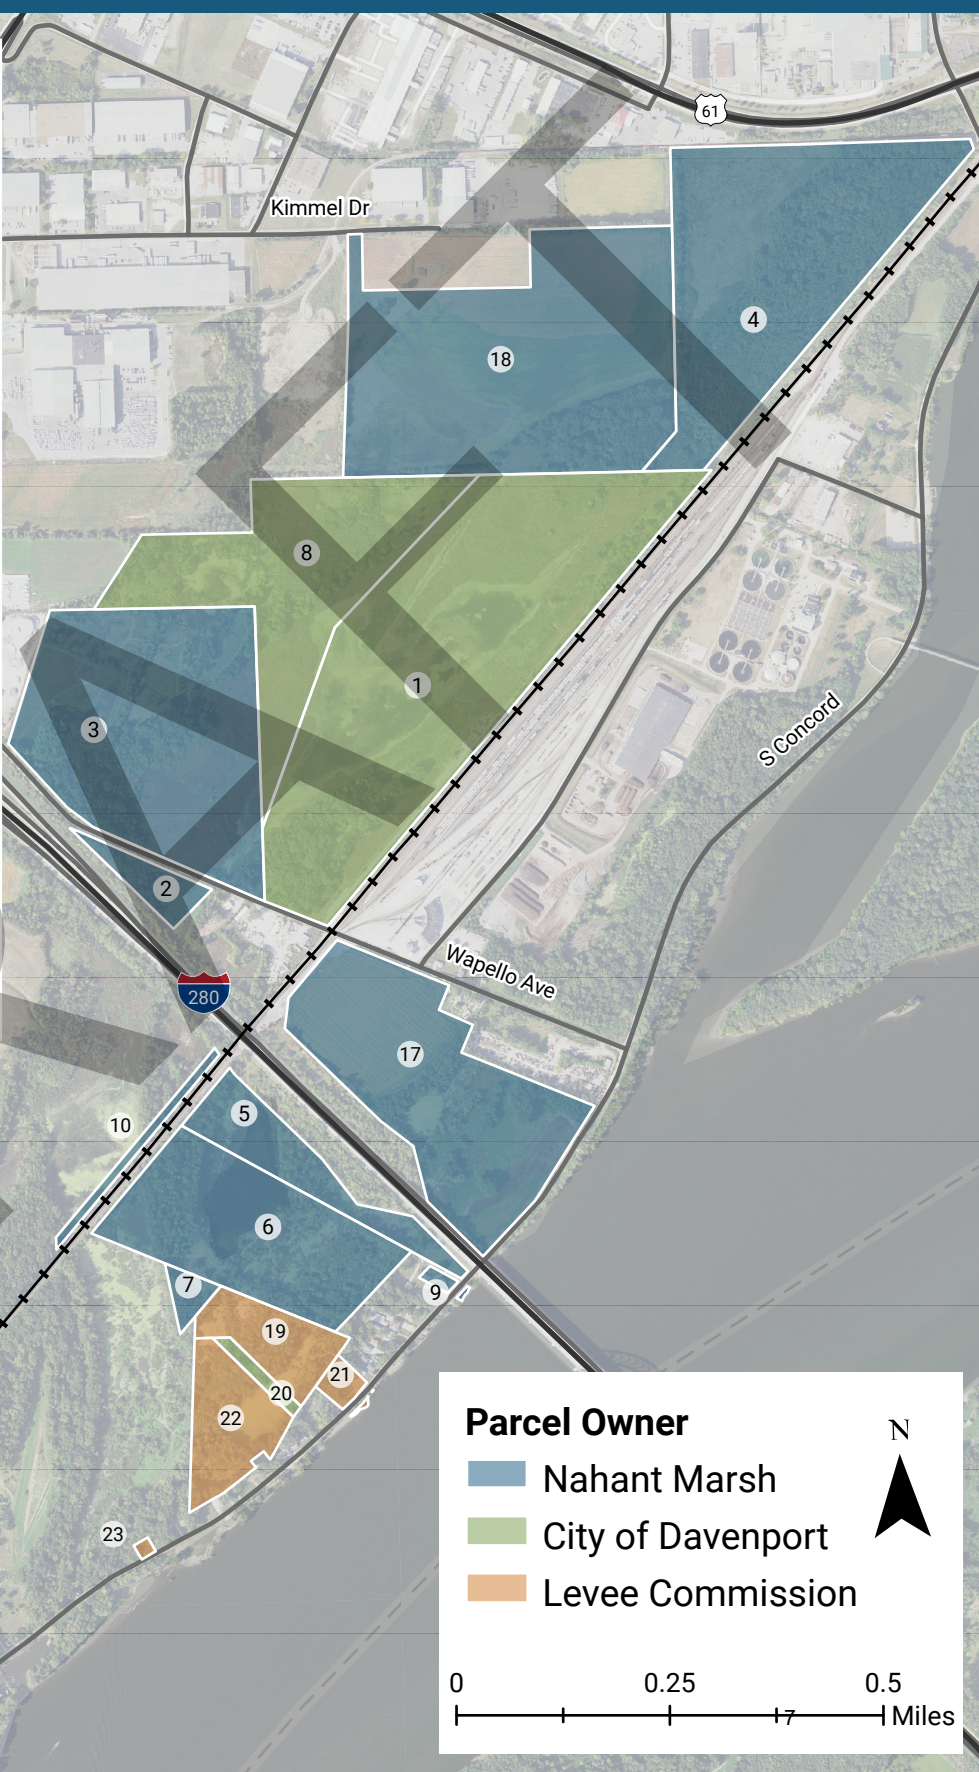
Nahant Marsh Parcels

Map ID	Parcel Owner	Year of Acquisition	Acreage
1	City of Davenport	1999	74.96
2	Nahant Marsh	2000	3.553
3	Nahant Marsh	2001	48.19
4	Nahant Marsh	2002	48.54
5	Nahant Marsh	2002	10.29
6	Nahant Marsh	2002	27.79
7	Nahant Marsh	2002	1.61
8	City of Davenport	2003	35.98
9	Nahant Marsh	2011	0.51
10	Nahant Marsh	2015	0.81
11	Nahant Marsh	2015	0.46
12	Nahant Marsh	2015	0.46
13	Nahant Marsh	2015	0.46
14	Nahant Marsh	2015	0.46
15	Nahant Marsh	2015	0.46
16	Nahant Marsh	2015	0.46
17	Nahant Marsh	2018	27.45
18	Nahant Marsh	2022	60
19	Levee Commission	2022	7.42
20	City of Davenport	2022	1.21
21	Levee Commission	2022	1.68
22	Levee Commission	2022	12.69
23	Levee Commission	2022	0.23

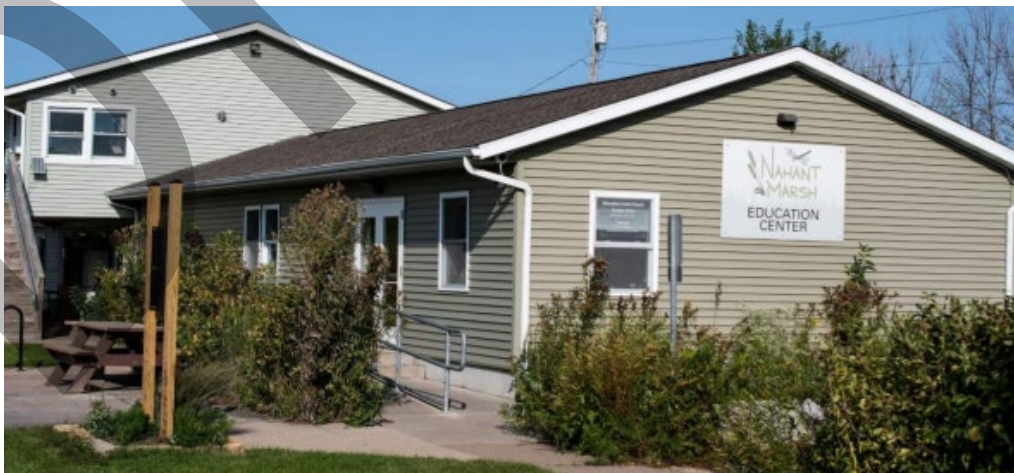
The NMEC addition built in 2015 is in good condition. It is a wood frame with vinyl siding and asphalt shingles for the roof. The grade of the addition is 18" higher than the original building.

The main entrance is part of the 2015 building addition. It is ADA accessible and is an obvious entrance for visitors. There are four entrance doors all on the north side of the building. The upstairs door has

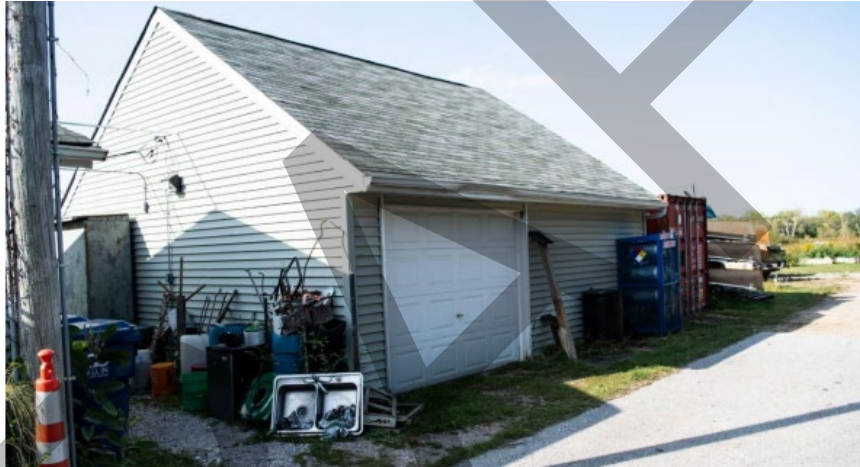
The garage was built in 1975 and is in fair condition based on age and integrity. Support beams were added for the second level storage in 2009. It is a wood framed building with vinyl siding and asphalt roofing.

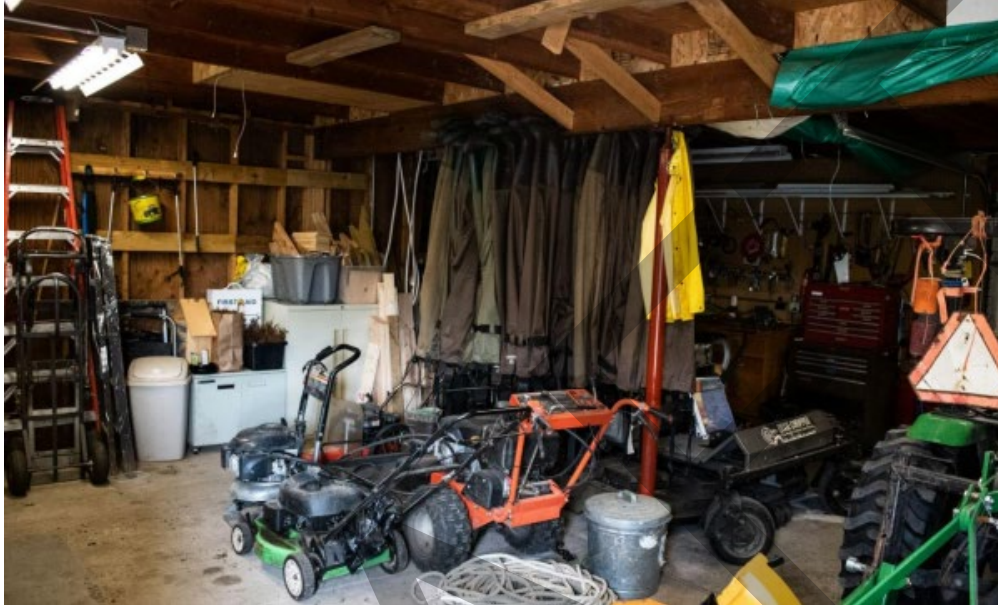
The NMEC garage is an oversized one-car garage, 576 square feet, located 8 feet to the east of the main building. It is used to store large equipment, personal protective equipment, and hand tools. There are two workbenches and an upstairs attic used for storage of recreational and water quality supplies.

The ladder to the attic is narrow and difficult to carry items up and down. The attic floor is damaged in some areas and treacherous to walk on. The main garage space is cluttered and does not offer a safe environment to work on projects. The natural resources staff often use the adjacent shelter to work on their projects. This takes coordination between the education team's programming and the natural resources team's projects.

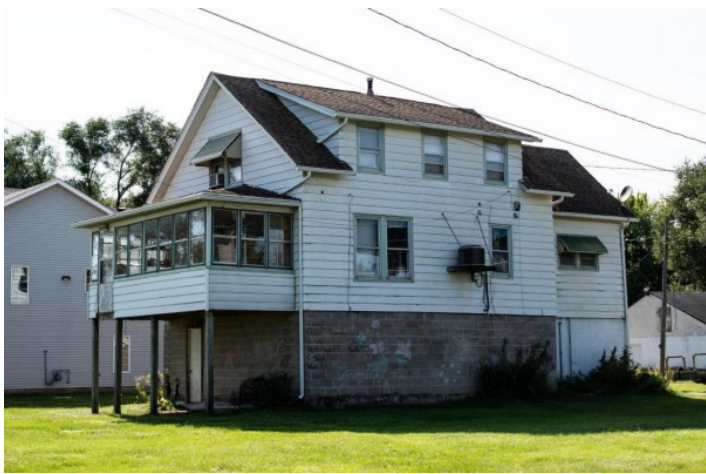
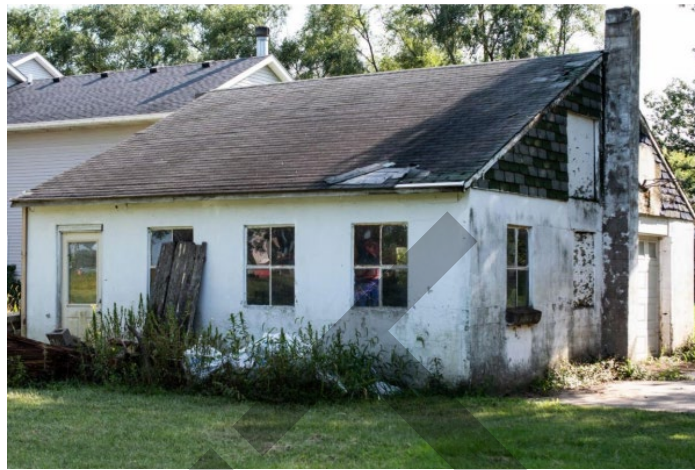
Adjacent to Carp Lake, a deep lake surrounded by bottomland woods, is a house located on the river that was built pre-1900 and was raised 8 feet in 2001. Nahant acquired and remodeled this house in 2011 and it is in fair condition. The garage was built in 1945. They are built from wood framing with vinyl siding and asphalt shingles for the roof. It is raised on concrete blocks. A new roof was installed in 2001. HVAC is approximately 30 years old and appliances vary in age, but are at least 10 years old. The remodel included new drywall and flooring, added insulation, significant structural support, plumbing and updated the electrical on the main level. Some modifications have been made to the detached garage including tearing down an older portion and adding a new garage door in 2021. This is used as housing for a Nahant employee. In exchange, that employee keeps an eye on NMEC's Carp Lake property and allows interns or NCCC AmeriCorps teams to stay there occasionally. The house becomes inaccessible when river level reaches 15' and water enters the house at approximately 18.5'.

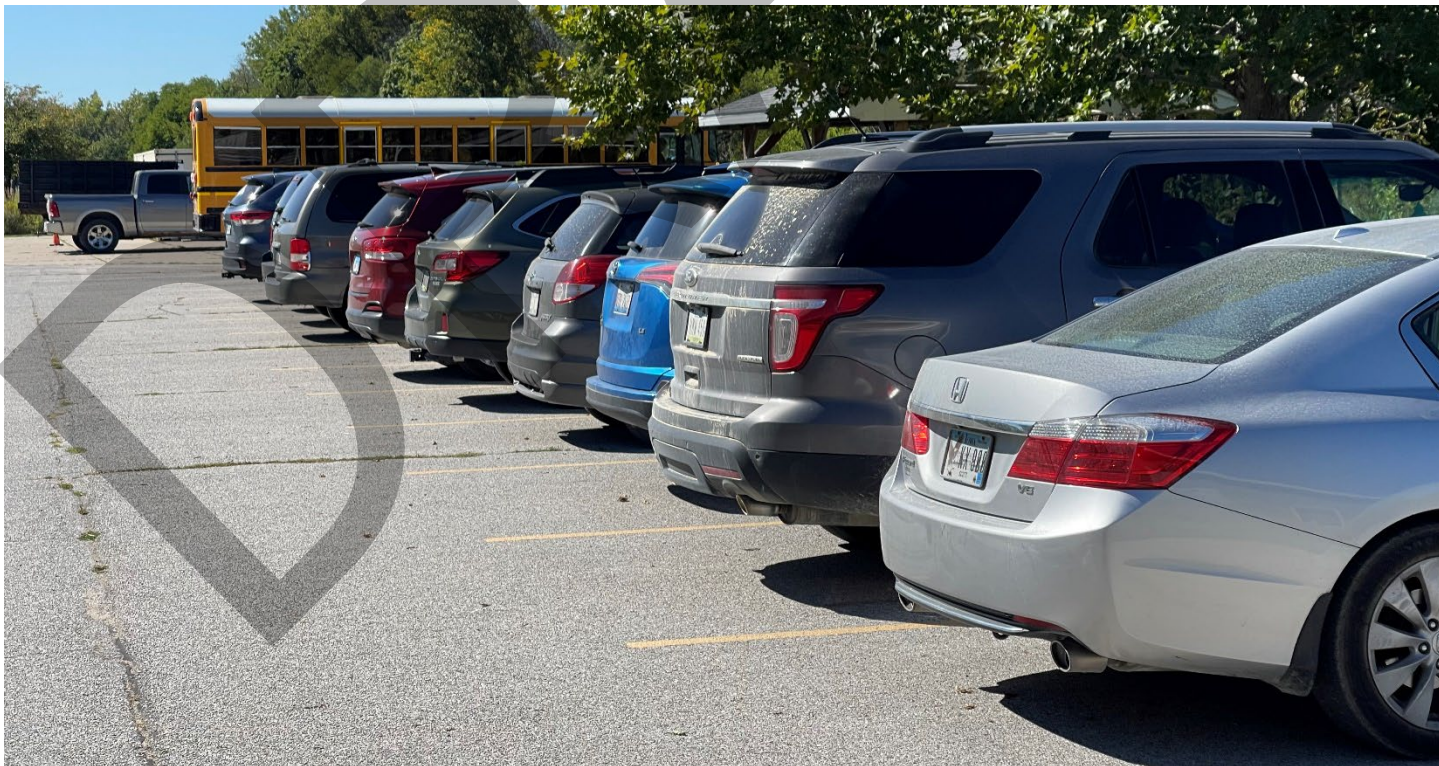
NMEC has three parking lots with additional parking on the lawn. The parking lot adjacent to the building has one handicap space, a bus turn around, and 27 additional parking spaces. Currently, one of the storage containers is taking up five of those spaces. There is an outer parking lot with 22 spaces. This is open to the public when the main gate is closed during non-business hours. There is also a parking lot with 20 spaces to the southwest across the road and railroad tracks on NMEC's 2018 acquired parcel. During large events, the public uses the grass along the drive to park on. The two parking lots on the main property and the drive are maintained by the City of Davenport. There is often a lack of parking during busy days, large field trips, and large events. There is also a small sinkhole in one of the spots, making it unusable.

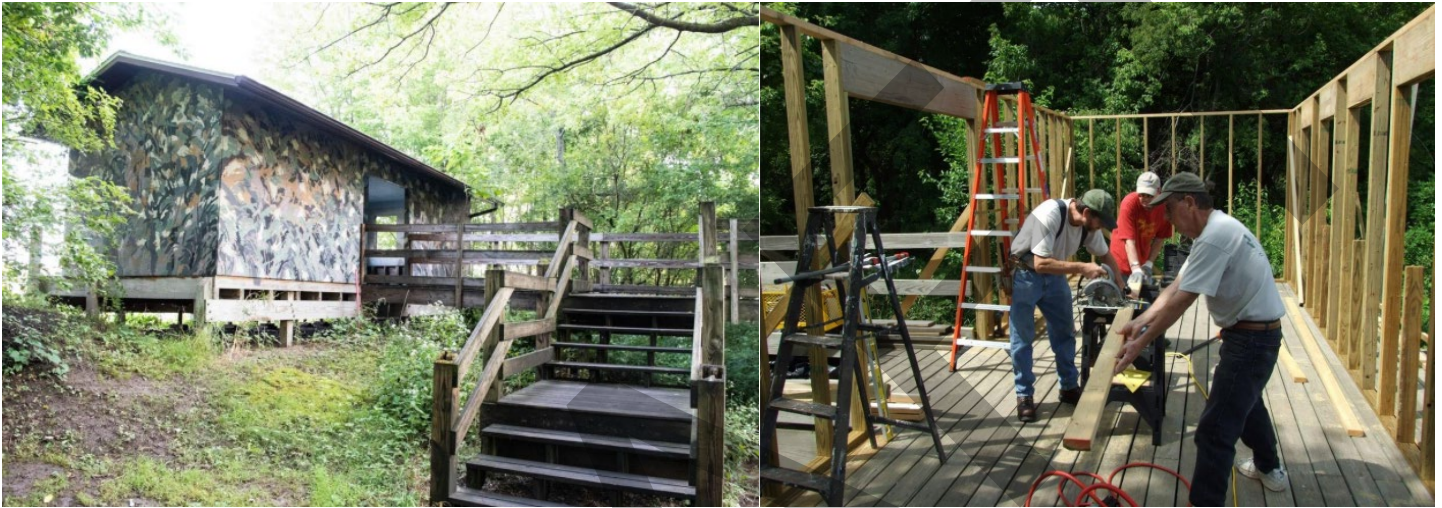
Bridge/Bird Blind

NMEC currently has a bridge crossing the bottomland woods and leading to the bird blind. This provides access and views to the plants and wildlife on the west side of the main marsh. The bridge was built in 2001 and bird blind was built in 2007. They are in good condition. Flooding has caused slight shifts in the bird blind support footings. These footings require a reset. These amenities are used for almost every group and program at NMEC. There are also two wooden benches on the bridge that are in fair condition.

Even though both structures are in good shape, annual inspections should be conducted to ensure the structures are stable and to assess maintenance needs. Cleaning and sealant application should be conducted as needed, likely annually or bi-annually. The support posts for the bird blind should be assessed for repair.

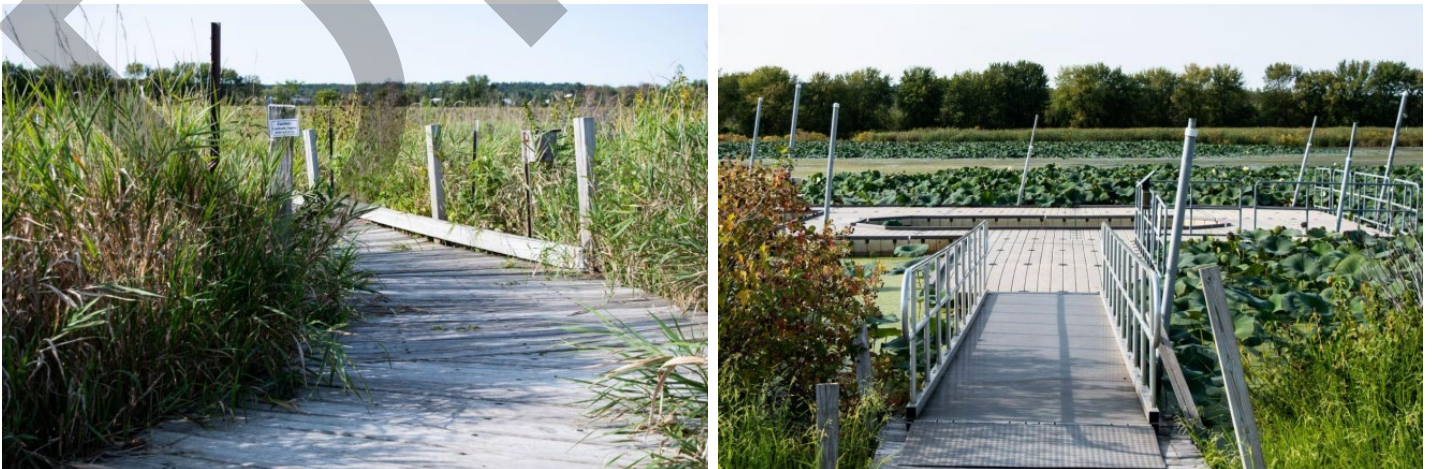
Boardwalk/Dock

NMEC has a wooden boardwalk leading to their dock which is centrally located at the main marsh. It was built in 2009 and has been through several minor and major flood events. The boardwalk is in fair condition. The dock was purchased from EZ Dock and is made out of a plastic composite material and was installed in 2009. It has also been through many flood events and needs to be reset every few years but is in good condition. The boardwalk and the dock are also used for the majority of NMEC's programs.

The boardwalk to the dock will likely need to be replaced in the next three to five years. Currently, the boardwalk sits on trapezoidal pads and does not have permanent footings. This design causes issues during major flood events. A new design should be considered for a future boardwalk to make it more flood resilient. The dock is in good shape with the exception of the support posts which need to be straightened occasionally following flooding and/or ice and wind events.

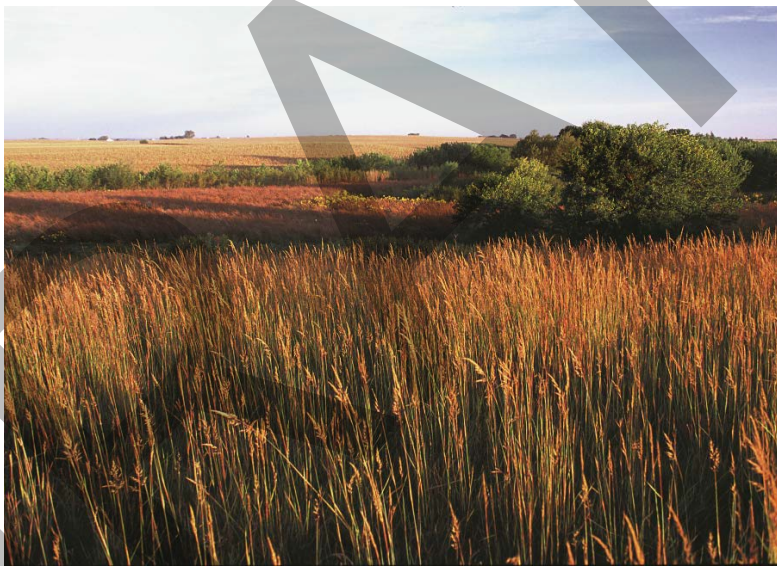
Figure 1: Without periodic disturbances, grassland habitats in the Midwest often become monotypic stands of grass, of poor value to monarch butterflies.

Monarch Butterfly and Habitat in the Midwest. In the absence of natural free-ranging herbivory and natural wildfires, artificial disturbances (e.g. prescribed burning, treatments with herbicides, brush management, prescribed grazing, or light disking) are periodically required to achieve and/or sustain the desired habitat condition of a mid-seral grassland plant community. Without such disturbance, the forb component will reduce in both richness and abundance (Figure 1), as will sedges and rushes in herbaceous wetlands. These habitats also require periodic management actions to control encroachment of trees and shrubs.

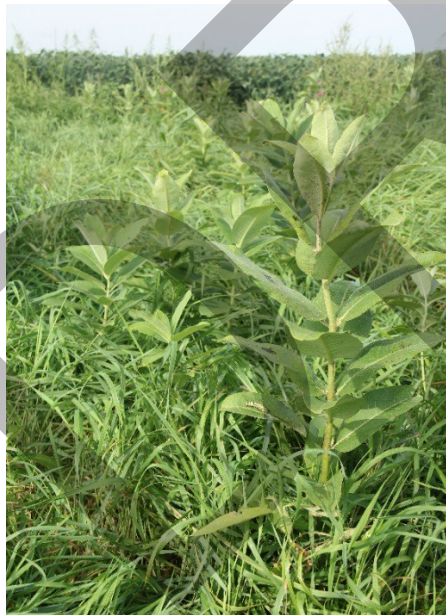
Figure 4: Common milkweed (Asclepias syriaca) growing adjacent to a soybean field. Milkweed (Asclepias spp.) and floral resources are often near cropland. The opportunities for large scale habitat restoration in the Midwest are limited, as this region supports some of the most productive soils in the world.

When not migrating, the movement of individual monarchs is not well understood, though adults appear to move very long distances to acquire life requirements (Brower 1995, Brower et al. 2011). Additionally, little is known about the importance of the spatial connectivity of habitats. What is known, is that the Eastern population of the North American monarch butterfly is at-risk (USDA 2015). Increasing the abundance, quality and distribution of habitat across its summer range is considered paramount to recover the species (Flockhart et al. 2014, Inamine et al. 2016, and Throgmartin et al. 2017). In consideration of the above statements, this monarch butterfly habitat guide recognizes that monarch butterflies are highly mobile and that the importance of connectivity and adjacency is unknown⁴. Thus, this WHEG is applied independently to different portions of the project area. Each unique area within the project area, is referred to as an *assessment area*. A farm or ranch (project area) will commonly have multiple assessment areas, including narrow linear habitats (Figure 4). Following independent implementation of the protocols to each assessment area.

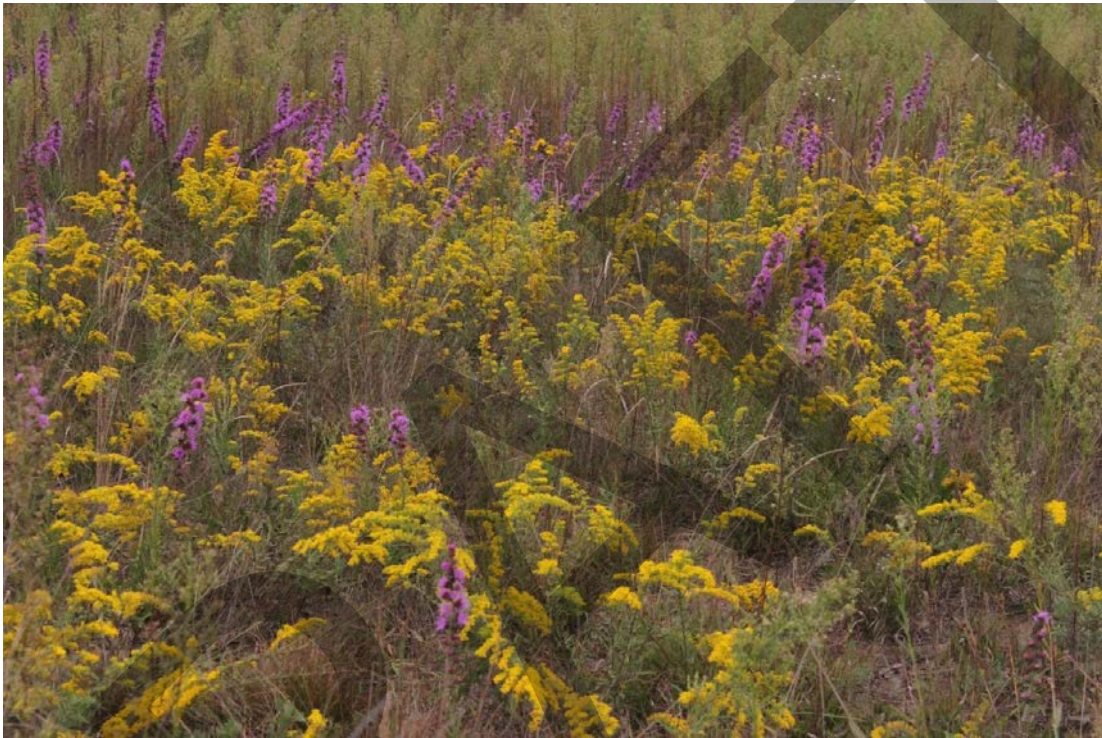
Figure 6: Late summer is an ideal time of the year to inventory a site for species richness and abundance.

For most situations, this WHEG can be applied during any time of the year with the use of remote sensing and/or a field visit without herbaceous vegetative data collection. However, for some situations, an inventory of forbs and milkweed (*Asclepias* spp.) is required. Ideally, this vegetative inventory is applied when species richness of the forb component is at its highest level, and when conditions are suitable for plant identification.

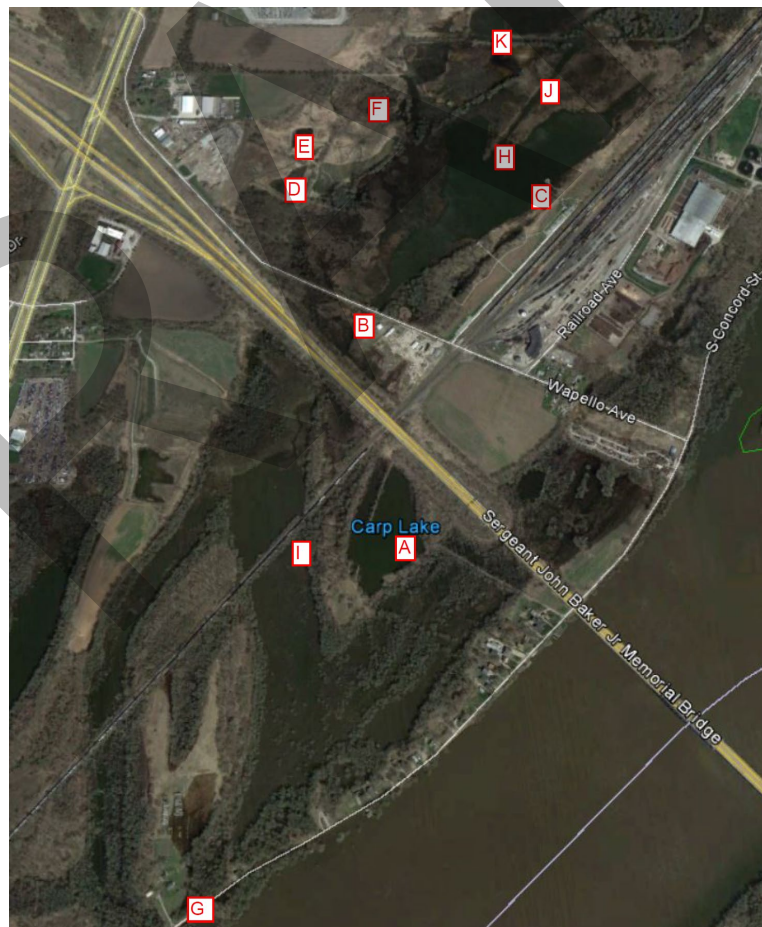
Figure H-1. Water Quality Sample Site Locations.

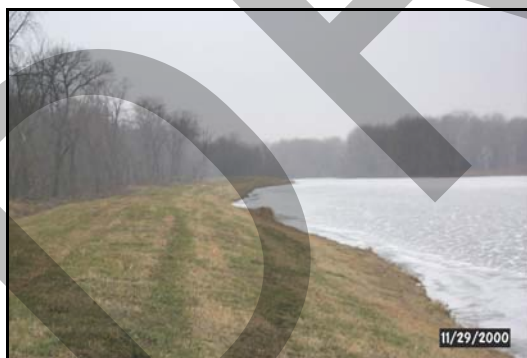
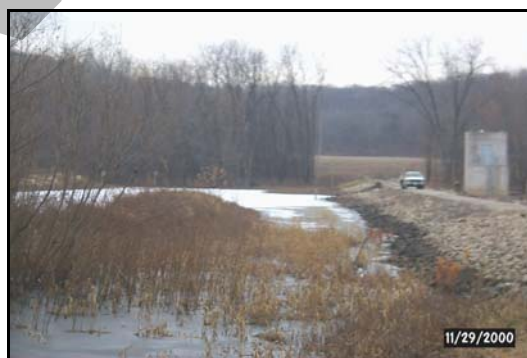
Photographs 5-1a and b. Andalusia Refuge HREP, Pool 16, UMR RM 462.0-463.0, Rock Island Co., IL, MVR

j. Photographs. Constructed HREPs with berms and/or spillways are shown here.

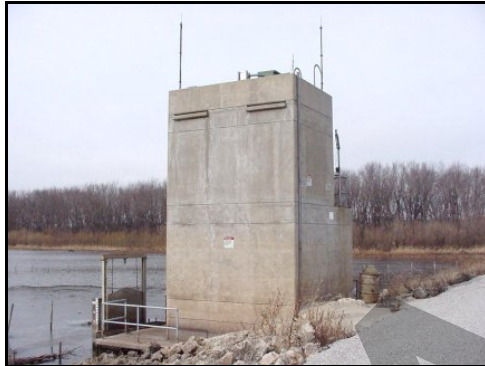
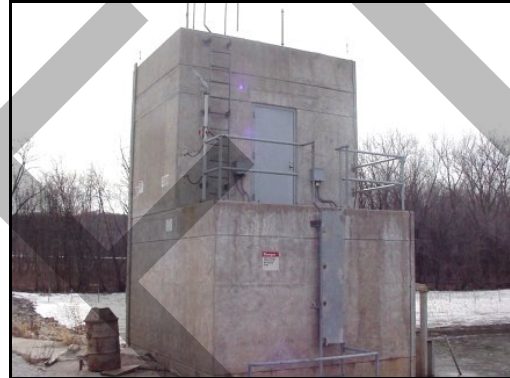
Photographs 5-4a and b. Andalusia Refuge HREP, Pool 16, UMR RM 462.0-463.0, Rock Island Co., IL, MVR

l. Photographs. Constructed HREPs with pump stations are shown here.

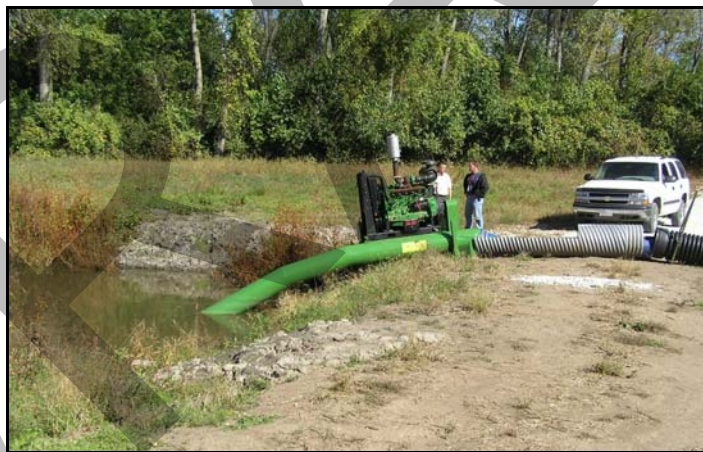
Photograph 5-5. Portable Pump-Lake Odessa HREP, Pools 17-18, UMR RM 435.0-440.0, Louisa Co., IA, MVR

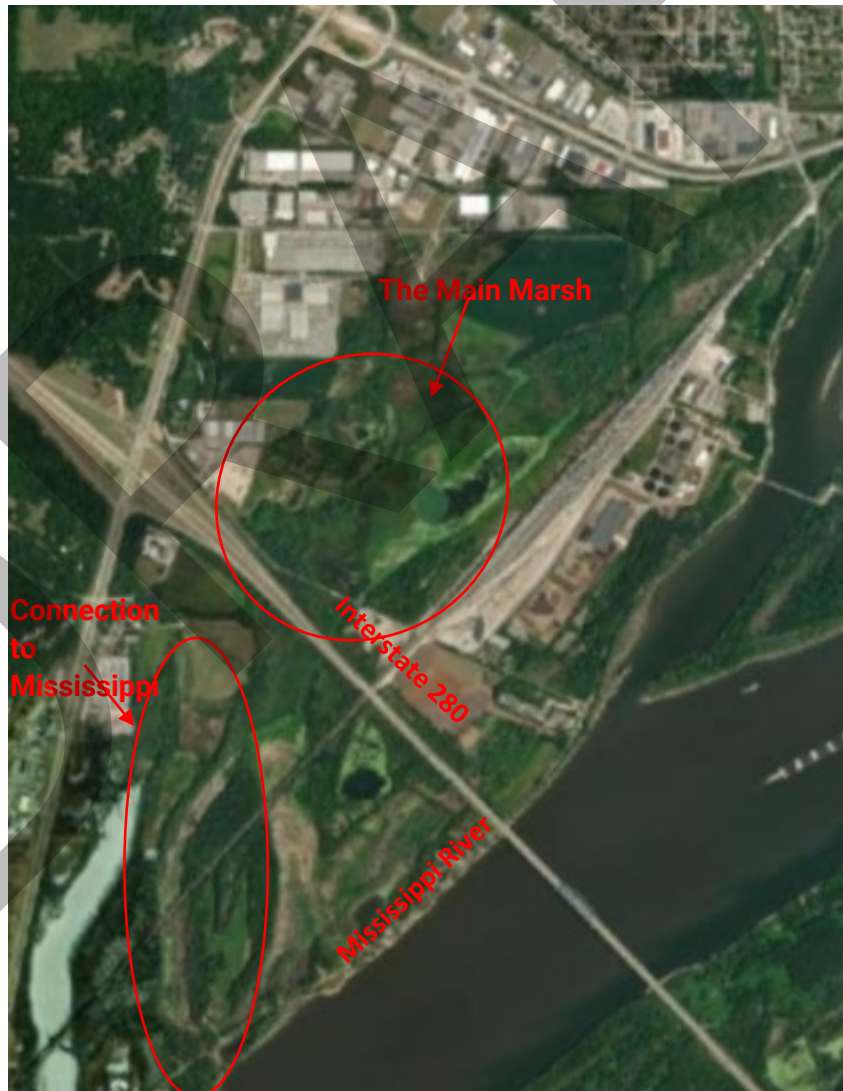
Figure J-1. Nahant Marsh and surrounding area

The main marsh is located on the lowa side of the Mississippi River at River Mile 477.8 (Figure J-1). The main marsh hydraulically connects with the Mississippi River just downstream of Interstate-280. Additionally, water enters the main marsh through runoff from surrounding agricultural and industrial areas. There is a water control structure at Wapello Avenue that can be used at times of high or low water depending on the season and environmental/ecological needs of the main marsh.

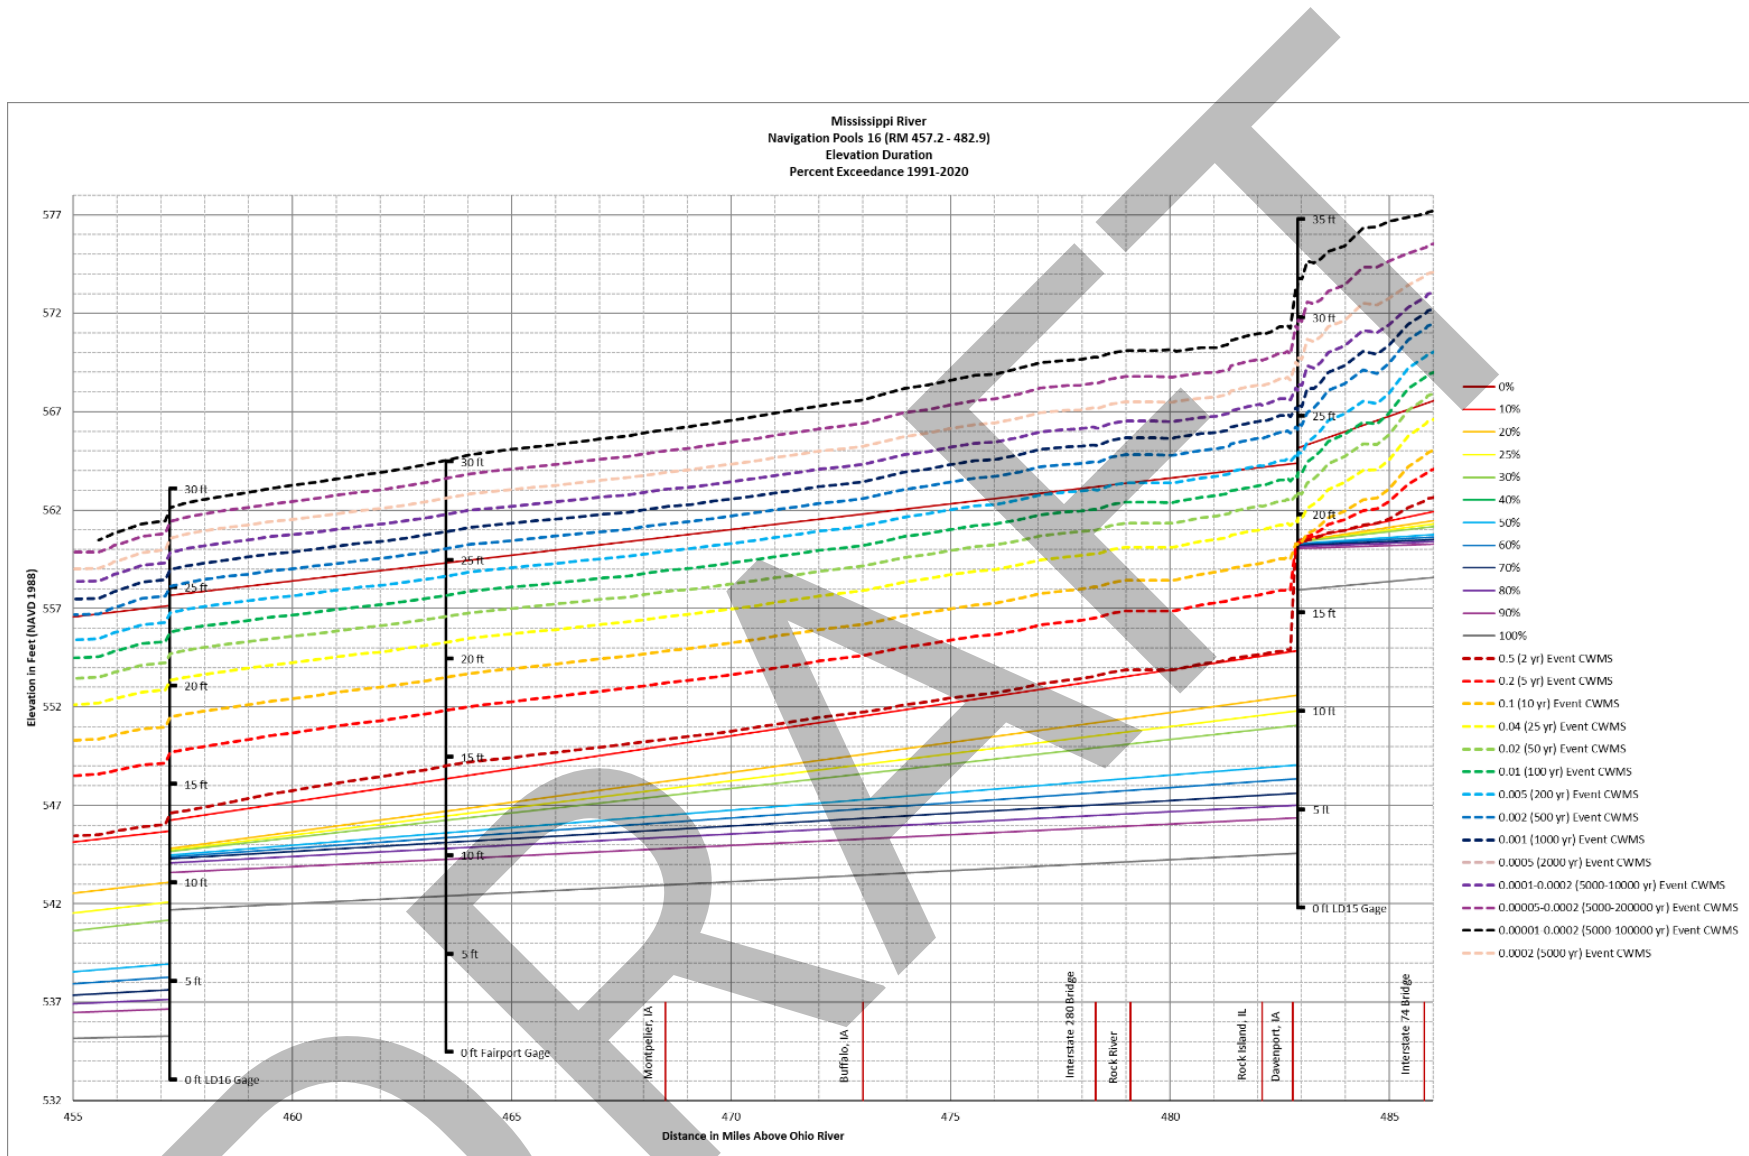
Figure J-2. Flow Frequency and Exceedance Duration Profiles for Mississippi River Pool 16. Nahant Marsh is located at River Mile 477.9

The Corps studied the hydraulic and hydrologic state of the main marsh. The goal of this work was to establish what information and data is already available, find data gaps and how to fill in those gaps, determine runoff/flow paths to the main marsh, and create a set of alert guidelines for NMEC staff when the Mississippi River is forecasted to rapidly rise. The Corps and NMEC staff also installed a staff gage in February 2022 to supplement upstream gage data from Lock and Dam 15. Data can be found in Appendix J.

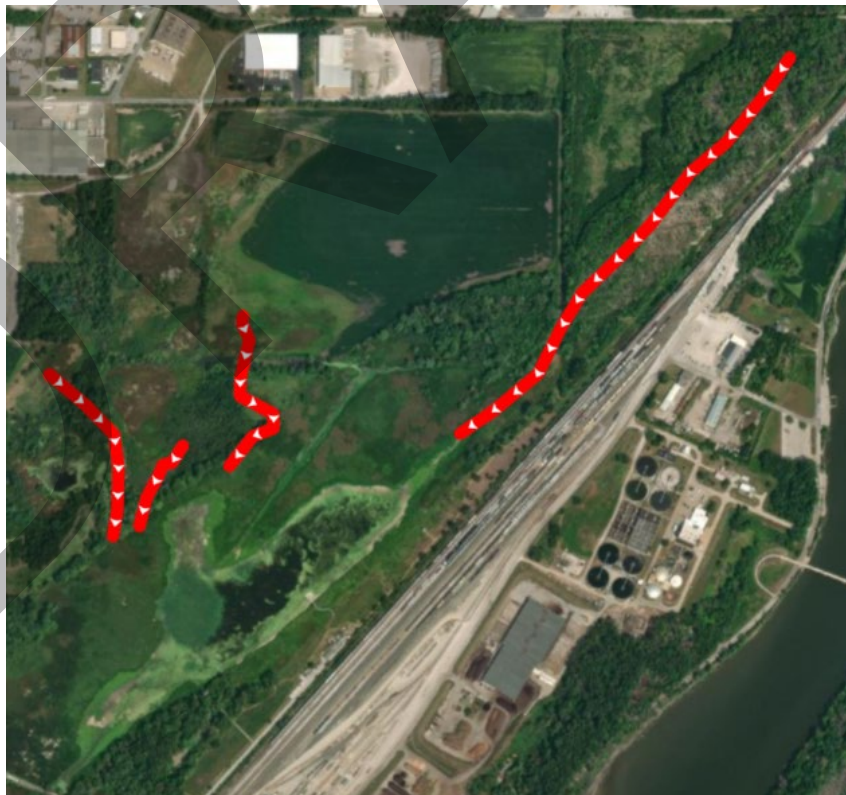
Figure J-3. Flow paths to the Marsh as determined by visual inspection of Green LiDAR data

Seeing the video results of the 2D HEC-RAS modeling confirm the flow paths from the ArcGIS Pro analysis. This is easiest to see for the 6 inch rain event since the large amount of water fills in depressions in the ground more quickly than the smaller rainfall events.

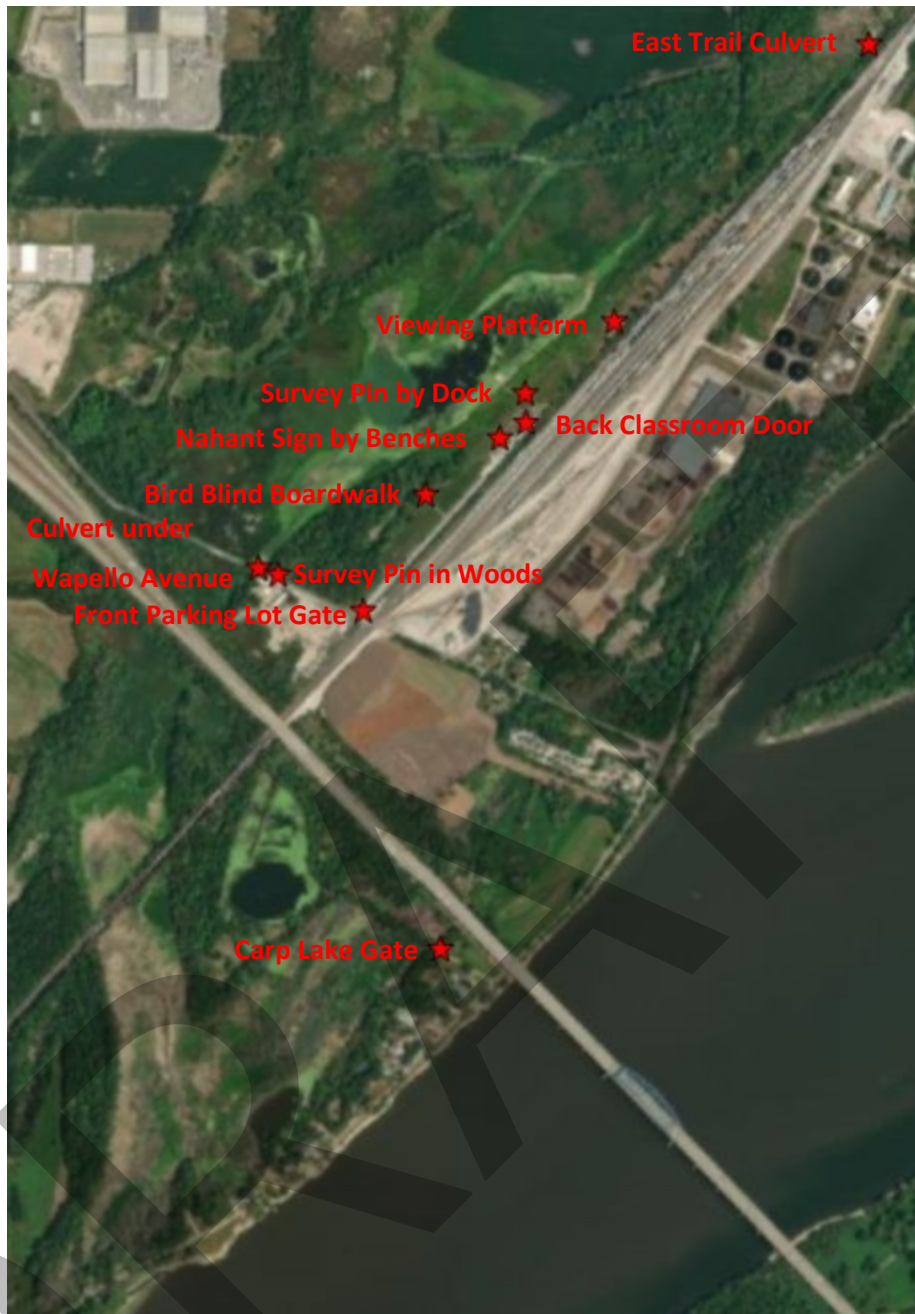
Figure J-9. Points of interest for the main marsh associated with the Flood Warnings
