## **Purpose and Need**

This vegetation management plan (VMP) is being developed as a management guide for Licton Springs Park. The intended audience of this document will be the Seattle Department of Parks and Recreation (DOPR), Licton Springs Community Council (LSCC), and members of the public. The purpose of this document is to provide a management tool that outlines restoration projects to be completed in a strategic and phased manner. For several years, the interior area of Licton Springs has been dominated by invasive plants. As a result, native plant species diversity has decreased dramatically.

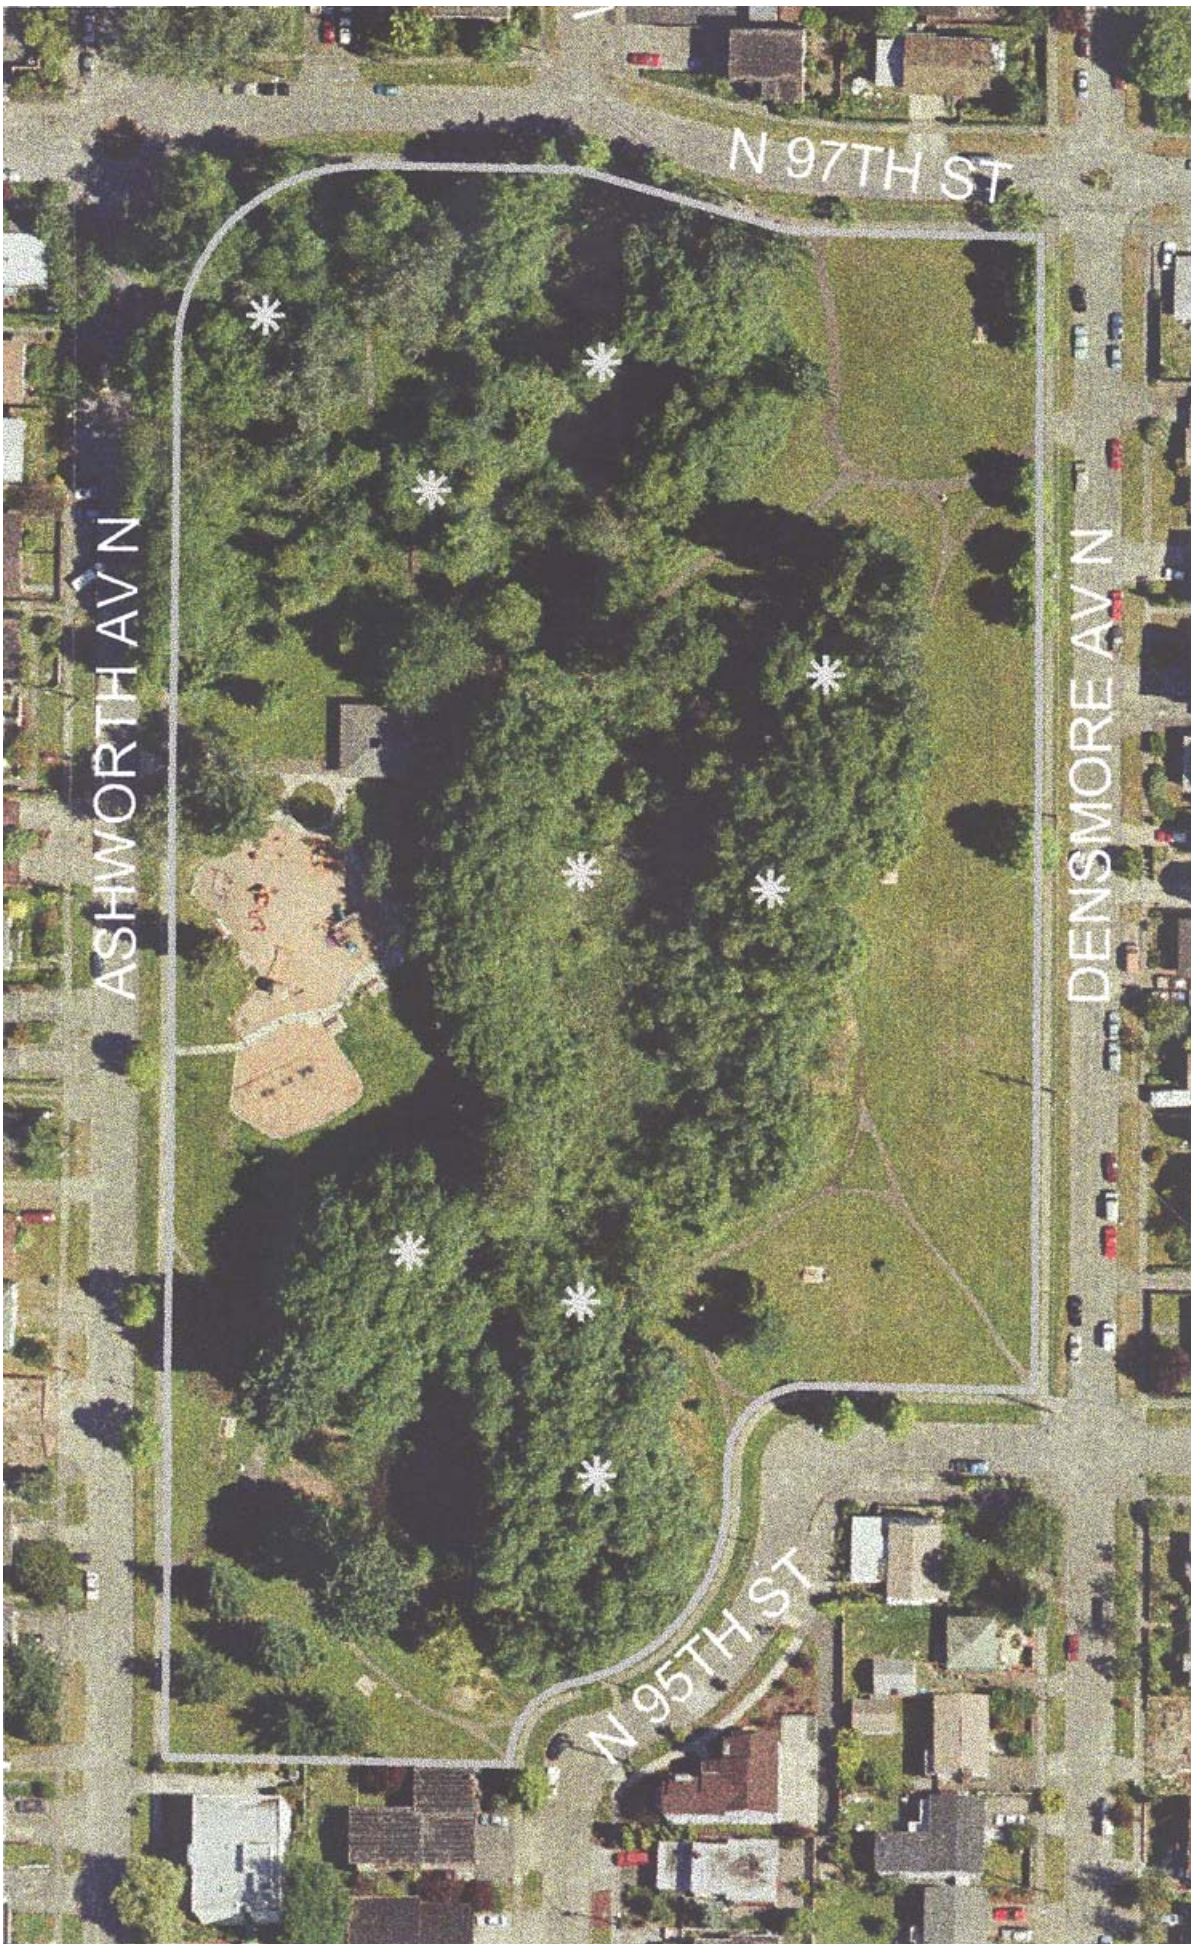
## Figure 2

The vegetation species at Licton Springs were surveyed by completing ten 1/10 acre plots (Figure 2). Recorded detail information included tree species, age, diameter, structure, and canopy cover, shrub and herbaceous species and their cover estimates, amount of downed logs and snags, special features (gully, slide, wetland, stream, seep, trail) soil type, water presence, and aspect. Data from the plot was then used to develop vegetation types based on the highest percentage of species sampled and public input (Table A). The ten plots sampled make up nine vegetative zones (Table A). The percentages in Table A and discussed throughout the Zone discussion are based on vegetation cover estimates taken from plot information for each zone. Table B displays the percent cover of each shrub and herbaceous sampled in the ten plots throughout Licton.

# Vegetation Plot Locations

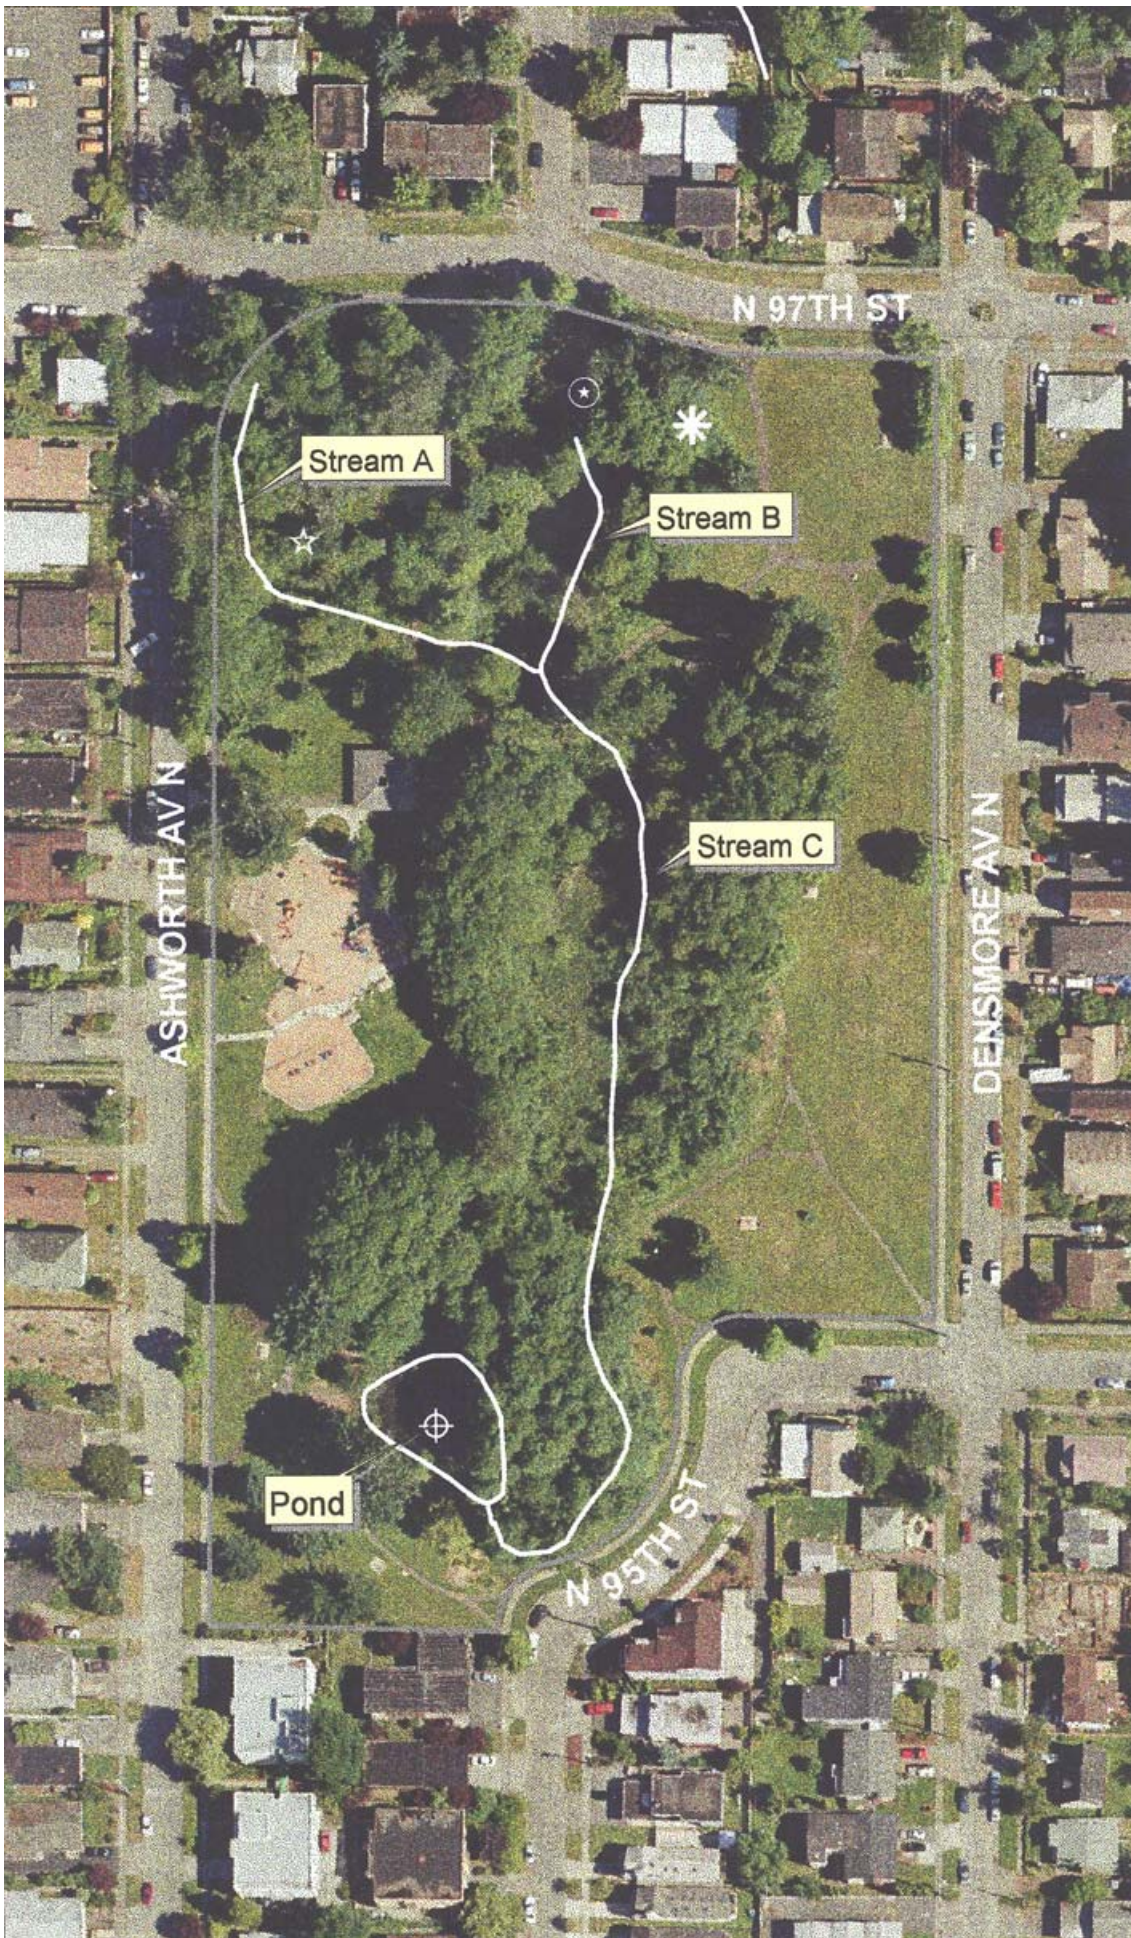
## Figure 5

-   Park Boundary
-   Streams
-   eastern drainline
-   western drainline
-   northern spring
-   southern spring

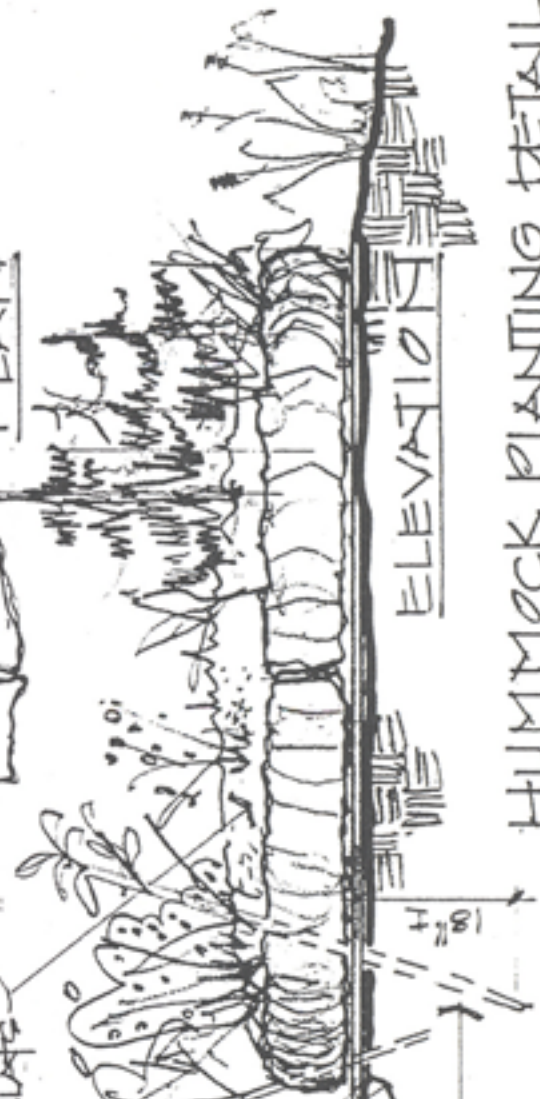
HUMMOCK PLANTING DETAIL

PLAN

12"  $\phi$  COIR OR COCONUT  
FIBER LOG  
DOUBLE LAYER  
HEAVY CARDBOARD  
PLANT HUMMOCK  
W/ SPECIFIED PALETTE

PEAT BASED SOIL MIX  
W/ HYDRO-POLYMER PELLETS

ELEVATION

CUT REED CANARY GRASS  
& REMOVE BIOMASS TO  
MINERAL SOIL  
DBL. LAYER CARDBOARD  
STAKE: W/ RED CEDAR  
DOWEL @ 3/4".

In an attempt to mimic processes in coniferous forested wetlands we are recommending creating three hummocks to provide an environment for establishment of conifer species in Area II (Figure 8). The placement of thirteen logs or stumps is recommended in areas throughout Areas II, IV, and V (Figure 6).

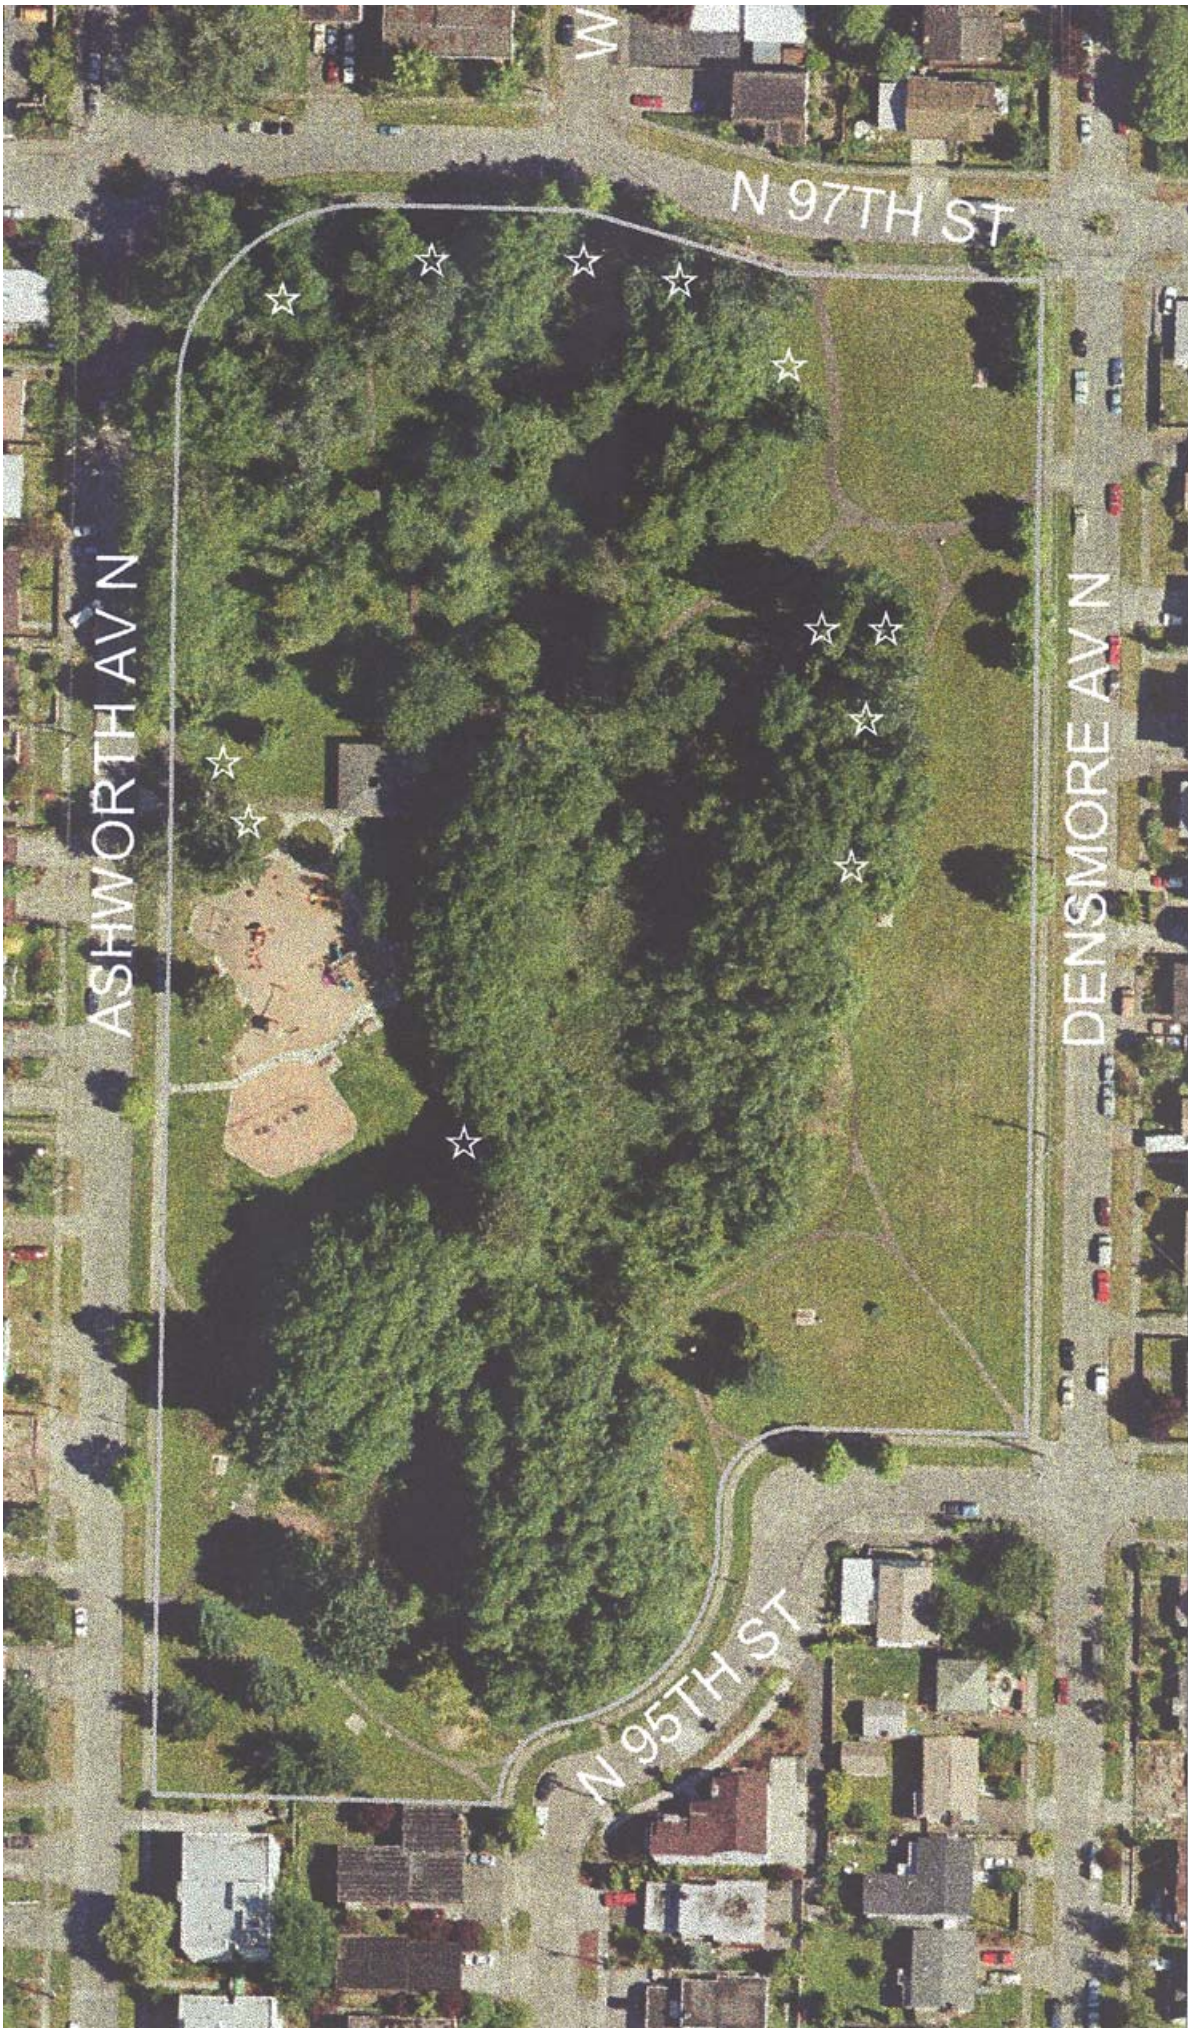
## Figure 8

Eleven trees (Figure 6) were deemed hazard trees by the Acting Senior Urban Forester based on the following criteria:

☆ Hazard trees

- Visible defects that will be considered in hazard evaluation include, but will not be limited to, cracks in limbs and/or trunk, seams in limbs and/or trunk, spiral cracks in limbs and/or trunks, rib cracks, weak branch unions(V crotches), decay in limbs and/or trunk, cankers in limbs and/or trunk, deadwood, root problems, and poor tree architecture (form).

- Aggravating factors in hazard evaluation will include, but not be limited to: fast-growing species, sprouting from topping cuts, weak branch attachments, heavy end weight of branches, included bark, evidence of past branch/trunk failure, saturated soil, frequent irrigation, more than 30% of buttress roots decayed and/or disturbed, evidence of excessive mechanical bark damage, large dense crown, lack of basal trunk flare (poor taper), recent construction activity, willow soil, and mushrooms visible at base or in root zone.

- A combination of any of these factors may greatly elevate the hazard rating. For determination of hazard rating the Department will utilize the Hazard Tree

Assessment Tatum Guidelines as developed by the Minnesota Department of Resources- Forestry latest revision (Appendix C)Trees that rate a high hazard will be considered an imminent risk and will be scheduled for immediate remediation. Trees that are rated a moderate risk may be reevaluated at a specific interval or scheduled for immediate remediation.
