EL PASO WATER UTILITIES PUBLIC SERVICE BOARD
 PHASE I & II UPPER VALLEY/STRAHAN ROAD 36" WATER
 TRANSMISSION MAIN INSTALLATION PROJECT

PROJECT NUMBER: 239663

GENERAL LOCATION - AERIAL
 EL PASO WATER UTILITIES PUBLIC SERVICE BOARD
 PHASE I & II UPPER VALLEY/STRAHAN ROAD 36" WATER
 TRANSMISSION MAIN INSTALLATION PROJECT

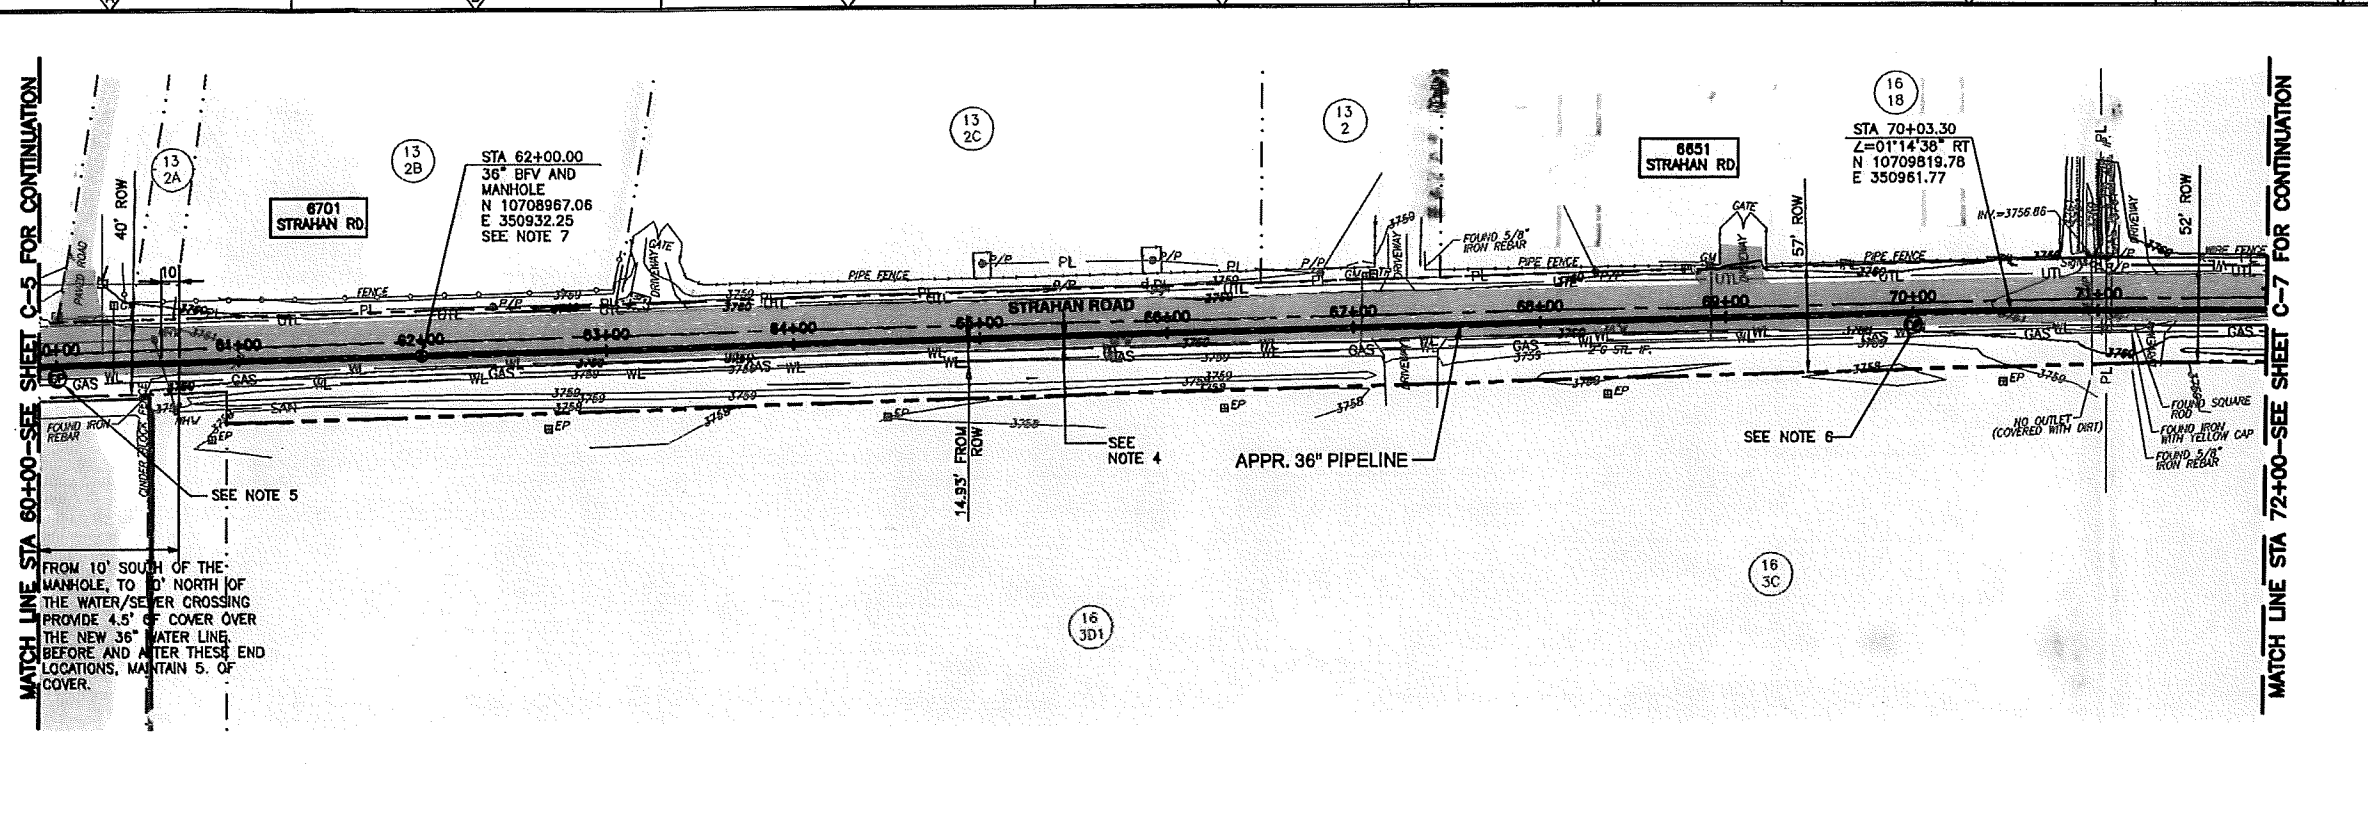
- CONSTRUCTION NOTES:**
1. CONTRACTOR PROVIDE PROJECT-WIDE TRAFFIC CONTROL. VEHICLE ACCESS IS REQUIRED ALONG STRAHAN ROAD AT ALL TIMES INCLUDING DRIVEWAYS THAT INTERSECT STRAHAN RD. PROVIDE FLAGMEN AS NECESSARY TO DIRECT TRAFFIC AROUND THE WORK AREA. SEE THE SPECIFICATIONS FOR LIMITS OF EXCAVATION AND ALLOWABLE OPEN TRENCH.

2. AT THE END OF EACH WORKING DAY AND ON WEEKENDS AND HOLIDAYS, CONTRACTOR ESTABLISH UNATTENDED VEHICLE ACCESS PAST THE WORK ZONE THROUGH THE USE OF TYPE III FLASHING BARRICADES, TRAFFIC BARRELS AND SIGNAGE TO PROVIDE SAFE ACCESS, PER IT'S TRAFFIC CONTROL PLAN.

5. CONTRACTOR INSTALL CP TEST STATION AT STA 60+00.
 6. CONTRACTOR INSTALL CP TEST STATION AT STA 70+00.
 7. AT THE 36" BUTTERFLY VALVE LOCATION, CONTRACTOR CUT AND REMOVE 20' OF EXISTING 36" WATER LINE, CENTERED AT THE NEW MANHOLE. PLUG BOTH ENDS OF EXISTING WATER LINE WITH BRICK AND MORTAR. SUPPORT AND PROTECT THE EXISTING NATURAL GAS LINE AND COORDINATE THIS EFFORT WITH TEXAS GAS SERVICE. TGS MAY ELECT TO RECOAT OR REHAB THE EXISTING EXPOSED GAS LINE, PROVIDED THE CONTRACTOR DOES NOT DAMAGE IT WHILE BEING EXPOSED. IF THE CONTRACTOR DAMAGES THE GAS LINE DURING THE EXPOSURE, THE DAMAGE WILL BE PAID BY THE CONTRACTOR AT NO COST TO THIS PROJECT.

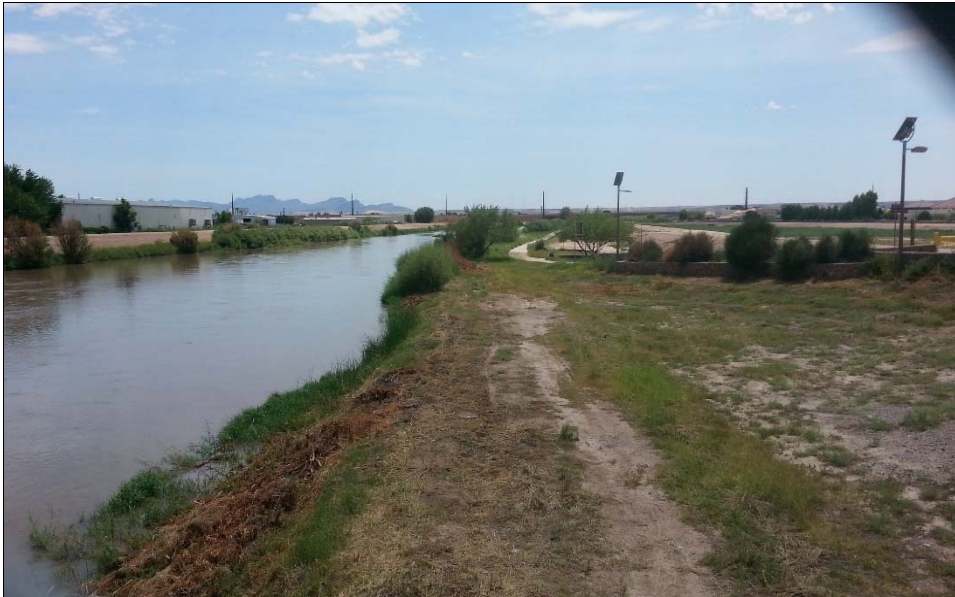
Rio Grande near Phase I survey area from West Borderland Road.
Photo Direction: south (downstream). Photo taken 8/18/2015.

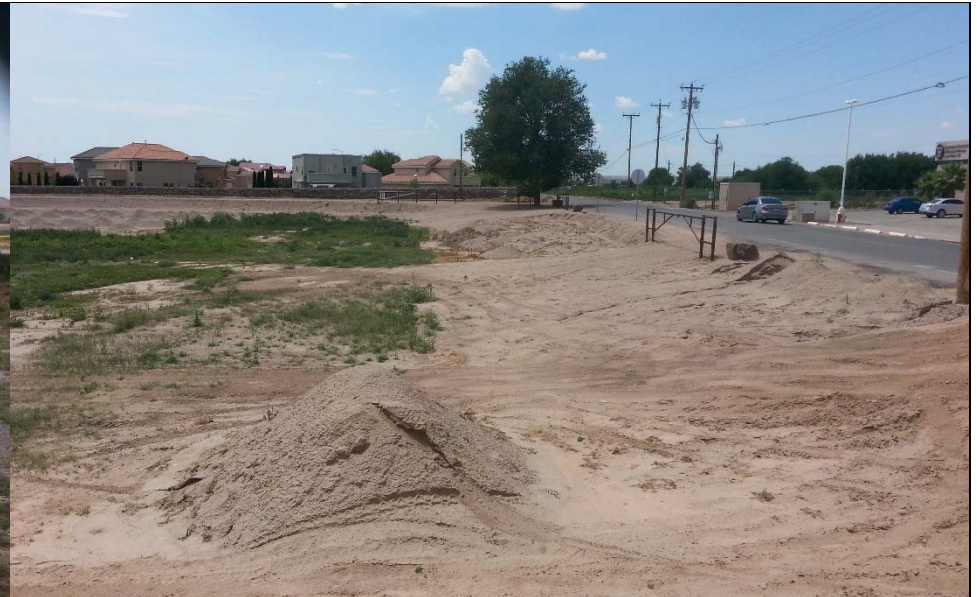
Phase I survey area located west of Rio Grande along West Borderland Road.
Photo Direction: west. Photo taken 8/18/2015.

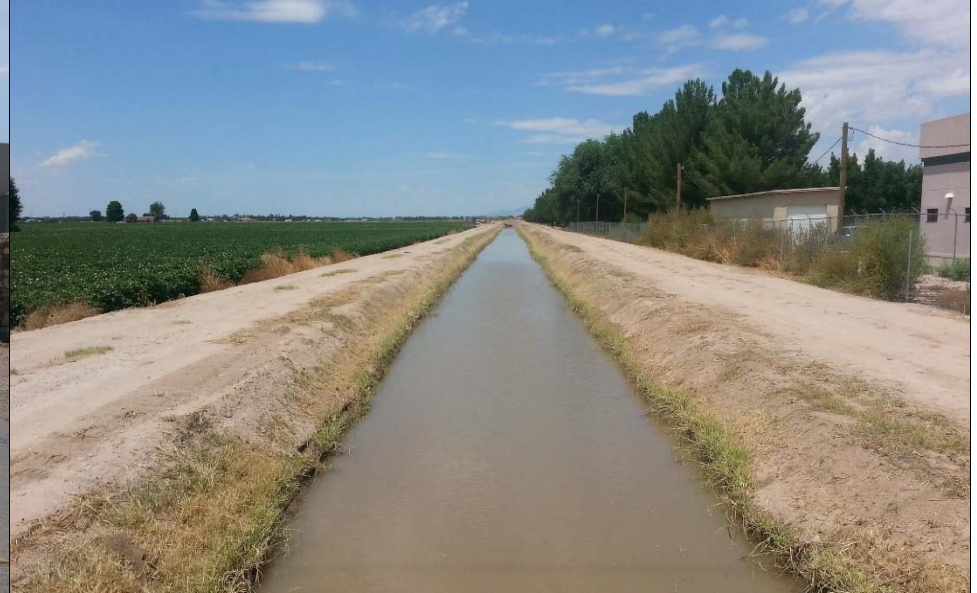
Phase I survey area irrigation canal (S-105) facing downstream adjacent to West Borderland Road. Photo Direction: south. Photo taken 8/18/2015.

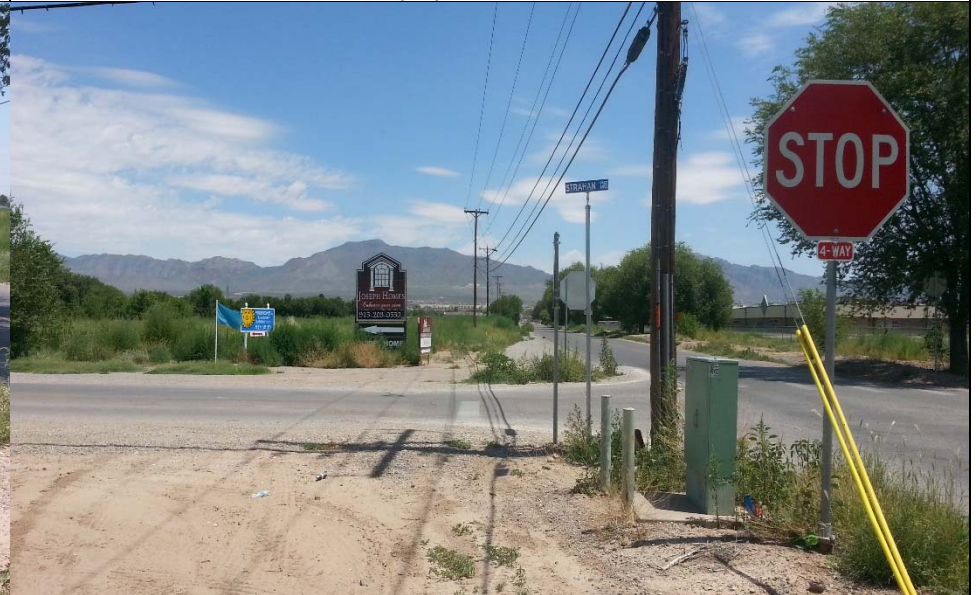
Roadside drainage ditch (D-104) located along West Borderland Road. Photo Direction: west. Photo taken 8/18/2015.

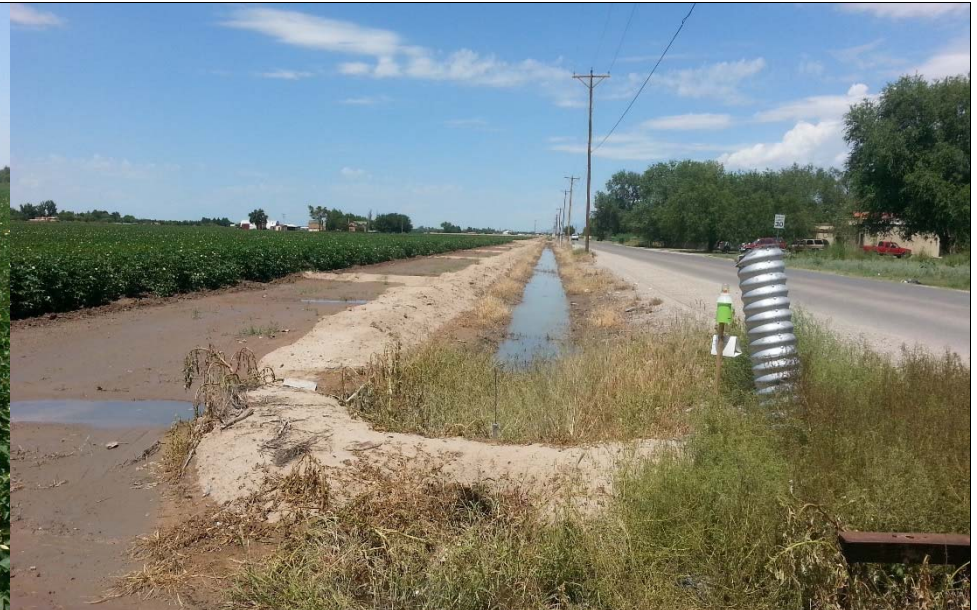
End of irrigation stream (S-102) along Strahan Road. Photo Direction: west (upstream). Photo taken 8/18/2015.

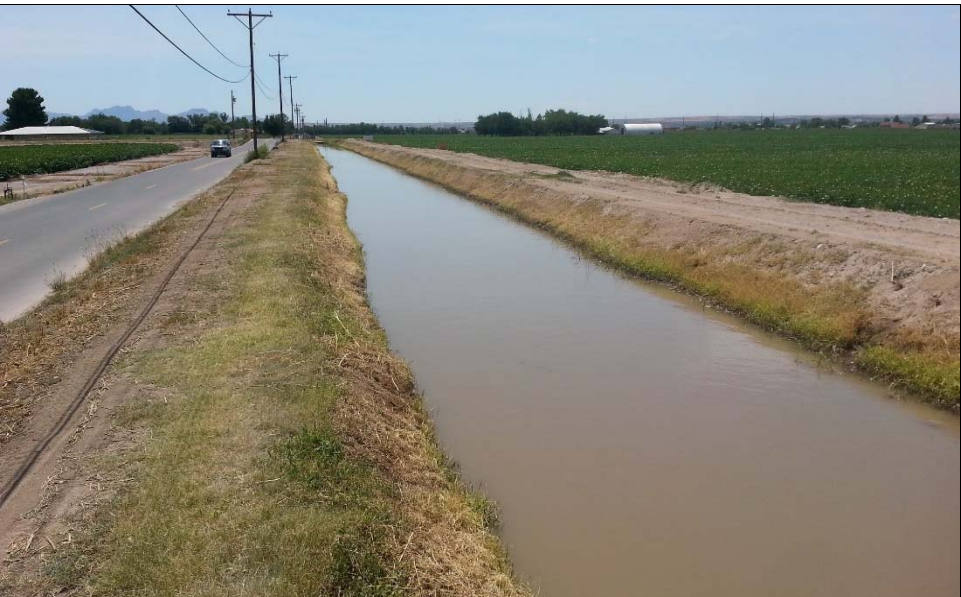
Unnamed Irrigation Canal (S-101) along Strahan Road. Photo Direction: south (downstream) Photo taken 8/18/2015.

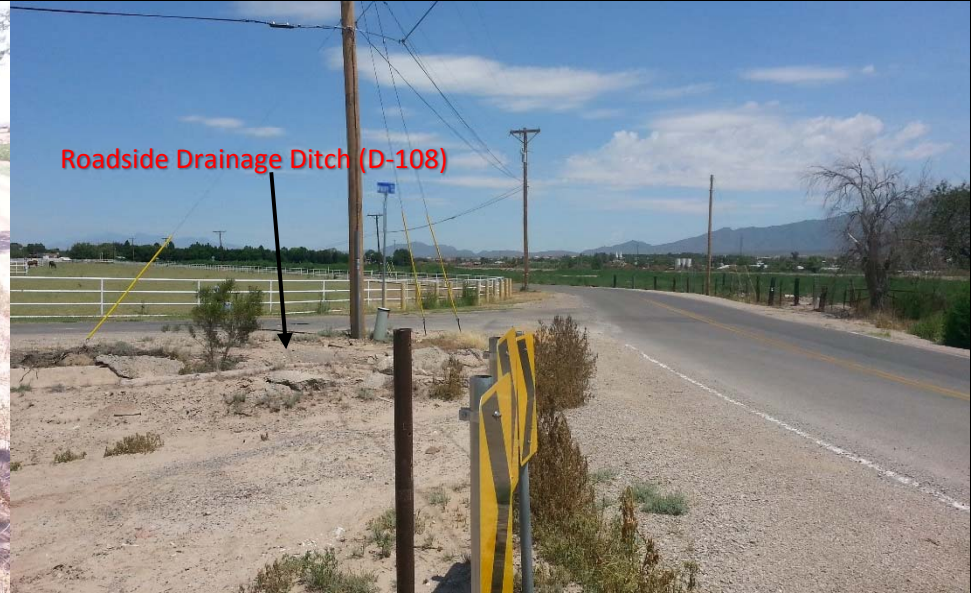
Roadside Drainage Ditch (D-100) located 0.5 miles south of Moore Road (Phase I survey area). Photo Direction: west (downstream). Photo taken 8/18/2015.

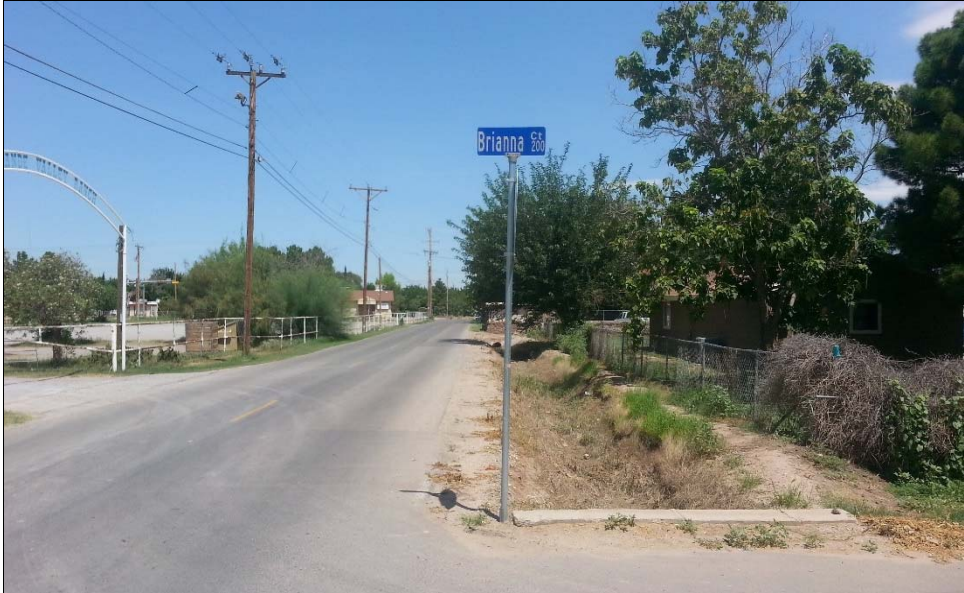
Beginning of Phase II survey area. Roadside drainage ditch (D-107) located north of Brianna Court. Photo Direction: north (upstream). Photo taken 8/18/2015.

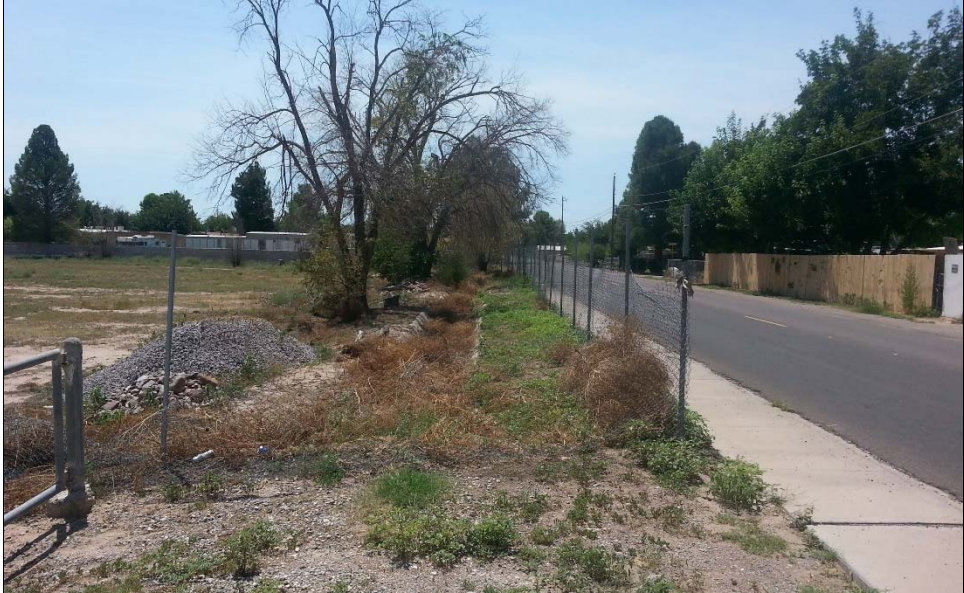
Roadside drainage ditch (D-106) located along Bosque Road, south of Western Way (Phase II survey area). Photo Direction: south (downstream). Photo taken 8/18/2015.

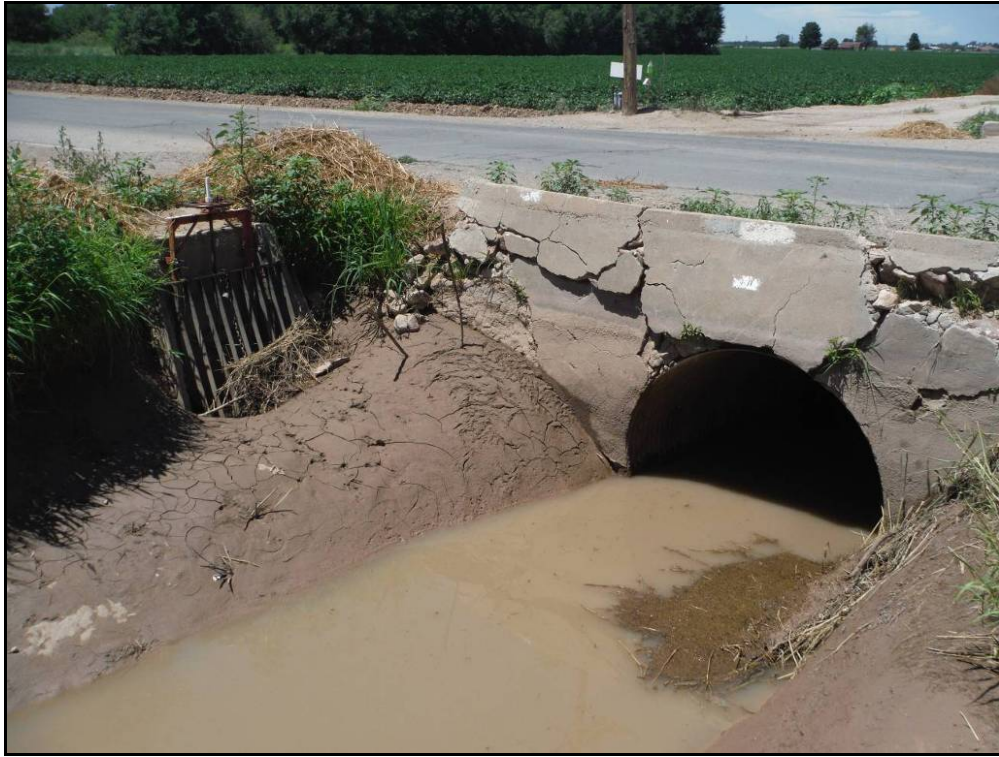
Figure 9. Canutillo Lateral on Borderland Road, near the Rio Grande Bridge, facing north.

The Canutillo Lateral bisects the project area in two places and has existing damage (**Figure 9**); however, boring under the lateral (5 feet below the surface) will not further affect it. Cultural properties identified within the 1.0-mile radius of the proposed project area included approximately eight archeological sites and four archeological pedestrian survey projects. **Table 1** lists the cultural properties identified.

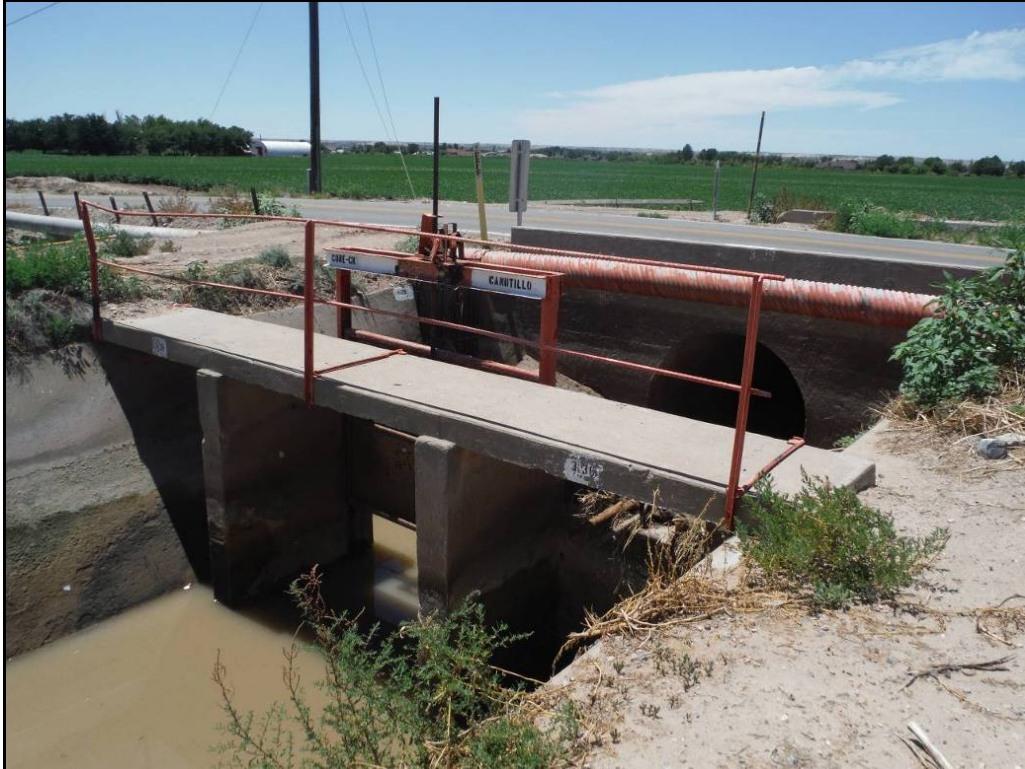
Figure 10. Canutillo Lateral on Strahan Road, facing west.
