Structure Plan

Lot 1 (303) Corfield Street, Gosnells

Prepared for Powerstar Pty Ltd atf Aveling Family Trust and Zeditave Pty Ltd JV C/- Viridian Property Group

June 2017

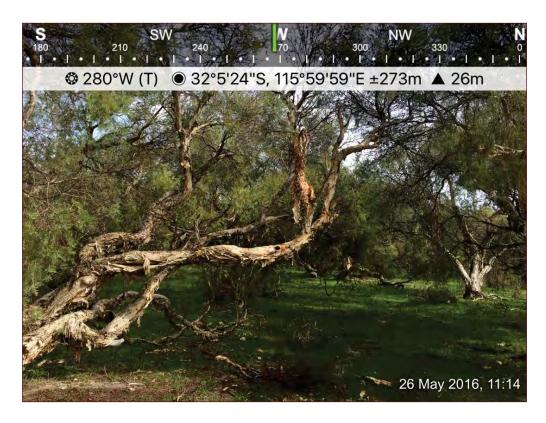
Plate 1: Class B woodland vegetation within the REW POS area

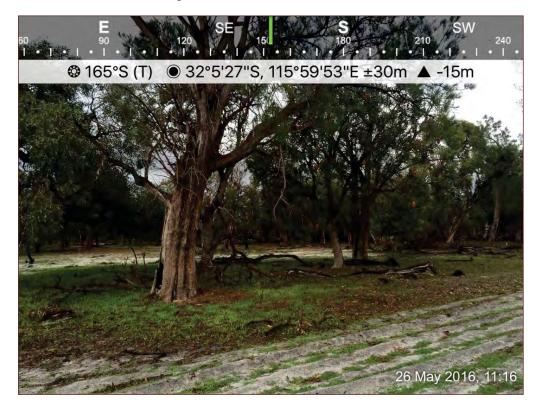
Plate 2: Class B woodland vegetation south of the subject site

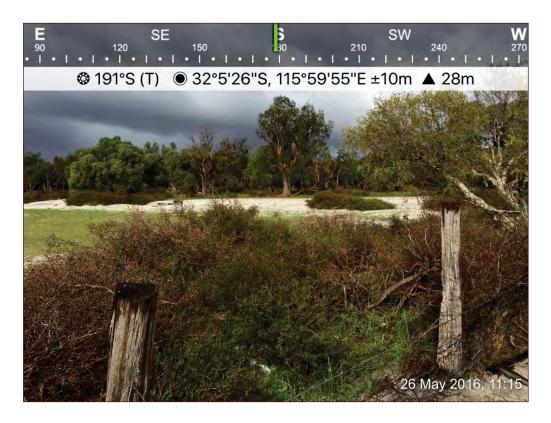
Plate 3: Class C shrubland south of the subject site

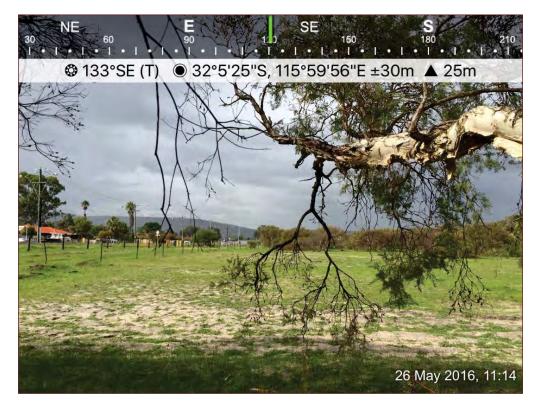
Plate 4: Class G grassland south of the subject site (background)

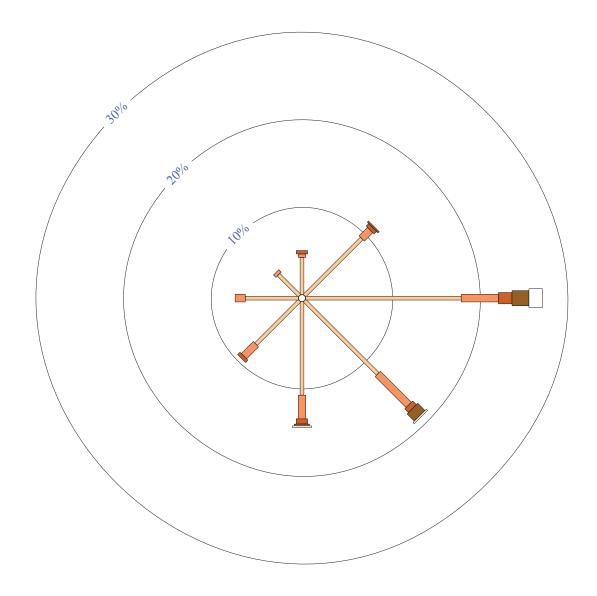
Rose of Wind direction versus Wind speed in km/h (17 Jul 1991 to 30 Sep 2010)

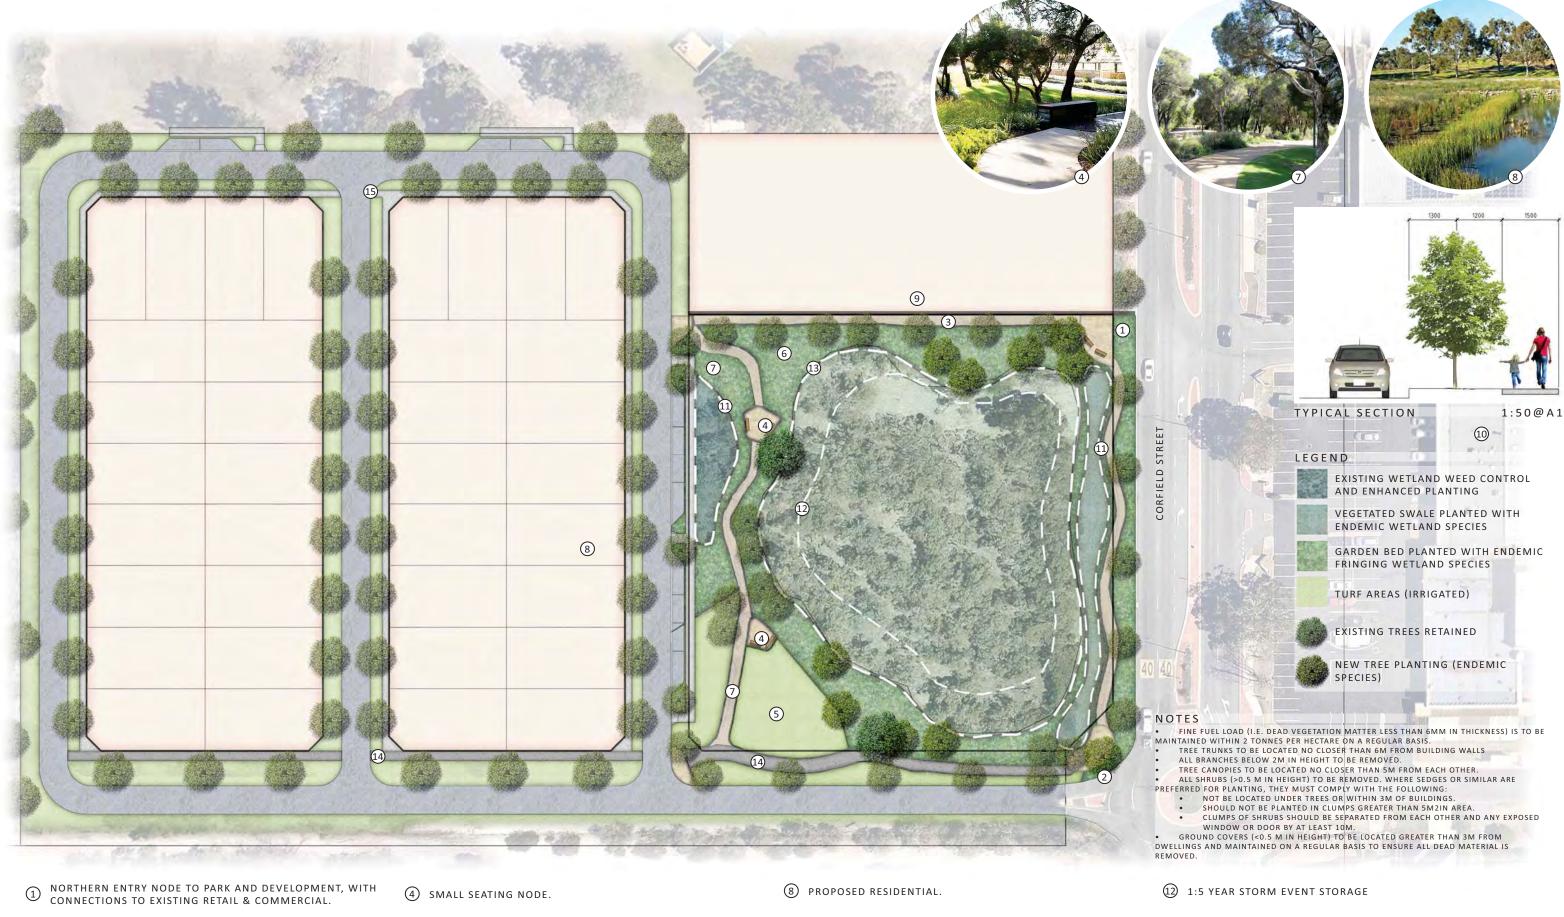
- ② SOUTHERN ENTRY NODE TO DEFINE ENTRY TO PARK AND DEVELOPMENT WITH PUBLIC ART.
- 3 FOOTPATH TO PROVIDE ACCESS AND SERVICE TO NEW COMMERCIAL.
- (5) INFORMAL KICK-ABOUT AREA.
- 6 BENCH SEAT.
- (7) INSITU CONCRETE PATH.

- 9 PROPOSED COMMERCIAL.
- 10 EXISTING RETAIL & COMMERCIAL.
- 11 1:1 YEAR STORM EVENT STORAGE

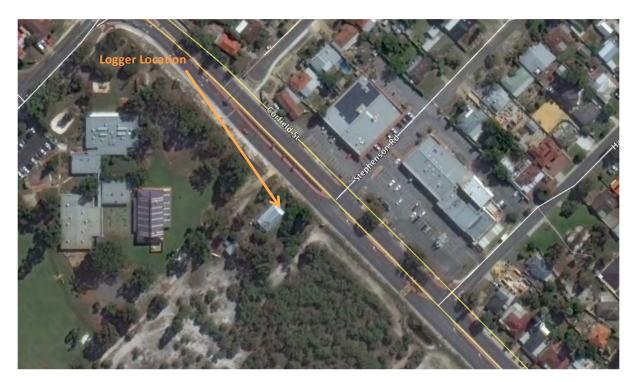
Figure 3-1 Logger Location

The instrument used was an ARL Type 316 noise data logger, located 16 metres from the edge of the road, with the microphone 1.4 metres above ground level. The logger was programmed to record hourly L_{A1} , L_{A10} , L_{A90} , and L_{Aeq} levels. This instrument complies with the instrumentation requirements of *Australian Standard 2702-1984 Acoustics – Methods for the Measurement of Road Traffic Noise*. The logger was field calibrated before and after the measurement session and found to be accurate to within +/- 1 dB. Lloyd George Acoustics also holds current laboratory calibration certificate for the loggers.

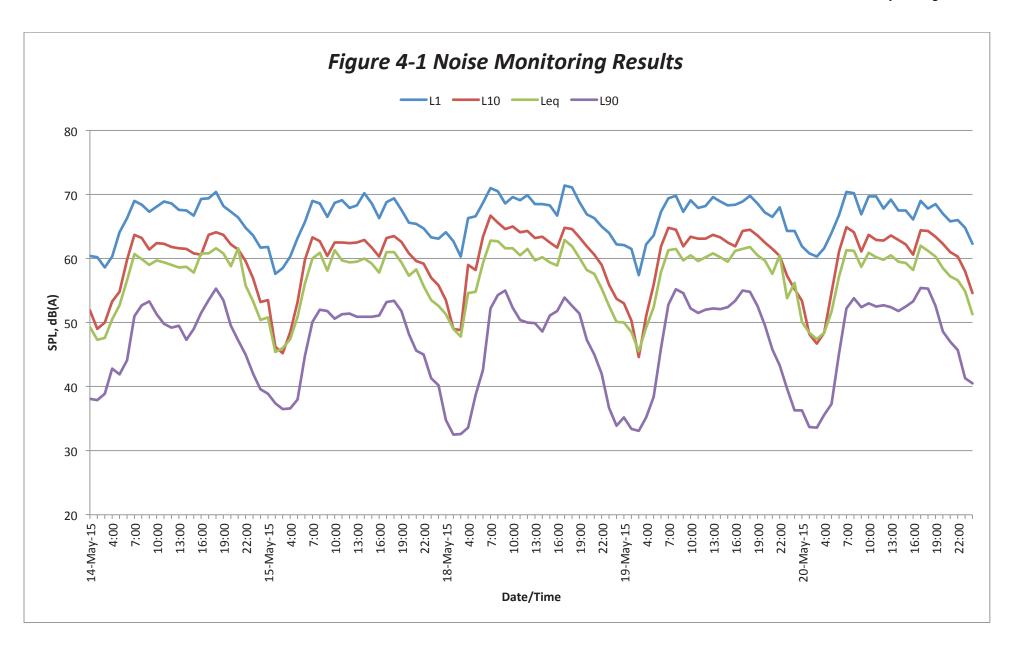
The average differences between the weekday $L_{A10,18hour}$ and $L_{Aeq(Day)}$ is 1.8 dB and this conversion has been used in the modelling. The average differences between the weekday $L_{Aeq(Day)}$ and $L_{Aeq(Night)}$ is 7.4 dB. This same difference has been assumed to exist in future years. As such, it is the daytime noise levels that will dictate compliance since these are at least 5 dB more than night-time levels.
