FULL-SCALE 1,800 LB. VEHICLE CRASH TEST ON THE IOWA W-BEAM APPROACH GUARDRAIL TO THE CONCRETE SAFETY SHAPE BRIDGE RAIL

TRANSPORTATION RESEARCH REPORT TRP-03-23-90

February 1991

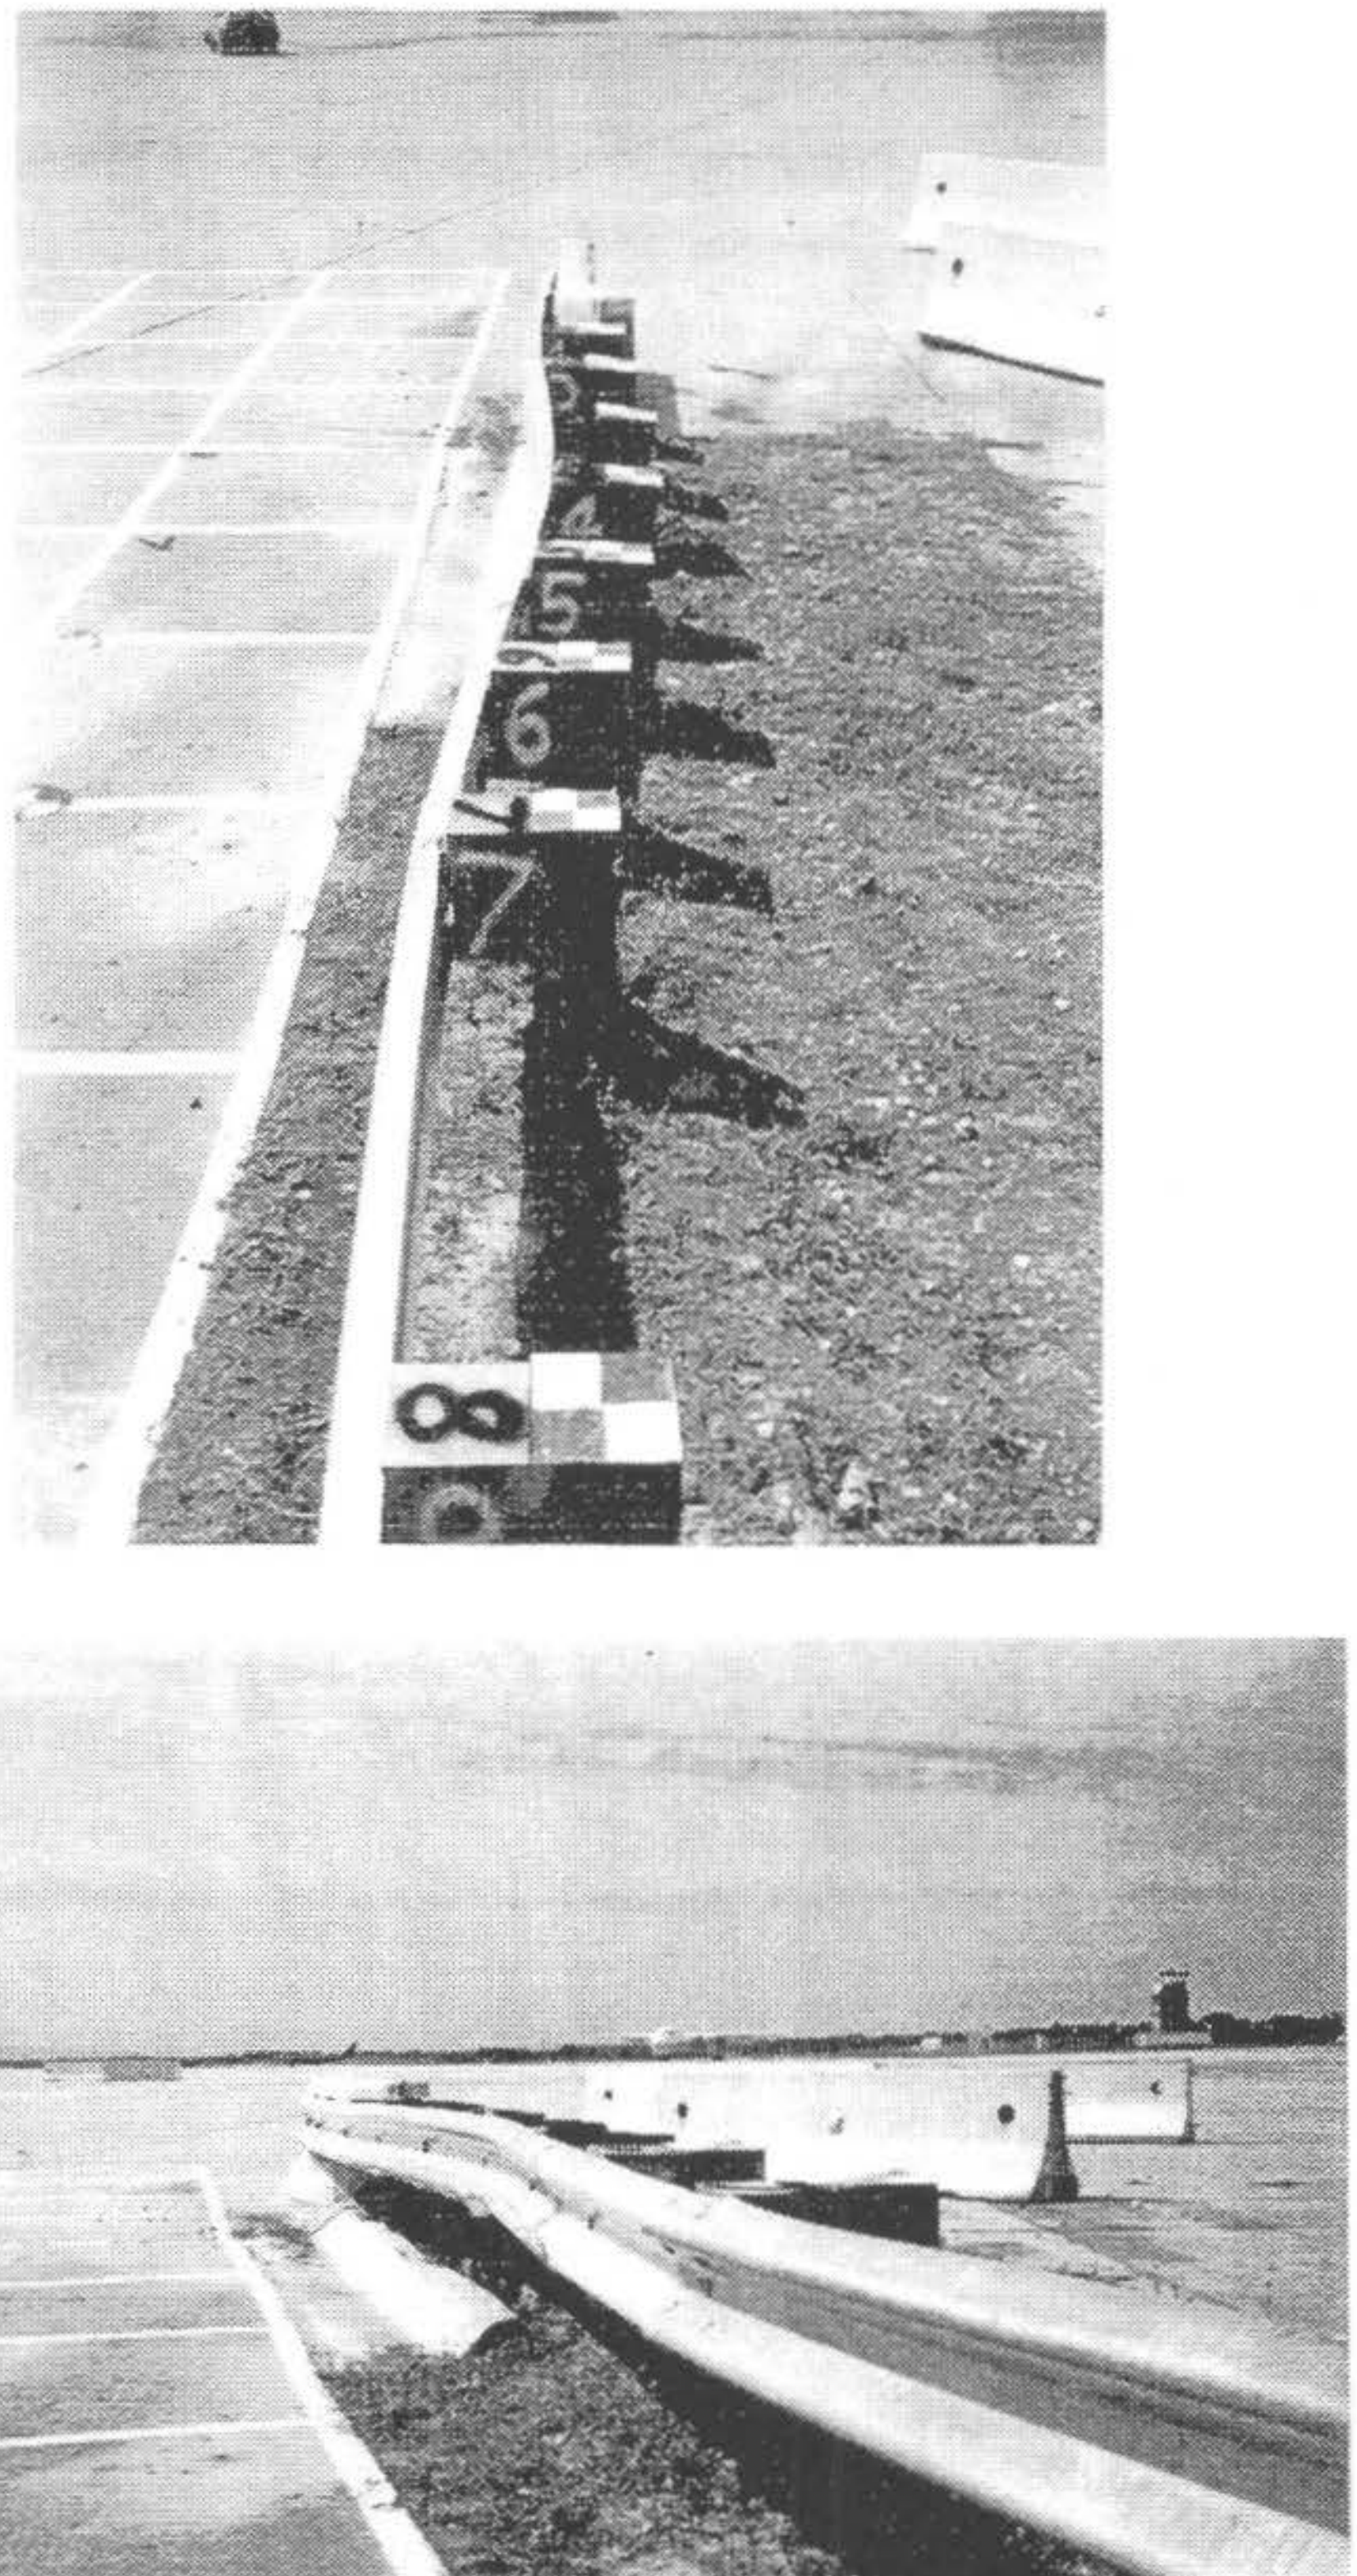
FIGURE 23. PHOTOGRAPHS OF DAMAGE TO APPROACH GUARDRAIL TRANSITION SECTION.

Photographs of the vehicle damage are shown in Figure 22. As evident, the vehicle damage was marginal. The TAD and VDI damage classifications are shown in Figure 20. Photographs of the satisfactory damage to the approach guardrail transition section are shown in Figures 23 and 24.

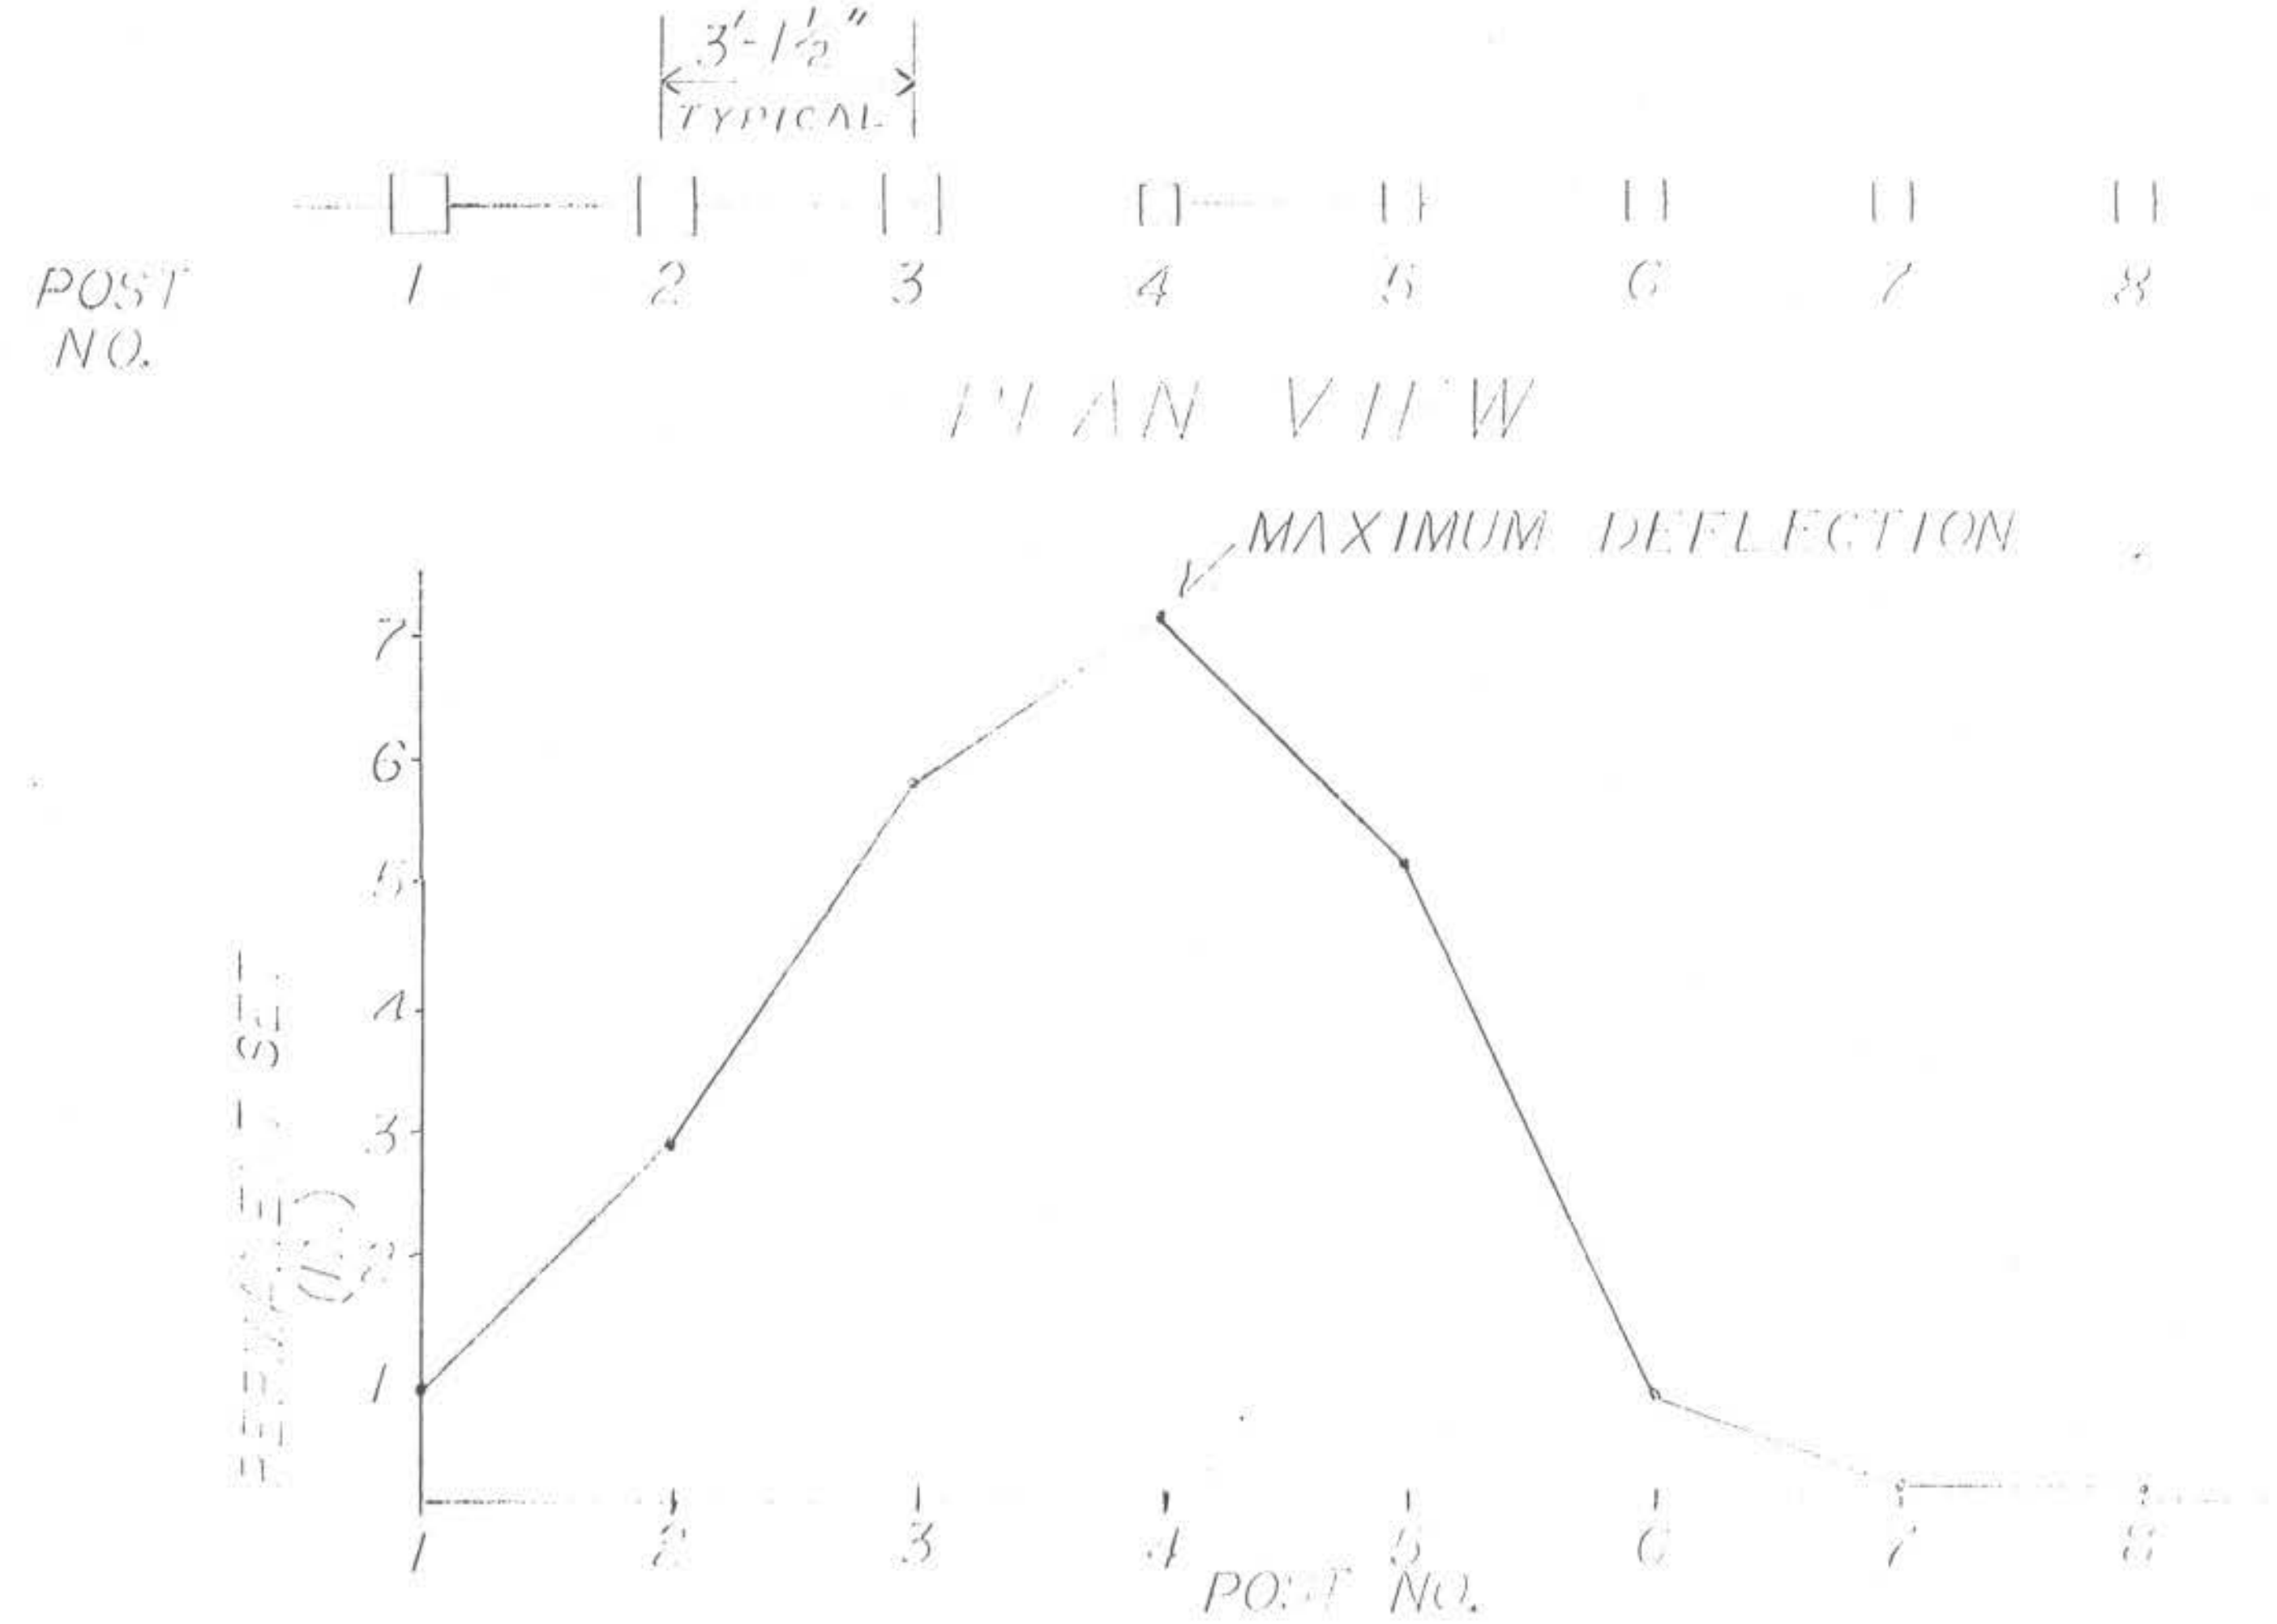
FIGURE 25. GRAPH OF PERMANENT SET DISPLACEMENTS

After the test, the permanent set was measured and is shown in Figure 25. The maximum permanent set was 7.2-in. which occurred at post 4. The maximum lateral dynamic deflection was 14.0-in. as determined from the overhead high-speed camera.
