# Currawong Farm

## Bushland Vegetation Snapshot Habitat Survey

Eco-restoration planning as part of Gondwana Link

## September 2019- Draft Report

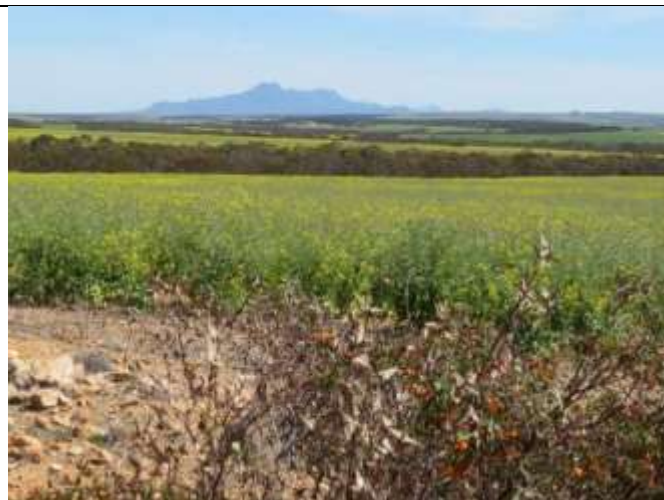
Site 69: *Gastrolobium spinosum* (Prickly Poison), Canola crops, remnant vegetation corridors and the Stirling Ranges

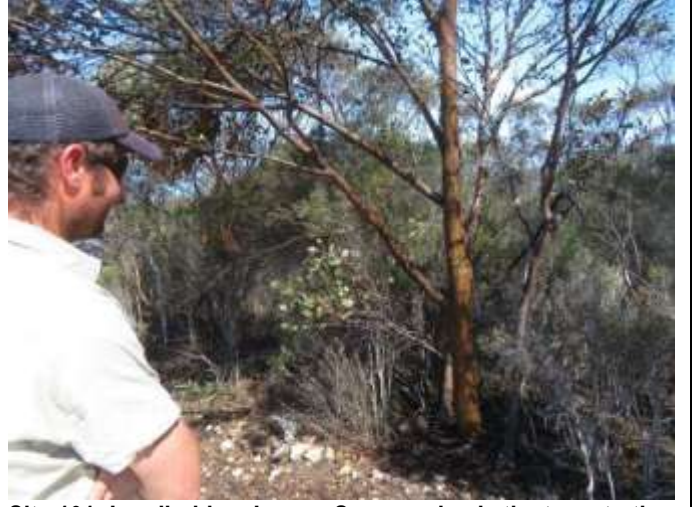
**Site 101: Landholder, Jeremy Spencer, leads the team to the Red Moort (*Eucalyptus vesiculosa*).**

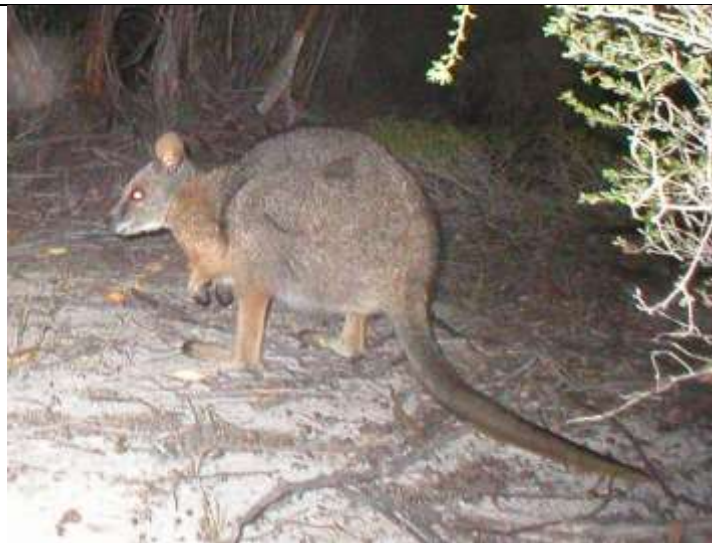
**Tammar Wallaby in Mallee heath vegetation ion Monjebup Reserve adjacent to Currawong (Photo: Angela Sanders)**

MANAGEMENT RECOMMENDATIONS AND/OR REASON FOR PRIORITY
<ul style="list-style-type: none"> <li>➤ Very high priority to retain</li> <li>➤ Tammar Wallaby and Malleefowl have been sighted in this remnant vegetation</li> <li>➤ Landholder has indicated interest in some associating this portion of bushland to the Bush Heritage Reserve nearby ( North Monjebup)</li> <li>➤ Project site 0.881 km required to re-fence southern edge of this remnant (Project 14)</li> </ul>
