# Destruction of Mature Tree Geebungs (*persoonia arborea*) Breach Report

Icy Creek, Tanjil State Forest

461-503-0006 'Glanworth'

Report on the destruction of mature Tree Geebungs (*Persoonia arborea*) within active VicForests coupe 461-503-0006 'Glanworth' in Icy Creek in breach of the 'Management Standards and Procedures for timber harvesting operations in Victoria's State forests' and 'Code of Practice for Timber Production'.

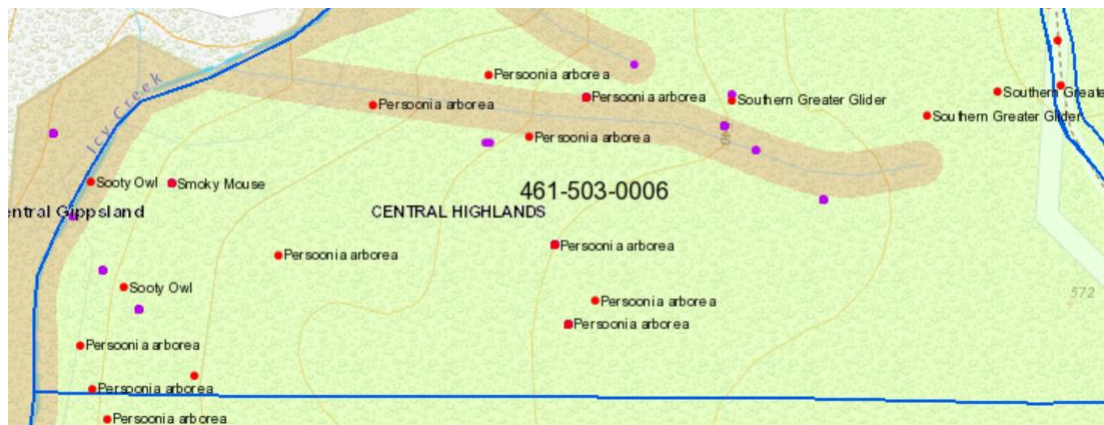
Figure 5. Forest Protection Survey Program data within VicForests active coupe 461-503-0006, attained on June 22<sup>nd</sup>, 2020 at:

503-0006. We request DELWP and OCR to thoroughly investigate the destroyed mature Tree Geebungs at 'FELLED PA' (Figure 4) and visit each of the Tree Geebung sites in Table 1 and Figure 5 above to assess if any additional Tree Geebungs have been destroyed. We expect that justice will be delivered for the Tree Geebungs that were destroyed within the coupe and that VicForests will be prosecuted for this breach of the law.
