NONCONFORMANCE - REPORT LOG & STATUS BOOK

1. PROJECT NO. 7220

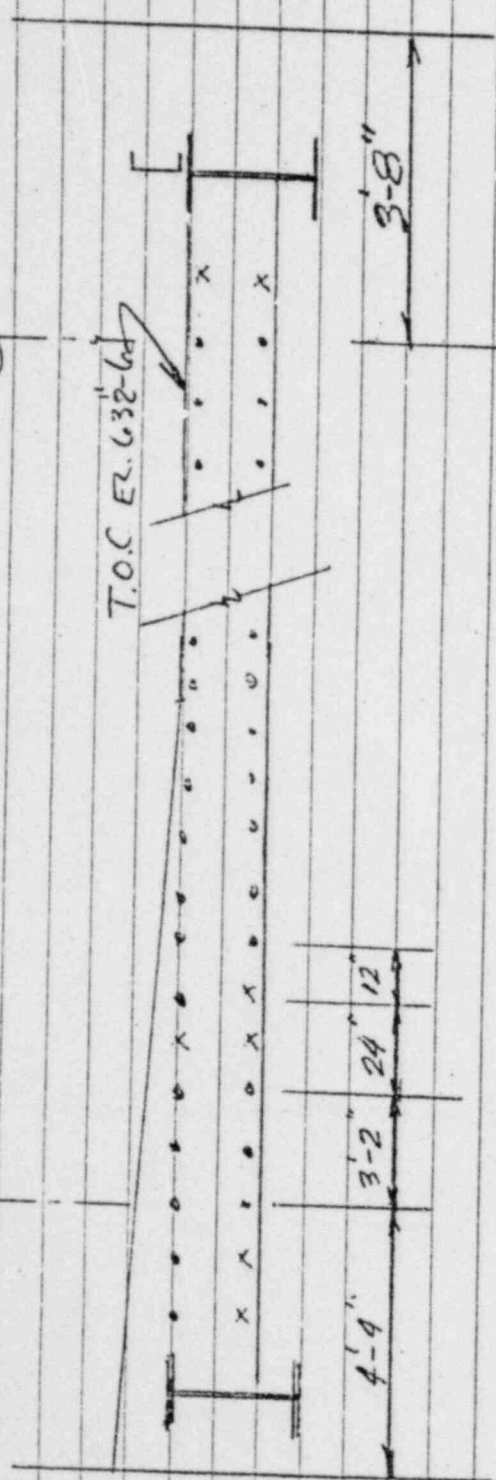
G-LINE WALL SOUTH FACE
(LOOKING NORTH)

NOTE: "X" DENOTES "NO AXCEL"
PR. Account
6/25/76

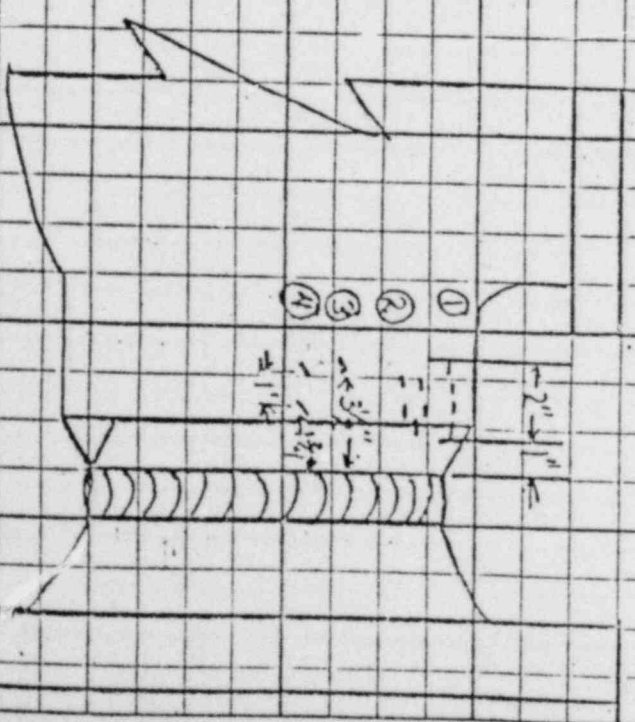
ANCHOR/DARLING
 VALVE I.D. 16-HBC-QK-Z
 SN# 5206-01
 SN# 3N-641
 16" 700 PSI

- 1) 3/4" From 12:00
- 2) 4 3/4" From 12:00
- 3) 7 1/2" From 12:00
- 4) 11" From 12:00
