EcoStruxure Machine Expert V2.0

Release Notes

RN0000000035.09

04/2021

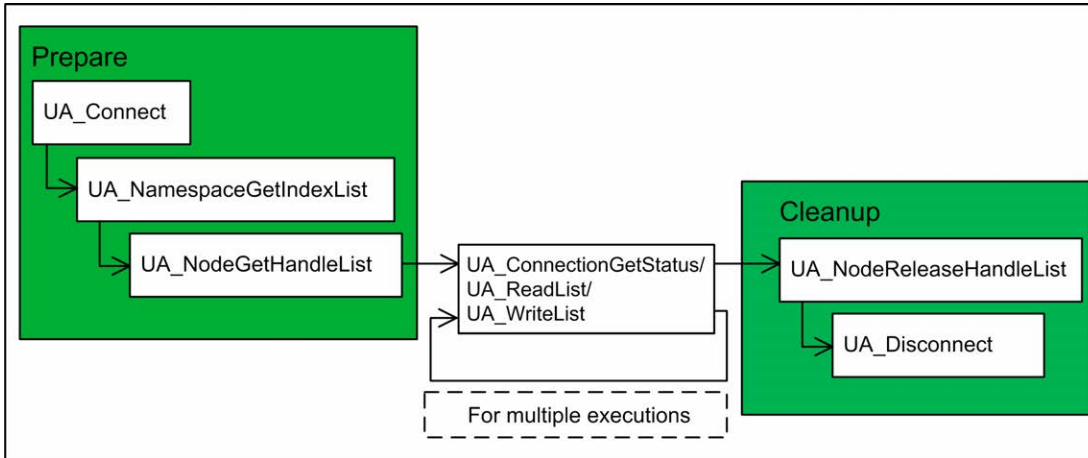
The graphic provides an example for managing the read/write list:
