Final Environmental Assessment
for the

West Puerto de Luna Acequia Rehabilitation Project
Guadalupe County, New Mexico
Section 1113 of P.L. 99-662 (WRDA 1986)

January 2010

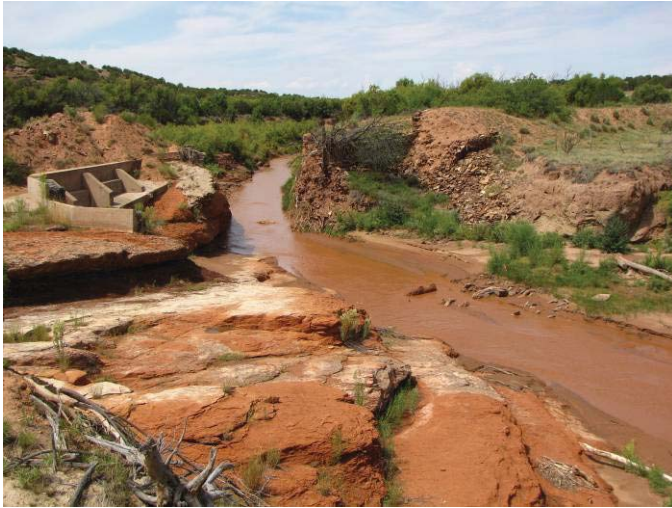
Washed-out West Puerto de Luna diversion dam on Agua Negra Creek, looking upstream and to the west.

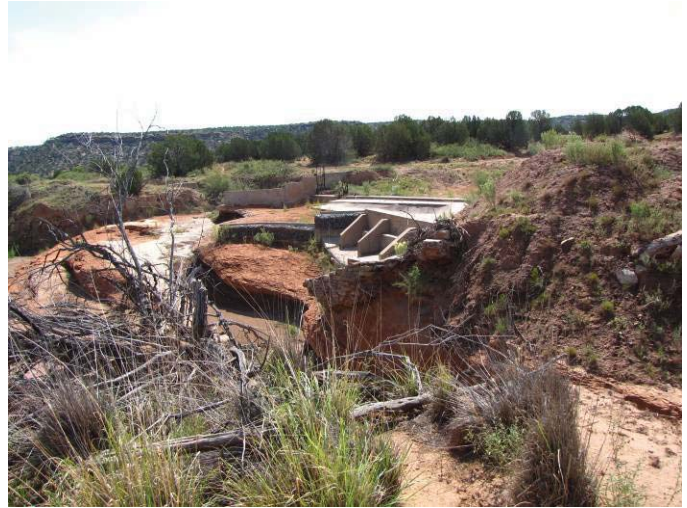
Washed out West Puerto de Luna diversion dam on Agua Negra Creek, looking downstream and to the east.

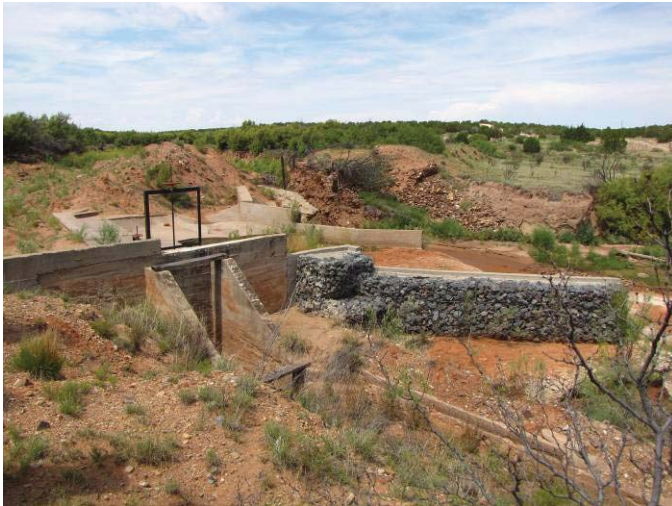
West Puerto de Luna Acequia head gate and washed-out diversion dam, looking north.

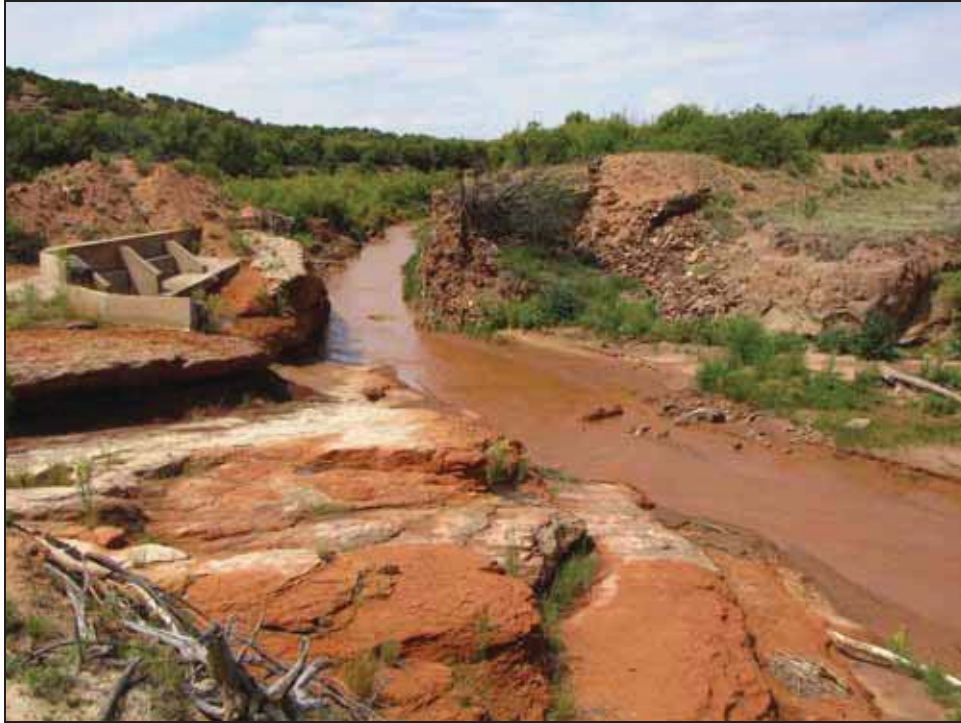
Figure 2.1. Overview of the diversion structure, looking west.

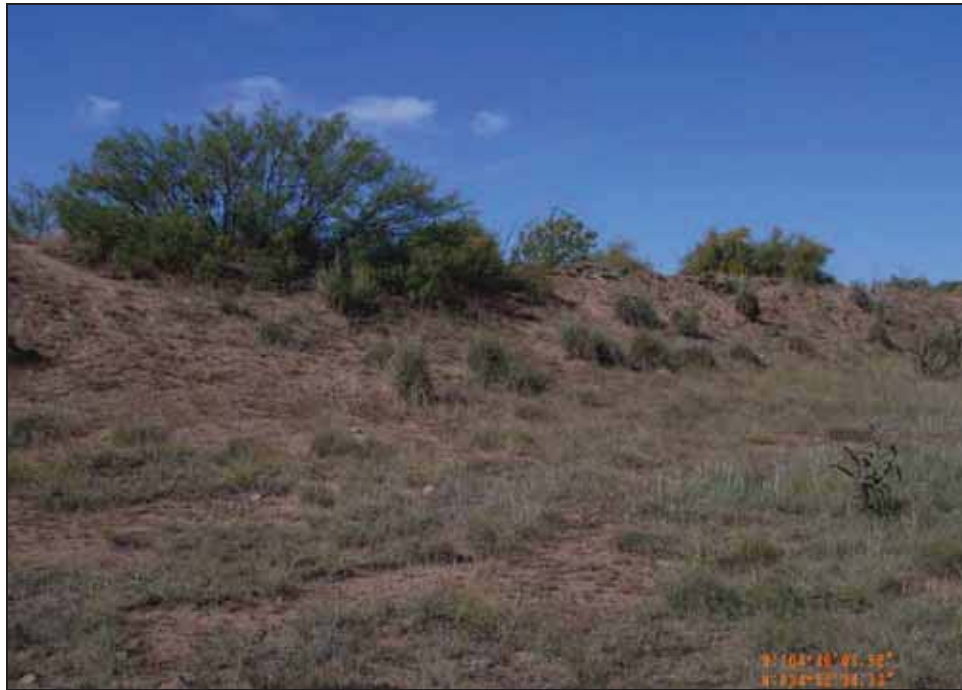
Figure 4.2. Earthen berm extending northwest from diversion, facing west.

On the north side of the river, there is a raised earthen berm extending from the diversion approximately 90 meters to the northwest (Figure 4.2; see again Figure 4.1). As it approaches the diversion, it measures between approximately 8.7 meters wide to a maximum of 13.5 meters wide, with a height above surrounding ground surface ranging between approximately one and two meters. At the berm's southern end, where it reaches the upper river bank and the beginning of the rock-and-brush diversion dam, it is surrounded on west, south, and eastern sides by masonry retaining walls (Figure 4.3).

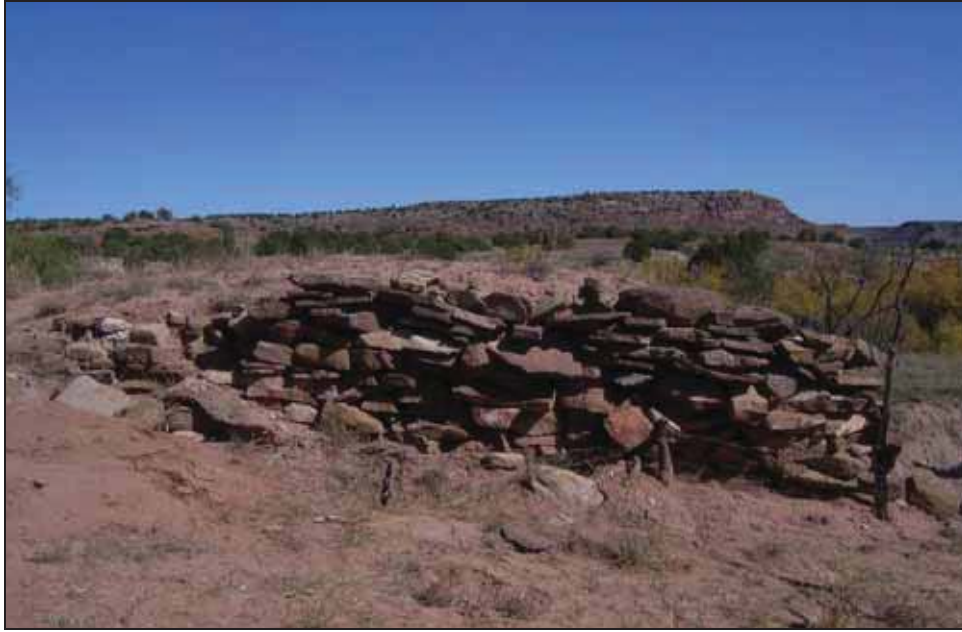
Figure 4.4. Western retaining wall, facing east.

The retaining walls are built of coursed and unshaped or minimally shaped tabular sandstone slabs. The walls vary from approximately 70 to 130 cm in height, and between 7 and 10 courses tall. Walls are between one and two courses deep, and none show evidence of mortar. A retaining fence of chicken wire secured to rough-hewn wooden posts extends around the entire southern end of the earthen berm, serving to support all of the remaining masonry retaining walls. The wire fence itself is failing at multiple locations.

The eastern and western retaining wall segments are still largely intact, the most intact being the western wall. The western retaining wall is mostly straight and largely undamaged. It is between four and ten courses high (Figure 4.4, Figure 4.5). The eastern retaining wall is curved, following the curvature of the end of the earthen berm (Figure 4.6, Figure 4.7). It is two courses deep and between six and nine courses high. It is partially collapsed, but is being held in place by the wire fence, visible in Figure 4.6. The southern retaining wall, however, has largely collapsed, with the rock falling downslope onto a large mass of collapsed sandstone rock originally used to armor the northern river bank (Figure 4.3; also visible in Figure 4.8). The sandstone used in all of these walls and in the collapsed masonry now littering the northern river bank all appears to be of the same type, and likely came from the same general source areas.

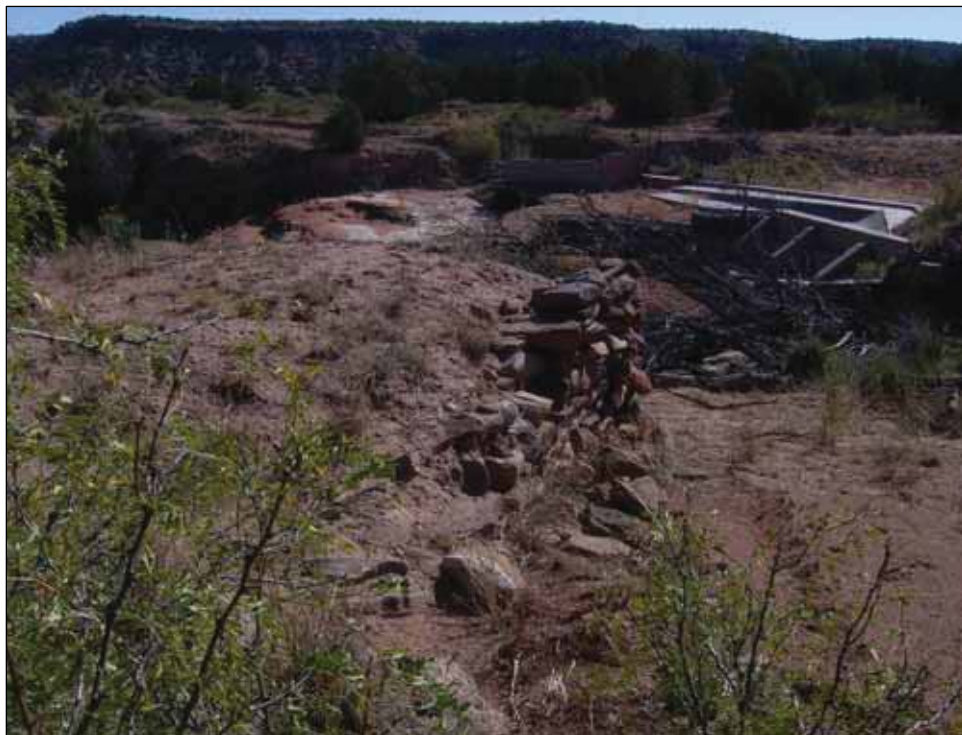
Figure 4.5. Western retaining wall, facing southeast.

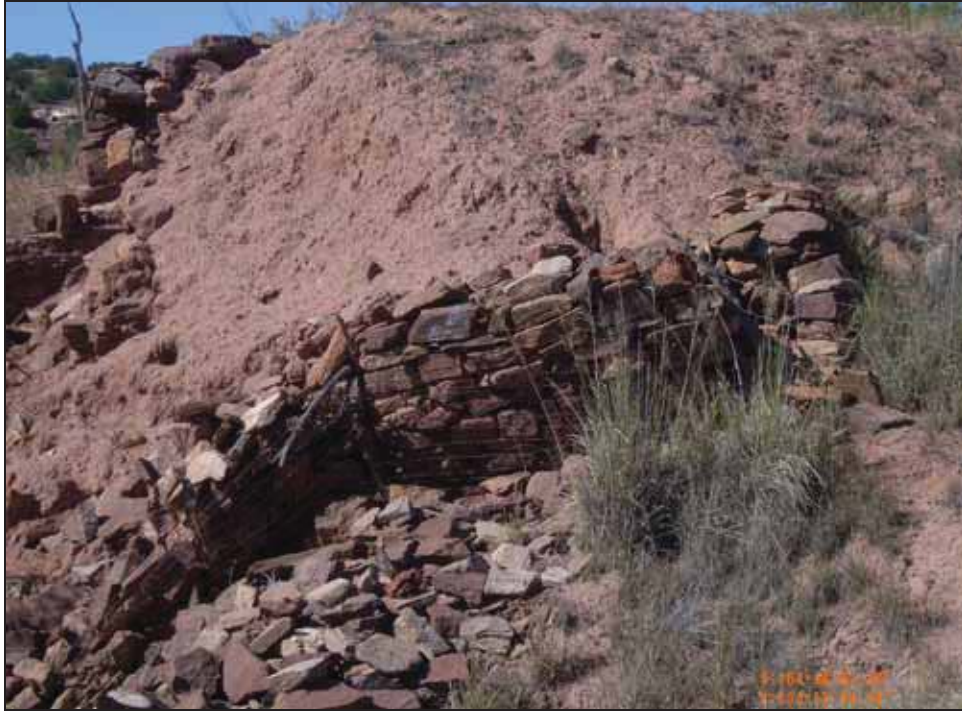
Figure 4.6. Eastern retaining walls at southern end of earthen berm, facing west.

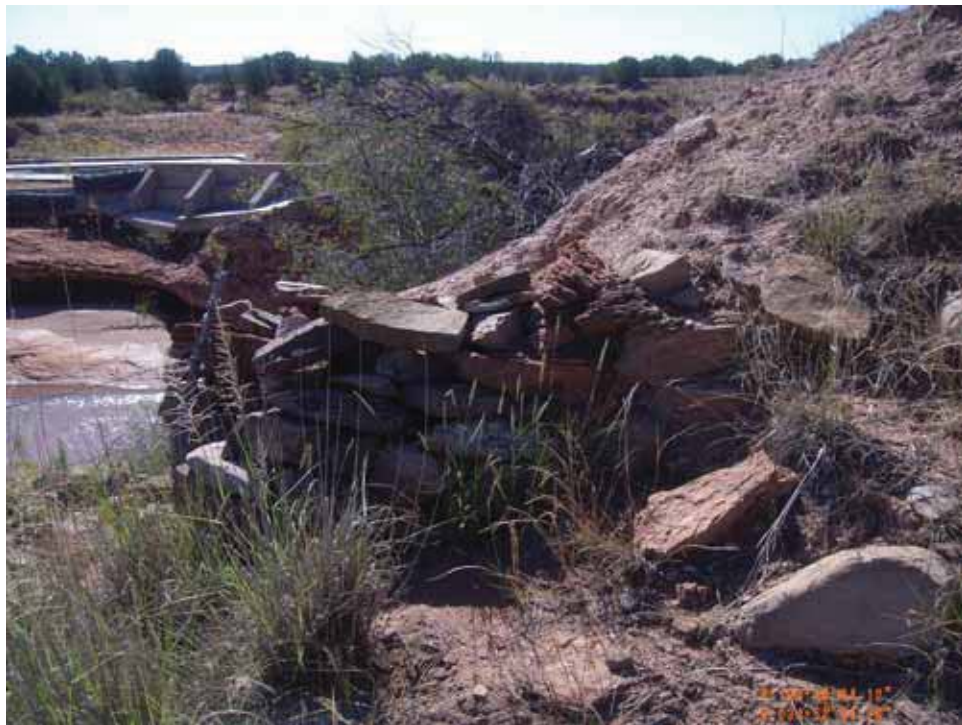
Figure 4.7. Northern end of eastern retaining wall, arcing inward toward the earthen berm.

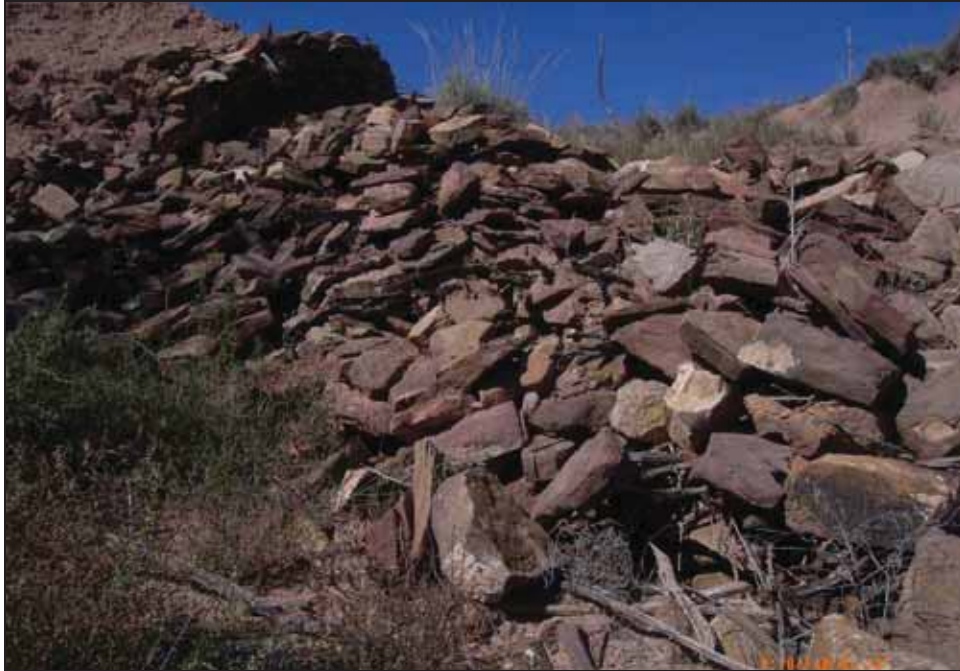
Figure 4.9. Remnants of masonry armor river bank, facing northwest (uphill) toward earthen berm.

As noted above, there is a large, dense scatter of unshaped tabular sandstone covering the northern river bank and the eastern face of the remaining portion of the rock and brush diversion dam, extending in a disorganized and displaced fashion down to near the river channel (Figure 4.3, Figure 4.8, and Figure 4.9). This masonry appears originally to have been installed as a method of armoring the northern river bank against erosion, as well as strengthening the downstream face of the diversion dam and protecting it from erosion as well. After the dam was breached, much of this appears to have been eroded, displaced and collapsed. The original extent of this armoring is unclear, but it appears to have extended over some portion of the northern bank and at least over the entire eastern face of the diversion dam (see discussion of diversion structure below).

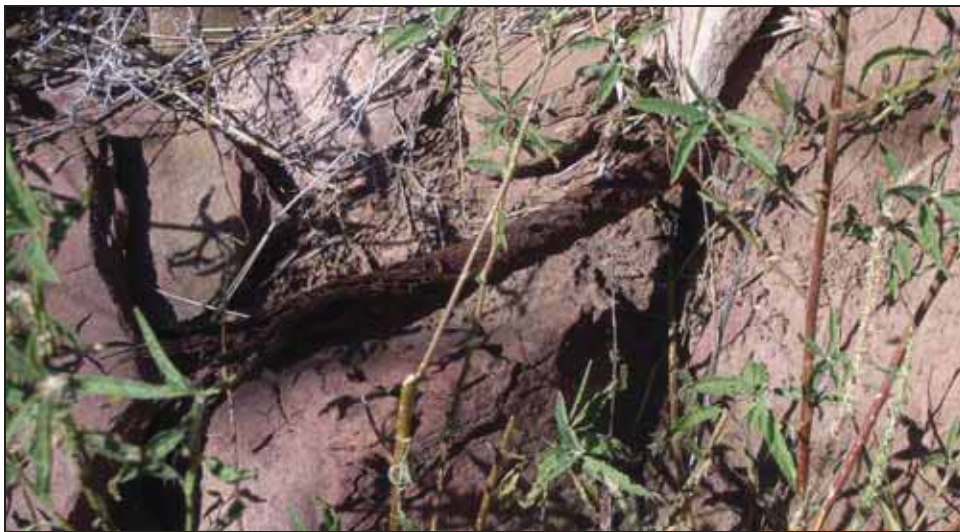
Figure 4.10. Braided steel cable found among collapsed sandstone rubble.

Within the rubble downslope, archaeologists noted a severed segment of one-inch braided steel cable of the same type found associated with wooden posts/pilings appearing west of the berm and diversion structures. These are discussed in greater detail below; the precise association of this cable with those is unclear, however, as the cables on the western side of the berm appear to be connected to a large series of wooden pilings that have not been found on the eastern side of the diversion.

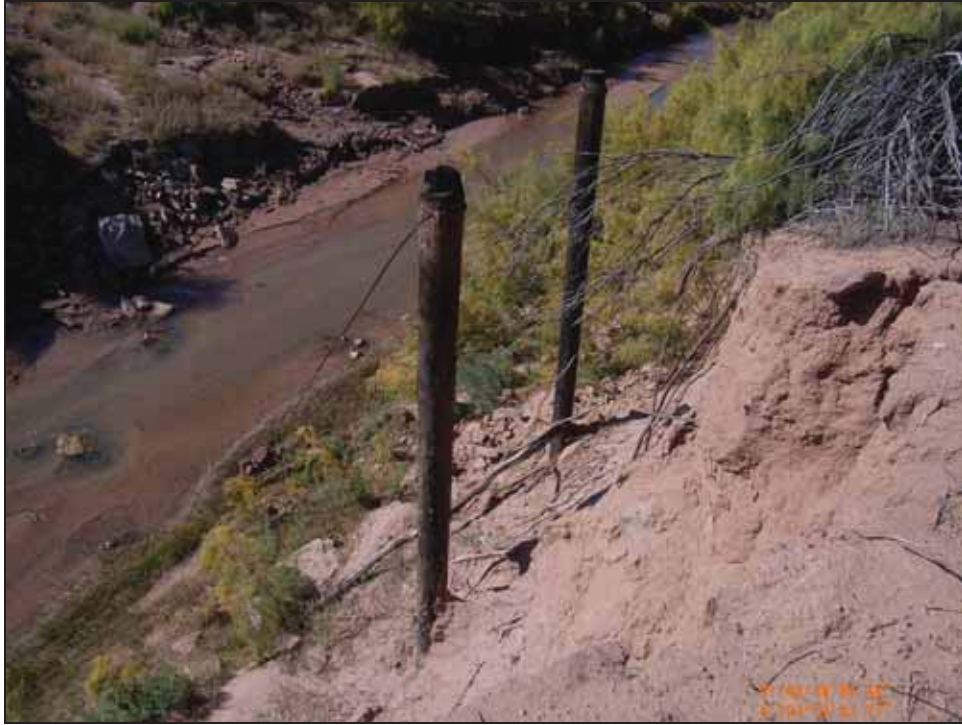
Figure 4.11. Wooden pilings eroding out of northern bank, facing southwest.

On the northern side of the river, archaeologists observed a number of what appear to be wooden pilings or posts arranged in a roughly northwest-to-southeast direction to the east of the berm, and possibly extending down into the area once covered by the diversion dam itself (see Figure 4.1). The most highly visible of these are the set of three posts eroding out of the northern river bank (Figure 4.11). These were presumably originally dug down into the sediment to a depth of several feet, but are now standing with approximately 20 feet of height exposed. Around two of them are the remains of a one-inch diameter braided steel cable of the same type found in the eastern collapsed-rubble area (see above).

The actual purpose of these posts, all apparently connected to other posts with steel cable, is unclear. It is possible that they were intended to shore up and strengthen the diversion structurally. It is also possible that they served as supports for some sort of other structure, such as a bridge or similar feature.

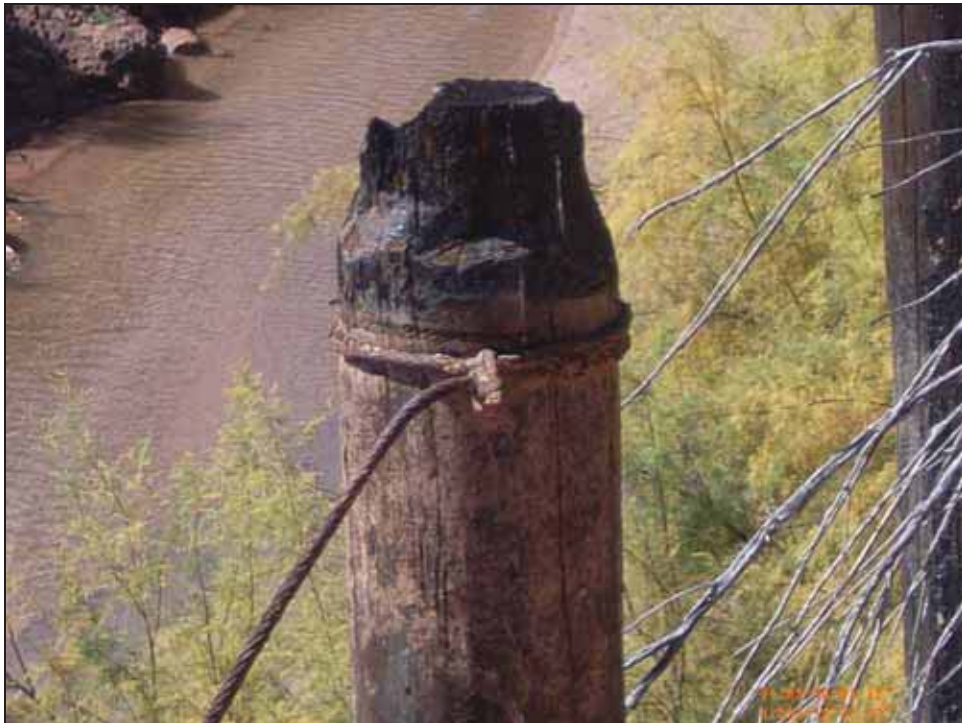
Figure 4.12. Top of one of the wooden pilings eroding out of the south bank, showing attached steel cable, facing west. Dangling cable end points southeast.

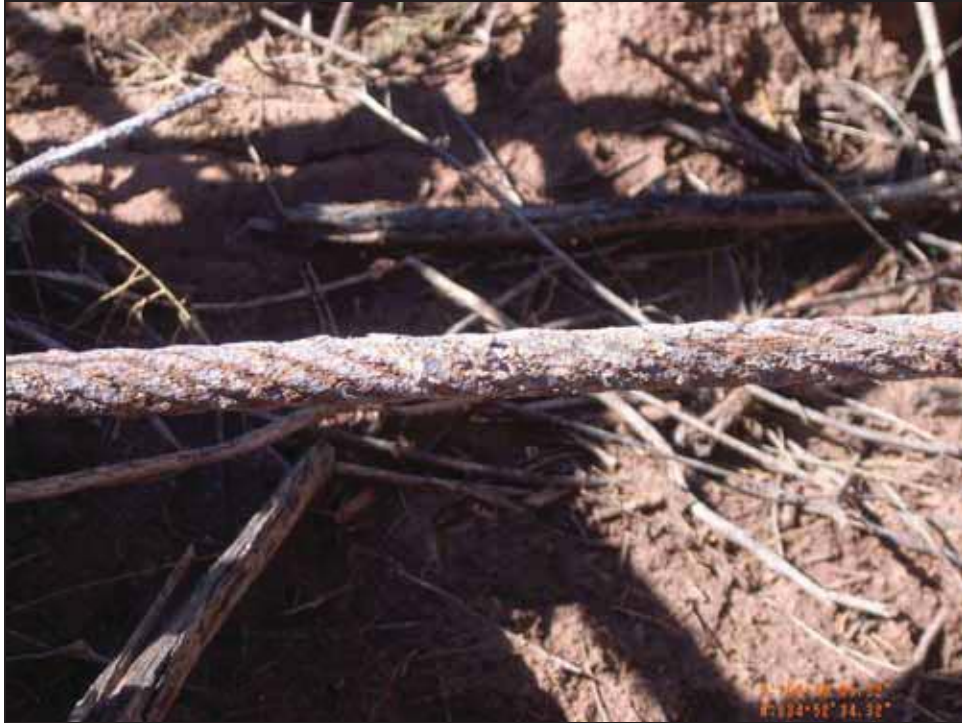
Figure 4.13. Steel cable connecting wooden pilings to one another.

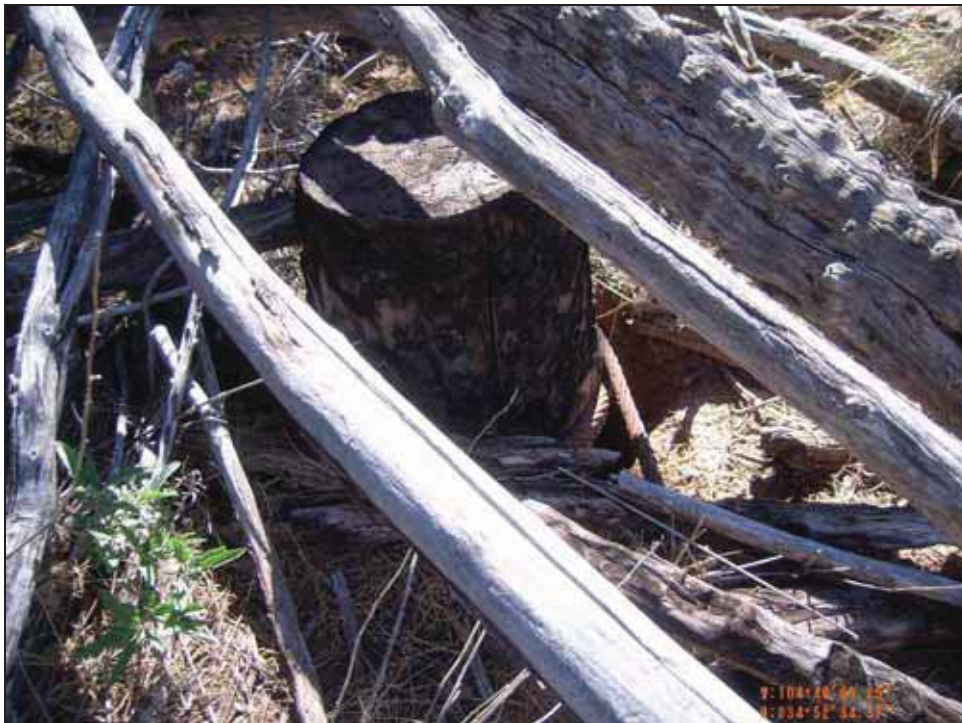
Figure 4.14. Another wooden piling protruding approximately one foot above current ground surface. Note steel cable wrapped around it.

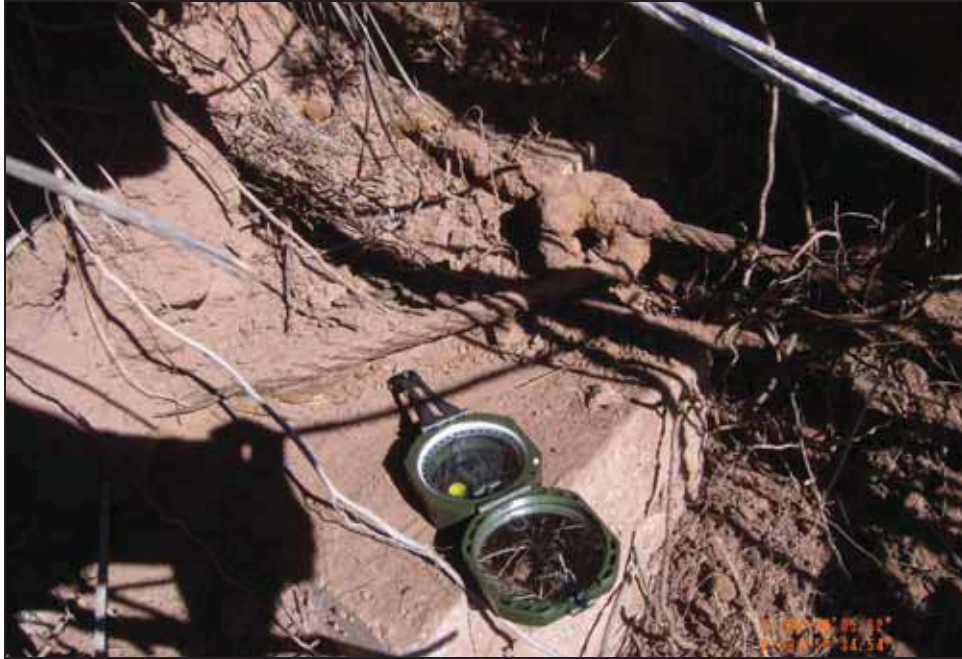
Figure 4.15. Concrete blocks and steel cable.

Following the steel cables in a line toward the northwest, field personnel noted a series of concrete blocks set into the ground and eroding out of an arroyo cut. These concrete blocks appeared to serve as an anchor point for the northernmost segment of steel cable (Figure 4.15). The drawing presented in Figure 4.16 shows the configuration of the blocks that were visible in the field; there appeared to be a minimum of three blocks of roughly cubic shape, measuring 30 centimeters on an edge. The steel cable is formed into a loop with a knot; however, the portion of the assembly that the cable is looped around is not evident in what is now visible.

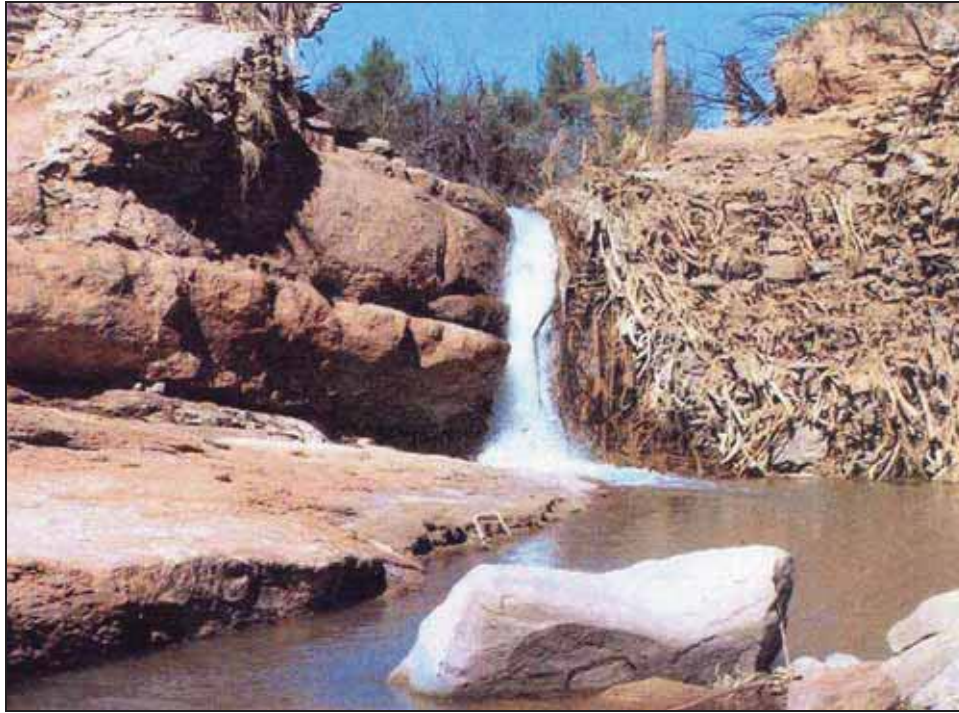
**Figure 4.17. View of the diversion dam after the initial 2005 breach, facing west.
Note wooden pilings visible over the top left.**

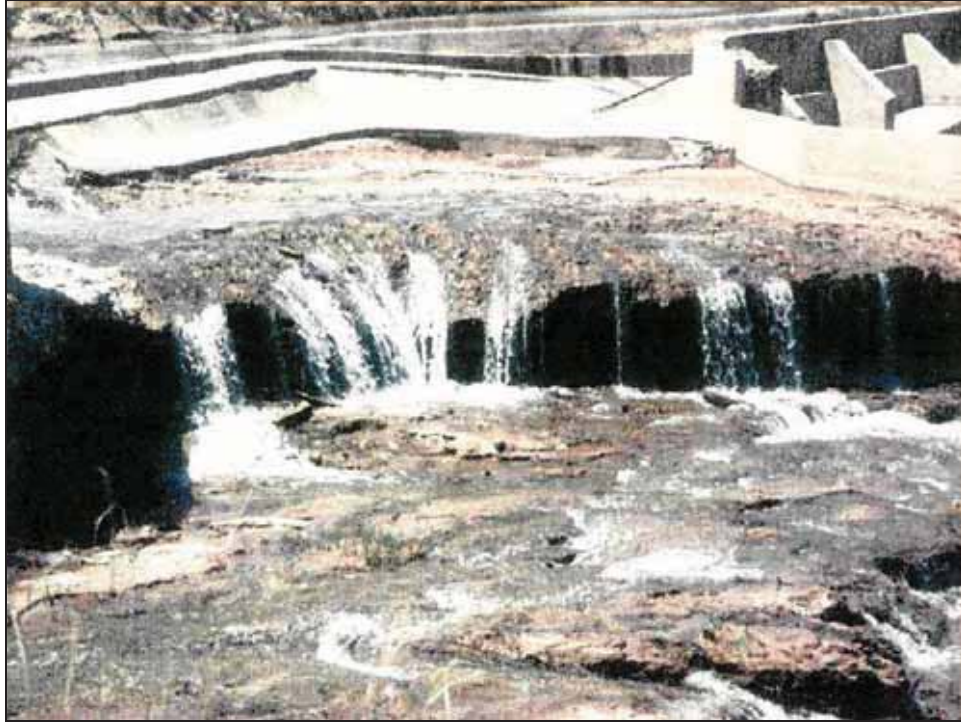
Figure 4.19. Spillway before breach, facing southwest. (Photograph courtesy of the West Puerto de Luna Acequia Association).

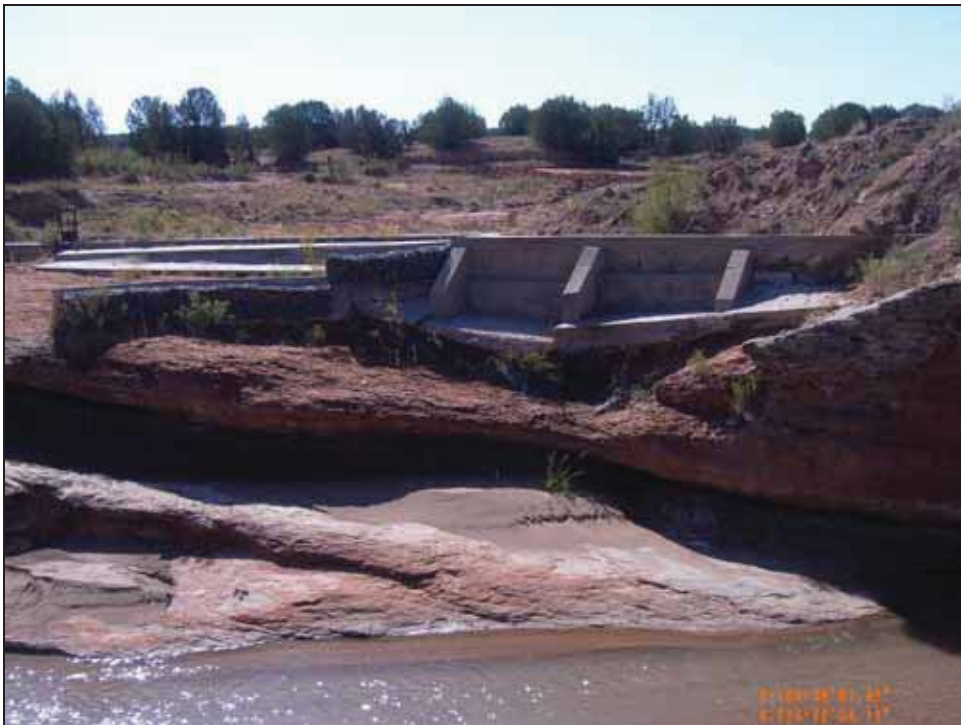
Figure 4.20. Overview of wall and gabion portions of spillway complex, facing south.

On the northern side of the masonry/concrete spillway wall, there are three small concrete support walls oriented perpendicular to the main wall, and reinforced with smaller concrete bracing elements oriented parallel to and abutting the main wall (Figure 4.29; see also Figure 4.18 and Figure 4.20). These rest on two separate concrete slabs, one of which (the eastern one) appears to be older than the other. Based on abutment and superposition relationships, the construction sequence appears to be: (1) masonry/concrete wall; (2) horizontal slabs; (3) vertical/perpendicular reinforcement walls; and (4) parallel

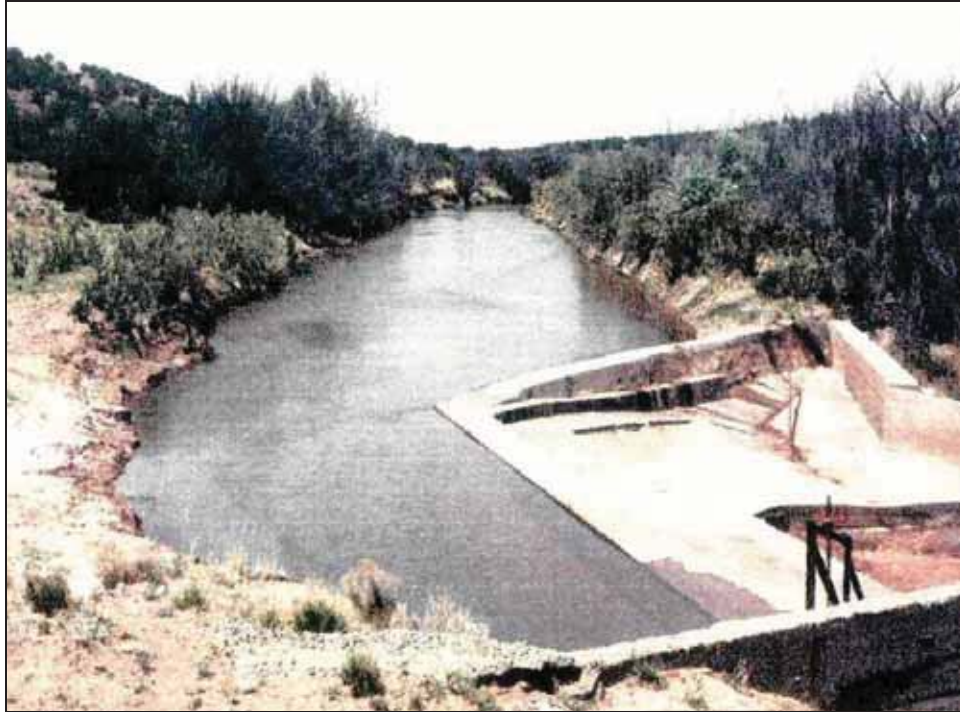
Figure 4.21. Diverted water approaching spillway and headgate, before the breach.
(Photograph courtesy of the West Puerto de Luna Acequia Association).

The southern portion of the spillway served as a low wall to channel water diverted from the Rio Agua Negra eastward toward the headgate, as shown in the photograph in Figure 4.21, taken when the acequia was still functioning. If water levels exceeded the height of the low wall (approximately 30 centimeters in height), the excess would flow over the wall and concrete slabs that form the spillway, emptying onto bare sandstone bedrock. The water would flow over three discrete sandstone ledges (see Figure 4.1 and Figure 4.19) before emptying into the river channel. At present, the spillway is partially covered on its western edge by a large pile of dirt and rock, bulldozed into place within the last four years, dating after the breach of the diversion (Figure 4.22, Figure 4.23).

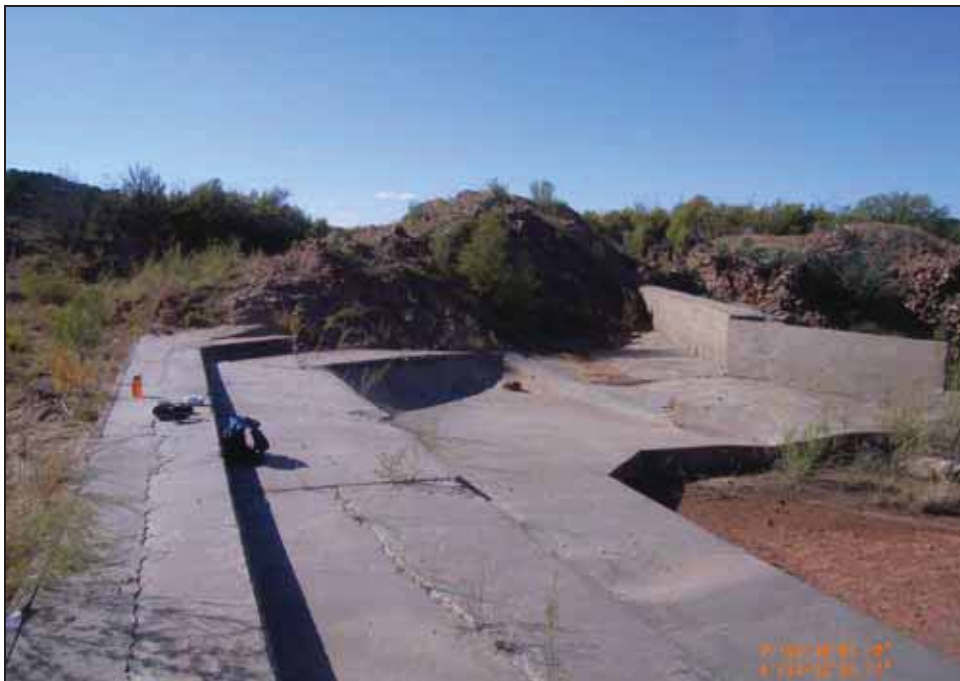
Figure 4.22. View of southern portion of spillway, facing west. Note recent bulldozed rock / dirt pile covering the spillway's western edge.

The spillway is a set of connected concrete and masonry elements that together worked to channel the flow of water along the spillway's southern margin to the location of the headgate just east of the spillway's southern edge. Excess water would then flow over the top of the spillway's southern margin and down a series of flat and/or concave concrete slabs and three natural large sandstone bedrock ledges before returning to the Rio Agua Negra (Figure 4.18, Figure 4.22; see also Figure 4.1).

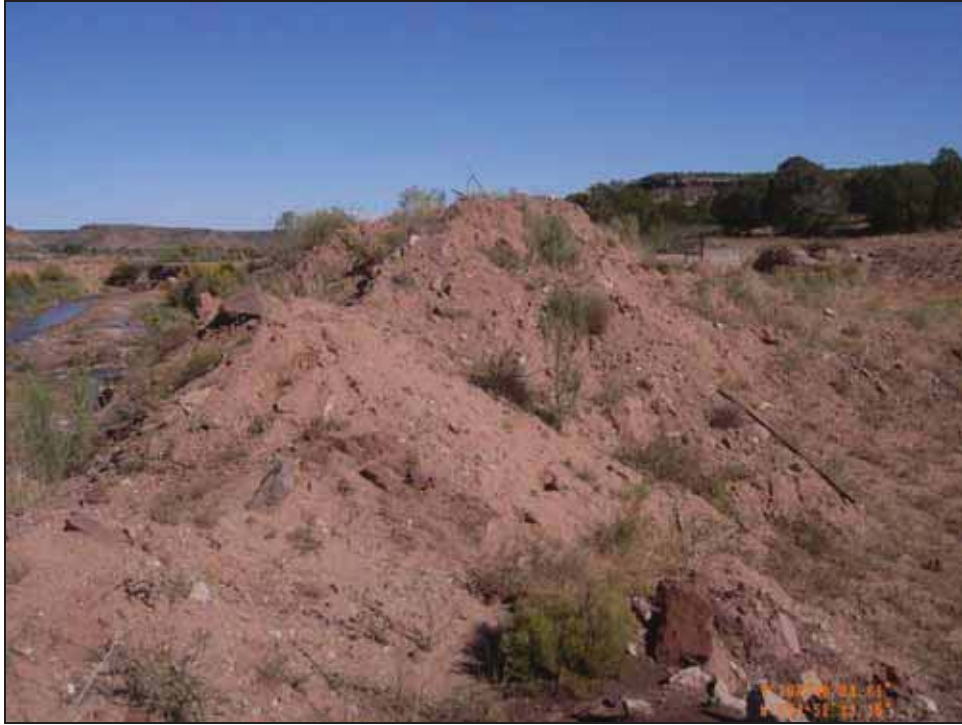
Figure 4.23. Large pile of rocks and dirt recently bulldozed over part of the spillway. This was done after the diversion was breached in 2006.

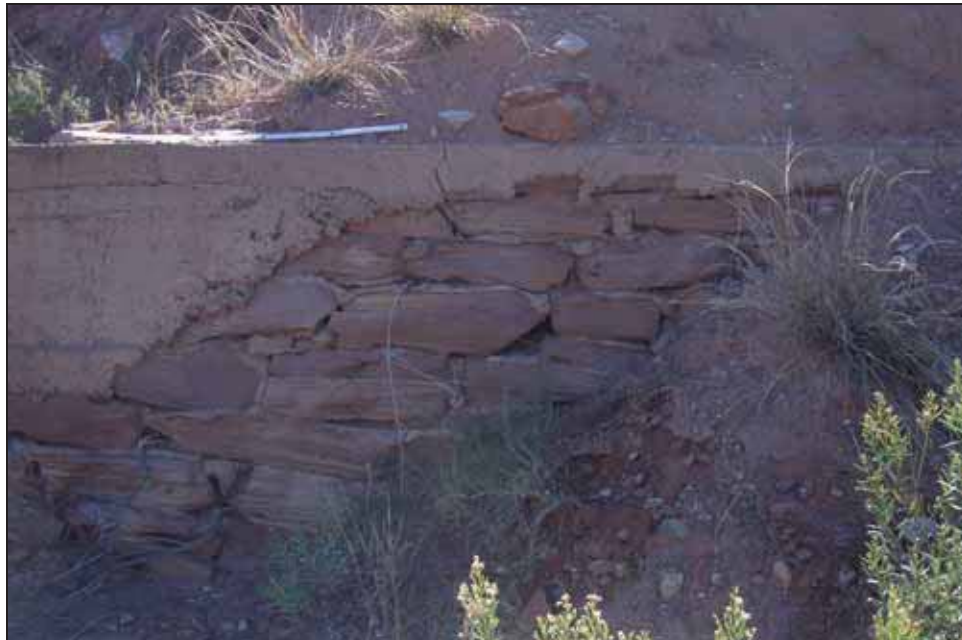
Figure 4.25. Eastern portion of northern spillway wall, showing original sandstone masonry visible under fragmented concrete plaster. Folding ruler at top left is one meter in length.

As the photograph in Figure 4.25 shows, this masonry wall was later plastered over with concrete; the masonry itself is only visible on the northern face of the wall at its far western end, where it is nearest to the remnants of the masonry diversion wall. The concrete used to cover the masonry wall was reinforced by an irregular array of wire segments, which still protrude from the wall surface, as seen in Figure 4.26.

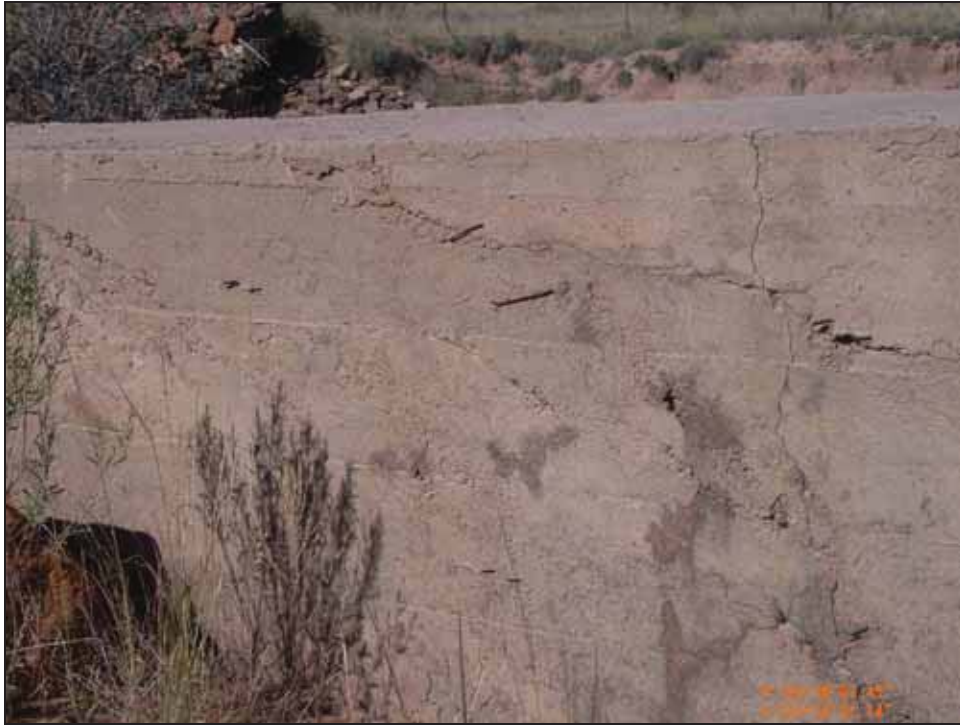
Figure 4.26. Southern face of the masonry spillway wall, facing north, showing wire used to reinforce concrete plastering covering wall face. Note also multiple patching / plastering events visible on this wall face.

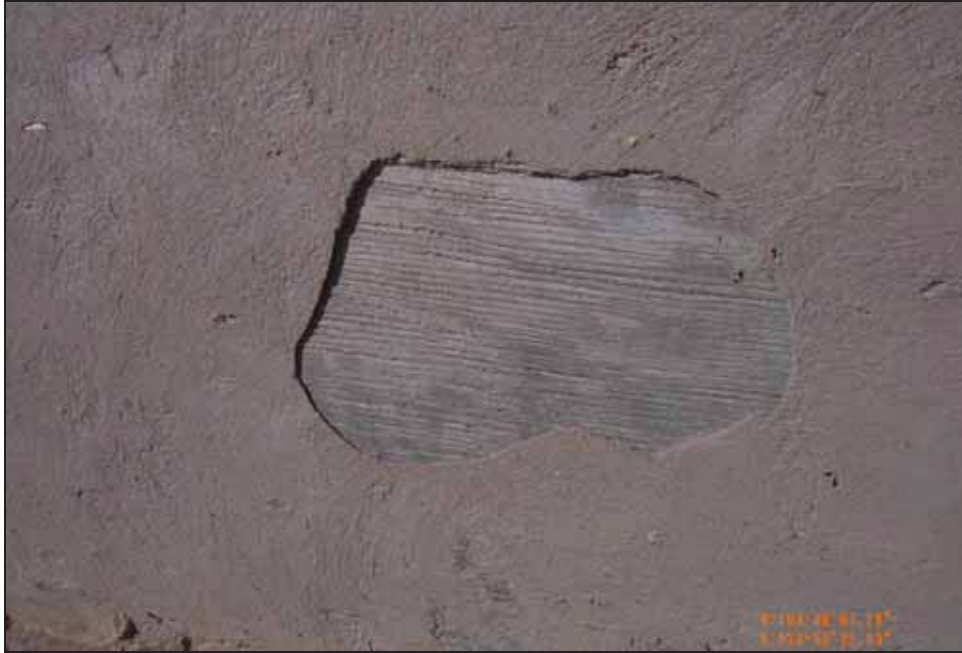
Figure 4.27. Close-up of hole in concrete plaster, showing different concrete surface underneath.

bracing walls. The time between these construction episodes is unclear; however, it appears that the original construction of the masonry wall likely predated the construction of the other elements by some time, as they are of substantially dissimilar construction. The reinforcement walls and bracing elements may very well have coincided with the original addition of concrete plaster to the masonry wall, however, as wood grain patterns of the type seen in Figure 4.27 are highly visible on almost all surfaces of these later support elements.

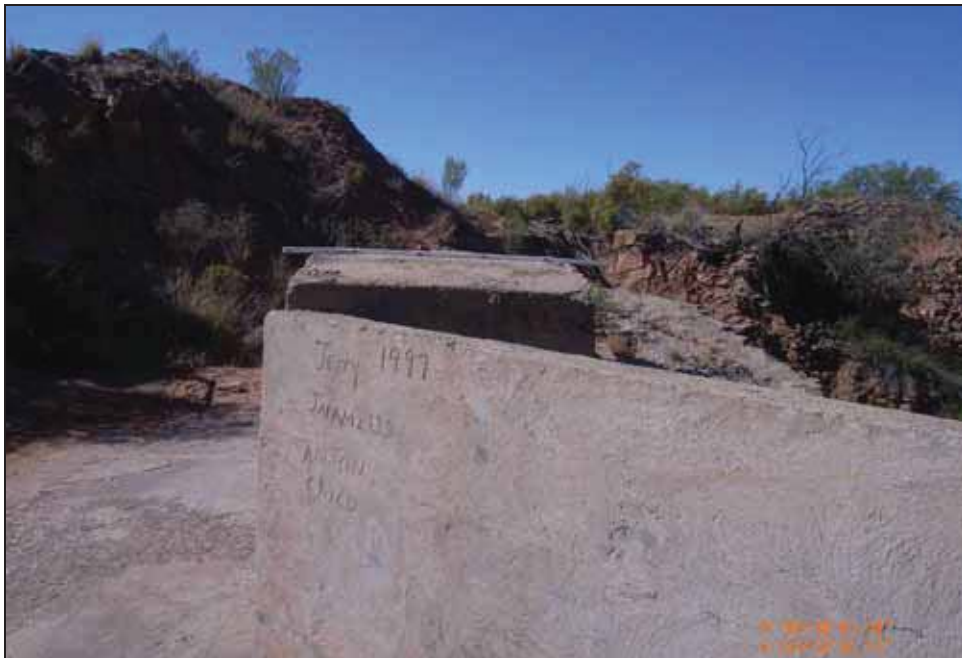
Figure 4.28. End-on view of masonry/concrete spillway wall, facing west, showing wall with gabion in foreground.

Adjoining the eastern end of this original wall is another wall that extends to the northeast, and which abuts a gabion basket structure oriented the same way (Figure 4.28, Figure 4.29; see again Figure 4.18). This wall abuts and therefore postdates the earlier wall, and appears to be quite recent; an inscription in the concrete surface of this wall reads “1997 JERRY JARAMILLO ANTON CHICO.” While this might only date the plastering of the wall, the condition of the wall and gabion are such that this likely dates their construction.

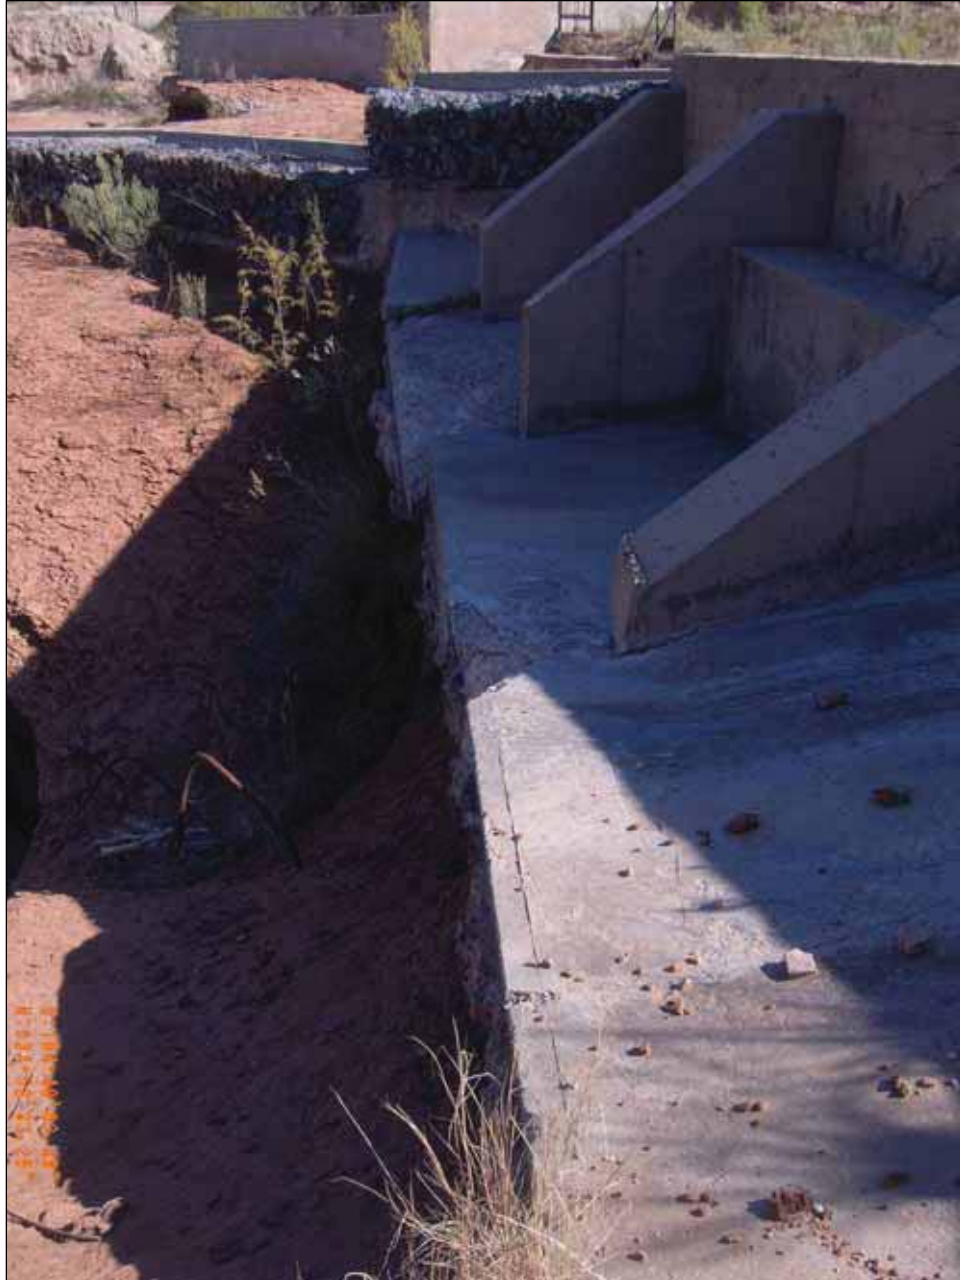
Figure 4.29. View of wall at north end of spillway, with gabion in background.

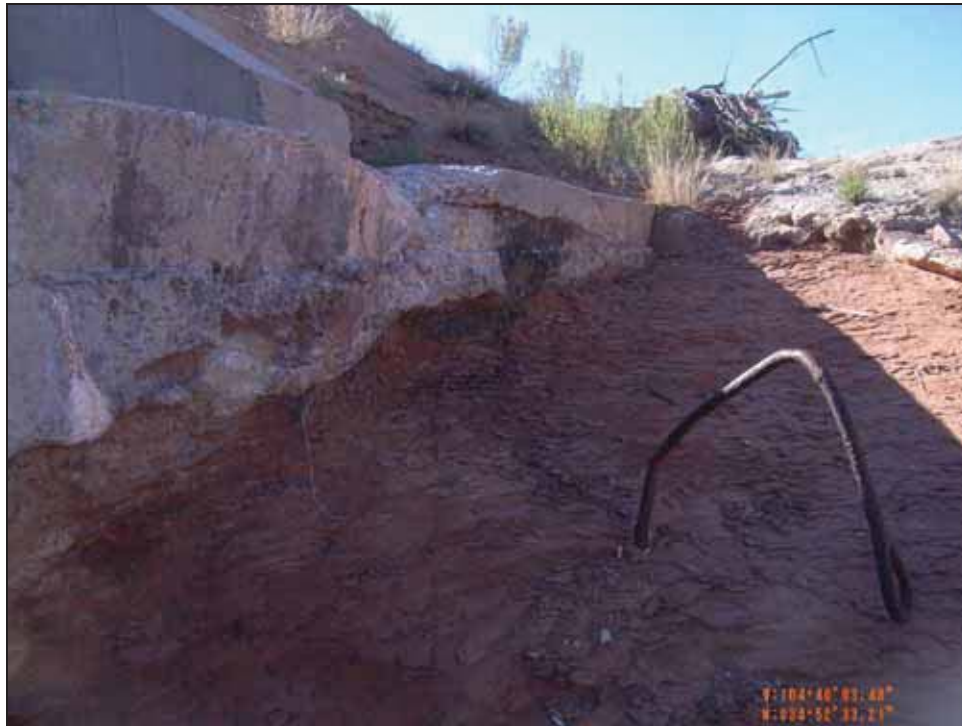
Figure 4.30. Metal rebar loop driven into bedrock adjacent to spillway structure.

Just north of the spillway, driven into the exposed bedrock, are four metal loops of undetermined function (Figure 4.30; see Figure 4.18 for locations).

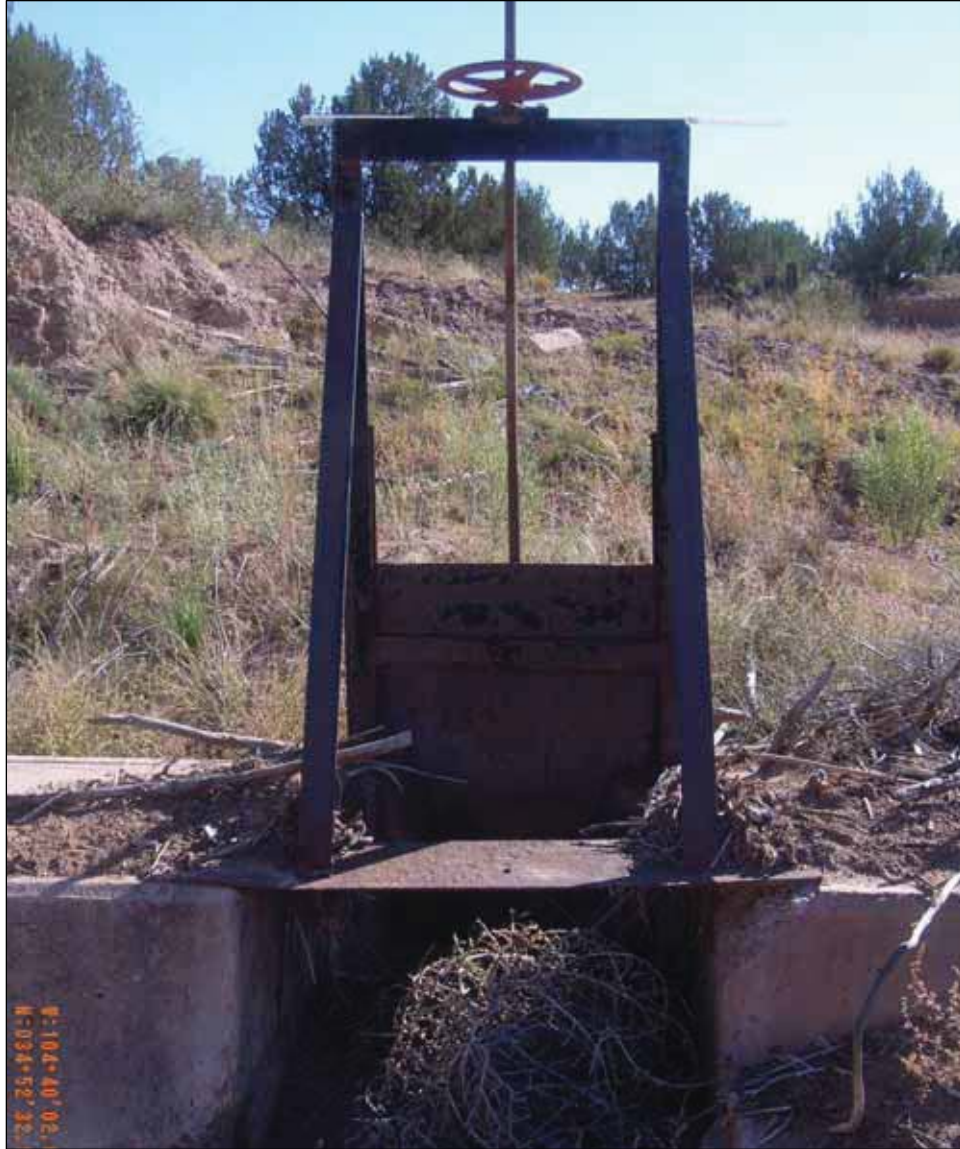
Figure 4.31. Sliding metal outfall gate with screw-type mechanism, situated at eastern end of spillway.

Immediately adjoining the southwest corner of the spillway is a metal outfall gate (appearing before the headgate) allowing water to be released back into the river before entering the headgate. This gate is a welded steel frame with a sliding metal gate, controlled with a screw-type mechanism operated via a metal wheel mounted parallel to the ground (Figure 4.31). This gate is of similar construction to the acequia's headgate, described later in this chapter.
