Final Environmental Assessment
for the

West Puerto de Luna Acequia Rehabilitation Project
Guadalupe County, New Mexico
Section 1113 of P.L. 99-662 (WRDA 1986)

January 2010

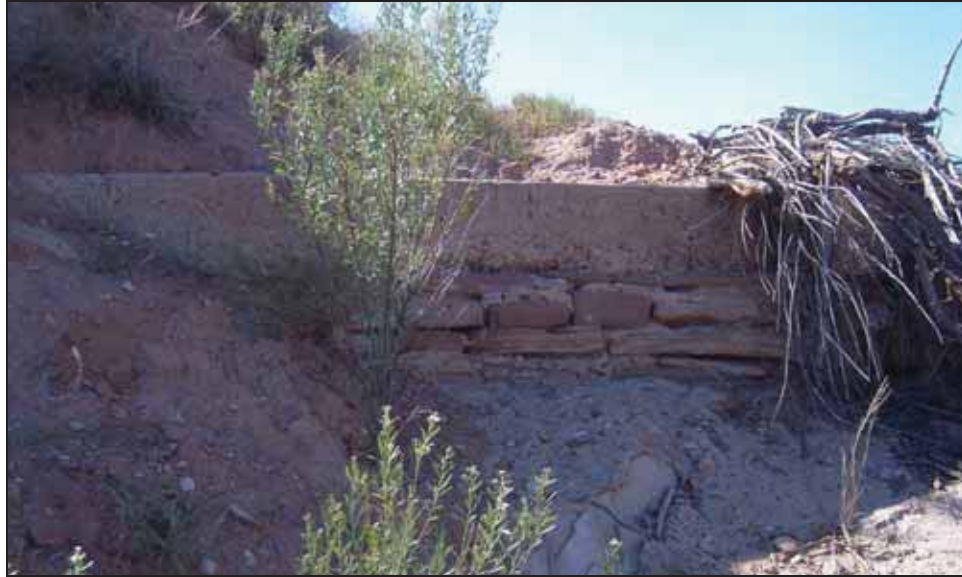
Figure 4.32. Segment of masonry diversion wall adjacent to northwestern corner of spillway.

While the masonry diversion wall (noted above in the description of the area north of the river) is not properly part of the spillway, it does connect to it and will be briefly described here. A segment of this wall, which once traversed the river channel as part of the diversion structure itself, remains on the very edge of the southern bank of the river, and adjoins the spillway at the spillway's northwest corner (Figure 4.18). The wall is of tabular sandstone masonry, the same type as both the northern segment of the same wall, and the same as the northern spillway wall (Figure 4.32). Immediately to the east of this wall segment is a concrete-capped clump of masonry that once formed part of the diversion's eastern face; this remains in place due to the adhesion of the concrete to the bedrock. These elements will be described in further detail below, in the description of the diversion.

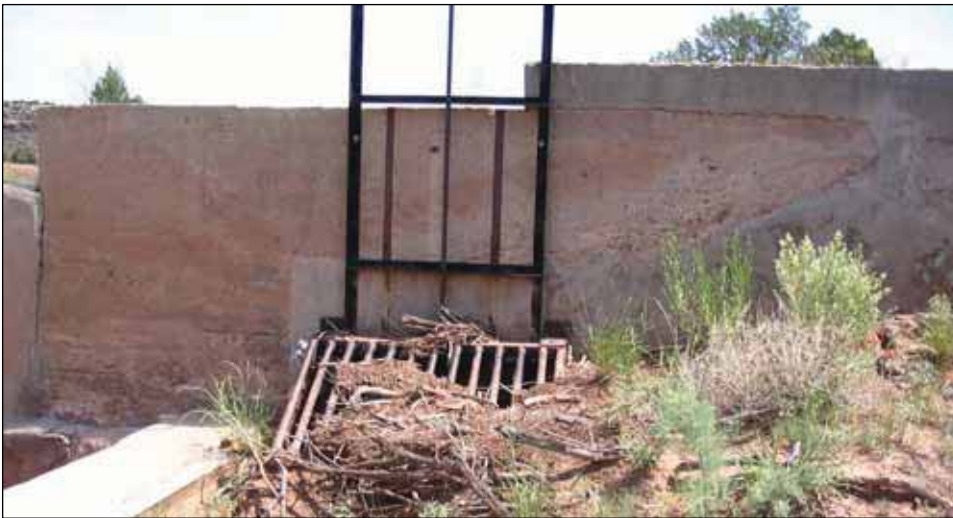
Figure 4.35. View of headgate, facing east.

The headgate is set into a concrete wall that appears to have been built in at least two episodes, as evidenced by the different types of concrete visible on the faces of the wall (Figure 4.35). This wall is 25 centimeters thick at all points, and measures approximately 9.5 meters in length and between 195 and 225 centimeters high. The headgate assembly itself is a welded metal frame measuring 120 centimeters in width, and supports a sliding metal gate operated via a screw-type mechanism operated with a metal wheel. At the wall's southern end, there is a wider concrete pad set into the ground approximately 180 cm in length (Figure 4.36, Figure 4.37).

Immediately in front of the headgate is a large grating made up of 13 welded metal pipes (each pipe two inches in diameter), which served to block large debris from entering the acequia (Figure 4.35, Figure 4.36). This grating is approximately triangular in cross-section, with a base measuring approximately 2 meters in length and a height of approximately 60 centimeters.

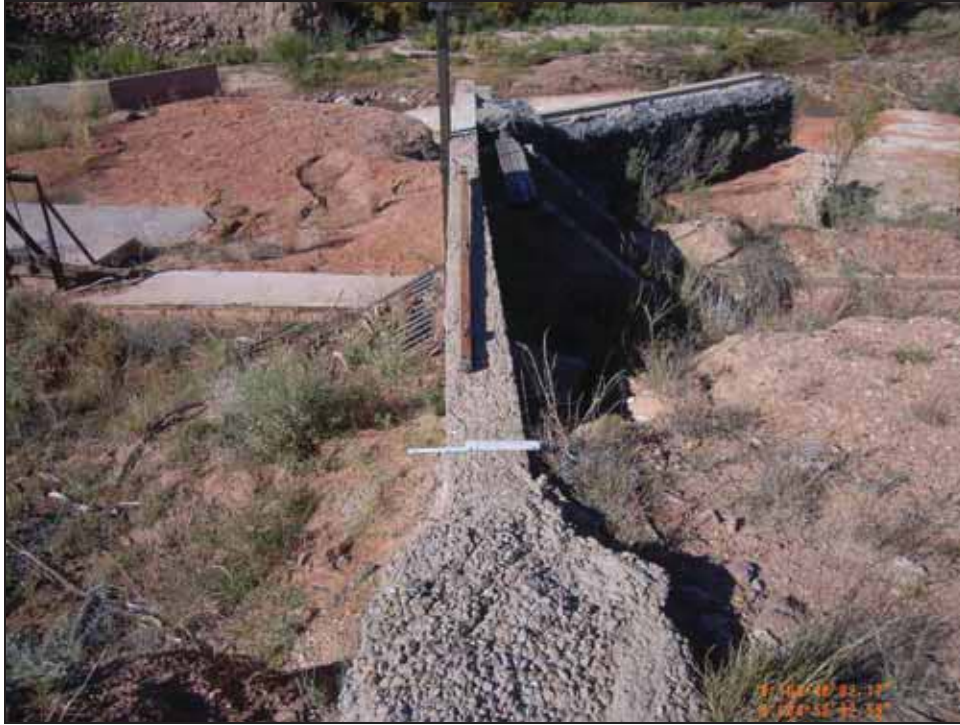
Figure 4.37. View of the headgate structure from the south, showing concrete wall and gabion.

The eastern side of the wall contains two smaller concrete walls perpendicular to the main wall and flanking the gate opening as the water enters the acequia (Figure 4.38, Figure 4.39). These walls are approximately 20 centimeters thick, and are approximately 230 centimeters long at the base. They are trapezoidal in cross-section, tapering at the top to a length of 51 centimeters. (see Figure 4.37).

Adjoining this concrete wall at its northern end is a gabion and associated wall, which extend at an angle toward the northeast (Figure 4.36, Figure 4.37, and Figure 4.40). The gabion is approximately seven meters long and 80 centimeters wide, and matches the gabion adjacent to the spillway wall in form and construction. A date inscribed on the exterior of the concrete wall associated with the gabion reads:

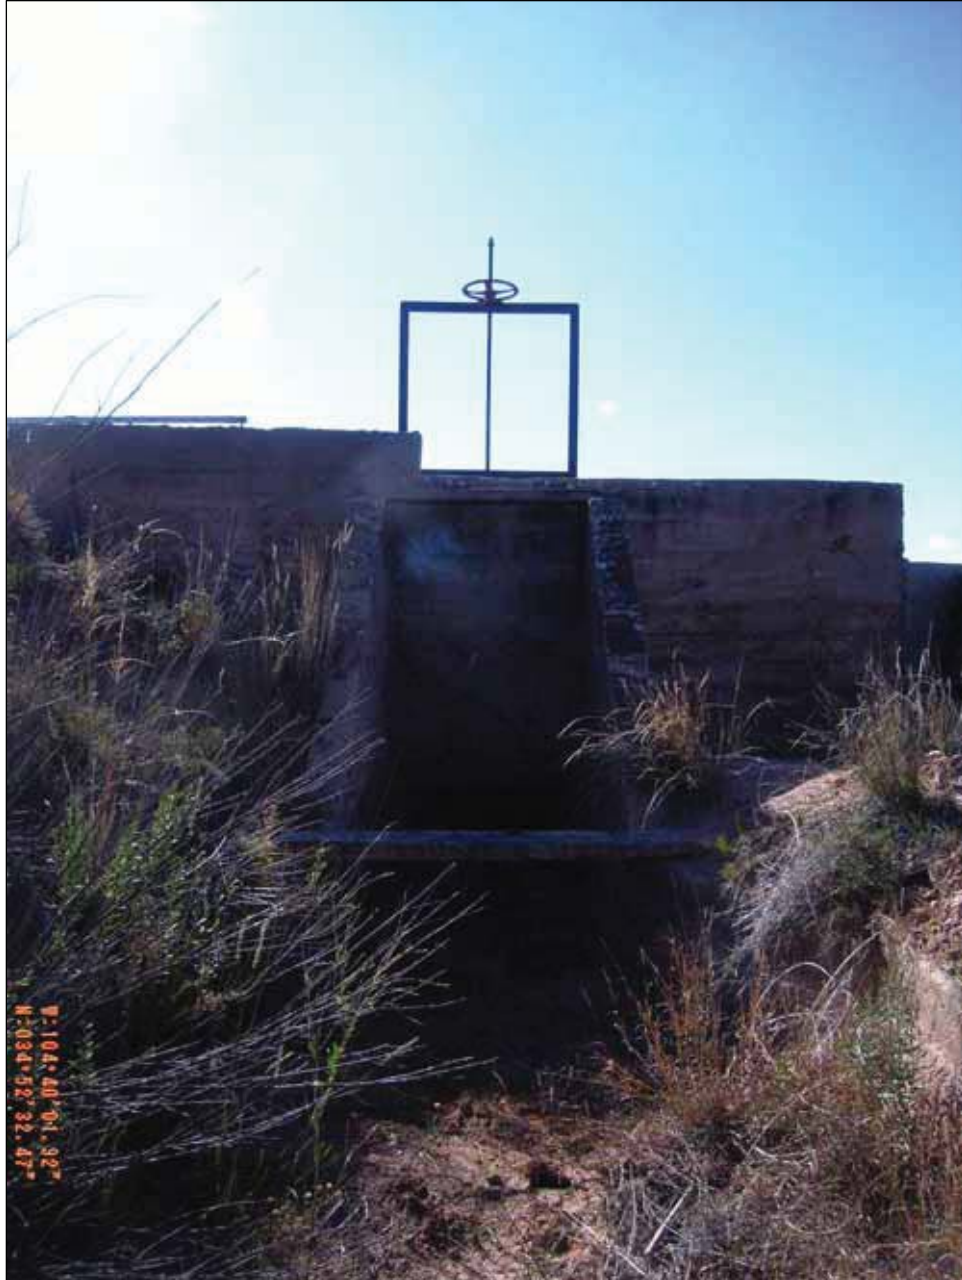
Figure 4.38. Headgate, facing east.

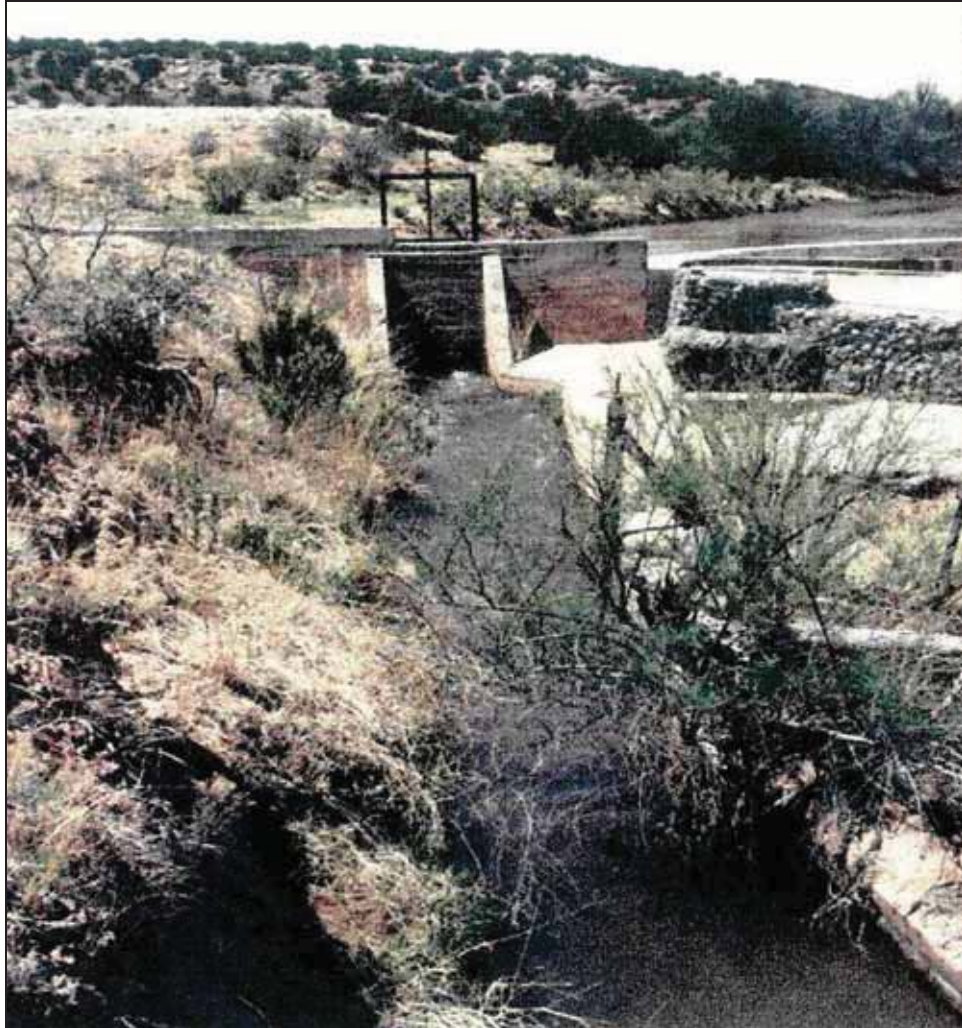
Figure 4.39. Headgate and acequia before breach, facing west. (Photograph courtesy of the West Puerto de Luna Acequia Association).

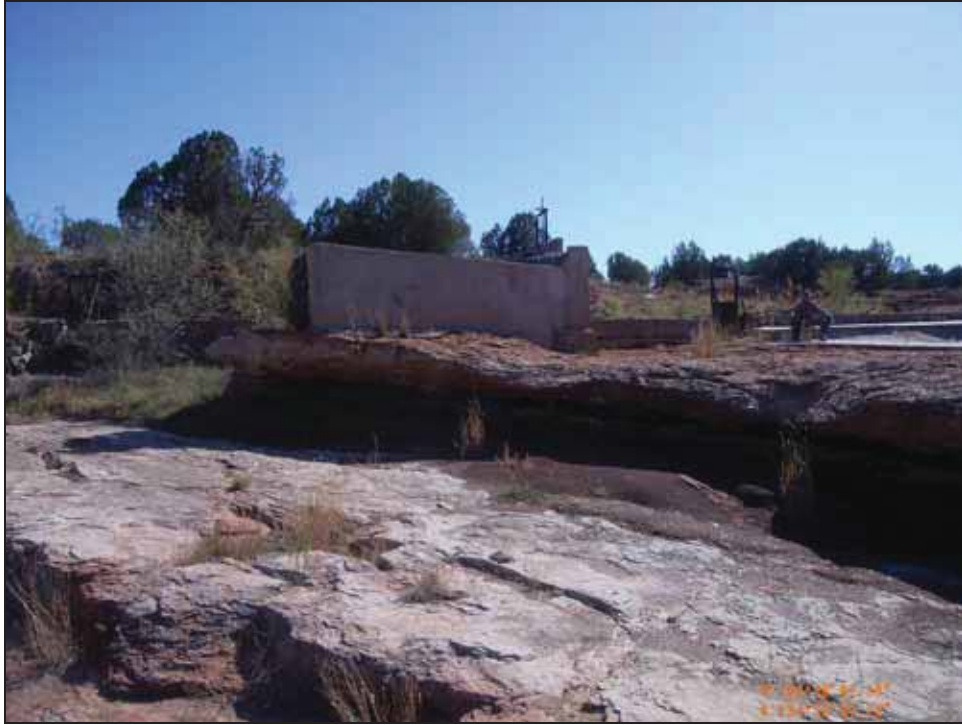
Figure 4.40. View of headgate and gabion, facing south.

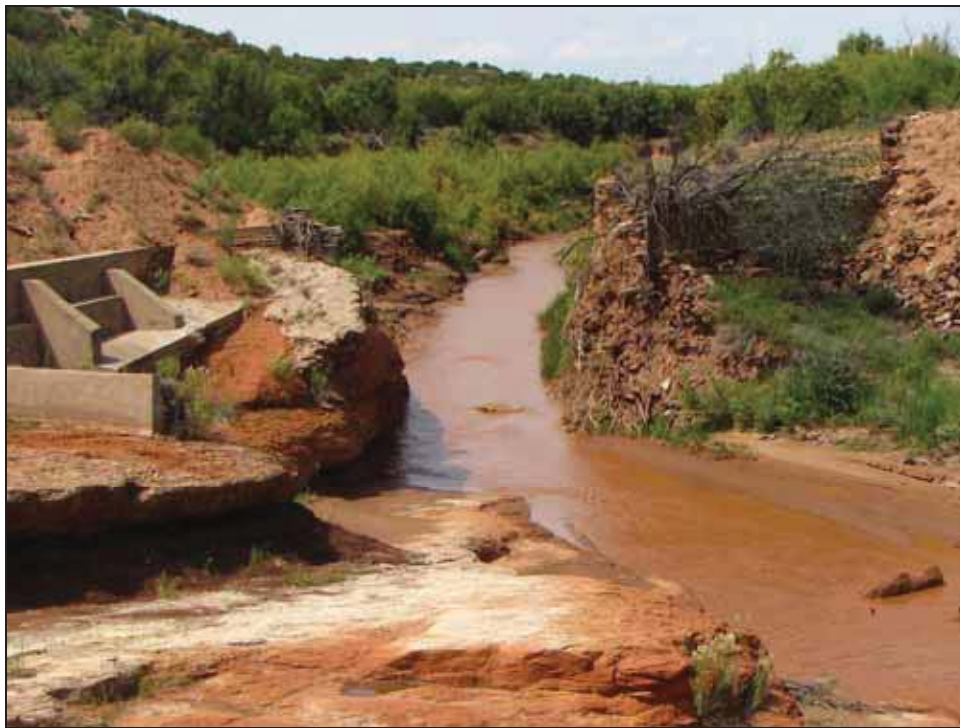
Figure 4.42. Overview of diversion complex, facing west.

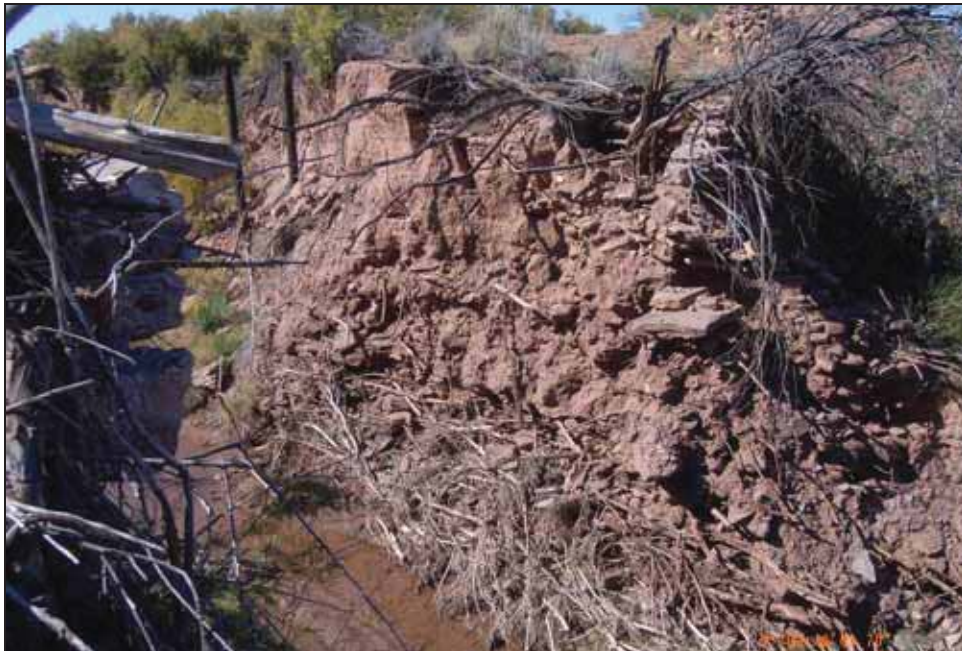
Figure 4.43. Northern cross-section of diversion dam, showing successive layers of rock and brush, facing northwest.

This brush and rubble construction is easily visible in the northern cross-section of the diversion as it exists now. As shown in Figure 4.43, Figure 4.44, and Figure 4.45, the bottom layer is dominated by brush, while upper layers are more dominated by rock. The photograph in this figure reveals stratigraphy showing the successive layers of large rock and smaller material including brush. Indeed, the contrast between the brush-dominated base layer and the upper layers is striking (Figure 4.44); it is even possible that this bottom layer may be a remnant of a separate and earlier construction event, perhaps even being a remaining portion of the earlier nineteenth-century dam.

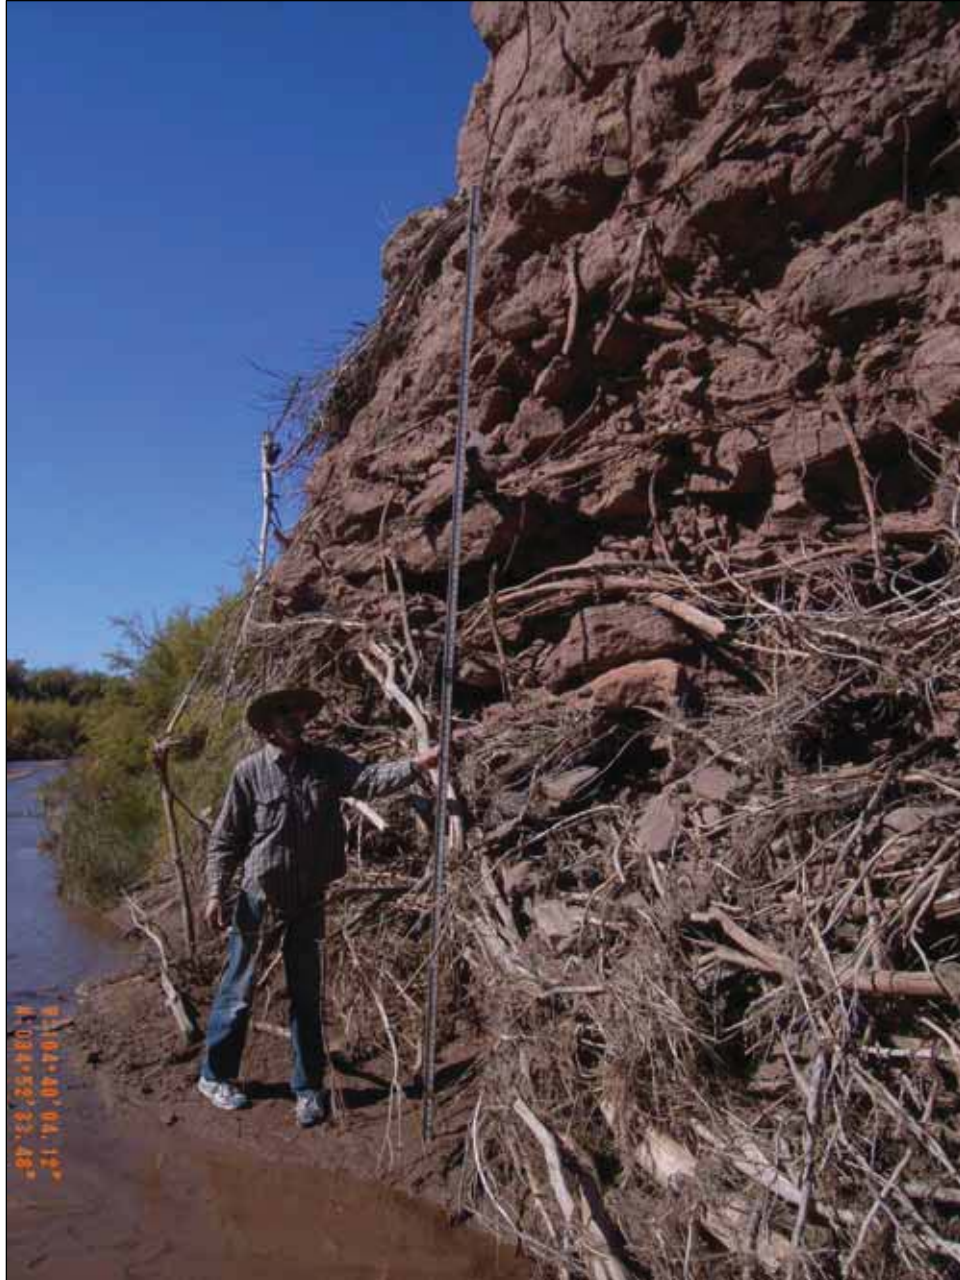
Figure 4.44. View of the northern cross-section of the diversion, showing base brush-dominated layer and multiple overlying layers of rock and brush.

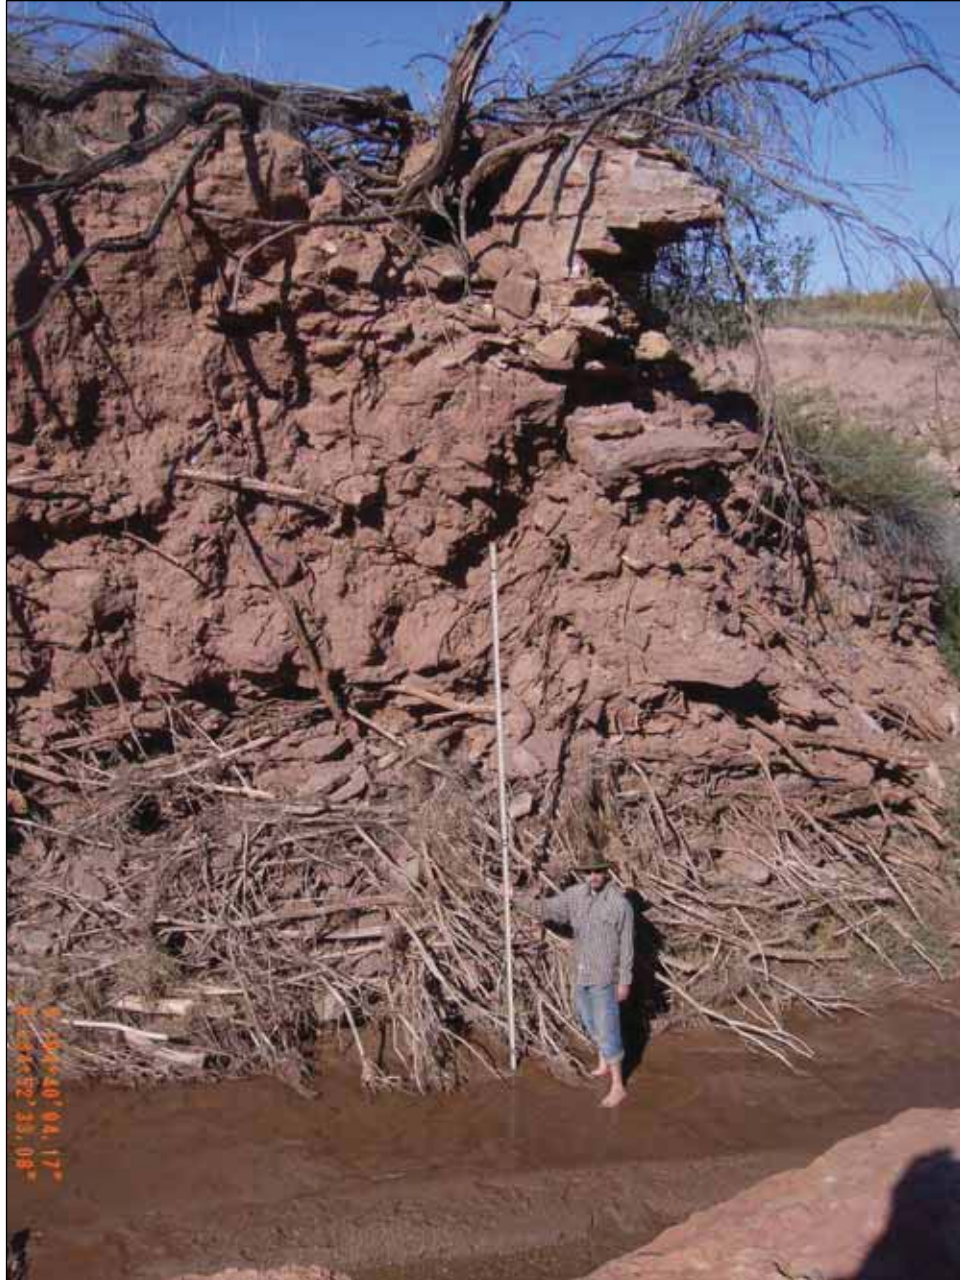
Figure 4.45. Another view of the northern cross-section of the diversion dam, facing northeast. Note remnants of masonry wall visible in cross-section.

The wall that remains as short segments on the north and south sides of the river once traversed the channel as a primary portion of the diversion dam. It is constructed of large pieces of tabular sandstone (visible in cross-section in Figure 4.45), with larger pieces occurring in the parts of the wall that are within the diversion, and somewhat smaller ones being found along the top. As it is visible from the top of the diversion, it is clear that the masonry wall segments at north and south are aligned with one another and once formed parts of the same wall (see Figure 4.47). The wall appears to have been built at the same time as the current diversion, as it appears to be footed on top of the bottom brush-dominated base layer (Figure 4.46). At its northern end, the wall is capped with concrete (Figure 4.48), and contains areas on the western face where the faces are inconsistently plastered or surfaced with concrete (Figure 4.49). On the western face, only approximately one meter or less of the wall is exposed above the ground surface of the dam top.

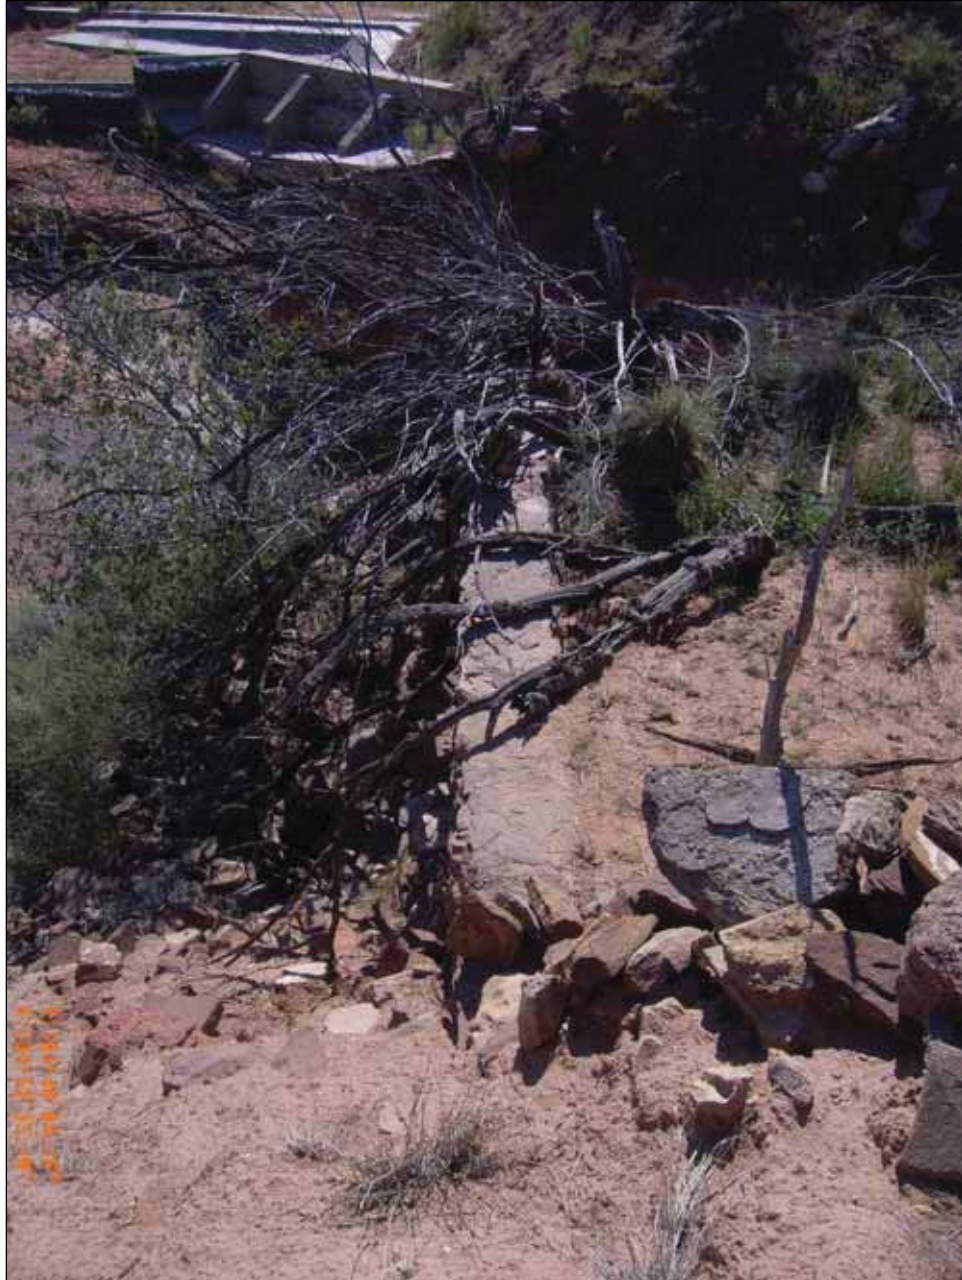
Figure 4.47. The alignment of both extant segments of masonry diversion wall are visible here, facing south across the river channel. The northern segment is in foreground.

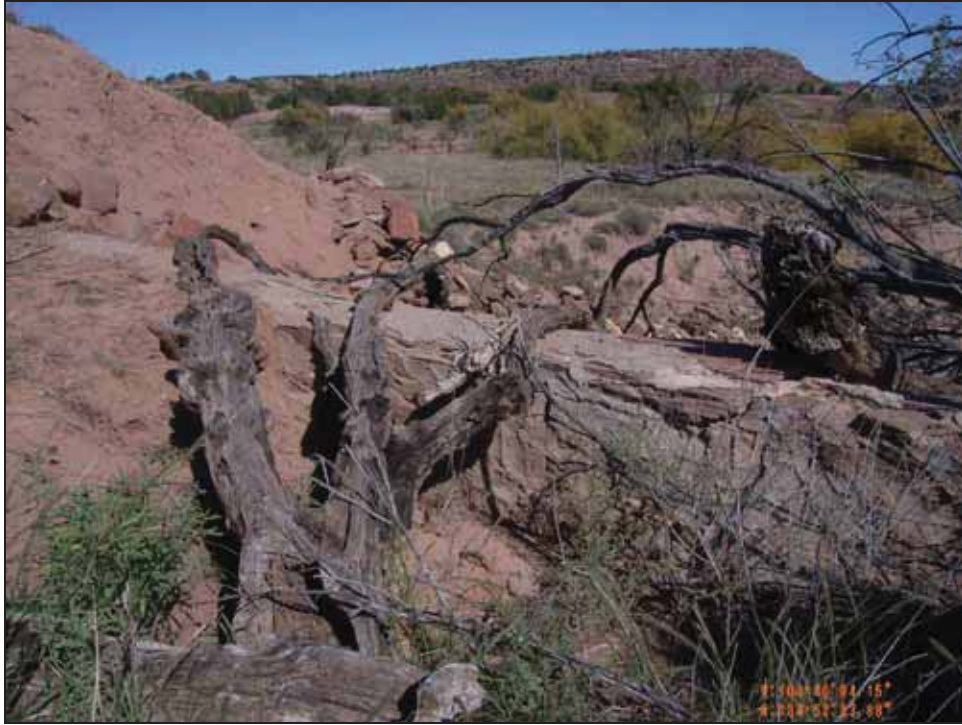
Figure 4.48. Northern segment of masonry diversion wall that once traversed the channel, facing east.

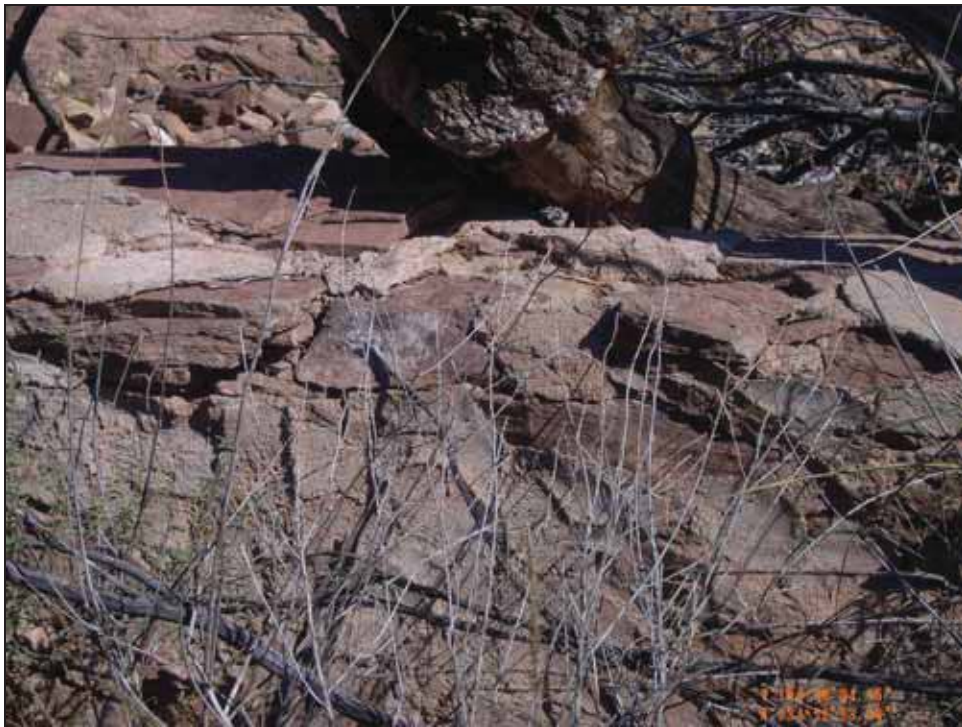
Figure 4.49. Close-up of masonry wall, showing concrete plastering, facing east.

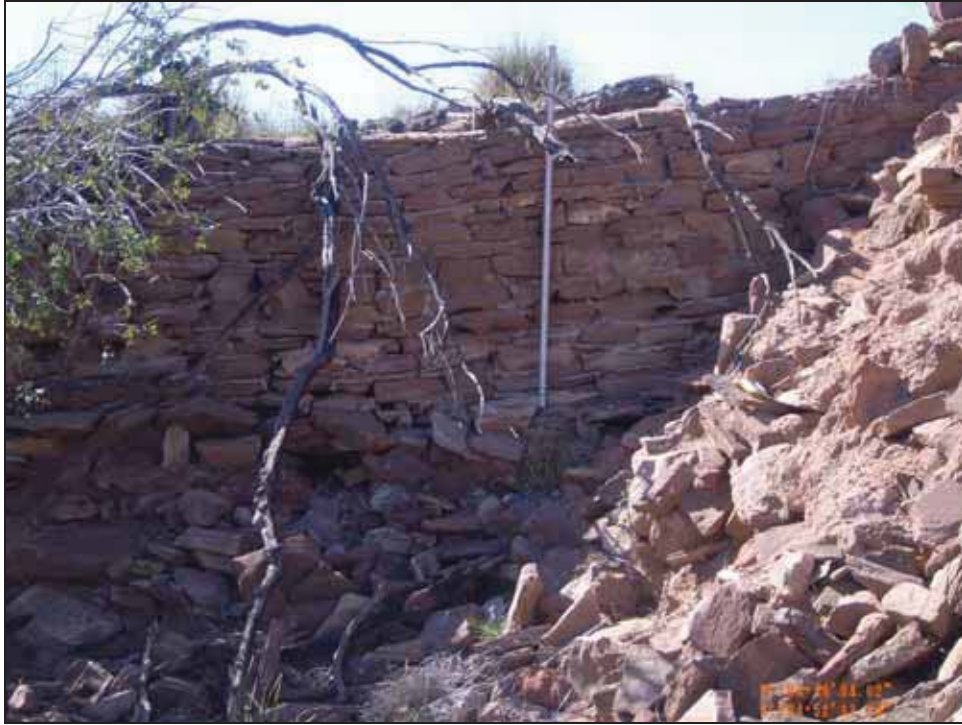
Figure 4.50. Northern segment of masonry diversion wall, facing west.

On the eastern face, more of this wall is exposed (Figure 4.50) ranging from approximately two to three meters, with no evident concrete plastering. Some concrete mortar is visible between the stones on this face, however. In its current state, the top of this wall extends out over the breach due to the presence of the capping layer of concrete over the top of the wall (Figure 4.51, Figure 4.52).

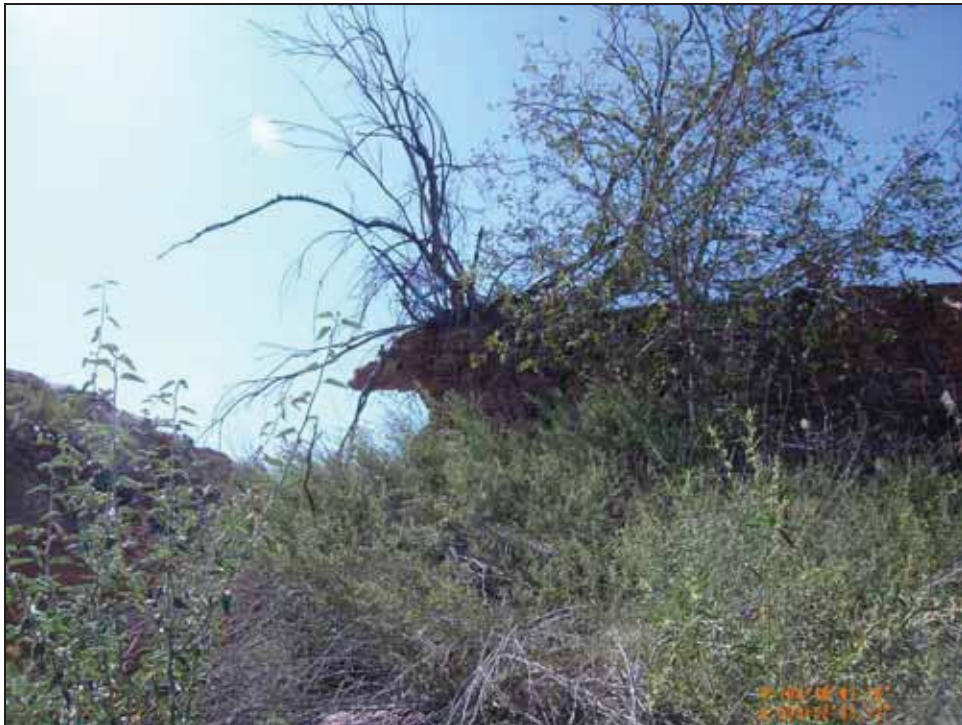
Figure 4.51. Northern segment of masonry diversion wall, facing west, showing remnant portion overhanging the breached diversion.

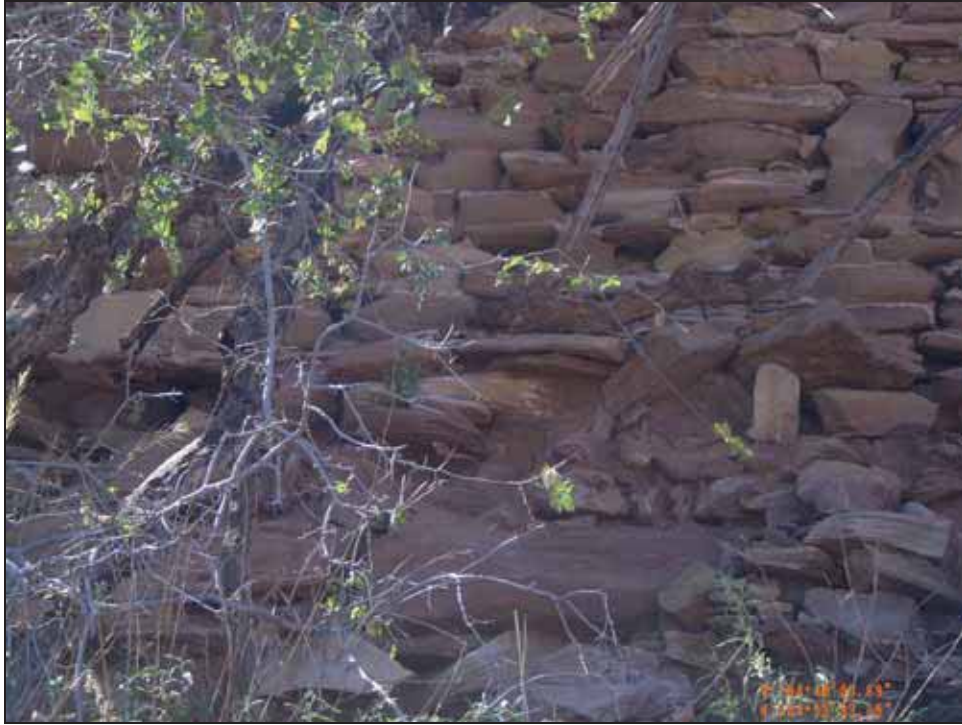
Figure 4.53. Base of masonry diversion wall, facing west, showing transition to rubble bank armoring.

As noted above in Figure 4.46, the eastern face of this masonry wall is obscured by additional sediment, which is in turn heavily armored with medium to large tabular sandstone rubble of the same type that was presumably also used to armor the northern bank of the river, and described earlier in this chapter. On the eastern face, only two to three vertical meters of wall are visible before disappearing behind this less-organized armoring rubble (Figure 4.53).

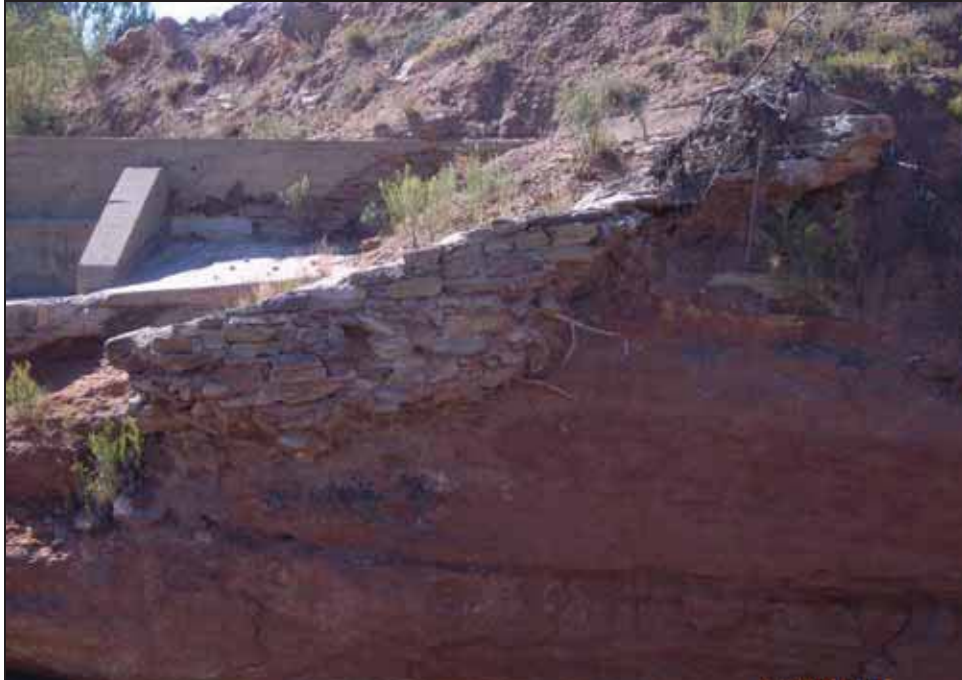
Figure 4.54. Remnants of masonry diversion wall and concrete-capped sandstone as viewed from the north side of the river, facing south.

Much less of the diversion is visible in the southern profile. All of the rock and brush that formed the core of the diversion dam is now gone, revealing only large layers of sandstone bedrock, upon which are situated a small portion of the masonry diversion wall, and an agglomeration of tabular sandstone capped with concrete that is presumably a continuation of the rubble bank armoring seen on the northern side of the river. The primary difference appears to be that this was capped with concrete and may have contained some additional mortar, which have allowed it to remain in place – indeed, hanging precariously over the river channel with little support from beneath (Figure 4.54). The construction of the masonry diversion wall on the southern side of the river appears consistent with that on the northern side: tabular sandstone masonry capped with concrete, and with some concrete mortar. A schematic cross-section of what remains of the diversion on this side of the river is presented in Figure 4.54.

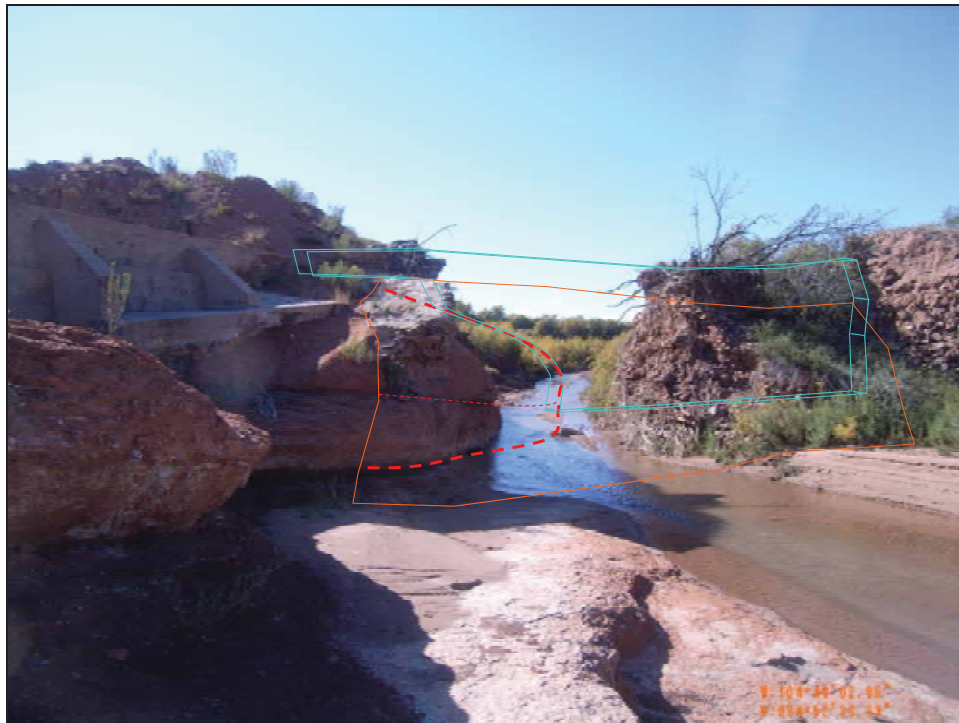
Figure 4.56. Approximate extrapolated positions of bedrock (dotted line), masonry wall (blue), and rubble armoring (orange).

Now, having described the extant components of the diversion complex above, it is now possible to discuss the likely pre-breach configuration of the diversion complex. In sum, the diversion complex consisted of a large rock-and-brush diversion dam which included a sandstone masonry wall near its eastern face. On the north, a long earthen berm with masonry retaining walls extended to the northwest to channel water during high-flow events. The diversion was armored on its eastern face by a deep and extensive covering of sandstone, likely arranged in an organized fashion (i.e. coursed and stacked where possible), and was capped with concrete on at least its southern end. This armoring extended around to the north, protecting the steep north bank of the river from erosion as well. Figure 4.56 presents an approximate picture of the relative locations and extents of the masonry diversion wall (blue) and the armored surface of the dam's eastern face (orange). (Note that the extent of the sandstone bedrock has changed since before the breach; the bedrock once extended further out into what is now the river channel; compare the photo in Figure 4.56 with that in Figure 4.17).

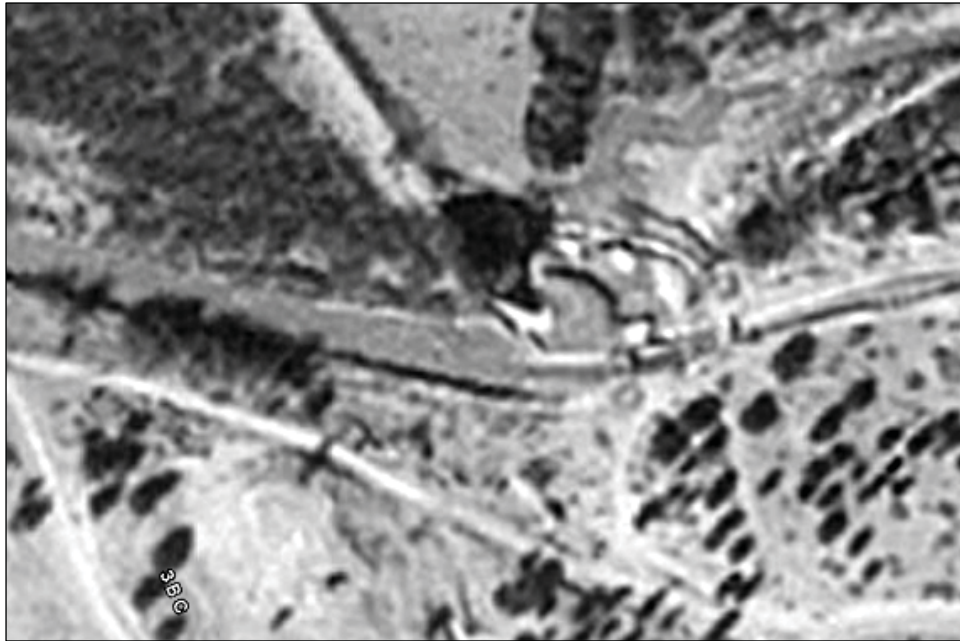
Figure 4.57. Aerial imagery of diversion complex dated May, 1997, showing location and shape of waterway leading to spillway and headgate. Imagery produced by U.S. Geological Survey and retrieved from Google Earth Pro (copyright 2009 Google and Europa Technologies).

Further, extensive sedimentation had built up behind the dam such that, by 1997, the effective width of the diversion was some 80 meters wider than the original rock-and-brush structure. This is evident both by observing the current cross-section of the northern bank (see again Figure 4.46), and by examining an aerial photograph of the project area from 1997, before the dam was breached. This photograph, obtained via Google Earth Pro, shows the area currently occupied by the river channel west of the diversion to be heavily vegetated, while the water from the river departs from its present channel approximately 80 meters to the west of the diversion's location (Figure 4.57).
