Tips, guides and reports for people repairing televisions and electronic equipment

AND HOME ELECTRONICS REPAIR JANUARY 2004 £3.20

New super-slim CRTs Introduction to Networking Using the correct coaxial cable

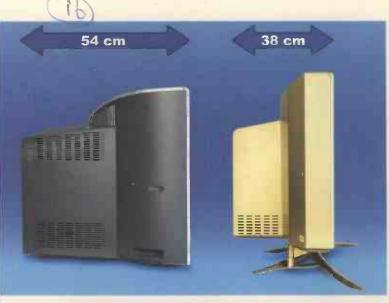
Photo 2: The LG.Philips 32in. widescreen Cybertube+ SuperSlim tube also enables the depth of a set to be reduced to 38cm, giving it a clearly slim-line appearance.

The use of a 125° deflection angle with the 32in. tube means that the beam strikes the shadowmask at a very shallow angle close to the edges of the screen. Compensation has been provided by optimising the mask curvature and by careful design of the mask-suspension system. As a result the ambient and local doming performance match that

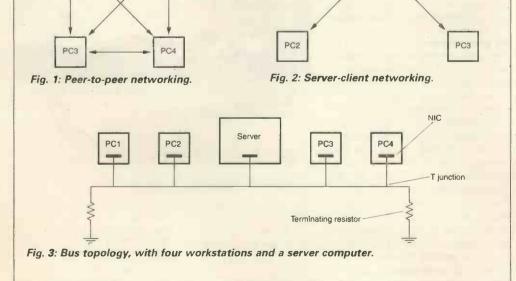
With bus topology, see Fig. 3, each computer is connected to a single cable by means of a T

junction. A terminating resistor whose value is equal to the cable's characteristic resistance, e.g. 50Ω for a thinnet-type coaxial cable, is fitted at each end of the cable to prevent data reflection, which would cause interference. With bus topology the failure of one PC/workstation does not cause network failure, but a break in the cable would do so.

The advantages of bus topology are easy cable connection, inexpensive cable and connectors can be used, and the fact that failure of a single workstation doesn't affect the rest of the LAN. Disadvantages are limited cable length and number of computers, the fact that heavy traffic can cause sudden performance degradation, difficulty in isolating network errors, and the fact that a break in the cable affects the whole network.

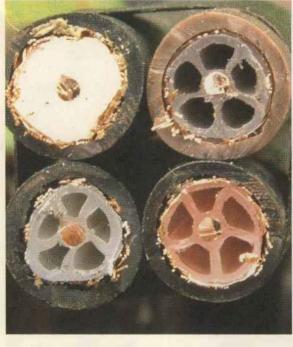
the other end of the cables were recently-calibrated spectrum analysers. Fig. 3 shows the results.

Cable types A and B performed almost identically, so the results are shown as a single line. Losses climb to 18dB per 100m at the top of the UHF band, and 33dB at the top of the satellite IF band. Cable type C is significantly more lossy at 24.5dB and 44.5dB respectively.

Fig. 3: Comparison of signal attenuation per unit length with different types of cable.

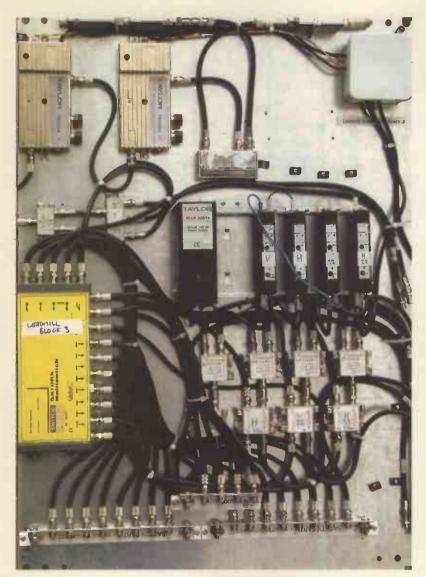
Fig. 4: A distribution system headend, ready for installation. The earth rails at the bottom are the connections for twenty downleads, some of which will be 30m long. The connections on the right are the feeds to the repeaters.

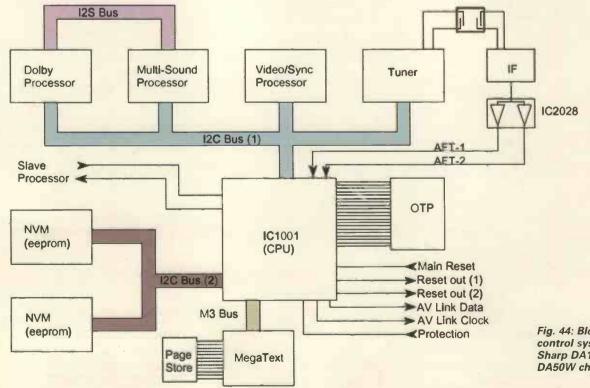
Fig. 44: Block diagram of the control system used in the Sharp DA100 (50Hz) and DA50W chassis.

s with all recent Sharp TV chassis, the main microcontroller chip (CPU) IC1001 is responsible for control of the set. It communicates with other areas of the chassis via various data buses but, as with similar chassis, it doesn't operate during standby. There is therefore a need for some form of control on the primary side of the power

IC1001 is connected to other parts of the chassis via several types of bus. A parallel bus links IC1001 to the EPROM/OTP/MTP

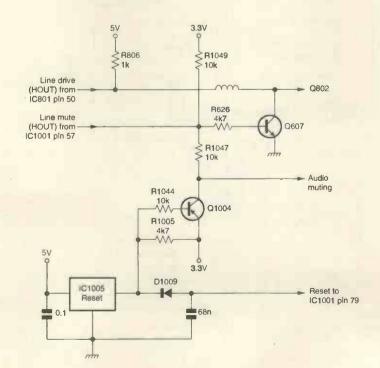
Fig. 47: The main reset and line-drive mute circuitry.

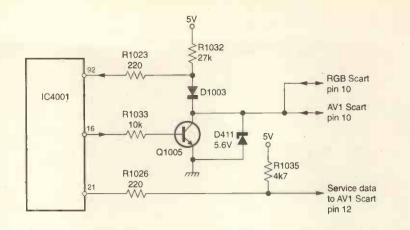
Fig. 48: The AV link control circuitry.

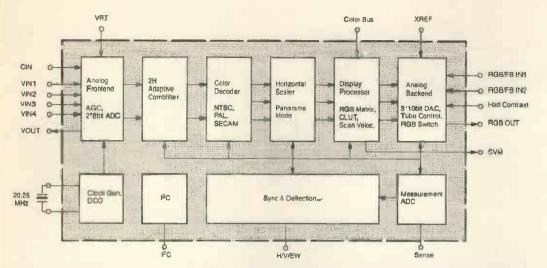
Fig. 49: Block diagram of the VDP3120 video/deflection processor chip IC801. works at the lower supply voltage (3·3V). Although it won't be damaged if used with a 5V set, the EEPROM will not be blanked. The reverse is also the case – when an FW/GF blanking jig is used with a 3·3V supply. Use of the jig is simple. Just follow the instructions below:

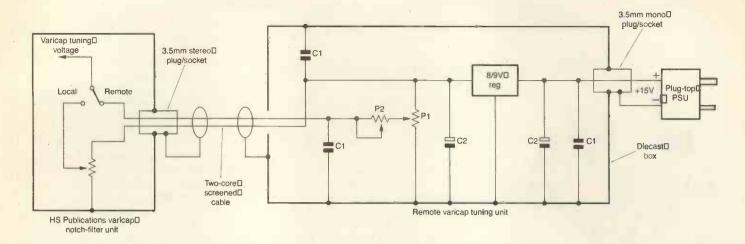
Fig. 1: Remote-control option for use with the HS Publications varicap-tuned notch filter. Reg 7808 or 7809, 1A. C1 0·01μF, 50V. C2 47μF, 25V. P1 4·7kΩ lin. P2 2kΩ lin.
