Llandogo

*Conservation Area
Appraisal &
Management Proposals*

Report Title: Llandogo Conservation Area Appraisal & Management Proposals
Client: Monmouthshire County Council
Project Number: 2009/089

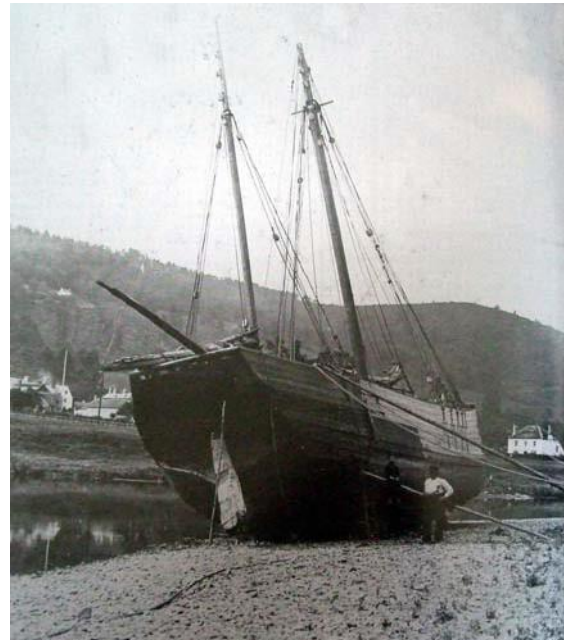
Fig.5 An example of a Trow - a type of flat bottomed boat built in or near the village for use on the river

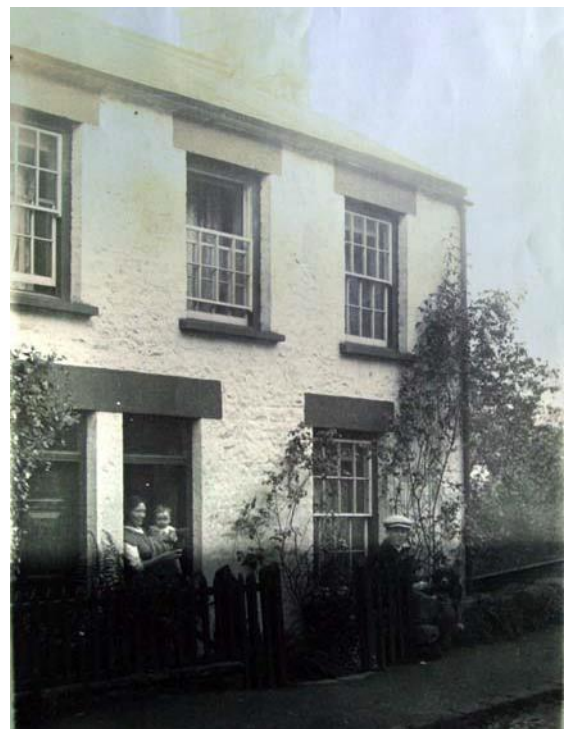
Fig.6 Myrtles, A466 photograph taken c1900 - villagers would have been employed in the local sawmills or engaged in boatbuilding on the riverside

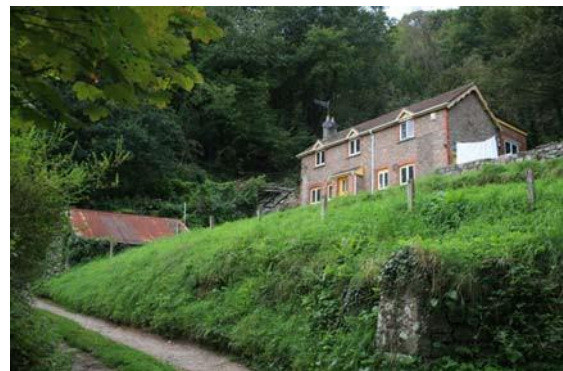
Fig.9 Topography plays a key role in defining the character of Llandogo

7.2.3 The topography of the village plays an essential role in defining the character of the Conservation Area. The historic village comprises small cottages and modest houses scattered over the hillside, most built into the bank with varied orientation but using the contours of the hillside to provide both protection and maximise sunlight. Each has their own small gardens, paddocks or orchards (**Fig.9**).

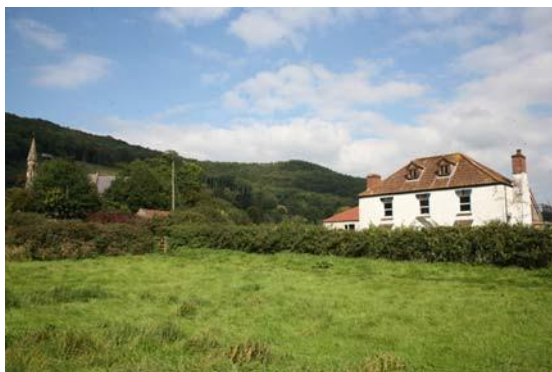
Fig.12 Holm Farmhouse with St Oudoceus's church in the background

7.3.5 In the northern part of the character area, there is a positive group of larger buildings, spaced further apart, and centred on the church. They comprise: The Sloop Inn, Wydean, Holm Farmhouse and the church itself. All four buildings are distinctive due to their size and status. Holm Farmhouse (Fig.12) is more isolated, surrounded by fields, south of the church. The close proximity of Wydean and The Sloop Inn either side of the lower lane running parallel to the A466 produces a sense of intimacy and historic character. The buildings are linked by the central position of the modest, Gothic style, Victorian church located in its stone-walled circular churchyard.

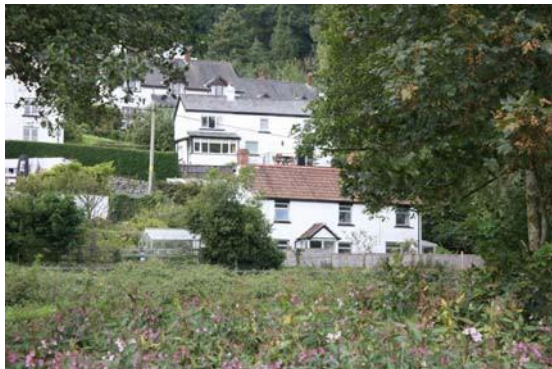
Fig.13 Hillside development in Llandogo displaying the usual painted rendered finish and a mix of slates and tiles to roofs

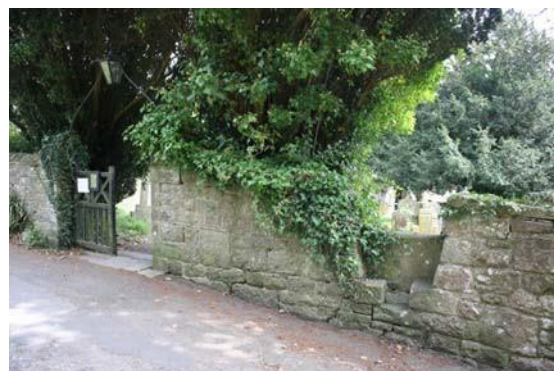
Fig.16 St Oudoceus churchyard wall including stone stile

7.3.9 As on the hillside, the river bank properties are linked by narrow winding footpaths, such a distinctive feature of the Conservation Area. The local quartz conglomerate rubble stone is to be found on the paths, in steps and boundary walls; the most impressive being the circa 17th century, Grade II listed, churchyard wall (Fig.16).

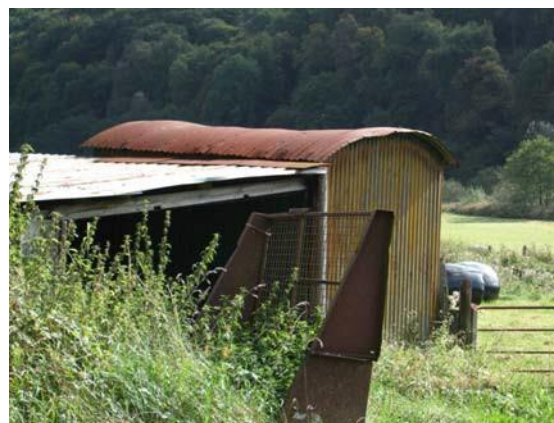
Fig.17 Llandogo Halt - Surviving Shelter

7.3.10 The 'scar' left by the former railway line is another key feature of this character area, recalling this once important transport link. The corrugated iron shelter, once located on Llandogo Halt, remains near Holm Farmhouse (Fig.17).

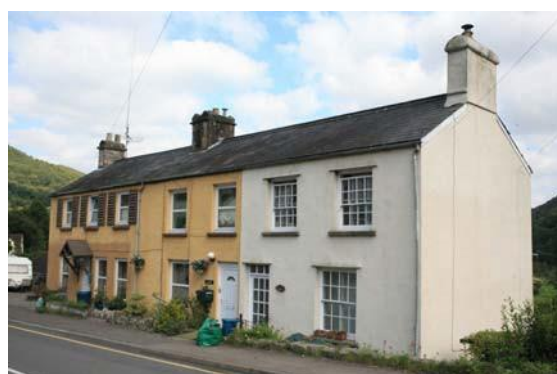
Fig.20 Enclosure to the roadside created by the terrace fronting the A466

7.3.13 Houses fronting the A466 are built into the bank and appear taller on the east side, often with cellars/lower rooms visible on the rear elevation. On the east side there are a collection of seven houses, including a short terrace, which form a strong building line (Fig.20). A further three (Greengate, Stoneleigh and Fox Cottage) are set back off the road facing the river rather than the road. As a result of this varied building line there are distinct pinch-points to the townscape which funnel views and signify a sense of arrival to the village core.

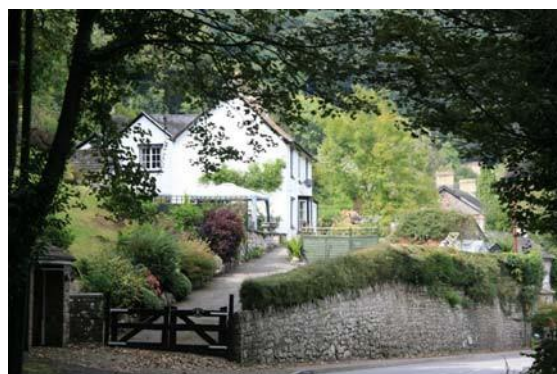
Fig.21 Pentwyn House with its prominent stone retaining walls at the southern entrance to the village

7.3.14 At the southern entrance to the village two groups of good quality buildings lie either side of the A466. To the west is Pentwyn House, set back above the road on top of a stone wall (Fig.21), and, next to a stone outbuilding and water trough, Spring Cottage. To the east, further into the village, The Old Bakery, Rose Bank, Penrhos Cottage and Myrtles, stand on the side of the road. The stone houses, some rendered, others simply painted white, retain their key features including barge-boards and timber sashes or casements.

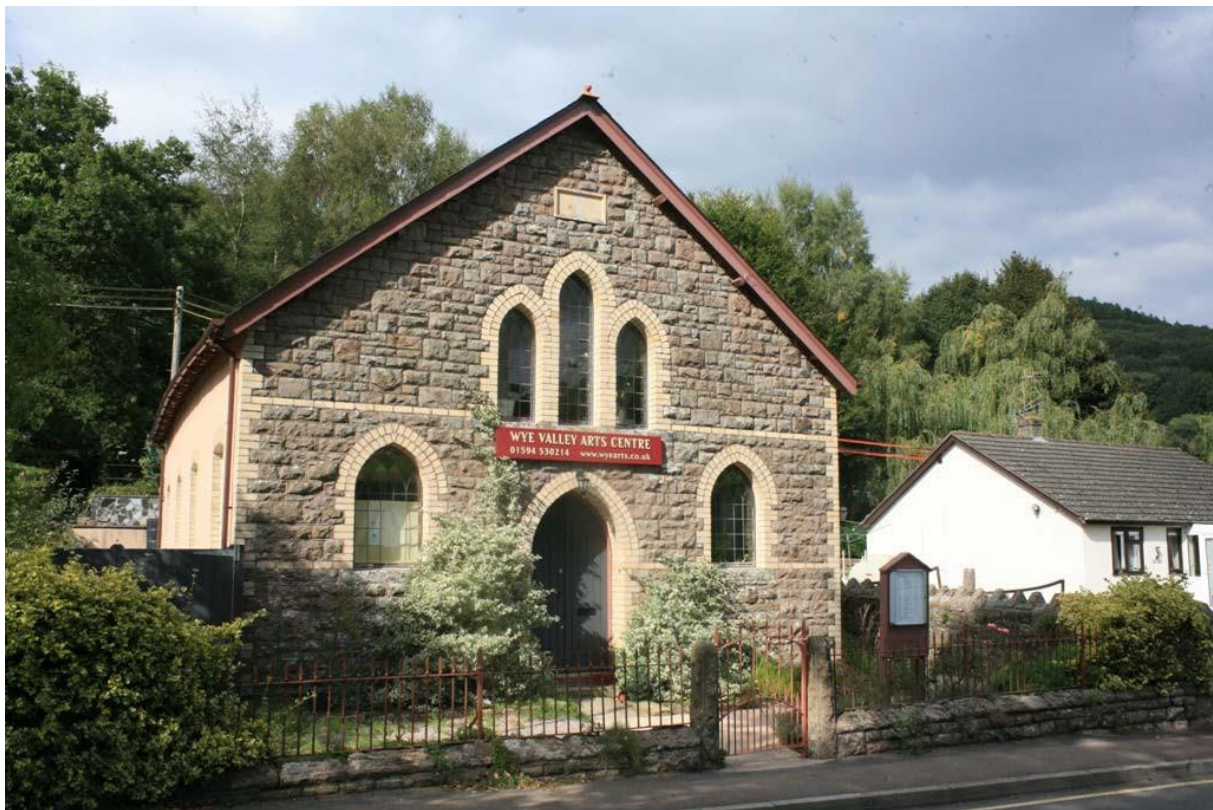
Fig.22 Wye Valley Arts Centre, formerly the Baptist Chapel

7.3.17 The rock-faced stone Baptist Chapel with yellow brick dressings (Wye Valley Arts Centre) (Fig.22) and sandstone School building (Gallery House) are two important but somewhat isolated historic buildings north of the church. The Sloop Inn (its oldest section dated 1707 – datestone to the rear gable) (see photo 25) has suffered the consequences of modernisation with concrete roof tiles, replacement windows, stone cladding with raised pointing, and a large functional, but

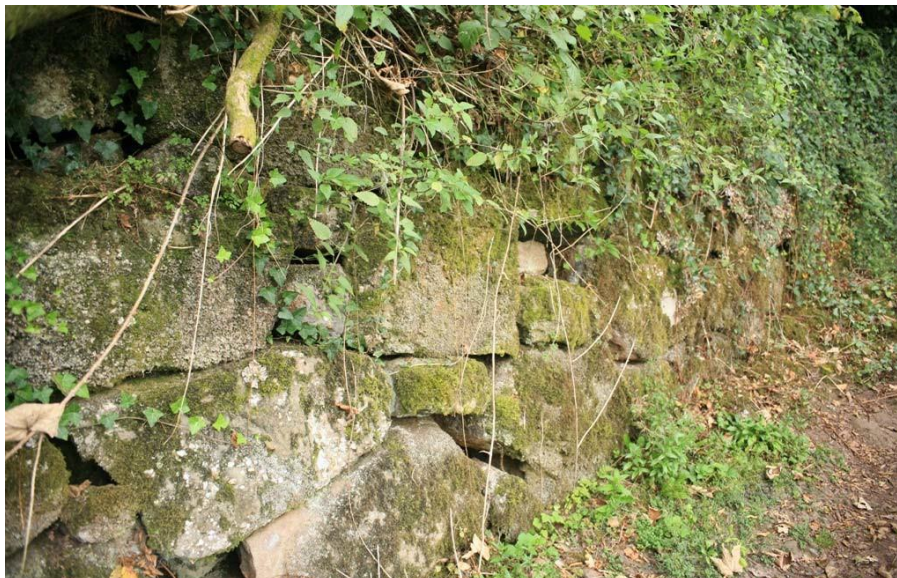
Fig.25 Dry stone walls are a defining local feature of the Conservation Area

7.3.24 Local features include the dry-stone walls, collapsing in places, and now picturesquely covered in moss and ferns (Fig.25). Broken millstones, quarried from the hillside, can be found lodged in the walls, acting as stepping stones over the stream, or left discarded in the woods and hidden by moss and trees further adding to the picturesque qualities of this intimate landscape.

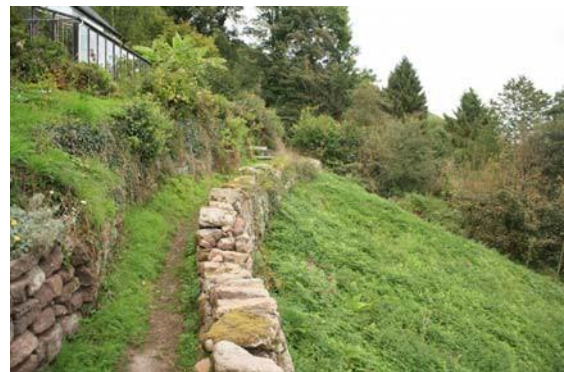
Fig.31 Footpaths are often demarked by stone walls

7.3.30 Local features, in common with most of the Conservation Area, include the sunken, stone-walled paths (**Fig.31**) between houses and the millstones either built into walls or displayed in driveways.

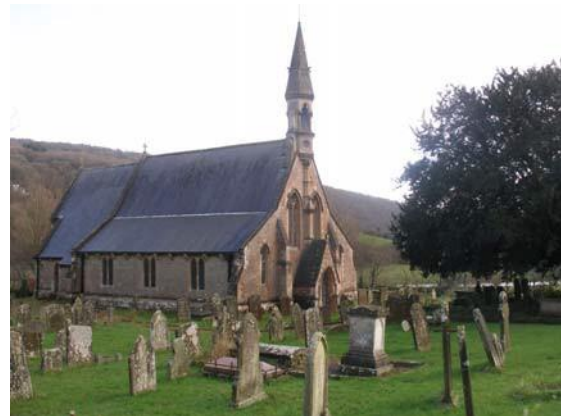
Fig.37 The church of St Oudoceus

7.4.9 The church of St Oudoceus (**Fig.37**) is a complete replacement in the Victorian Gothic Revival, on a modest scale. Its octagonal belfry topped by a steep conical capping is a local landmark. The church constructed in snecked red sandstone with Bathstone dressings, was completed in 1861, although there was some rebuilding in the late Victorian period.

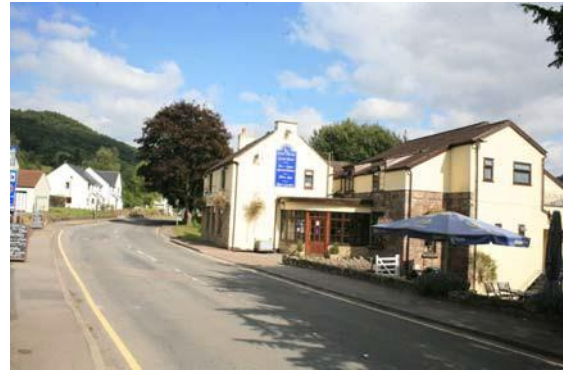
Fig.40 The Sloop Inn - a prominent building in views along the A466

7.6.3 The second group is also to the south side of the A466 but is centred around the green and churchyard to the south. This distinctive group includes The Sloop public house, a prominent building in local views along the main road (**Fig.40**) and with an earlier 18th century core of special interest. The Sloop and the houses to the south, and the church of St Oudoceus (Grade II listed) form a group of considerable character and special interest.

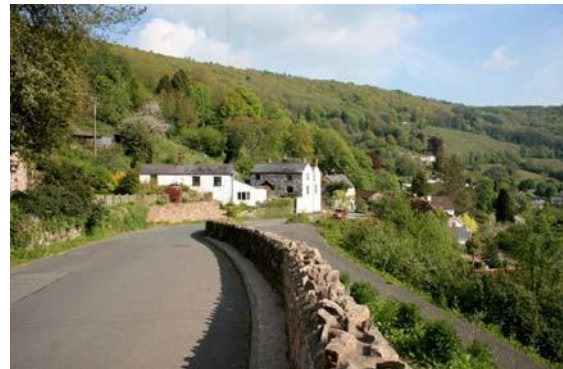
Fig.41 Relationship of houses to the carriageway, linked by boundary walls, retaining walls & steep banks

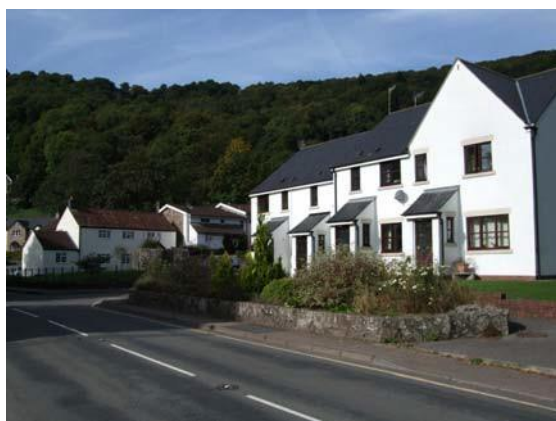
Fig.42 Use of render in modern infill

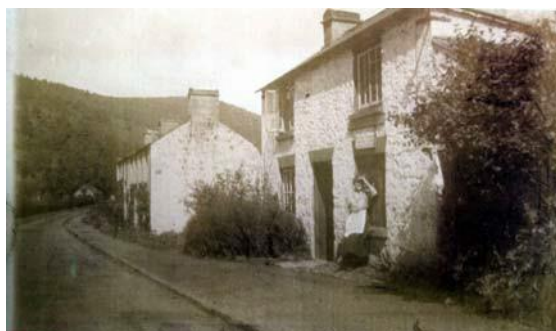
Fig.43 Photo taken c1900 showing traditional use of limewash to stone walls

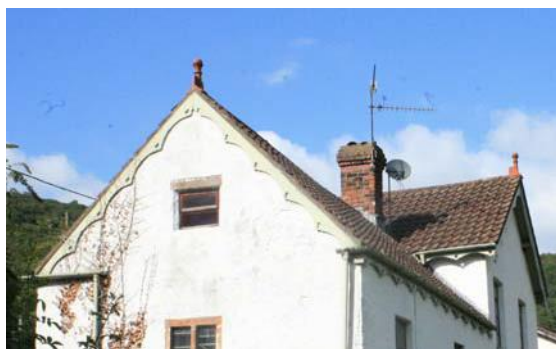
Fig.44 Decorative barge-boards

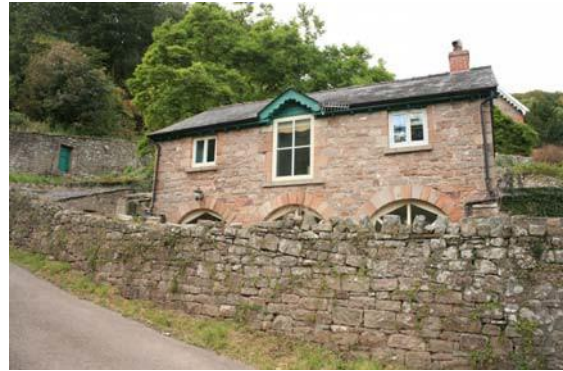
Fig.45 Rubblestone boundary wall

7.7.6 A key characteristic building type of the Conservation Area is the rubblestone boundary wall (**Fig.45**). These are often also retaining walls. Boundary walls define much of the intricate and complex series of footpaths and lanes which criss-cross the hillside and part of the riverside character areas. In addition, stone steps and stream culverts (**Fig.46**) are also seen as part of the footpath and lanes network. These walls are generally of a dry stone construction with large rubblestone components and usually uncoursed. Many of these are either partially or occasionally completely covered with moss/vegetation, which add to their picturesque qualities although in some cases this is affecting the structural stability of these important features.

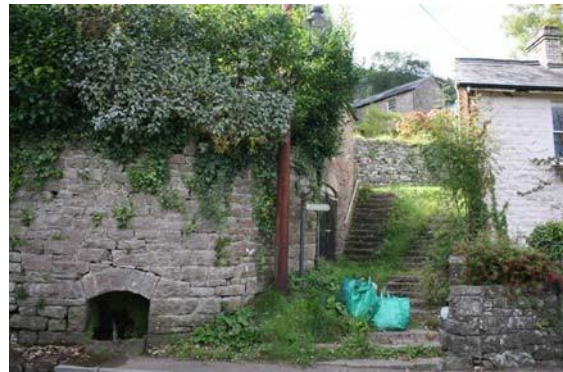
Fig.46 Stone steps & stream culvert

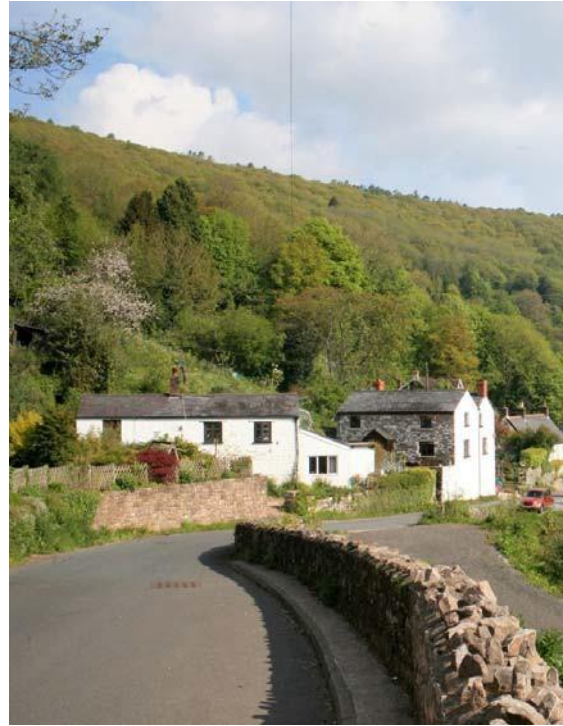
Fig.56 Terminated view found in the hillside character area

9.2.5 Due to the nature of the settlement pattern, there are very few terminated views to be had within the Conservation Area. There are some notable exceptions to the hillside character area, where houses set on the edge of the lanes partially terminate views along those lanes. This is sometimes emphasized by further buildings lining the lane or high stone retaining walls defining the roadside (**Fig.56**).

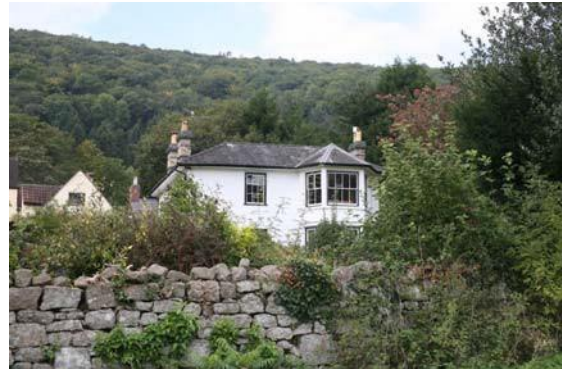
Fig.58 Dry stone boundary walls are important features throughout the Conservation Area

13.2 The stone walls of the Conservation Area should be fully recorded and monitored and provision for grant aid for repairs (with other partners such as Cadw) should be considered. Where walls are at risk from collapse they should be considered as Buildings at Risk and the Buildings at Risk strategy is directly relevant to their future management.

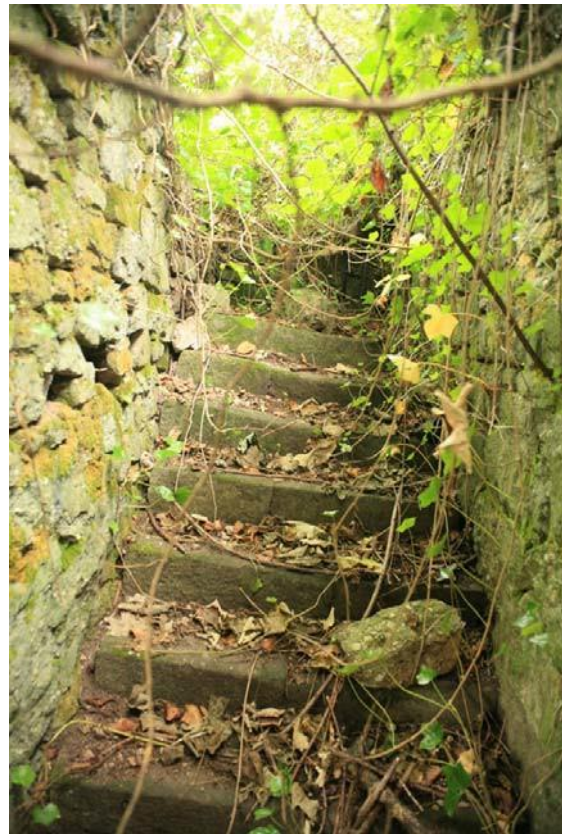
Fig.59 Footpaths are often enclosed to one or both sides by dry stone boundary walls and include important features such as stone steps
