# Currawong Farm

## Bushland Vegetation Snapshot Habitat Survey

Eco-restoration planning as part of Gondwana Link

## September 2019- Draft Report

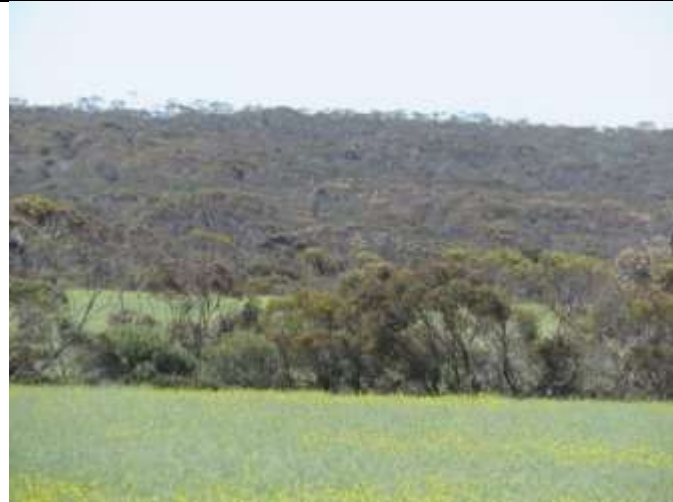
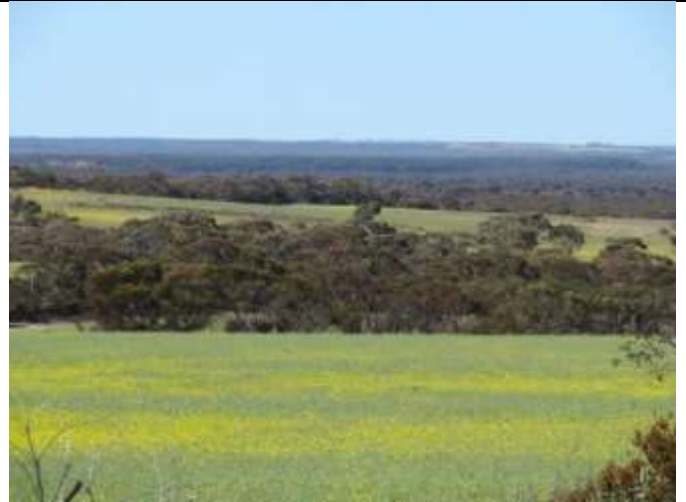
Site 40

SITE NO.	AREA (hectares)/ PERIMETER (metres)	VEGETATION TYPE	VEGETATION CONDITION: 1-VERY DEGRADED TO 5- EXCELLENT	PRIORITY FOR MANAGEMENT LOW, MEDIUM, HIGH, VERY HIGH
40, 41, 42, 43	40: 0.89ha/1129m 41: 0.83ha/790m 42: 0.71ha/841m 43: 0.5ha/655m	MALLEE HEATH	2 - DEGRADED	LOW

- Low priority for fencing, management
- Landholder wants to clear 40, 41, 42, 43 (particularly 42 & 43)
- All remnants have high edge to area ratio (long thin vegetation corridors) and have been assessed as being in a Degraded condition
- Some of the remnants contain good food plants for Black cockatoos

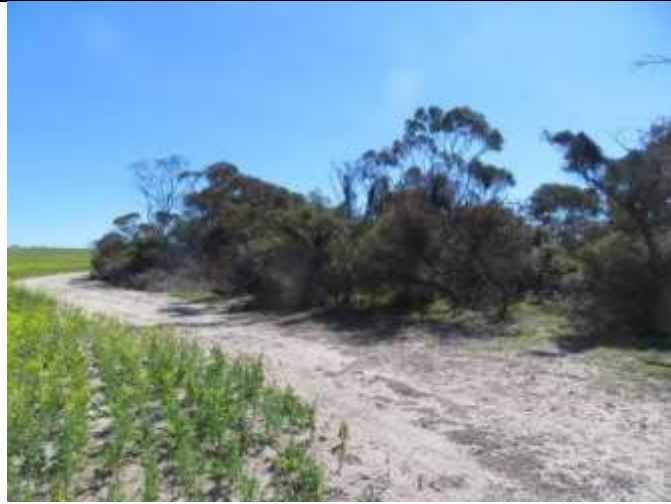
SITE NO.	AREA (hectares)/ PERIMETER (metres)	VEGETATION TYPE	VEGETATION CONDITION: 1-VERY DEGRADED TO 5- EXCELLENT	PRIORITY FOR MANAGEMENT LOW, MEDIUM, HIGH, VERY HIGH
73	2.62ha/478m	MALLEE HEATH	3-4 – GOOD TO VERY GOOD	HIGH

Site 73: 2.62 ha unfenced remnant Mallee heath vegetation

Site 73: Assessed to be in Good to Very Good condition

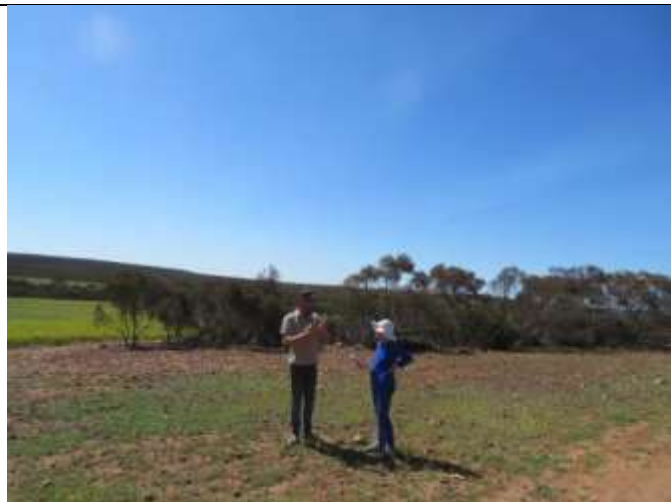
**Site 35: Small isolated Mallee heath remnant (background)**

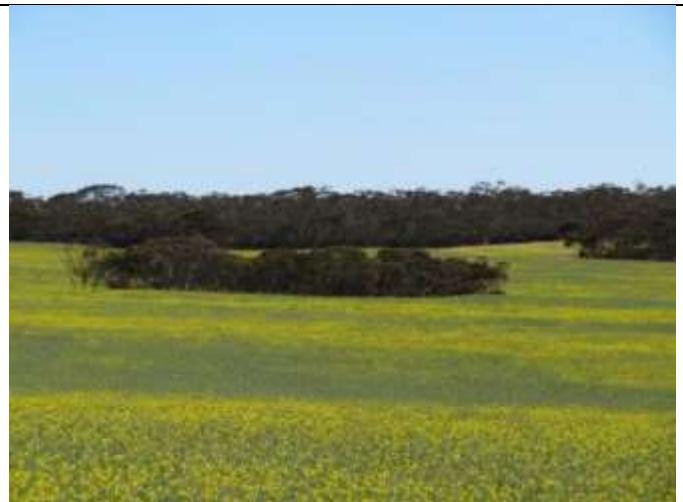
**Site 37: Isolated Mallee heath remnant in good condition**

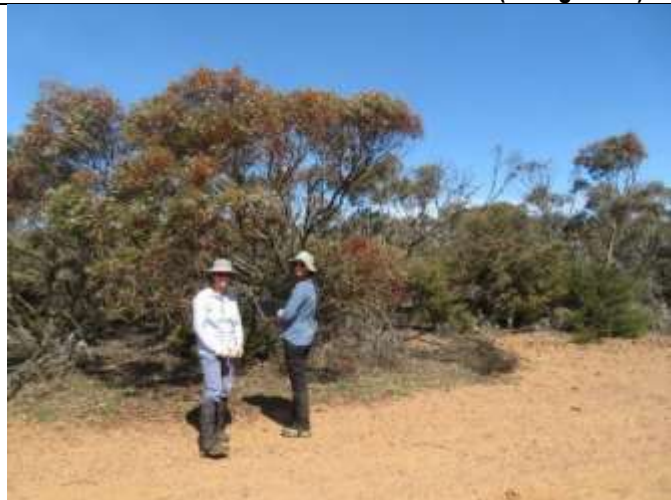
**Site 74: Large 6.4 ha unfenced Mallee heath remnant**

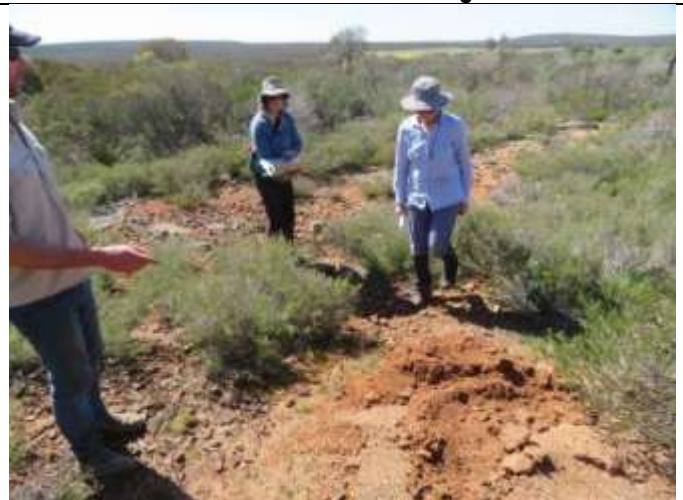
**Site 74: Echidna diggings**

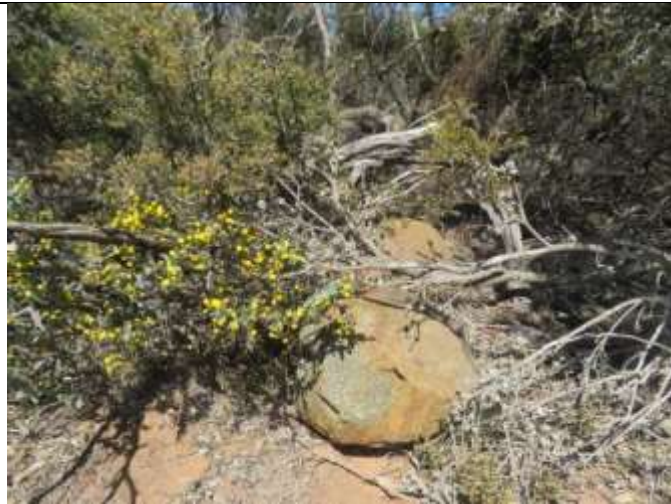
Site 74: Good habitat complexity within the remnant

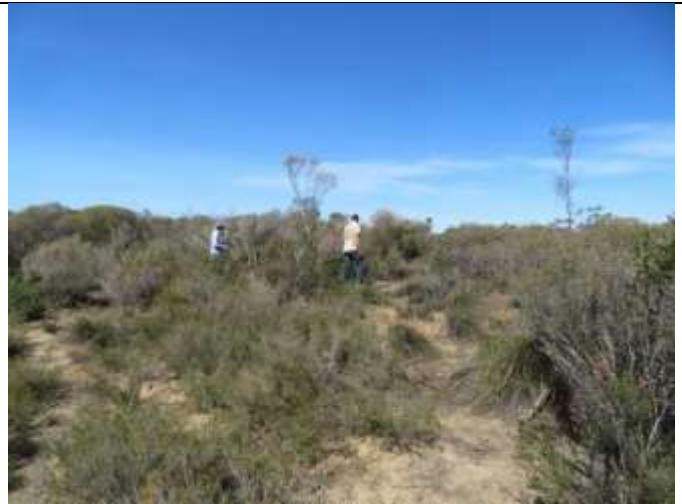
Site 74: 6.4 ha Mallee heath remnant vegetation to be fenced

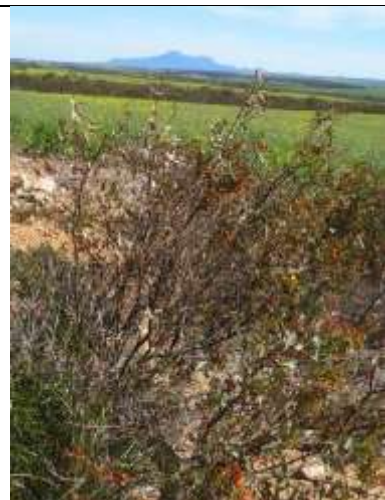
Site 69: *Gastrolobium spinosum* (Prickly Poison) is extremely toxic to stock

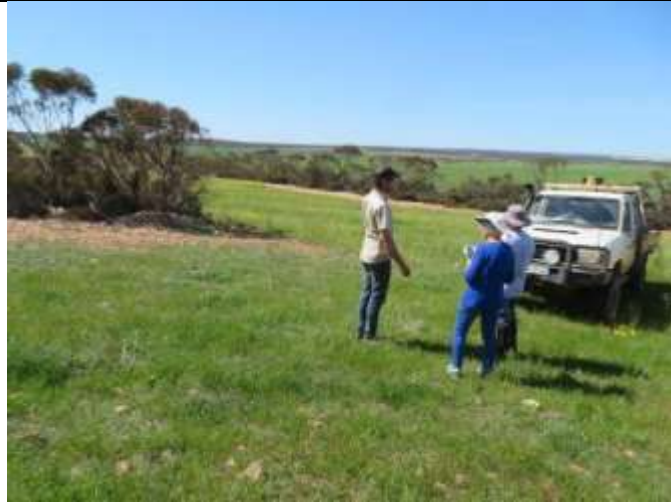
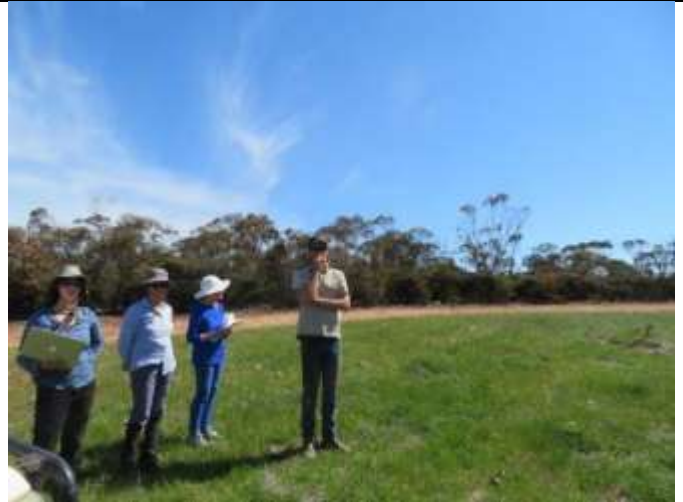
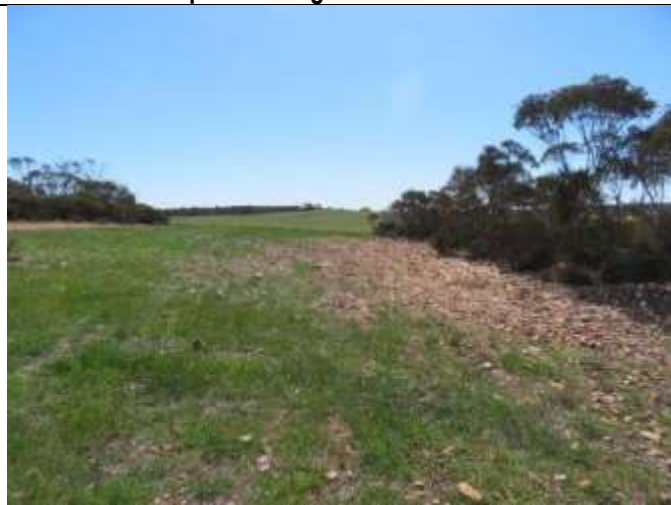
Site 14 & 69: Proposed revegetation area between sites

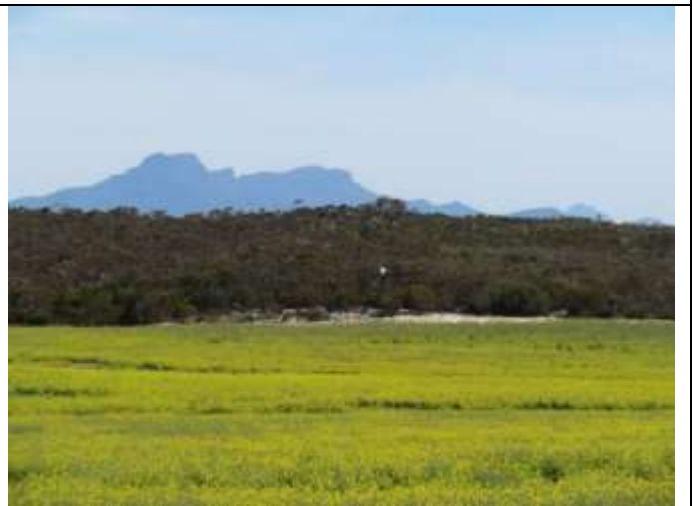
**Site 101: View of the Stirling Ranges to the west**

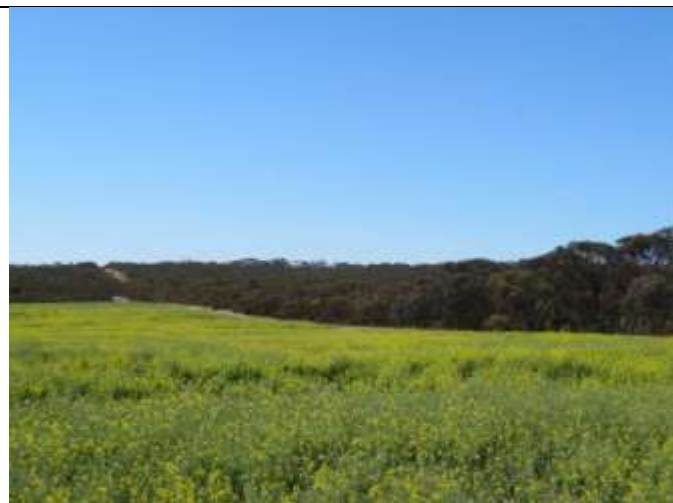
**Site 101: Mallee heath on the south-eastern corner boundary of the property**

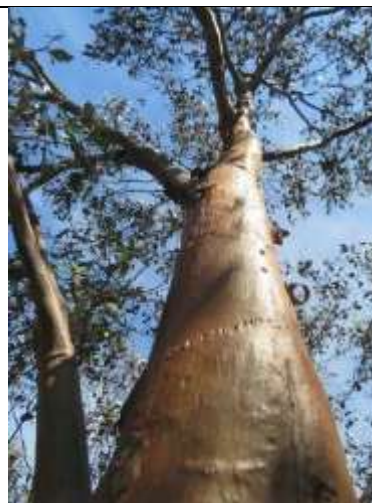
**Site 101: Red Moort (*Eucalyptus vesiculosa*), a Priority 4 conservation species.**
