**PINE-STRAWBERRY WATER IMPROVEMENT
DISTRICT**

**PRELIMINARY ENGINEERING REPORT
FOR
WATER DISTRIBUTION SYSTEM IMPROVEMENTS**

September 2020

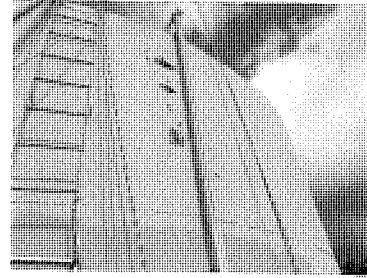
ACCESS LADDER

SUMMARY: Excellent
